# Full-Scale Crash Evaluation of a Modified Eccentric Loader Terminal, Final Report

PUBLICATION NO. FHWA-RD-99-031

SEPTEMBER 1999

| 9. Performing Organization Name and Address<br><br><b>Southwest Research Institute<br/>6220 Culebra Road<br/>San Antonio, Texas 78238-5166</b> | | 10. Work Unit No.(TRAIS) | |

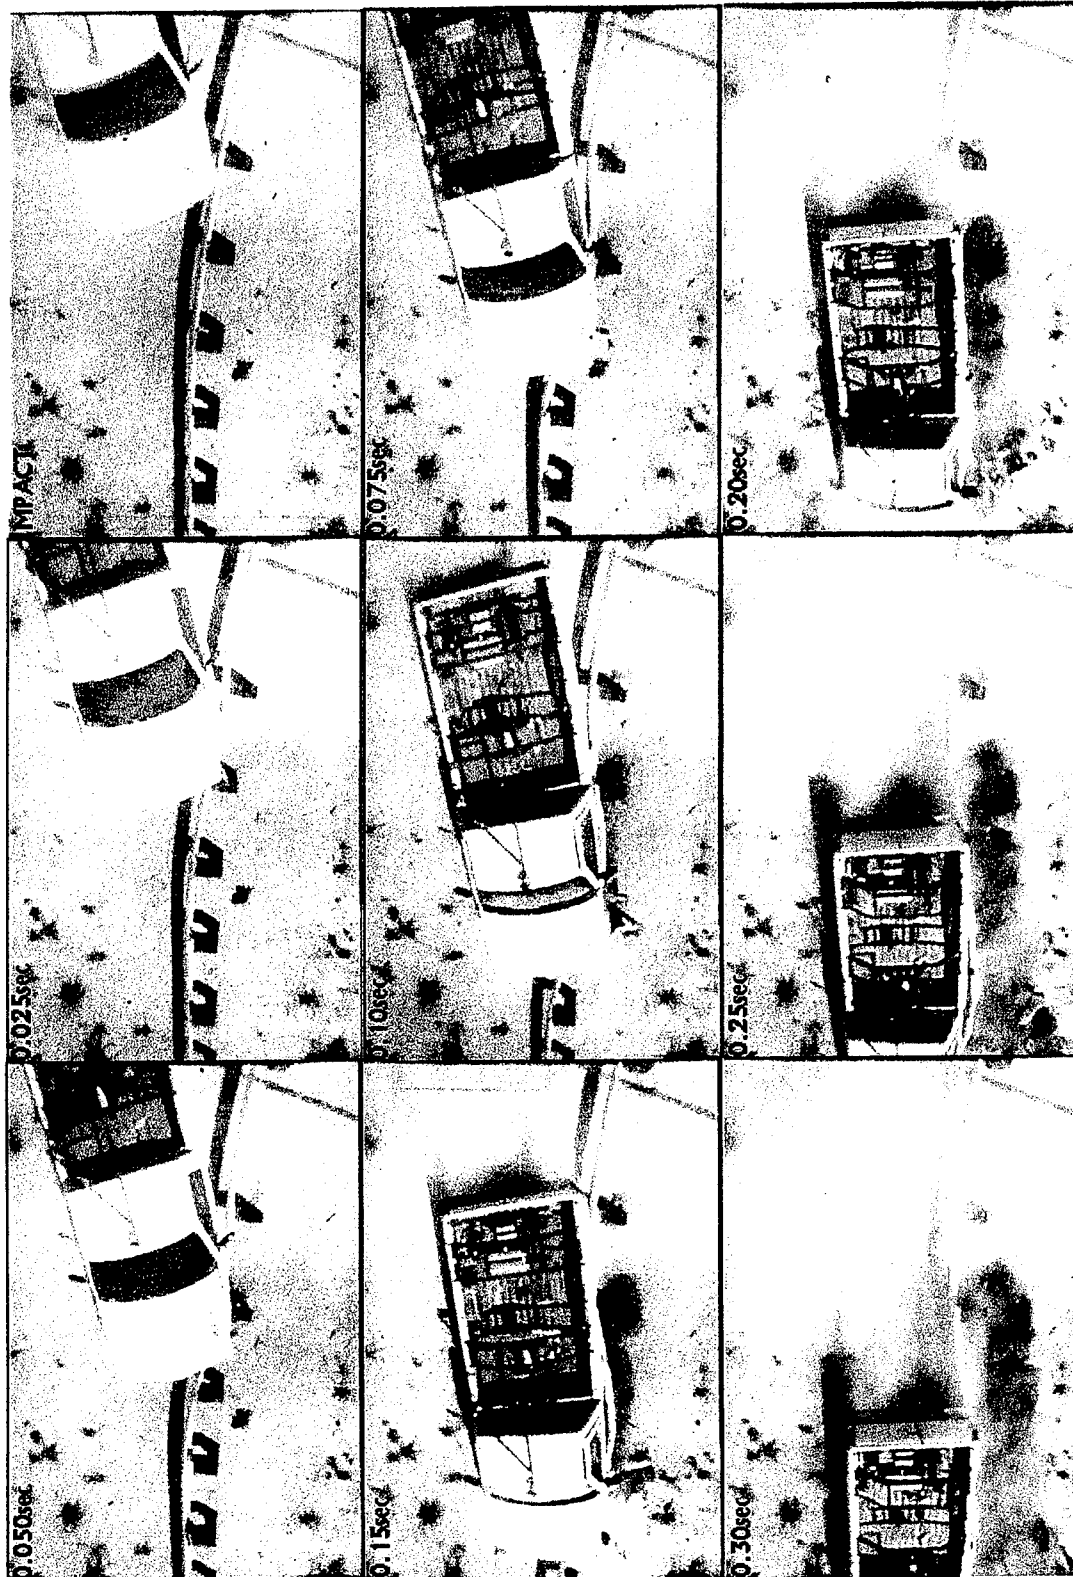
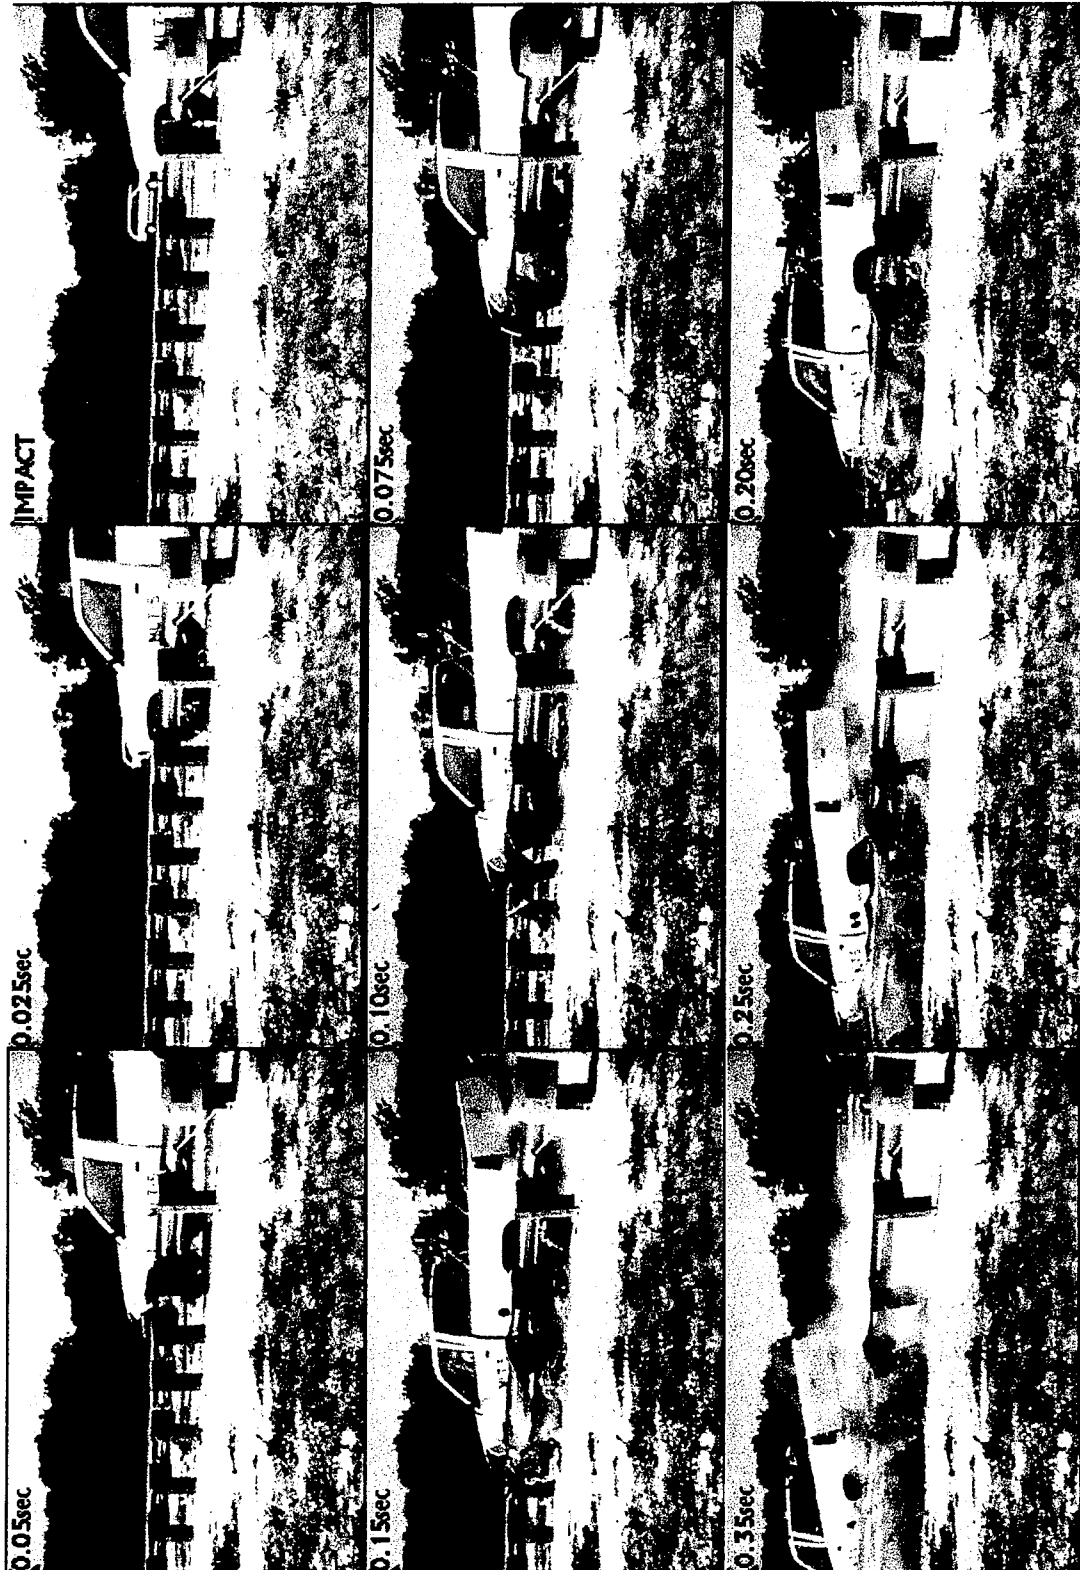
tion. The vehicle fractured posts 5 through 8, was smoothly redirected, and rolled to a stop 36.2 m downstream of impact. Figures 16 and 17 show the impact sequence of the vehicle from above and behind the barrier. Maximum 50-msec average accelerations measured from onboard transducer data indicated -5.8 G's longitudinal and 4.6 G's lateral.

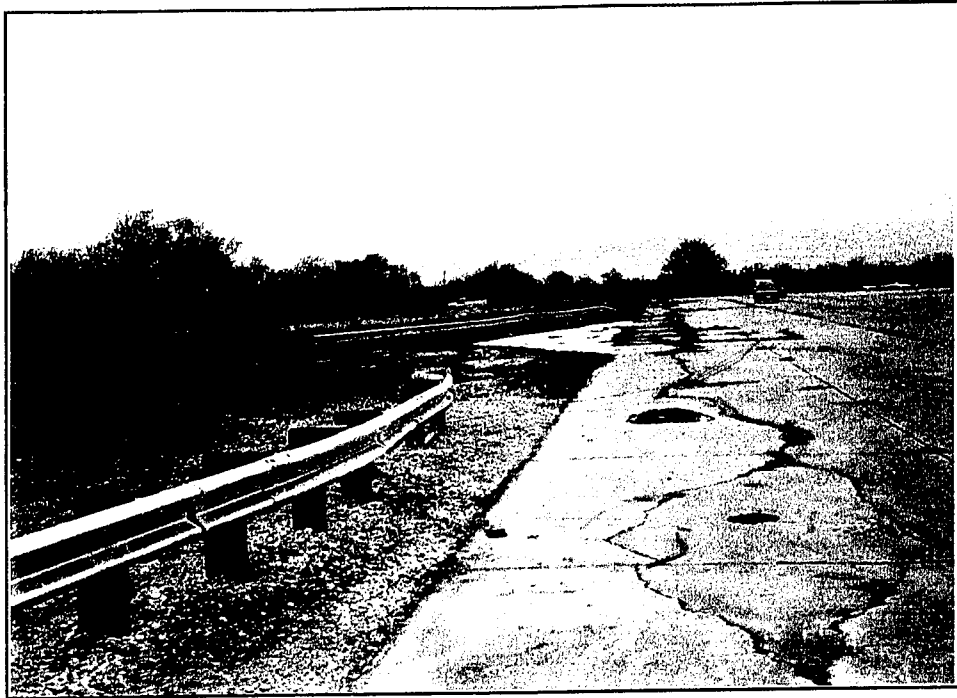
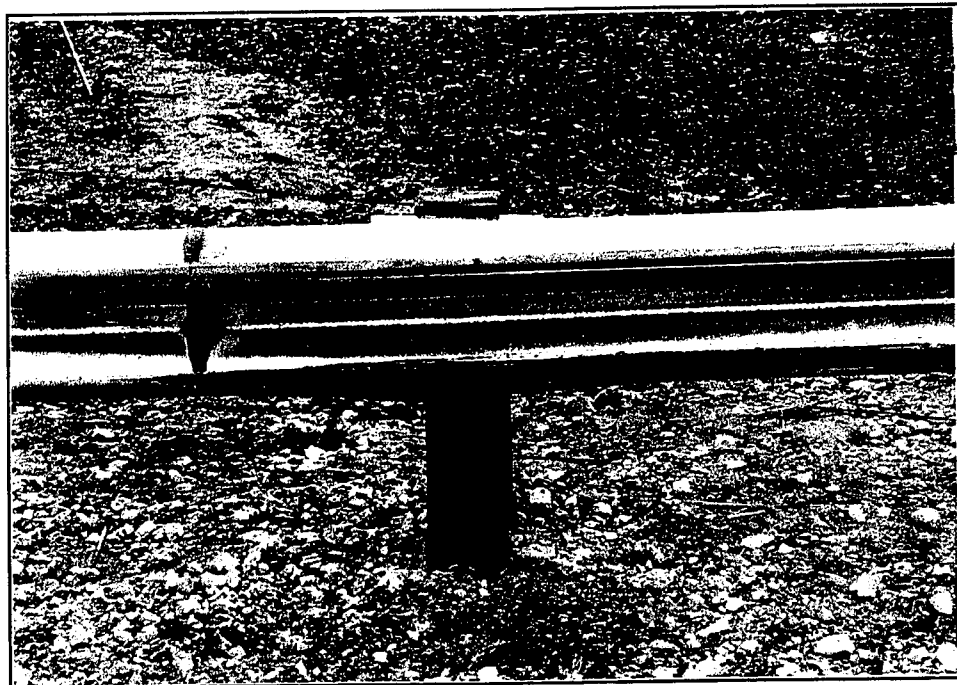
**Figure 18. Barrier damage photographs - Test MLT-1.**

**Test MLT-1.** Damage to the barrier, as shown in figure 18, consisted of fracturing of post 3 and deformation of two 3.8-m sections of w-beam. Permanent barrier deflection was 0.1 m after the test.

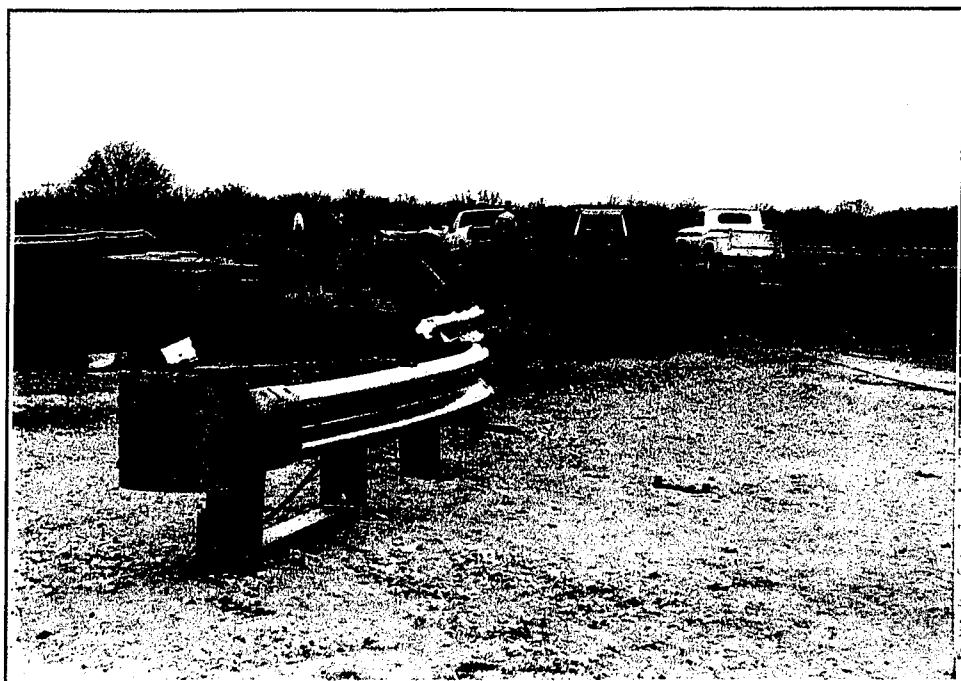
**Figure 19. Barrier damage photographs - Test MLT-2.**

**Test MLT-2.** Damage to the barrier, as shown in figure 19, consisted of fracturing at ground level of posts 4 through 8 and deformation of two 3.8-m sections of w-beam. Permanent barrier deflection was 0.4 m after the test.

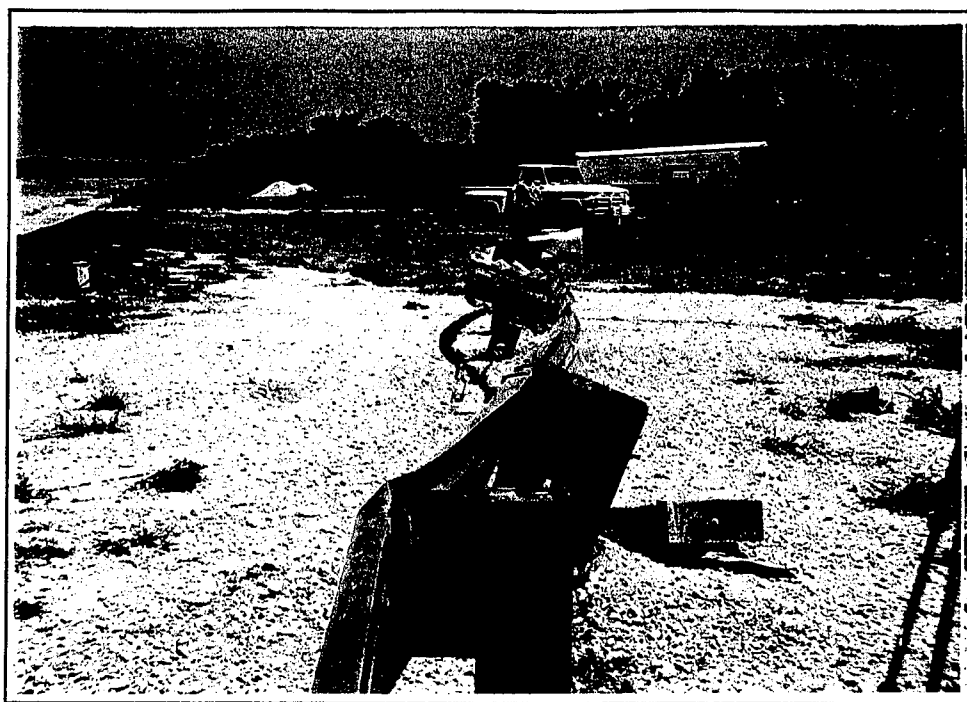
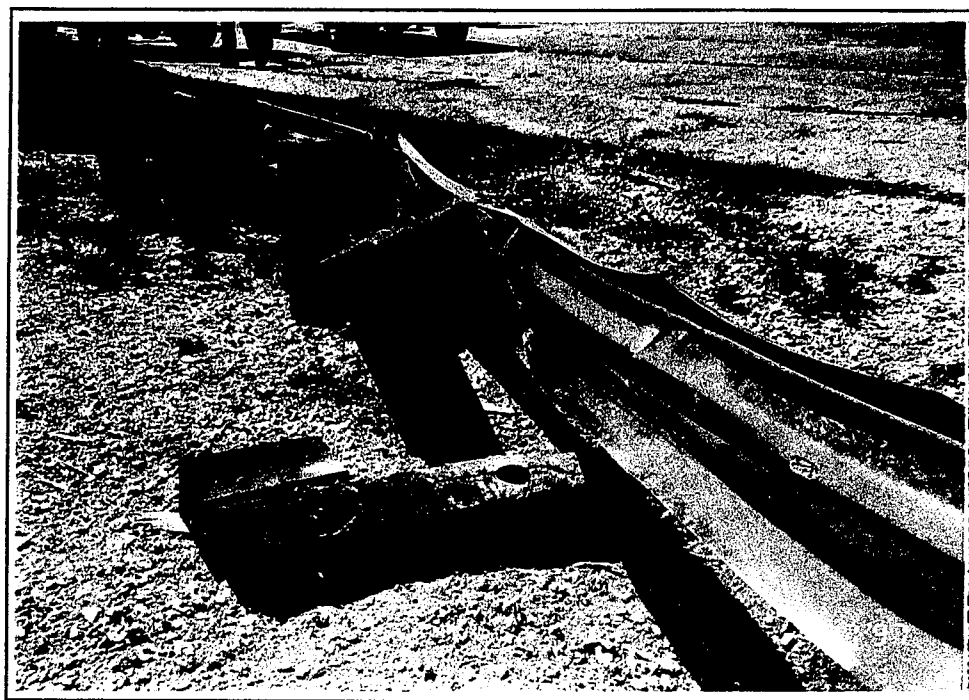
**Figure 21. Barrier damage photographs - Test MLT-5.**

**Test MLT-5.** Damage to the barrier, as shown in figure 21, consisted of fracturing at ground level of posts 5 through 8 and deformation of three 3.8-m sections of w-beam. Permanent barrier deflection was 1.1 m after the test.

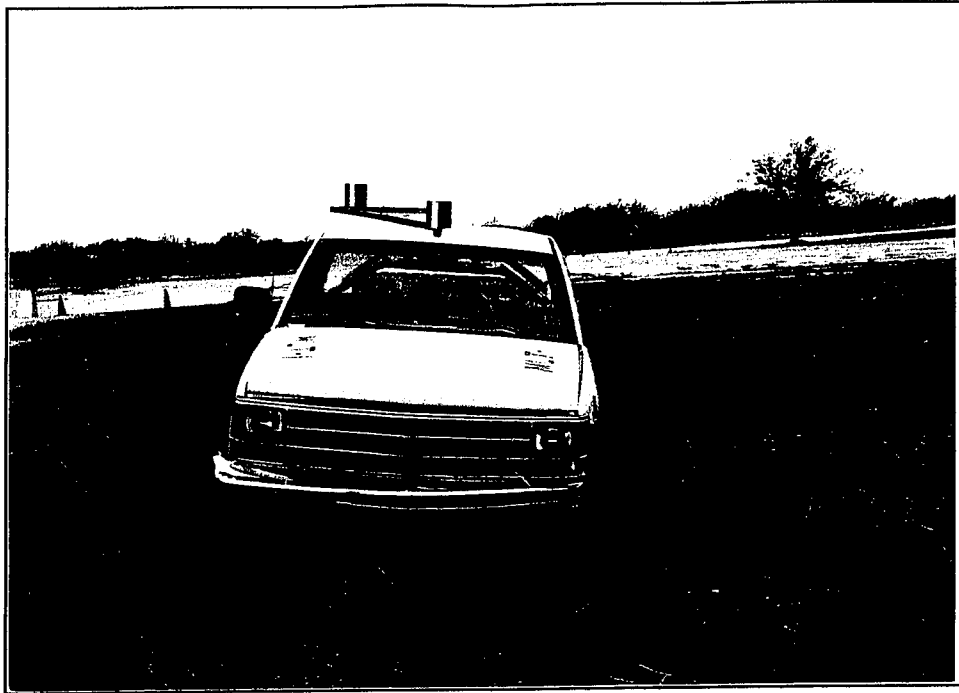
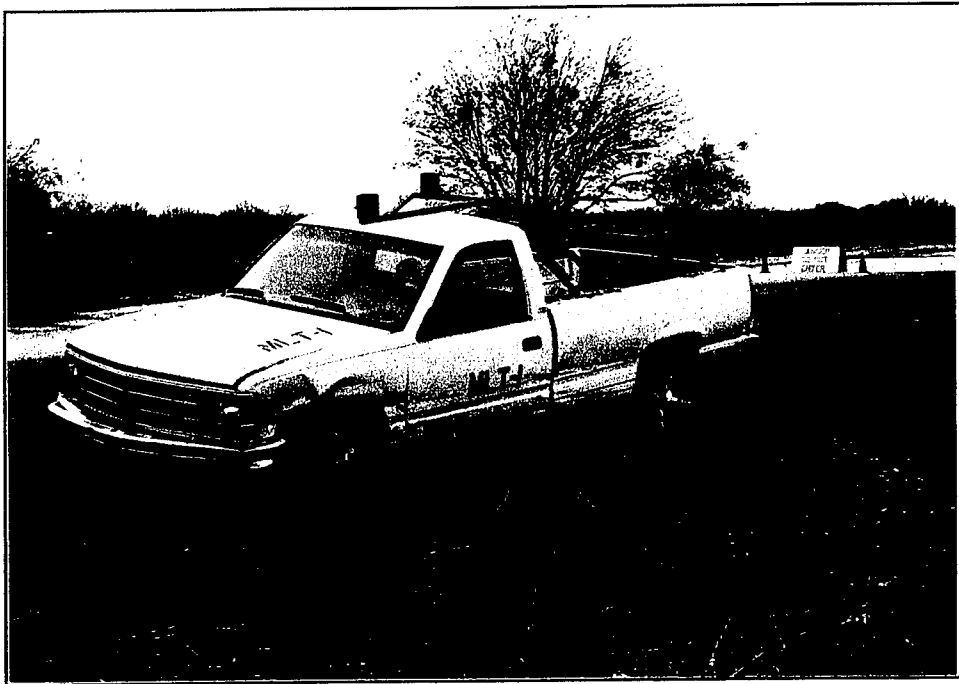
**Figure 22. Vehicle damage photographs - Test MLT-1.**

**Test MLT-1.** As shown in figure 22, the test vehicle sustained damage to the left front fender and along the left side, as well as damage to the headlight/grille area. The left side

of the front bumper was deformed rearward, and the left front suspension/wheel/tire displaced rearward. The left front tire was blown out as a result of the impact. The exterior vehicle damage scale was estimated to be 11-LFQ-2 using the VDS system and 11FFEN9 using the CDC system. The interior deformation of the occupant compartment was LF0000000 using the OCDI system. There was no deformation or intrusion into the occupant compartment.

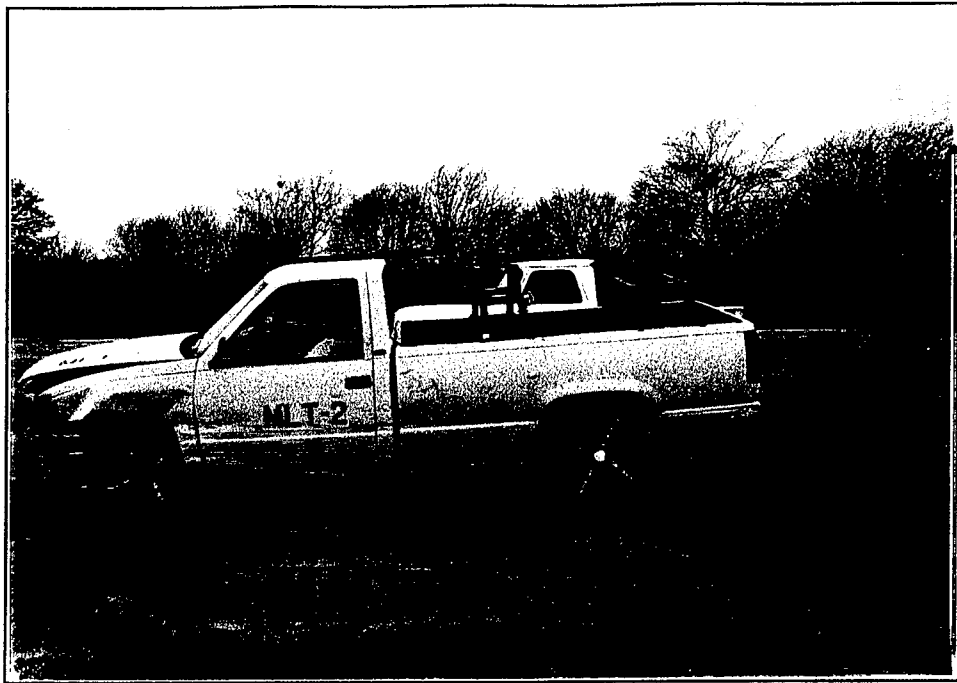
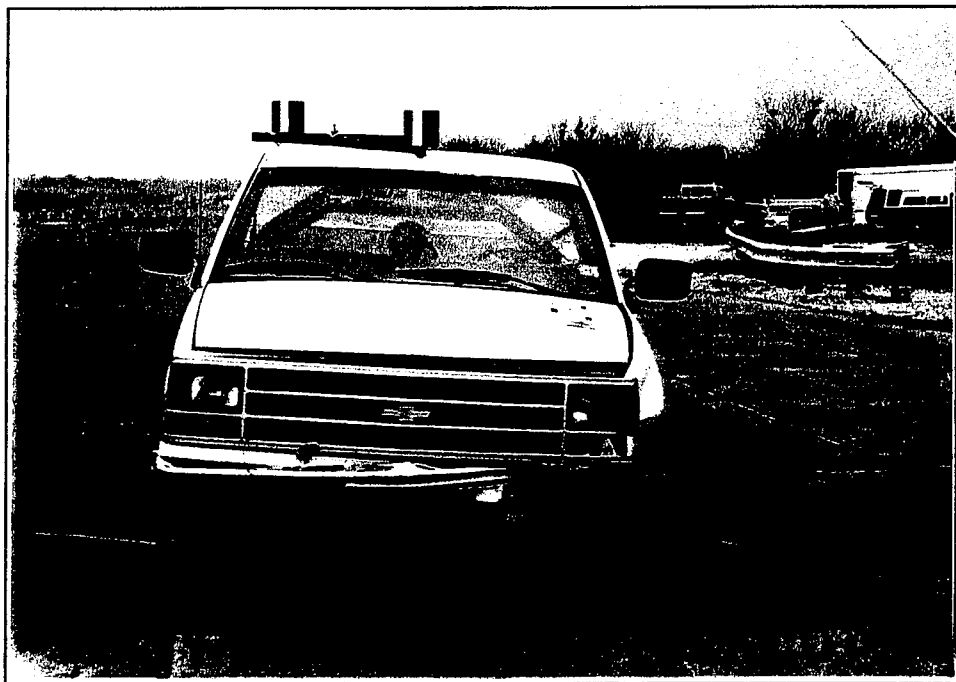
**Figure 23. Vehicle damage photographs - Test MLT-2.**

**Test MLT-2.** Figure 23 shows that the test vehicle sustained damage to the left front fender and along the left side, as well as damage to the headlight/grille area. The left side of the front bumper was deformed rearward, and the left front suspension/wheel/tire displaced rearward and inward. All tires remained inflated during impact. The exterior vehicle damage scale was estimated to be 11-FQ-3 using the VDS system and 11FFEN9 using the CDC system. The interior deformation of the occupant compartment was LF0000000 using the OCDI system. There was no deformation or intrusion into the occupant compartment.

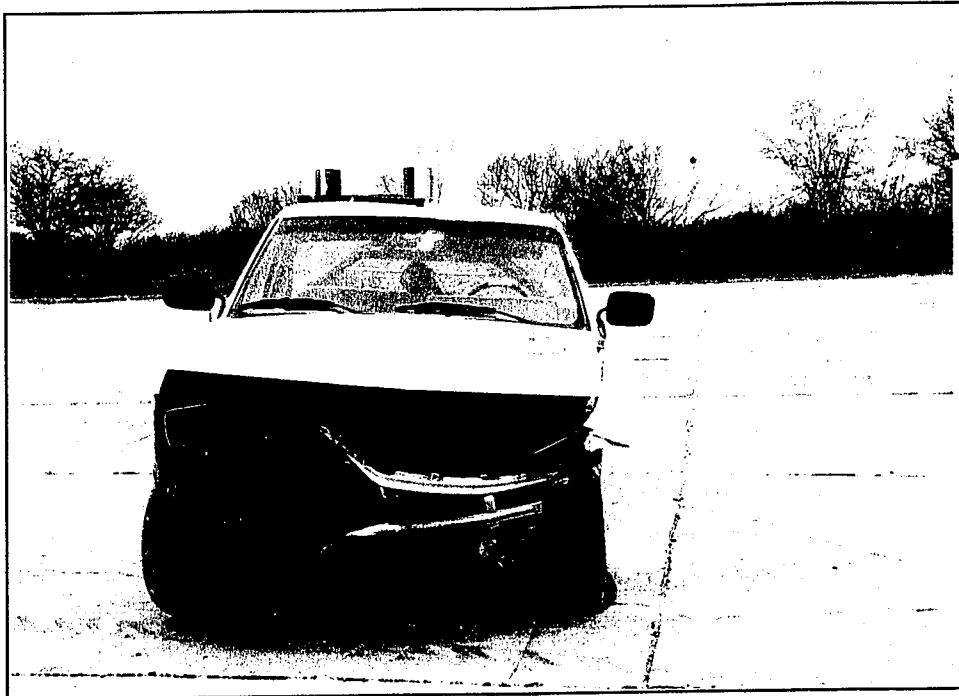
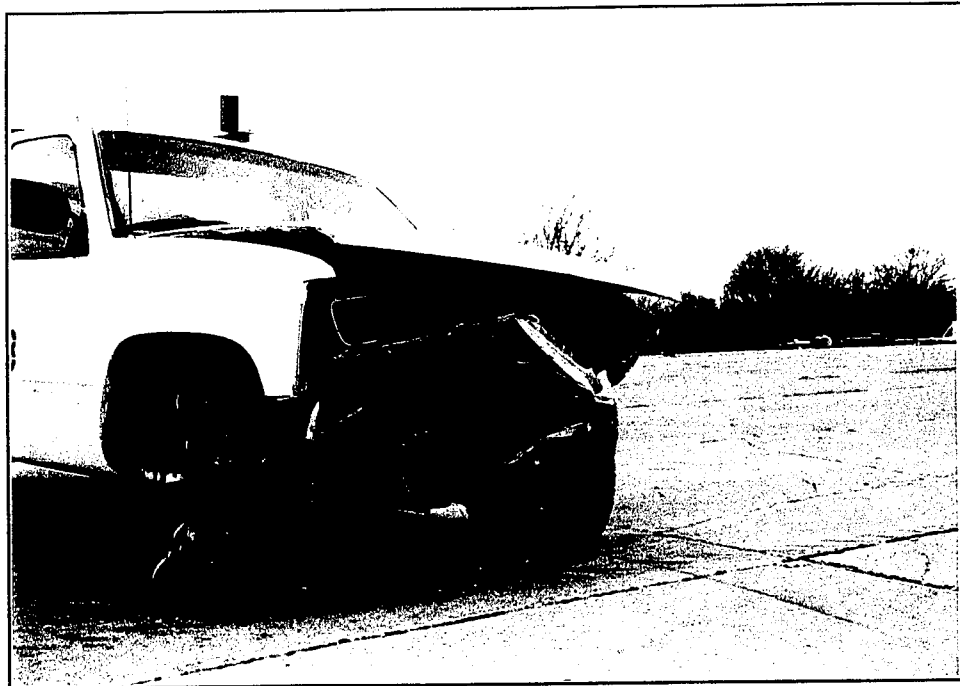
**Figure 24. Vehicle damage photographs - Test MLT-3.**

**Test MLT-3.** The test vehicle, as shown in figure 24, sustained significant sheet metal damage. The left front fender and side were damaged as well as the entire front bumper, grille/headlight area. The radiator and mounting shell was deformed into the engine compartment. All tires remained inflated during impact, although the left front tire deflated some time after impact. The exterior vehicle damage scale was estimated to be 11-FQ-4 using the VDS system and 11FFEW9 using the CDC system. The interior deformation of the occupant compartment was LF0000000 using the OCDI system. There was no deformation or intrusion into the occupant compartment.

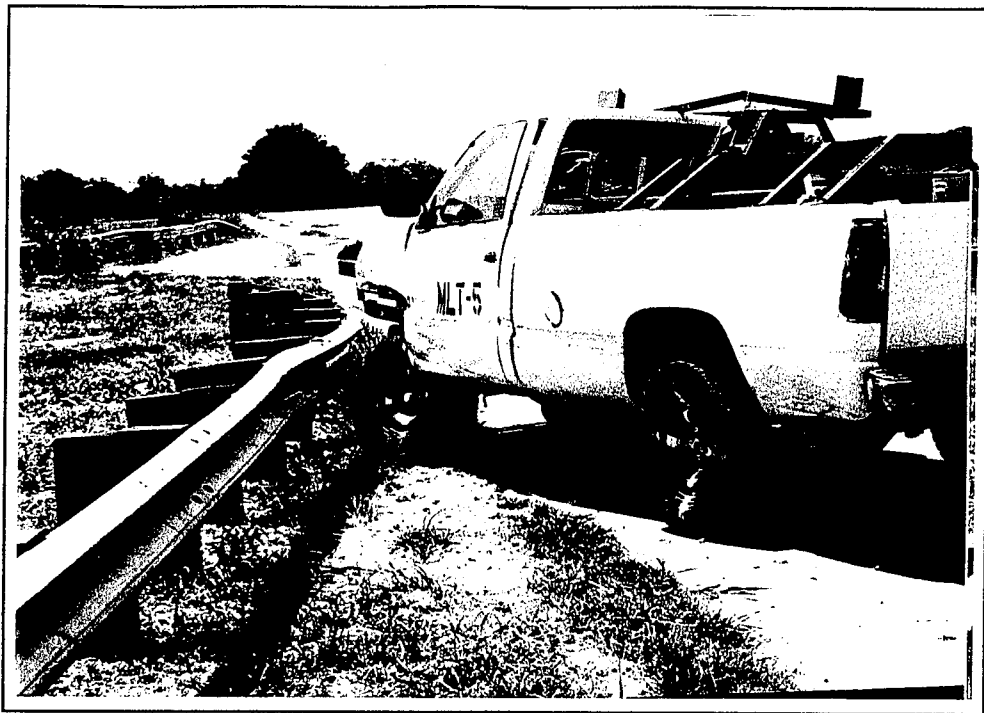
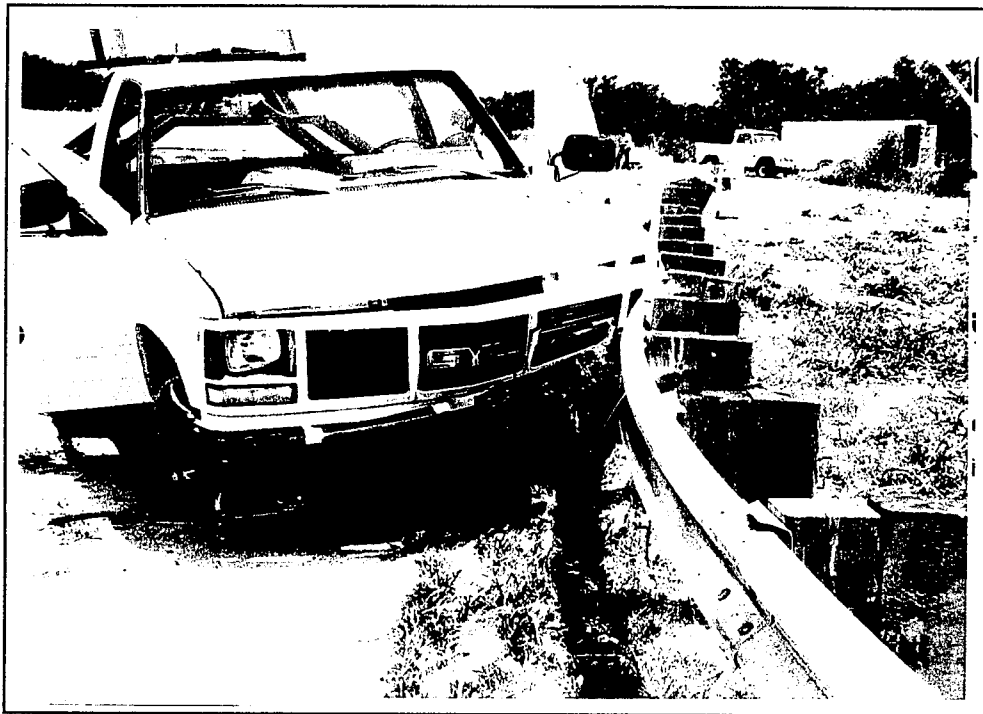
**Figure 25. Vehicle damage photographs - Test MLT-5.**

**Test MLT-5.** Figure 25 shows that the test vehicle sustained damage to the left front fender and along the left side, as well as damage to the headlight/grille area. The left side of the front bumper was deformed rearward, and the left front suspension/wheel/tire displaced rearward and inward. All tires remained inflated during impact. The exterior vehicle damage scale was estimated to be 11-LFQ-3 using the VDS system and 11FFEW6 using the CDC system. The interior deformation of the occupant compartment was LF0000000 using the OCDI system. There was no deformation or intrusion into the occupant compartment.
