# VEHICLE CRASH TESTS OF THE TYPE 80 BRIDGE RAIL

**VEHICLE CRASH TESTS OF THE  
TYPE 80 BRIDGE RAIL**

| 4. TITLE AND SUBTITLE<br><b>VEHICLE CRASH TESTS OF THE<br/>TYPE 80 BRIDGE RAIL</b> | | | | 5. REPORT DATE<br>March 1999 | |
| 7. AUTHOR(S)<br>Robert Meline, John Jewell, Rich Peter | | | | 8. PERFORMING ORGANIZATION REPORT NO.<br>59-680600 | |

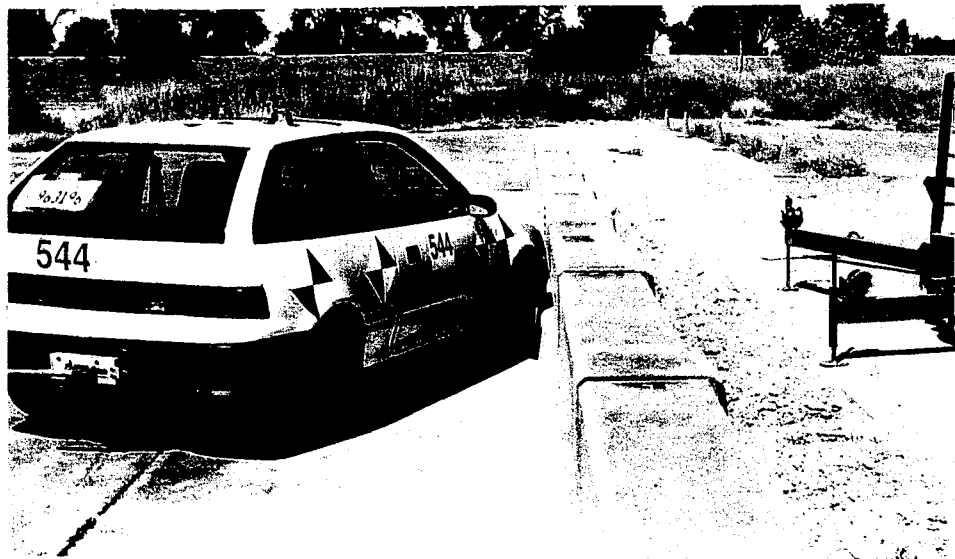
Figure 2-16 Post  
Impact Side View  
of Vehicle 544

The right front section of the vehicle sustained crushing of the bumper and frame, damage to the suspension and a flat tire, Figure 2-16 through Figure 2-18. The right side of the vehicle from the front bumper to the rear bumper was scraped during contact with the beam section of the rail. The hood was also crushed on the right side but remained attached at the latch and hinges.

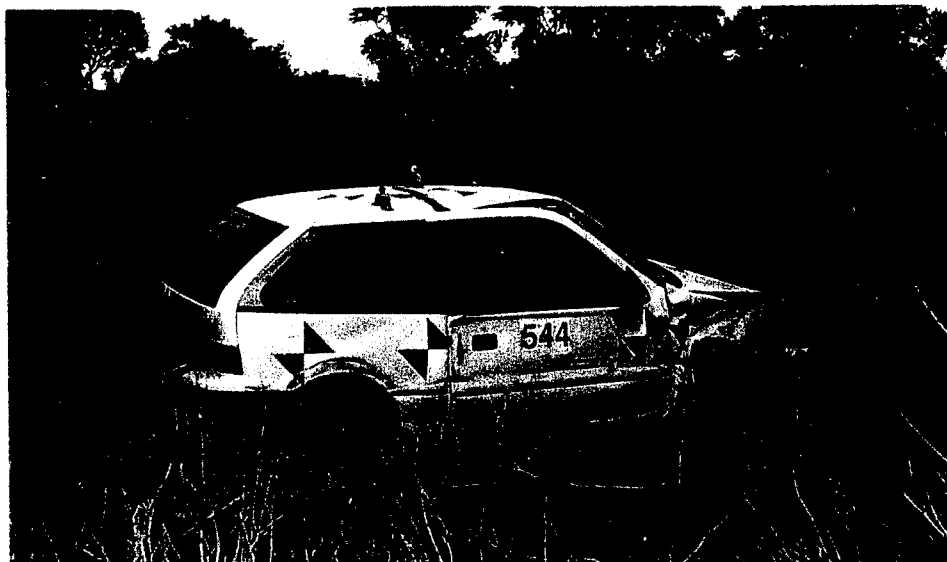
Figure 2-17  
Close up of  
Passenger Side  
Front Damage,  
Vehicle 544

The right door was pushed rearward about 90 mm and did not function. The left door and hatch functioned normally. The windshield was severely cracked but was not torn or penetrated. All of the windows on the right side of the car were broken. The hatch glass and left side glass were not cracked. The right front "A" pillar crinkled less than 25 mm along its length and was pushed rearward about 55 mm. The dash on the passenger side was pushed back about 60 mm.

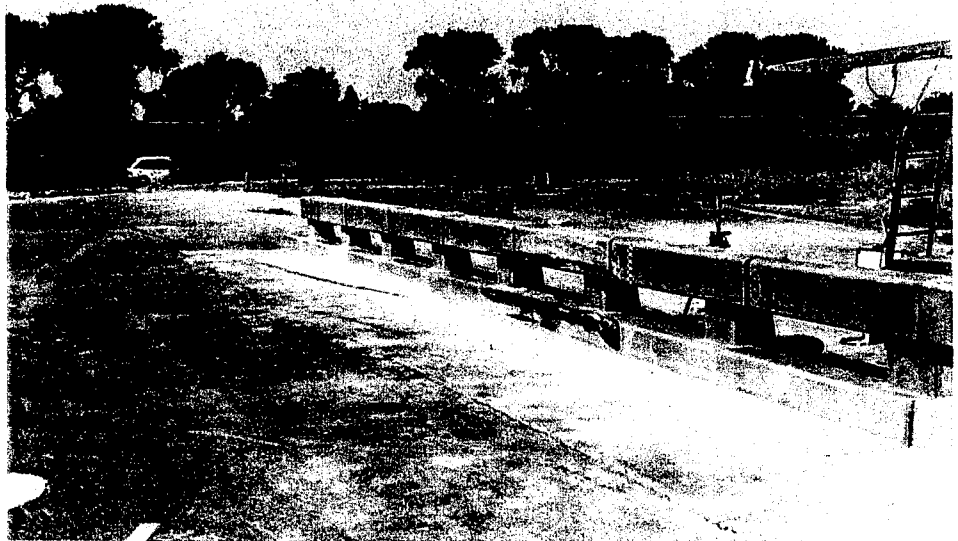
Figure 2-20  
Post Impact Bridge  
Rail Scuff Marks  
Test 544

Barrier damage was cosmetic only, consisting of scrapes and tire marks. Both of the right side tires left marks on the curb and beam section of the bridge rail. Small amounts of concrete spalled from the face of the barrier where the vehicle's sheet metal and wheels made contact.

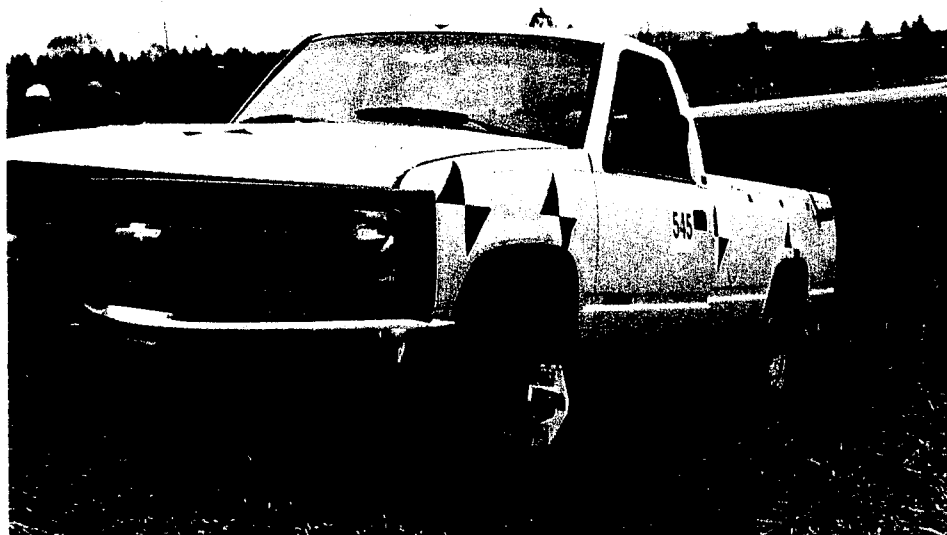
Figure 2-27  
Post Impact Side of  
Test Vehicle 545

The vehicle received damage from the right front corner to the right rear corner, Figure 2-27. The right front and right rear wheel rims were deformed and the tires deflated. The left side wheels and tires were undamaged. The spare tire was forced from its undercarriage storage location and ended up about 15 m from the vehicle resting position.

The initial impact occurred on the right front quarter panel, resulting in substantial buckling and scraping, Figure 2-27. The right side of the bumper was pushed back about 260 mm. As the vehicle continued along the rail the entire right side was deformed where it contacted the bridge rail beam face. As a result, the right door did not operate due to moderate buckling and scraping. The truck bed was also scraped and buckled along the right side and the entire bed shifted to the right 40 mm. The tailgate did not function but the hood and left door were left in good condition and were operable. The roof of the truck did not have any signs of buckling. The windshield was cracked but remained mounted. The left and rear windows were not cracked.
