VEHICLE CRASH TESTS OF THE AESTHETIC, SEE-THROUGH CONCRETE BRIDGE RAIL WITH SIDEWALK, TYPE 80SW

STATE OF CALIFORNIA
DEPARTMENT OF TRANSPORTATION
ENGINEERING SERVICE CENTER,
OFFICE OF MATERIALS ENGINEERING AND TESTING SERVICES

3. RECIPIENT'S CATALOG NO.	
4. TITLE AND SUBTITLE VEHICLE CRASH TESTS OF THE AESTHETIC, SEE-THROUGH CONCRETE BRIDGE RAIL WITH SIDEWALK, TYPE 80 SW		5. REPORT DATE August 1998, revised 8/99

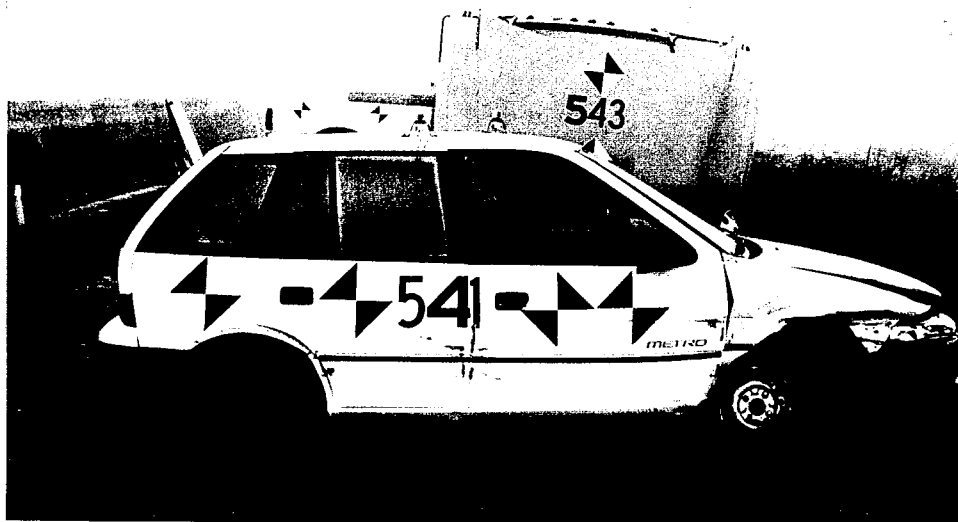
Figure 2-21 -
Close up of
Passenger Side
Front Damage,
Vehicle 541

The right front section of the vehicle sustained crushing of the bumper and minor unibody frame deformation, damage to the suspension and a flat tire. Initial right front wheel damage occurred on impact with the sidewalk 0.38 m from the beginning of the bridge rail installation. The sidewalk contact caused deformation of the wheel and tire deflation. Other tires experienced minor deformation on impact with the sidewalk but remained inflated. After contacting the bridge rail the right front wheel was pushed back, forcing the wheel well area to deform (Figure 2-21).

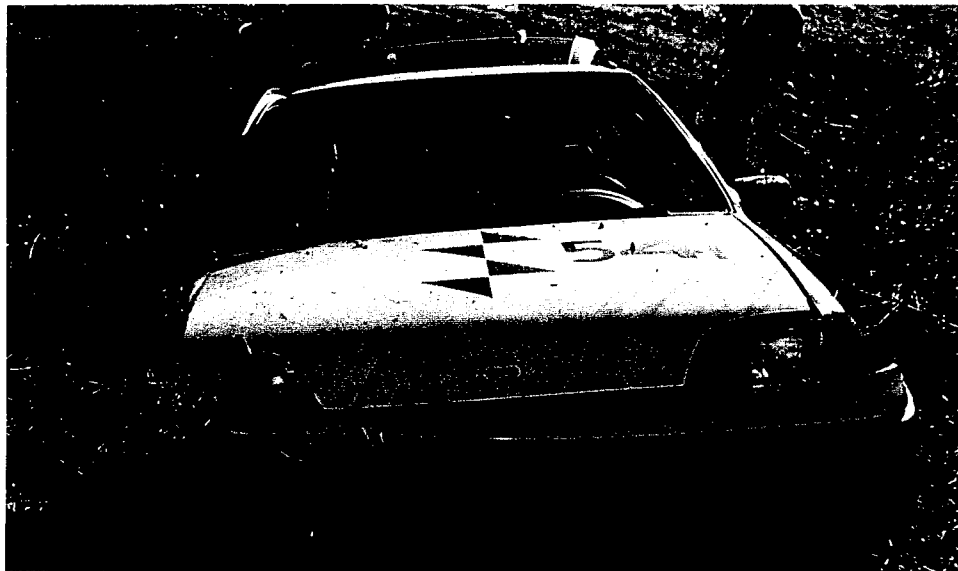
Figure 2-23 -
Post Impact
Bridge Rail Scuff
Marks Test 541

Barrier damage was cosmetic only, consisting of scrapes and tire marks. Both of the right side tires left marks on the sidewalk curb then on the curb and beam section of the bridge rail. Small amounts of concrete spalled from the face of the barrier where the vehicle's sheet metal and wheels made contact.

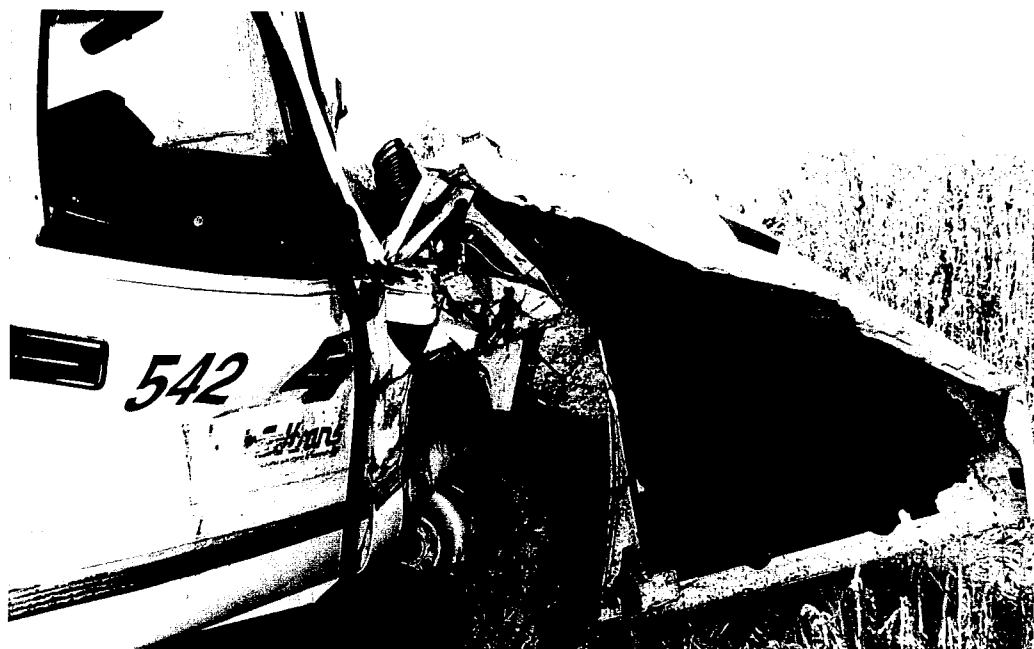
Figure 2-36 -
Close-up of
Impacting
Corner Of
Tested
Vehicle 542

The extra speed of the vehicle, 10.2 km/h over target, undoubtedly contributed to higher deformation of the impacting right corner of the vehicle than would have otherwise occurred. Figure 2-36 shows the right front wheel pushed back into the wheel well, caused by impact with the rail curb and beam face. All of the wheels stayed connected to the vehicle throughout the test. The front right shock absorber, stabilizer bar and upper and lower control arms were bent but still attached. The rear and left front suspension components were intact and appeared undamaged. There was minor deformation of the right front frame.

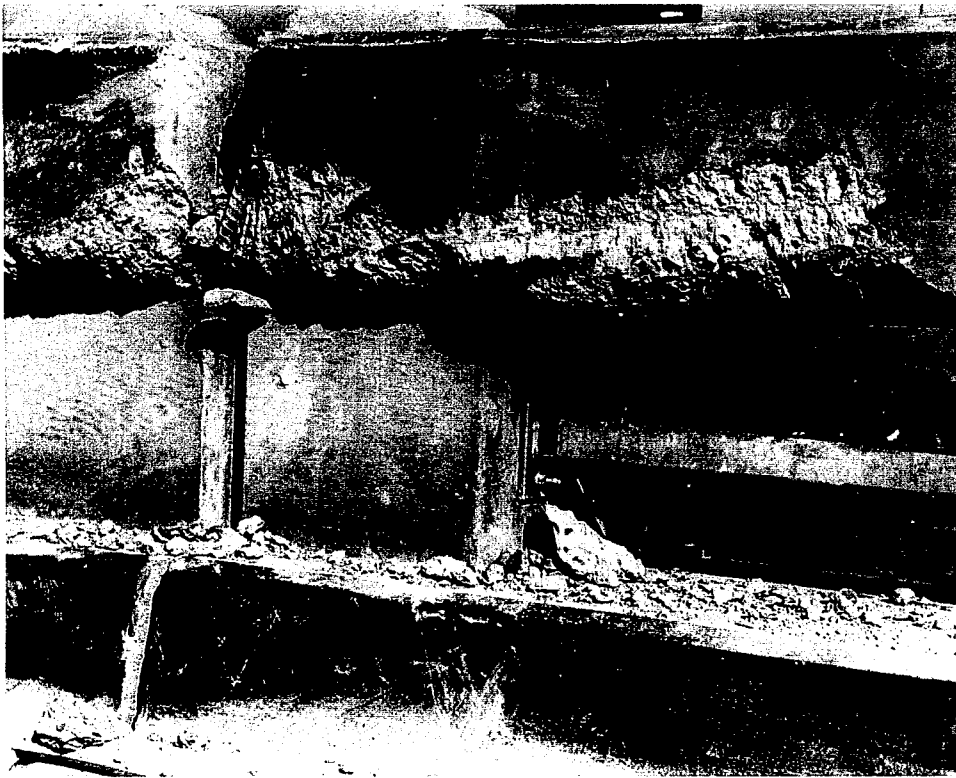
It appeared that the right front lug nuts scraped along the beam face, causing most of the concrete spalling seen in Figure 2-55. The right wheel well hit the handrail 0.028 s after initial contact with the bridge rail. Beginning 0.177 s after contact with the bridge rail, both the left front and left rear tires rose approximately 1 m off the ground and remained off the ground for 0.480 s and 0.757 s, respectively. The vehicle continued to make contact with the barrier for approximately 4.5 m. A peak roll of the vehicle box section to the right and then left was 17.5° at 0.521 s and 14.5° at 1.099 s, respectively, from the impact with the rail. These peaks were taken before the vehicle exited the end of the test article installation. Higher values may have occurred later after the brakes were applied. The vehicle continued to a point of rest on an earth berm about 43 m from the point of impact. The vehicle remained upright throughout and after the collision.

Figure 2-55 -
Close-up of
Impact Area for
Test 543

The barrier was scraped along the face and edges over a 3 m length. There was also spalling on the underside of the beam caused by the downward force of the rotating right front wheel lug nuts. The tire marks along the barrier were only a little longer than the scraping along the face. A concrete spall at the expansion joint was 80 mm to 100 mm deep and extended to the back face of the rail, shown in Figure 2-55 and Figure 2-56. The spall exposed the end of a piece of rebar but no structural damage was evident. The bridge rail withstood the impact from vehicle 543 well with only spall repairs necessary before subsequent tests.

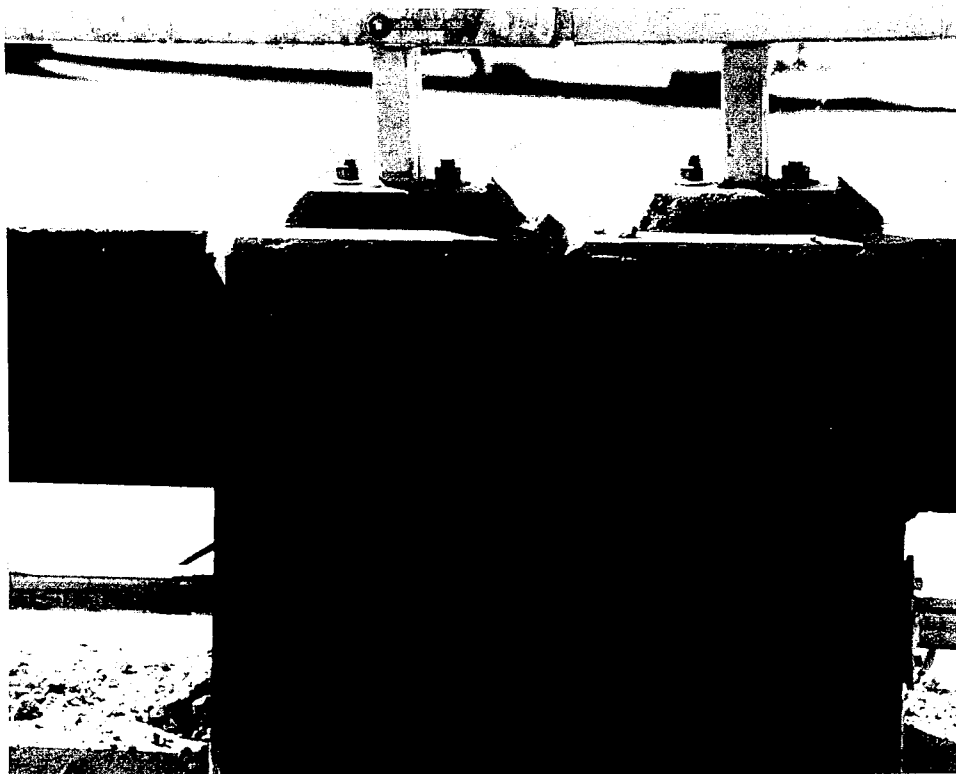
Figure 2-56 -
Backside of
Expansion Joint
Area after
Test 543

The barrier was scraped along the face and edges over a 3 m length. There was also spalling on the underside of the beam and at the expansion joint with no structural damage.
