# ***Evaluation of the Cause of Cracking in Bridge #MEG-124-6.78***

**Draft Final Report to the Sponsors:  
Ohio Department of Transportation  
Federal Highway Administration  
October 1999**

**University of Cincinnati  
Department of Civil and Environmental Engineering  
P. O. Box 210071  
Cincinnati, OH 45221-0071**

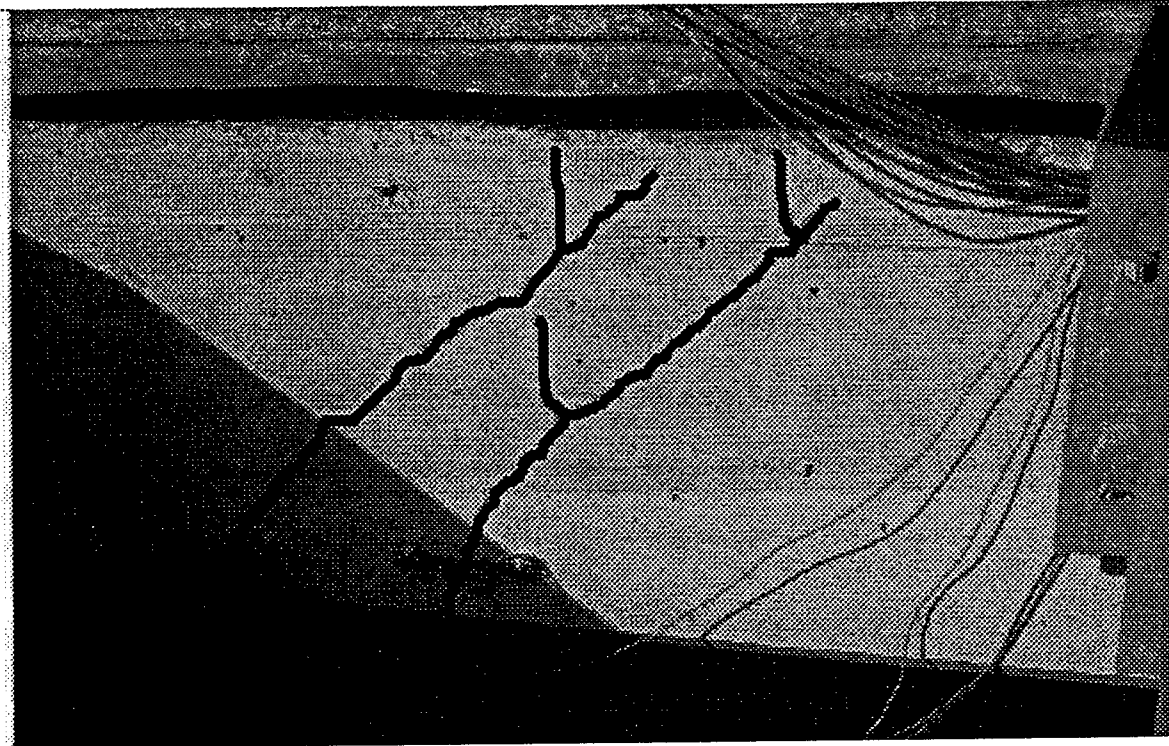
- 1) The beam on the southwest edge (numbered 9 in Figure 1.1 and shown in Figure 1.3) had diagonal cracks and straight cracks in the exposed side of the beam. These cracks continued to the bottom of the box where they became transverse (perpendicular to the span). Whether the cracks continued up the other side of the beam was not clear as the other side of the beam (being up against the adjacent beam) was not visible. The worst cracking occurred at the northwest corner where the cracks appeared to be diagonal shear cracks. Less severe cracking, which appeared to a vertical flexural crack, occurred at the other end of the beam as well. In both cases, the cracks formed about 4 ft. from the obtuse corner.

**Figure 1.3 a - Cracks at Northwest End of Beam 9 (cracks highlighted for clarity)**

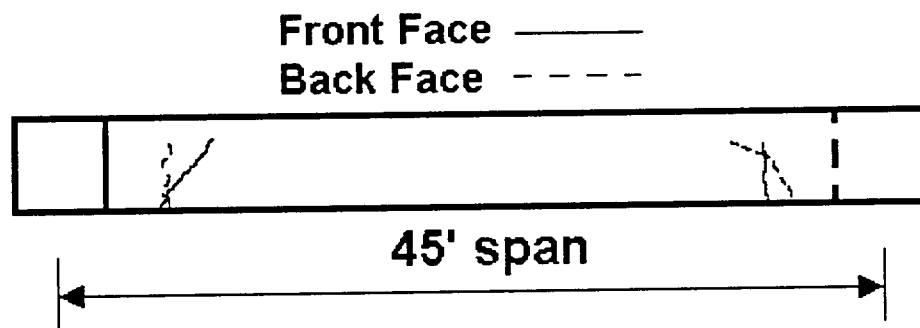
- 2) Each of the adjacent beams (numbered 7 and 8 in Figure 1.1) had transverse cracks along the bottom. The sides of the beam were not visible so it could not be ascertained if the diagonal cracks existed along the sides of the beam. Again, cracking occurred at both ends of the beams approximately 4 ft. from the obtuse corner.

**Figure 1.3 b - Crack Patterns**

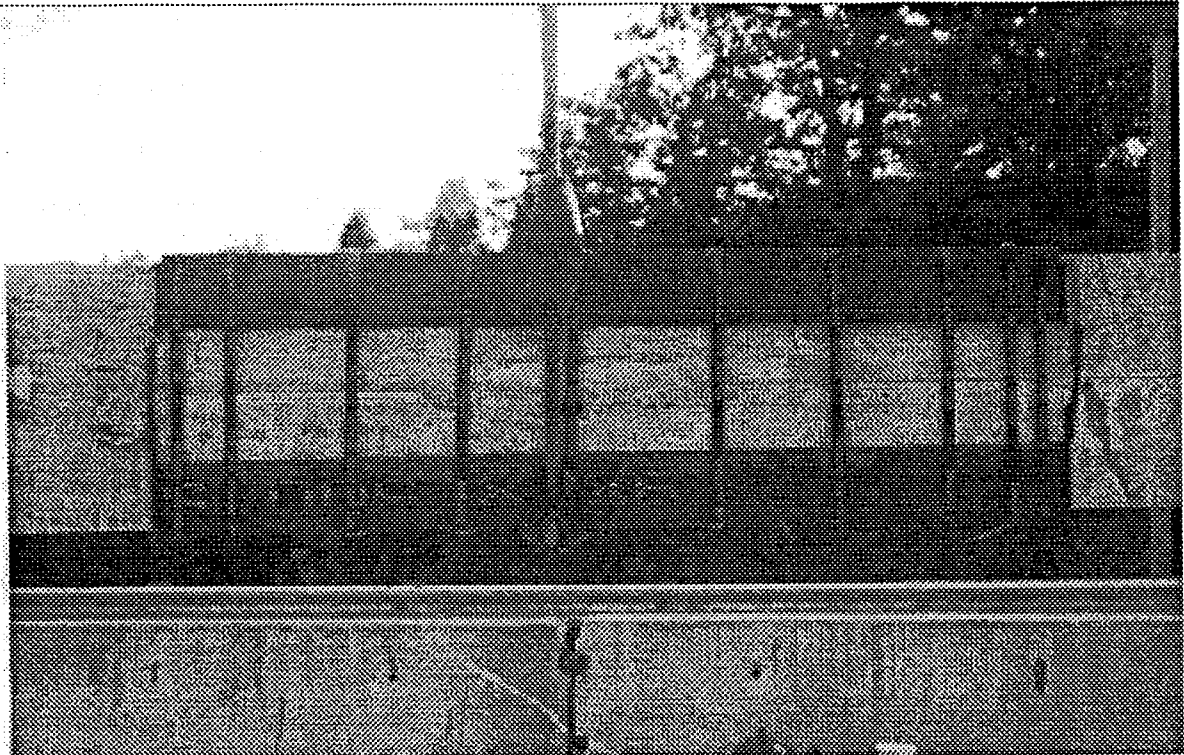
**Figure 3.2 - Bandage to protect the cracks during lifting and transport.**

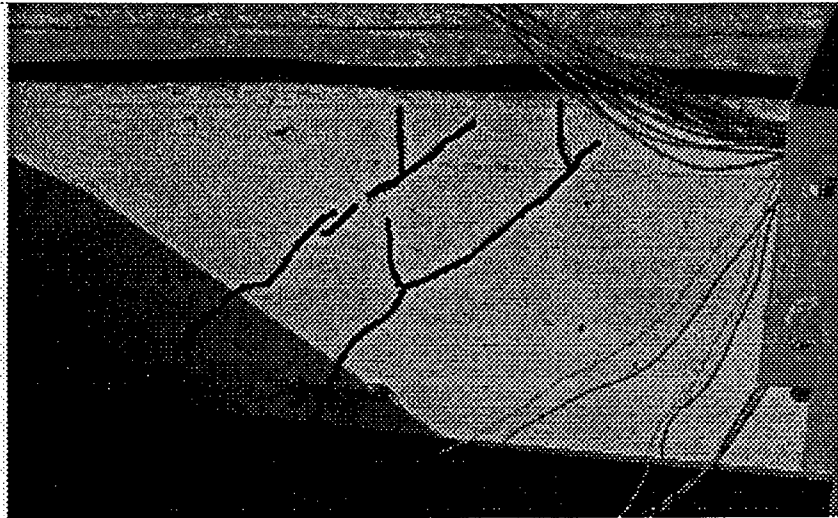
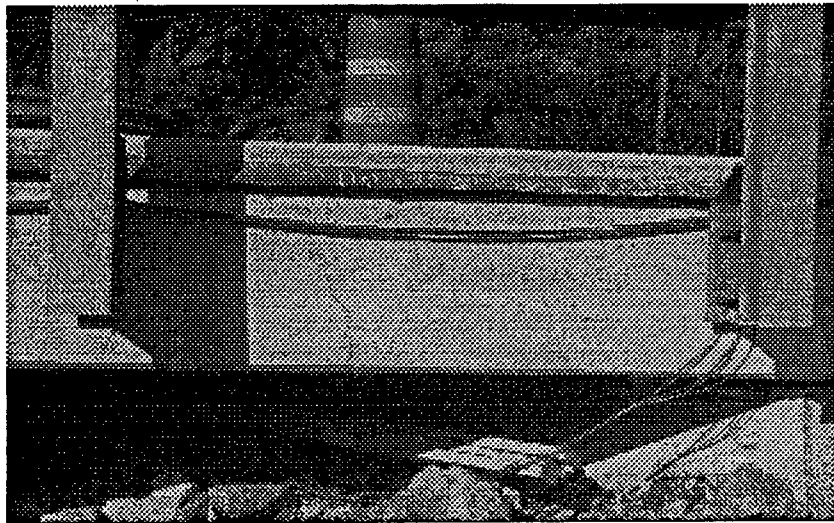
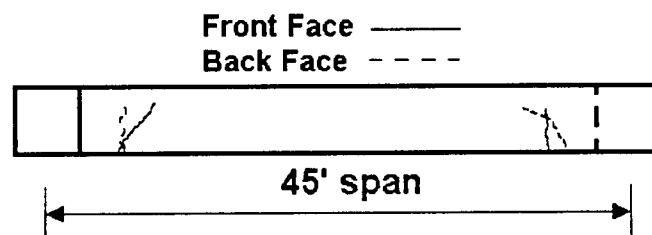
On removal, the hidden sides of the #7, #8 and #9 beams could be inspected. It was found that all three beams had the same crack pattern. Diagonal cracks occurred approximately 4 ft. from the obtuse corners and on the exact opposite face of the beams there were vertical flexural cracks, some of which had started to turn into diagonal cracks. (Figure 3.3).

Figure 3.3 - Cracks in beams. Top - Cracks at NW end of beam #9, Middle - Cracks at SE end of beam #9, Bottom - Typical crack patterns in beams 7, 8, 9.

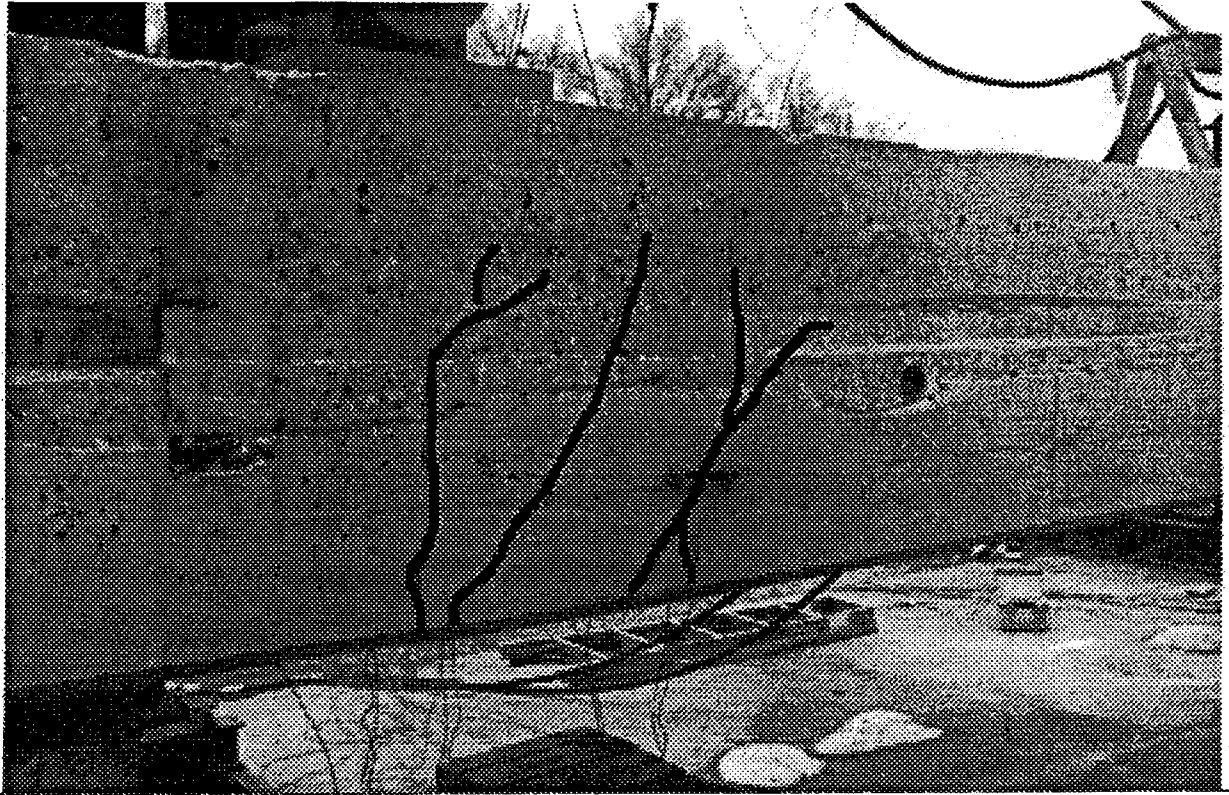
At a load of 23 kips at each load point, a flexural crack formed at midspan and flexural cracks also formed at the east end (the end away from the load) on both sides of the beam. On the next increment of load (approximately 25 kips per load point), flexural cracks formed at the west end; again on both sides of the beam. Subsequent load increments caused these flexural cracks at the ends to become diagonal (Figure 3.6). The cracks on both sides were connected by a crack through the bottom flange. Some additional midspan cracking was noted, but it was minimal.

**Figure 3.6 - Typical diagonal crack formation (cracks enhanced)**

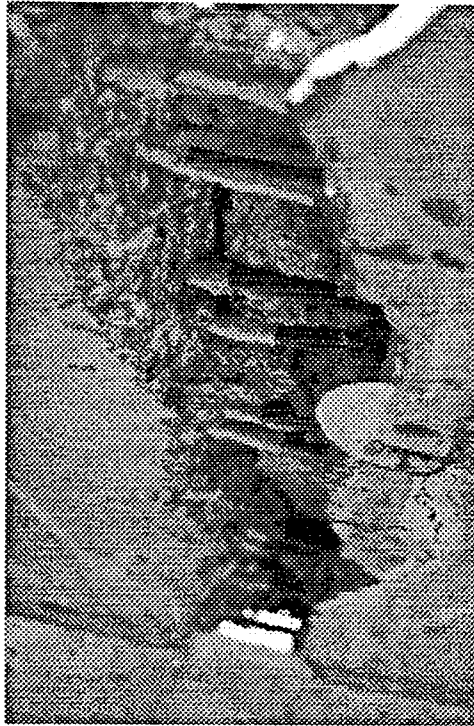
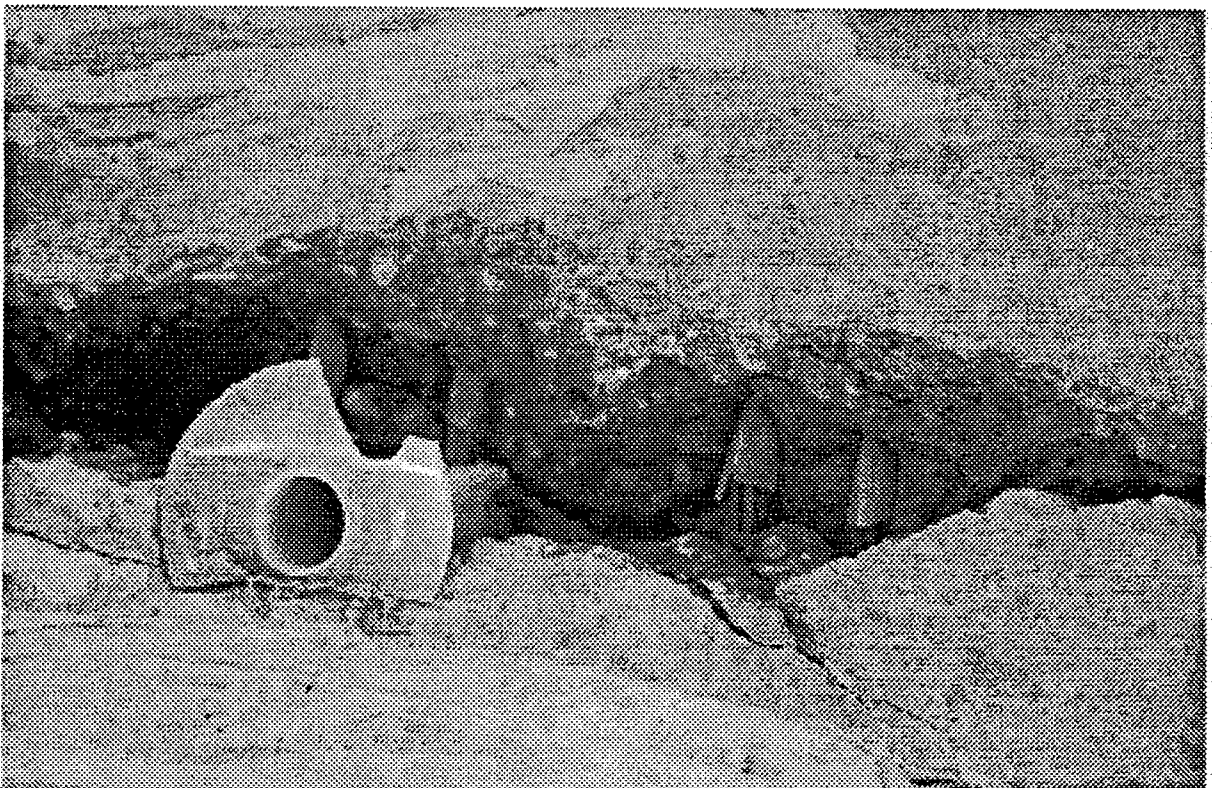
After the test, the spalled concrete was knocked off the bottom of the beam and a startling discovery was made. The cracking occurred exactly at the point where the mild steel was terminated, however, it was also found that all of the strands, except for one, had been debonded to the same termination point (Figure 3.7). By breaking off concrete at the end of the beam, it was determined that the strands had been debonded from the end of the beam to the termination point of the mild steel. The cause of failure was clearly that the section was unreinforced at this point. The only bonded strand was the one closest to the obtuse corner.

The results of destructive testing showed that the cause of failure was a fabrication error. It appears that the fabricator accidentally debonded all but one strand to the end of the mild steel (Figure 3.16), creating an unreinforced section at this point.

**Figure 3.7 - Failure surface. Note end of debonding sleeves.**

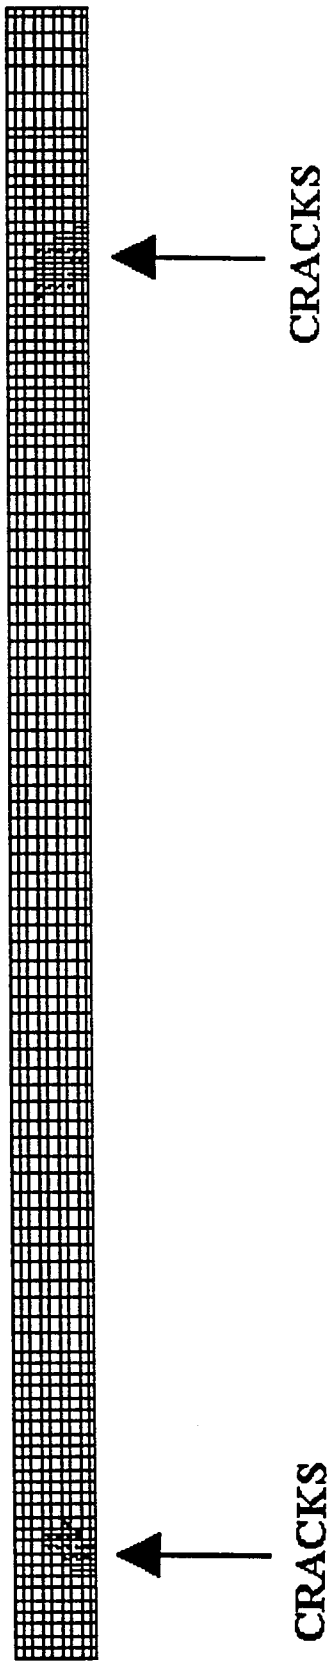
Figure 5.6 - Crack pattern - Case 1

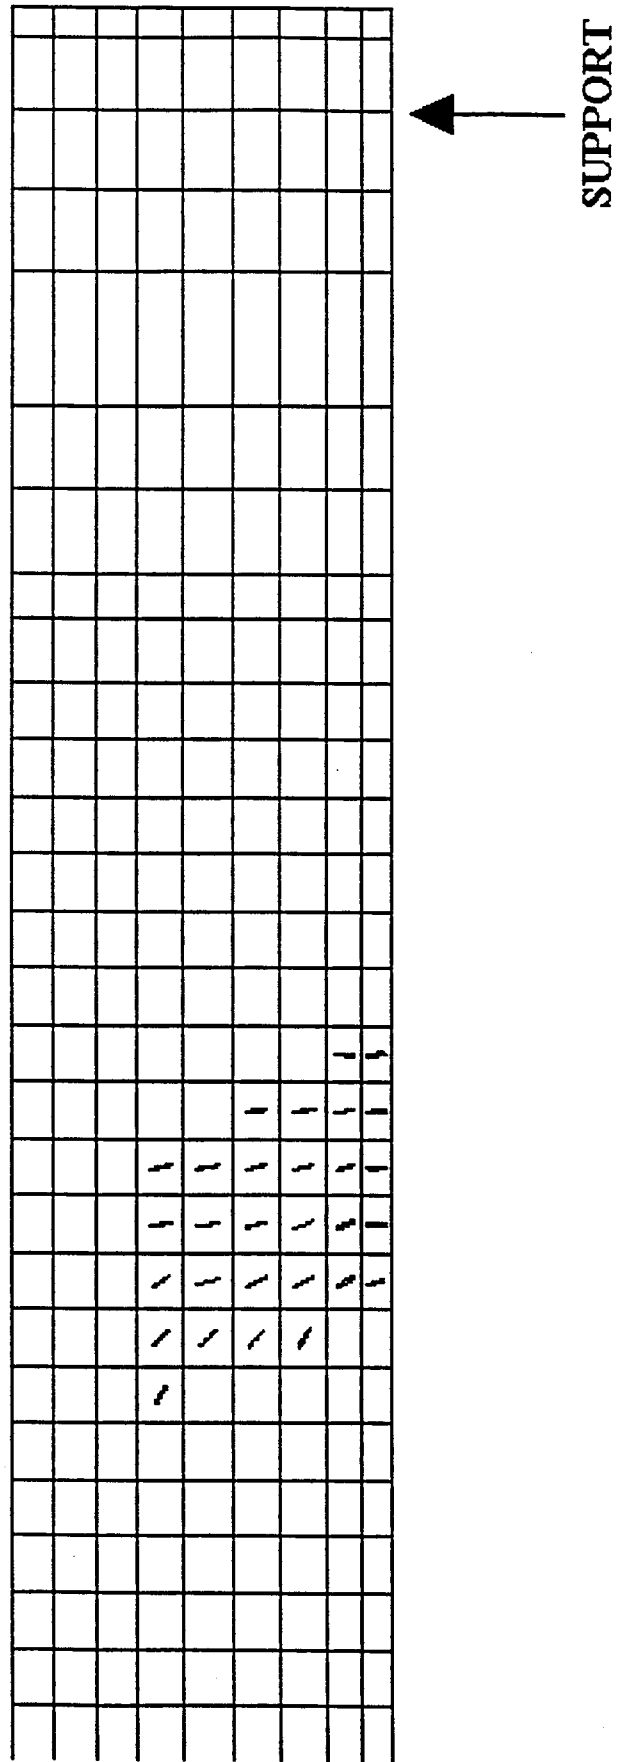
Figure 5.7 - Enlargement of cracking at end - Case 1

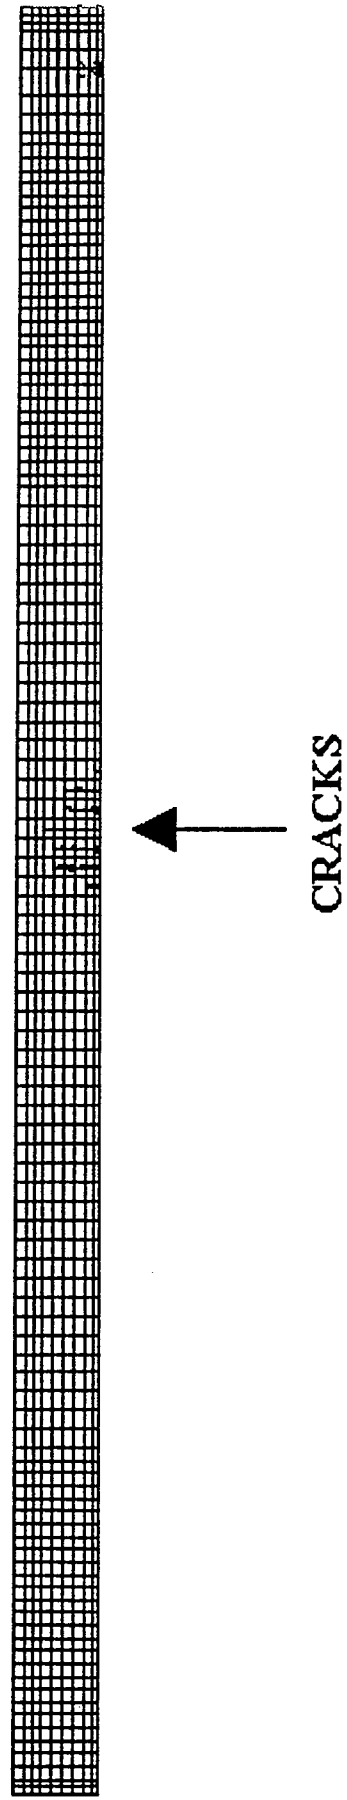
Figure 5.8 - Crack patterns - Case 2

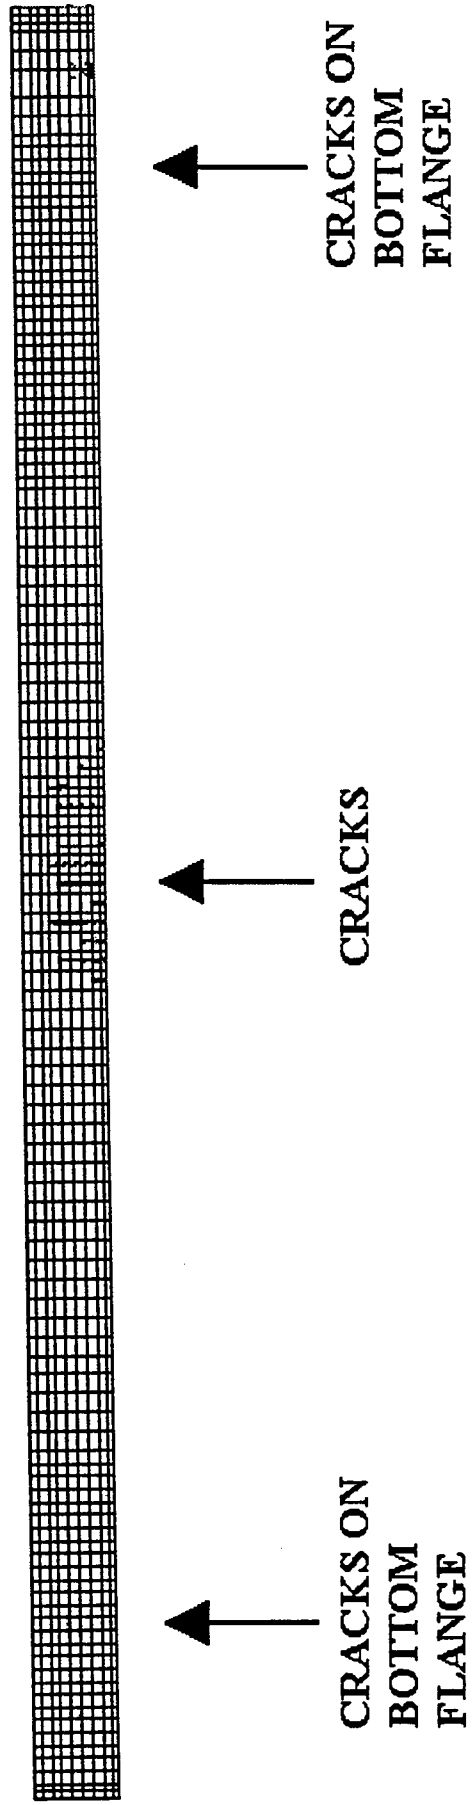
Figure 5.9 - Crack pattern - Case 3
