PERFORMANCE OF THIN BONDED CONCRETE OVERLAYS IN ILLINOIS

PHYSICAL RESEARCH REPORT NO. 134
MARCH 2000

Illinois Department of Transportation

Bureau of Materials and Physical Research

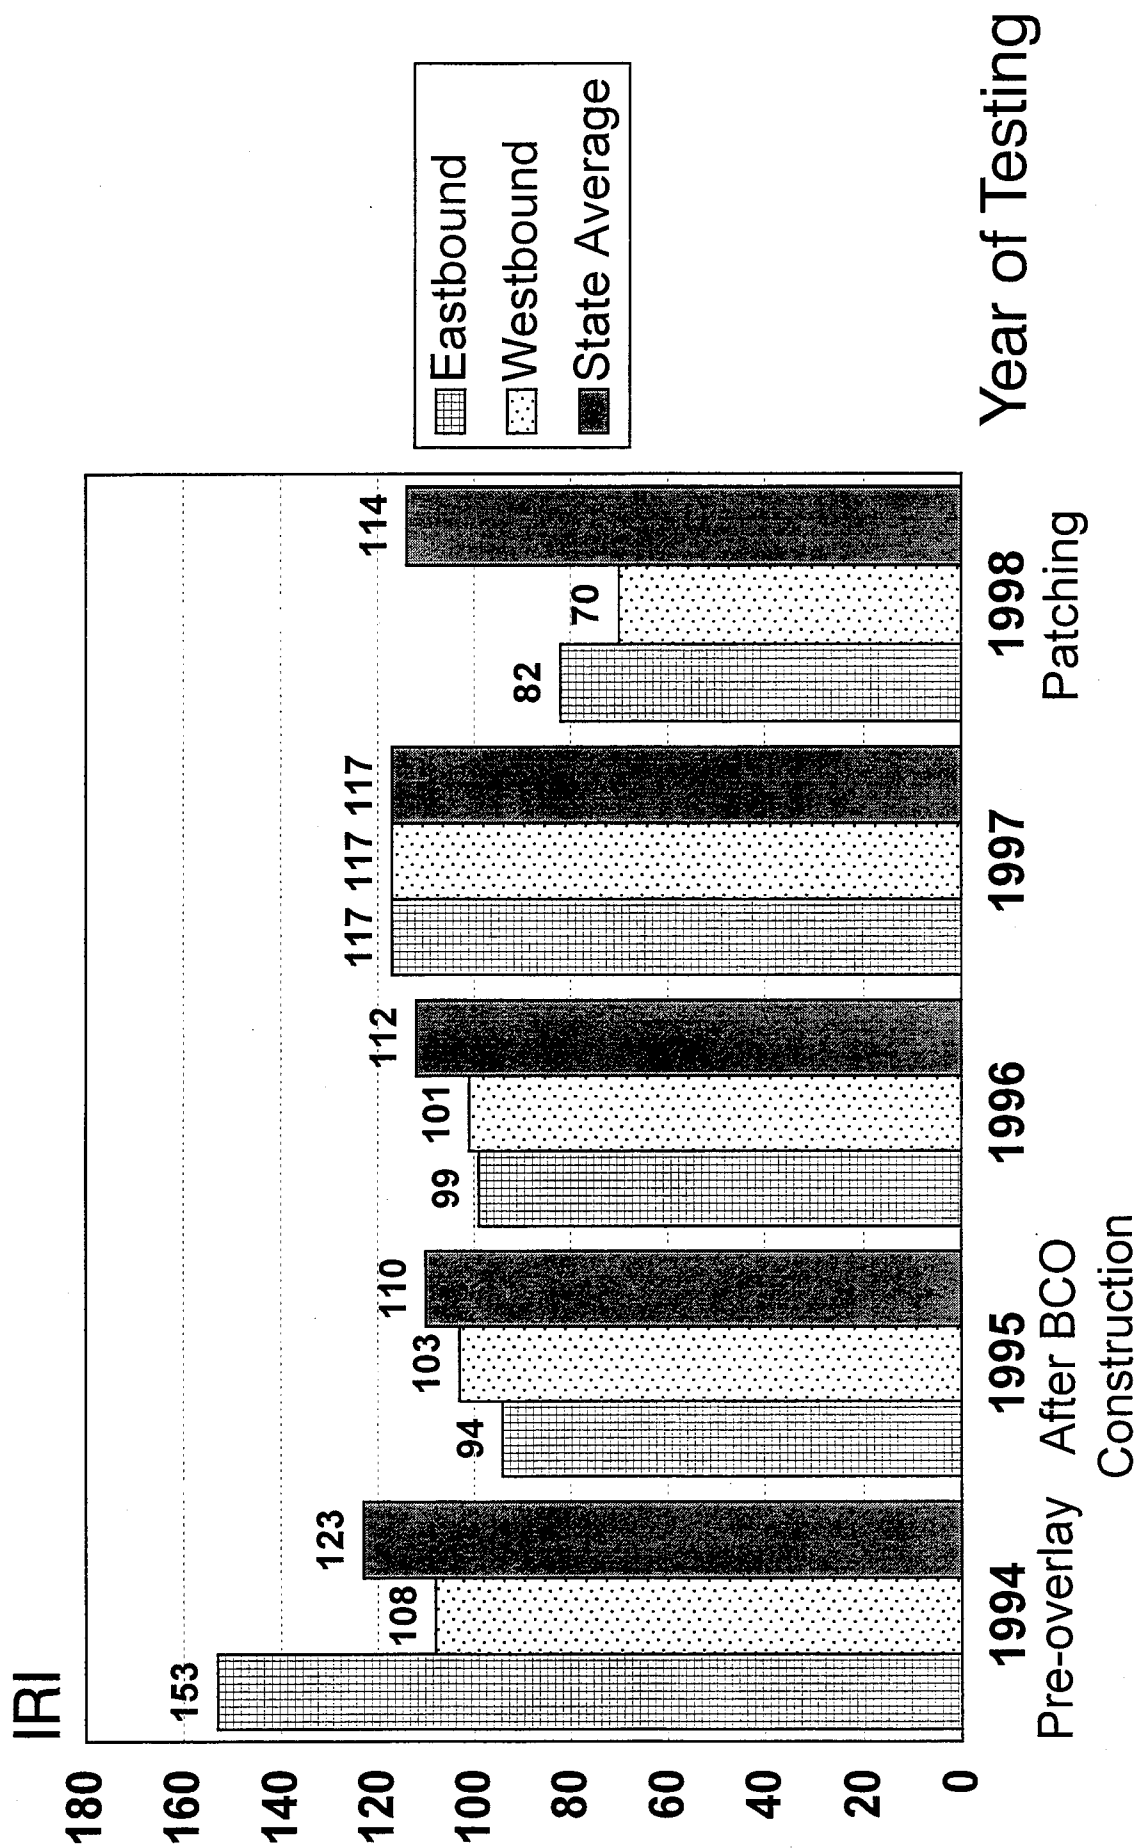
Figure 1

International Roughness Index (IRI) values decreased after construction of the I-80 and I-88 overlays. The I-80 average IRI values gradually increased in the years after construction but decreased significantly after sections of the I-80 BCO were patched in

I-80 Average IRI

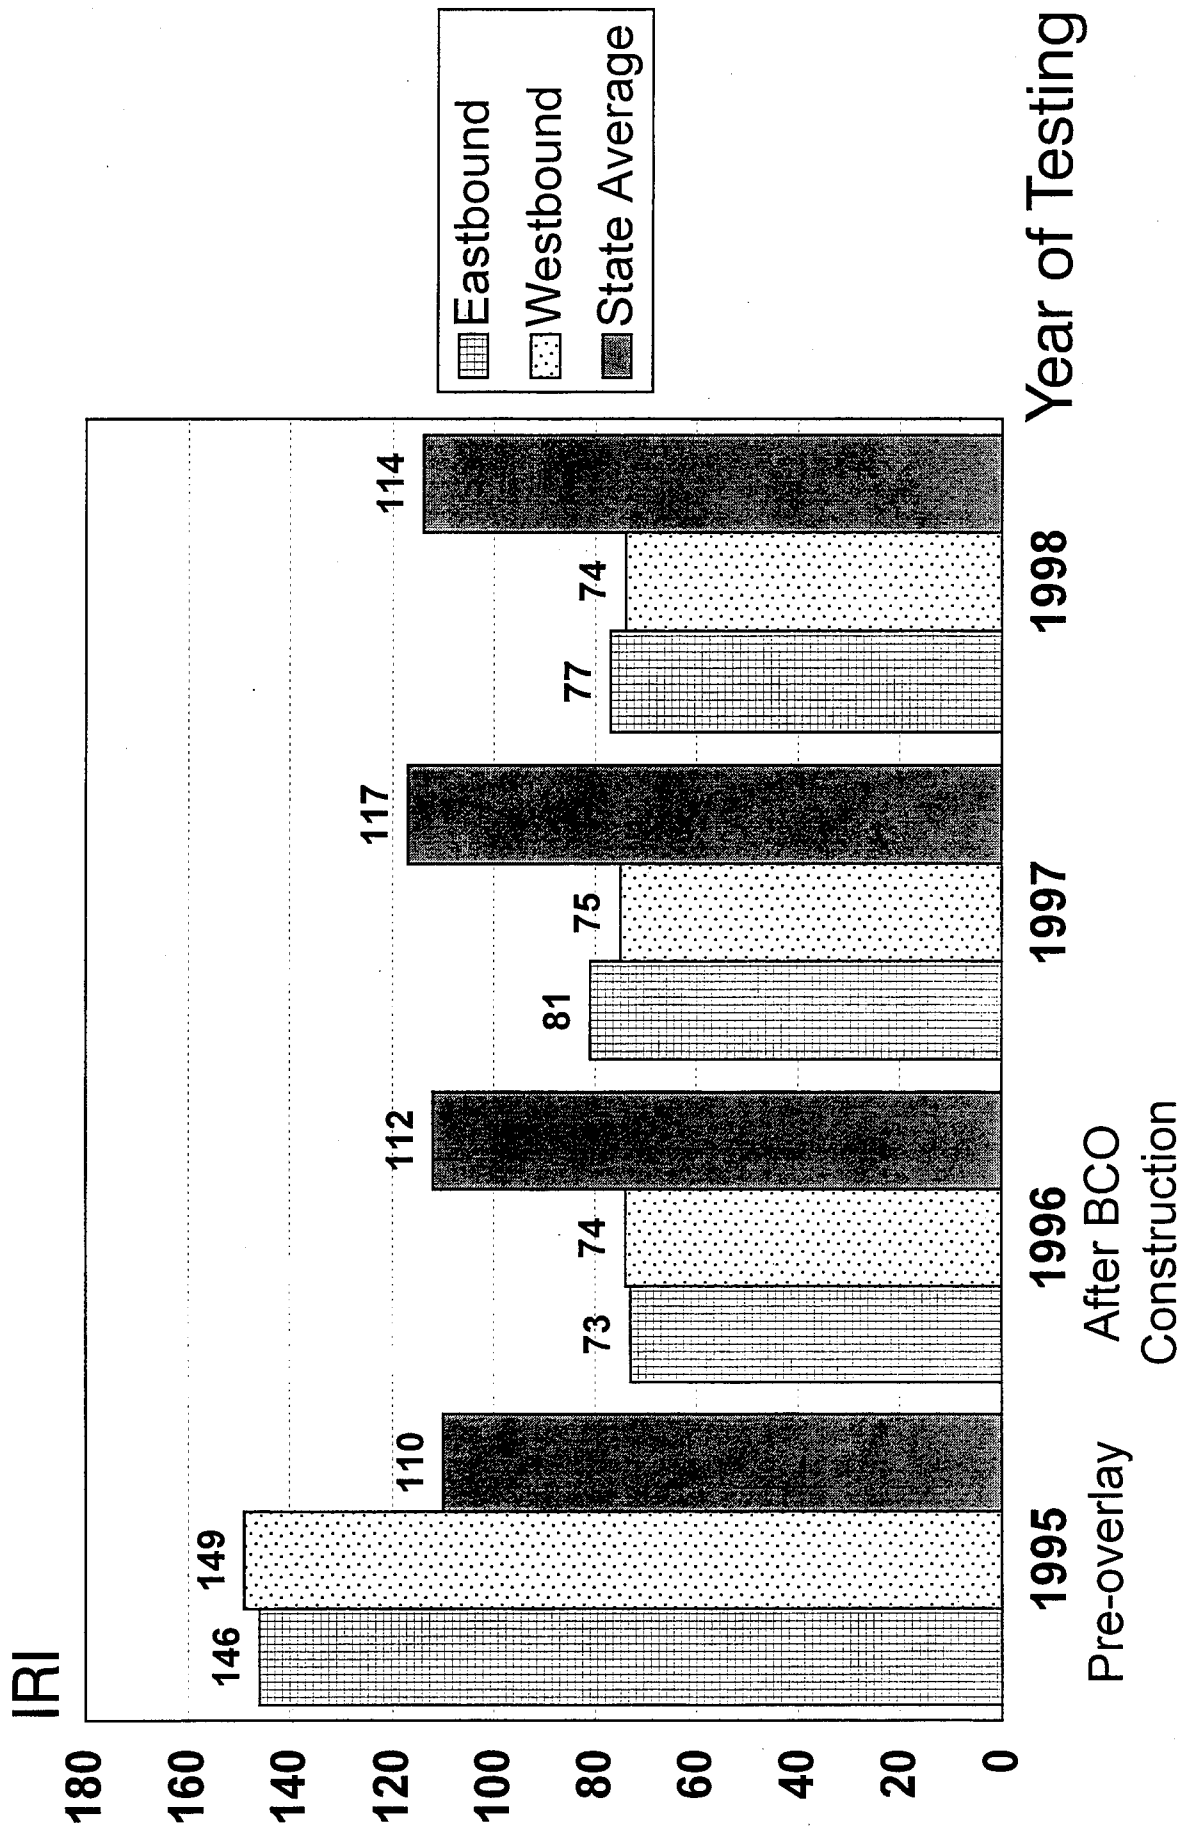
Figure 2

1998. The I-88 average IRI values have not fluctuated significantly since construction of the BCO in 1996.

I-88 Average IRI

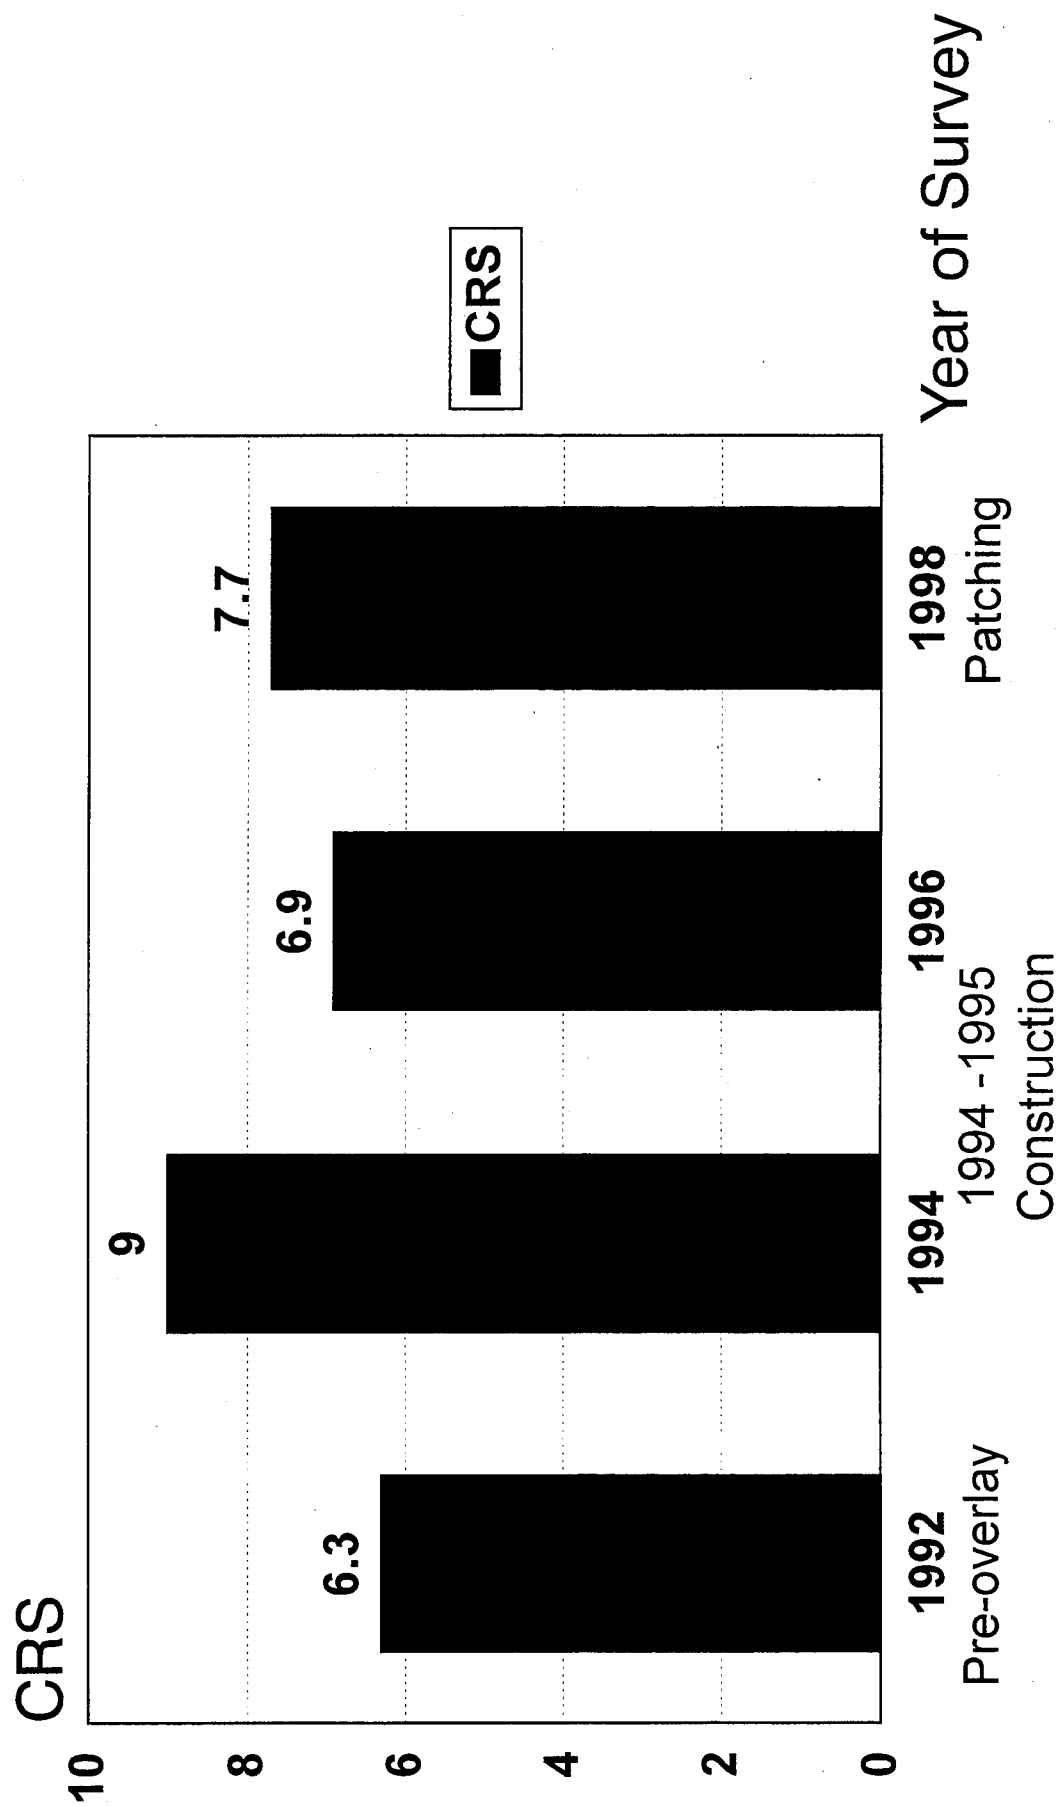
Figure 3

Even though the I-80 BCO was assigned a CRS of 9.0 in 1994, the year of construction, it quickly decreased to 6.9 in 1996, just two years after construction. A 1998 CRS value of 7.7, the most recent CRS value available for I-80, indicates that the patching completed in 1998 significantly improved the condition of the I-80 BCO. The 1994 CRS value of 7.8, assigned to I-88 before the BCO, indicates that the pavement was already in excellent condition. Furthermore, the 1998 CRS value for I-88 of 8.2 verifies that the BCO is still in excellent condition.

The 1992 CRS is the last available for I-80 that represents the condition of the pavement before the BCO. Since I-80 was planned for rehabilitation in 1994, it was assigned a CRS value of 9.0 in 1994. However, the actual 1994 CRS value of 9.0 does not accurately reflect the condition of the pavement just before the BCO was placed. As mentioned previously, the CRS assigned to I-80 in 1992 was a 6.3. By the time of the construction of the I-80 BCO in 1994 - 1995, the CRS value obviously decreased. With appropriate deduct values subtracted from the 1992 CRS value, an estimated CRS value for 1994 is 6.1. A CRS of 6.1 is at the bottom of the scale for a pavement considered to be in "good" condition.

I-80 CRS

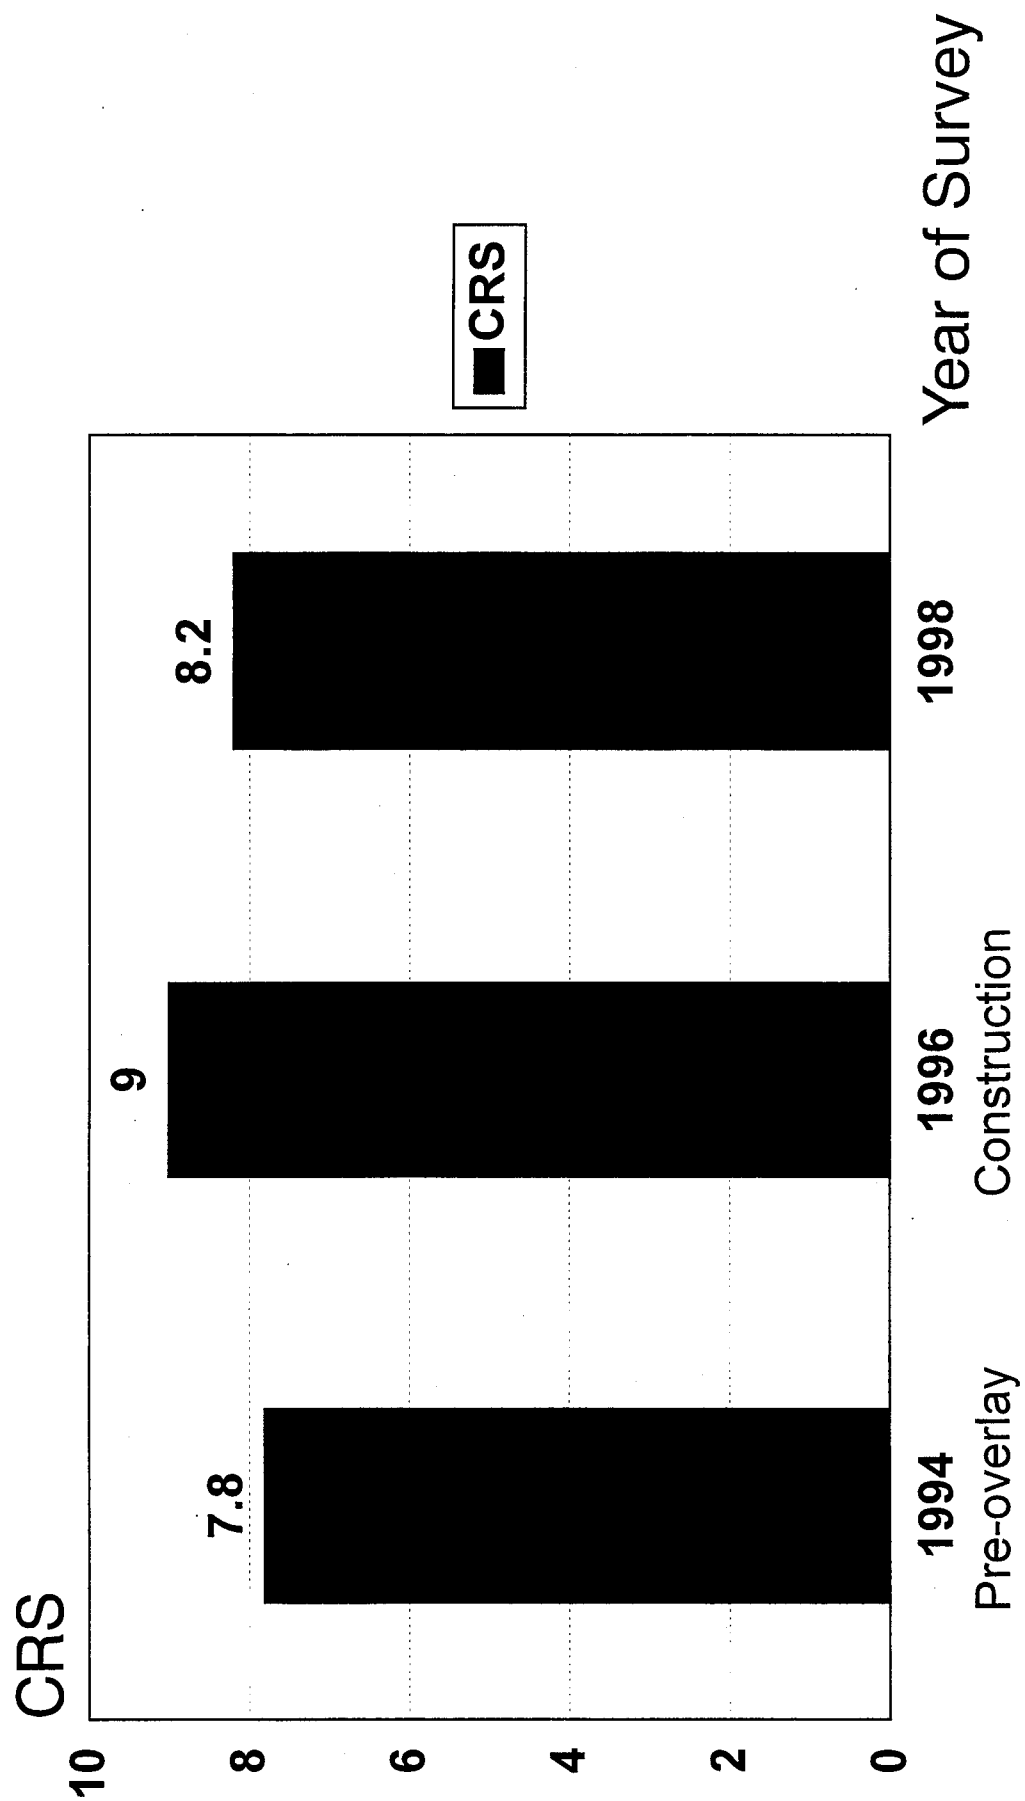
Figure 4

The CRS value of 7.8 assigned to I-88 in 1994 (before the BCO) indicates that the pavement was already in excellent condition. Like I-80, I-88 was assigned a 9.0 in 1996 (the year the BCO was constructed). With appropriate deduct values subtracted from the 1994 CRS value, an estimated CRS value for 1996 is 7.6 (an "excellent" rating). In 1998, two years after the construction of the overlay, I-88 was assigned a CRS value of 8.2 (an "excellent" rating).

I-88 CRS
