U. S. Department  
of Transportation  
**Maritime  
Administration**

# Port Damage Assessment

Short-term Action Report—April 2000

## Honduras: Assessment of Port Infrastructure Damage Caused by Hurricane Mitch, 1998

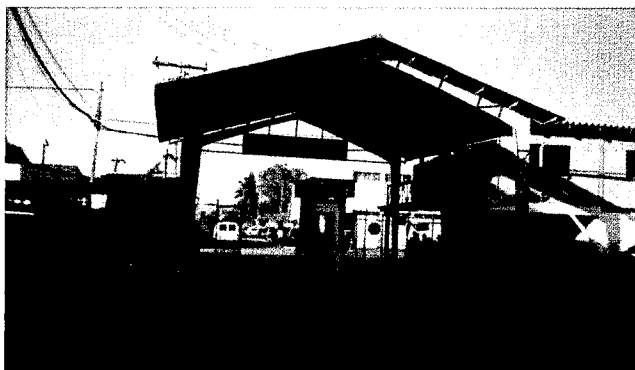
Security Force Issues: Puerto Cortés had two levels of security forces. ENP personnel patrol the gates and open areas, while the private leaseholders employ their own guards within their leased areas inside of the port's main security fence. ENP guards lacked identification, proper uniforms, and weapons. In addition, they did not have adequate communications equipment or vehicles. The private guards for the leaseholders were generally better equipped than the ENP guards but were still below standard. Poor communication seems to exist between the ENP and port users, as well as between the ENP guards and the private guards. In some cases an atmosphere of mistrust seemed to exist between the two groups of security.

**Photo 4.** *Entrance gate near Administration Buildings*

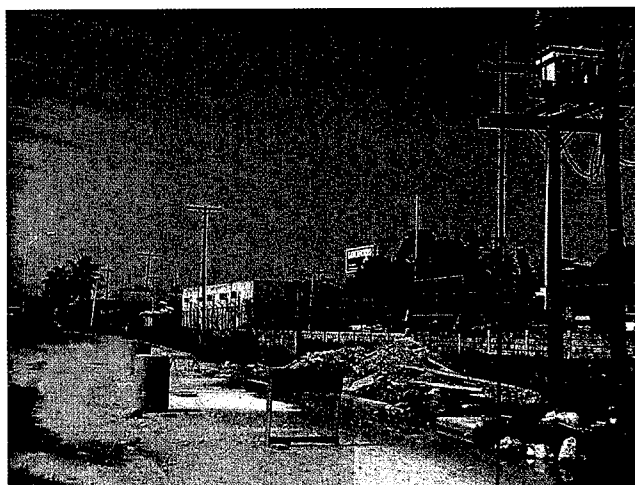
Equipment Issues: The perimeter security fence has several damaged areas and some areas where the fence is below standard height. Because the port is situated directly adjacent to the city of Cortés, open space zones are virtually eliminated, which exacerbates the fence vulnerability. Also, some buildings outside the port adjoin the perimeter fence, making illegal access easier. Currently, no remote systems (e.g., cameras and motion sensors) have been installed to assist the guards. The truck entrance gate is generally secure; however, the entrance near the administration buildings is poorly guarded, and unauthorized people were seen entering the port at this gate.

**Photo 5. Railroad gate in Security Fence Left Open and Unattended**

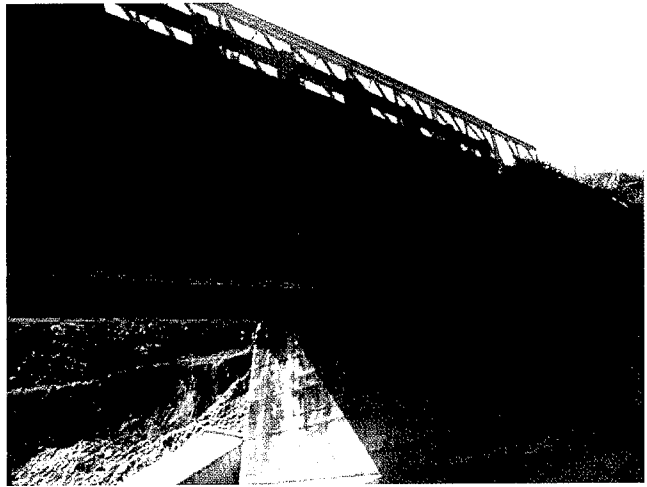
**Photo 6.** Bridge with North Abutment Failure

| <b>Project Area/Project Description</b> | <b>Cost (U.S. dollars)</b> |
|---|---|
| 1. Rio Silin Bridge—North abutment failed; recommend replacement with a longer single span structure | \$409,000 |

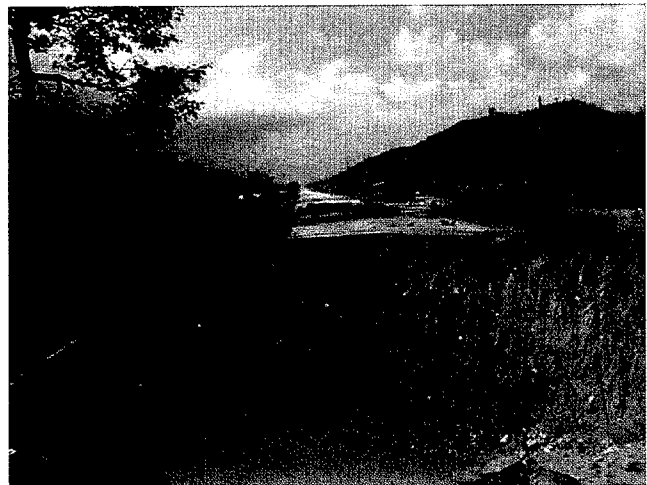
2. Culvert washed out in front of CREM (N15.91071, W085.85396) (see Photo 7). Damage was caused by additional heavy rains. Existing plans call for the construction of a double 3 x 2 foot box culvert. In addition to the planned work, the team recommends that the fill slopes be protected from erosion and the outlet be protected from scour. The proposed work is acceptable provided that it is validated by a sound hydraulic study. The estimated additional cost of the study and slope protection is \$51,000 (U.S.) (priority 1).

**Photo 7.** Culvert Washed Out

| <b>Project Area/Project Description</b> | <b>Cost (U.S. dollars)</b> |
|---|---|
| 2. CREM Culvert—Washed out culvert; construction of double 3x2 box culvert planned; also recommend slope protection and sound hydraulic study | \$51,000 (study and slope protection) |

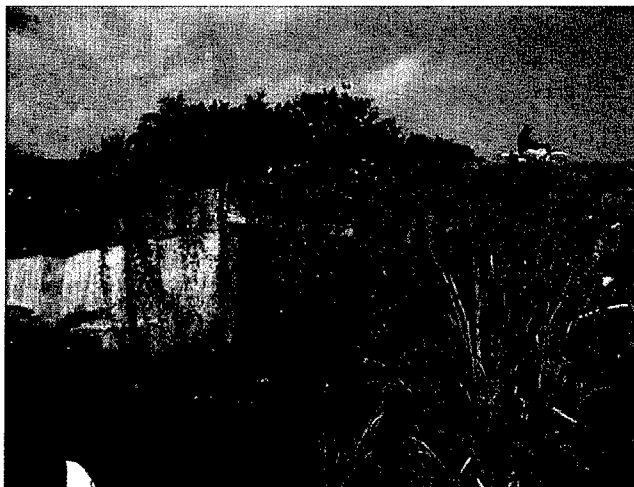
10. La Colorada, Sector Guaimitos, CA13 between Progreso and Tela (N15.50330, W87.69947). Hurricane Mitch created a new flow, joining the existing flow at the structure (see Photo 10). The embankment was washed out and has since been repaired. However, there is damage to the frame as a result of recent settlement. The team recommends a new 20-meter bridge with 50 meters of road reconstruction at a cost of \$272,000 (U.S.) (priority 1).

**Photo 10.** *Embankment Washed Out*

| <b>Project Area/Project Description</b> | <b>Cost (U.S. dollars)</b> |
|---|---|
| 10. CA13—Damage to frame as a result of settlement; recommend 20 meter bridge and 50 meter road | \$272,000 |

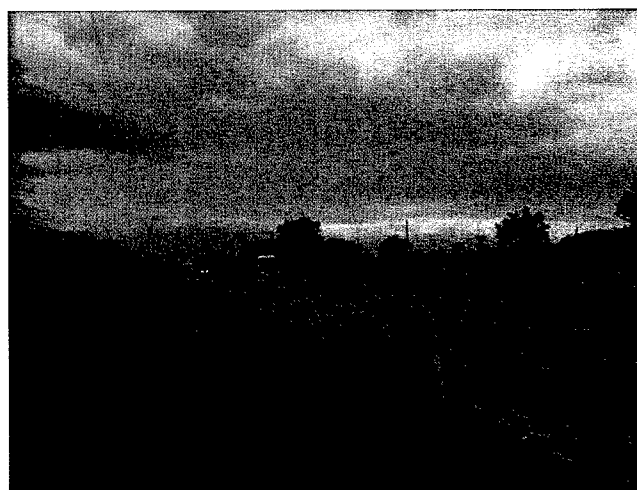
13. Rio Leon Area (milepost kilometer 117) (N15.66779, W87.33512) between Tela and La Ceiba. Water topped the highway damaging the embankment and the pavement for about 300 meters (see Photo 13). Under an existing contract, reinforced concrete pipes are being installed and the embankment is being restored. This is the continuation of an existing relief structure that suffered minor damage during Hurricane Mitch. The team recommends that, for maintenance purposes, a minimum pipe diameter of 30 inches be used on culverts crossing the main road. The team also recommends flare-end sections at the inlet to improve the capacity of the culvert.

**Photo 13.** Large Culverts Needed

| <b>Project Area/Project Description</b> | <b>Cost (U.S. dollars)</b> |
|---|---|
| 13. Rio Leon Area—Recommend 30-inch minimum culvert pipe diameter | |

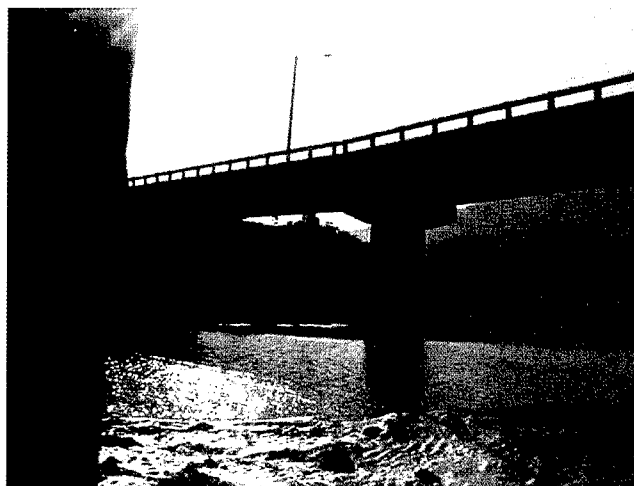
18. Bridge over the Rio Danto has scour problems (see Photo 16). This bridge is the only access to La Ceiba. Further studies are required to determine the amount of damage (priority 2).

**Photo 16.** *Scour Problems and Pier Settlement*

| <b>Project Area/Project Description</b> | <b>Cost (U.S. dollars)</b> |
|---|---|
| 18. Rio Danto Bridge—Bridge has scour problems; bridge is only access to La Ceiba; further studies required to determine amount of damage | No cost estimate |

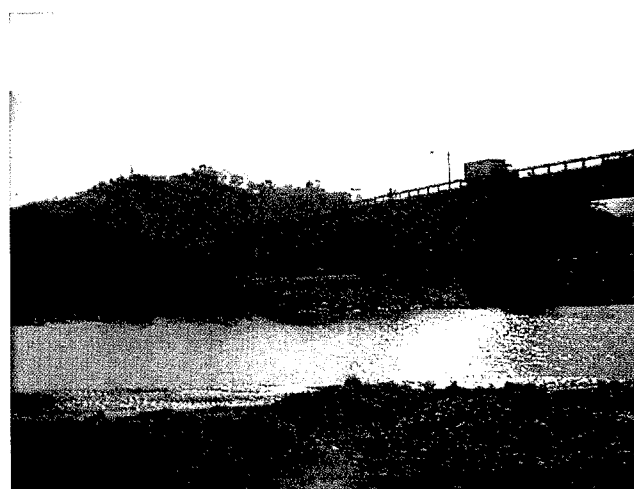
20. El Aire Sector (N15.70293, W86.50286) corrugated metal pipe washed out (see Photo 18). A temporary bridge was constructed. The consultant on the project is proposing the construction of a 3x72-inch concrete-pipe culvert. This project is included in the ongoing World Bank contract. The design of the culvert should be validated by a hydraulic study.

**Photo 18.** Hydraulic Study Needed

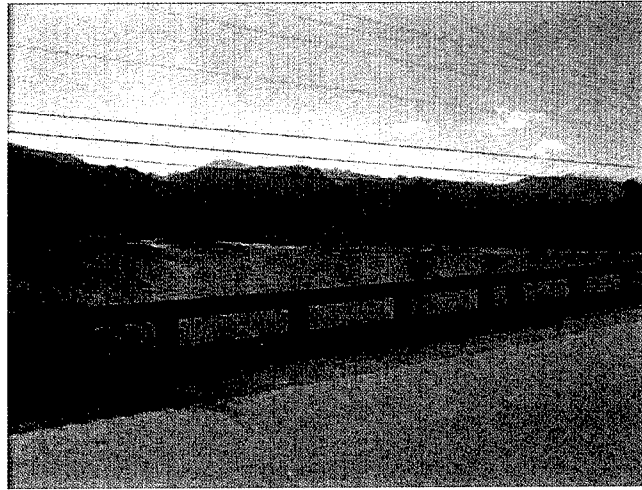
22. Bridge over Rio Tocoa (N15.64767, W86.01424) (see Photo 20). The bridge is in good condition but the streambed has risen because of heavy sedimentation, causing the freeboard to be reduced to less than 1 meter. The team recommends that a higher bridge, about 80 meters long, be built at an estimated cost of \$341,000 (U.S.) (priority 2).

**Photo 20.** *Heavy Stream Siltation has Raised Water to Hazardous Level*

| <b>Project Area/Project Description</b> | <b>Cost (U.S. dollars)</b> |
|---|---|
| 22. Rio Tocoa Bridge—Bridge in good condition; streambed has risen; recommend that a higher bridge (80 meters long) be built | \$341,000 |
