Marine Accident Report

**Ramming of the Eads Bridge by
Barges in Tow of the M/V *Anne Holly* With
Subsequent Ramming and Near Breakaway
of the *President Casino on the Admiral*
St. Louis Harbor, Missouri
April 4, 1998**

**NTSB/MAR-00/01
DCA98MM027
PB2000-916401
Notation 7009B
Adopted September 8, 2000**

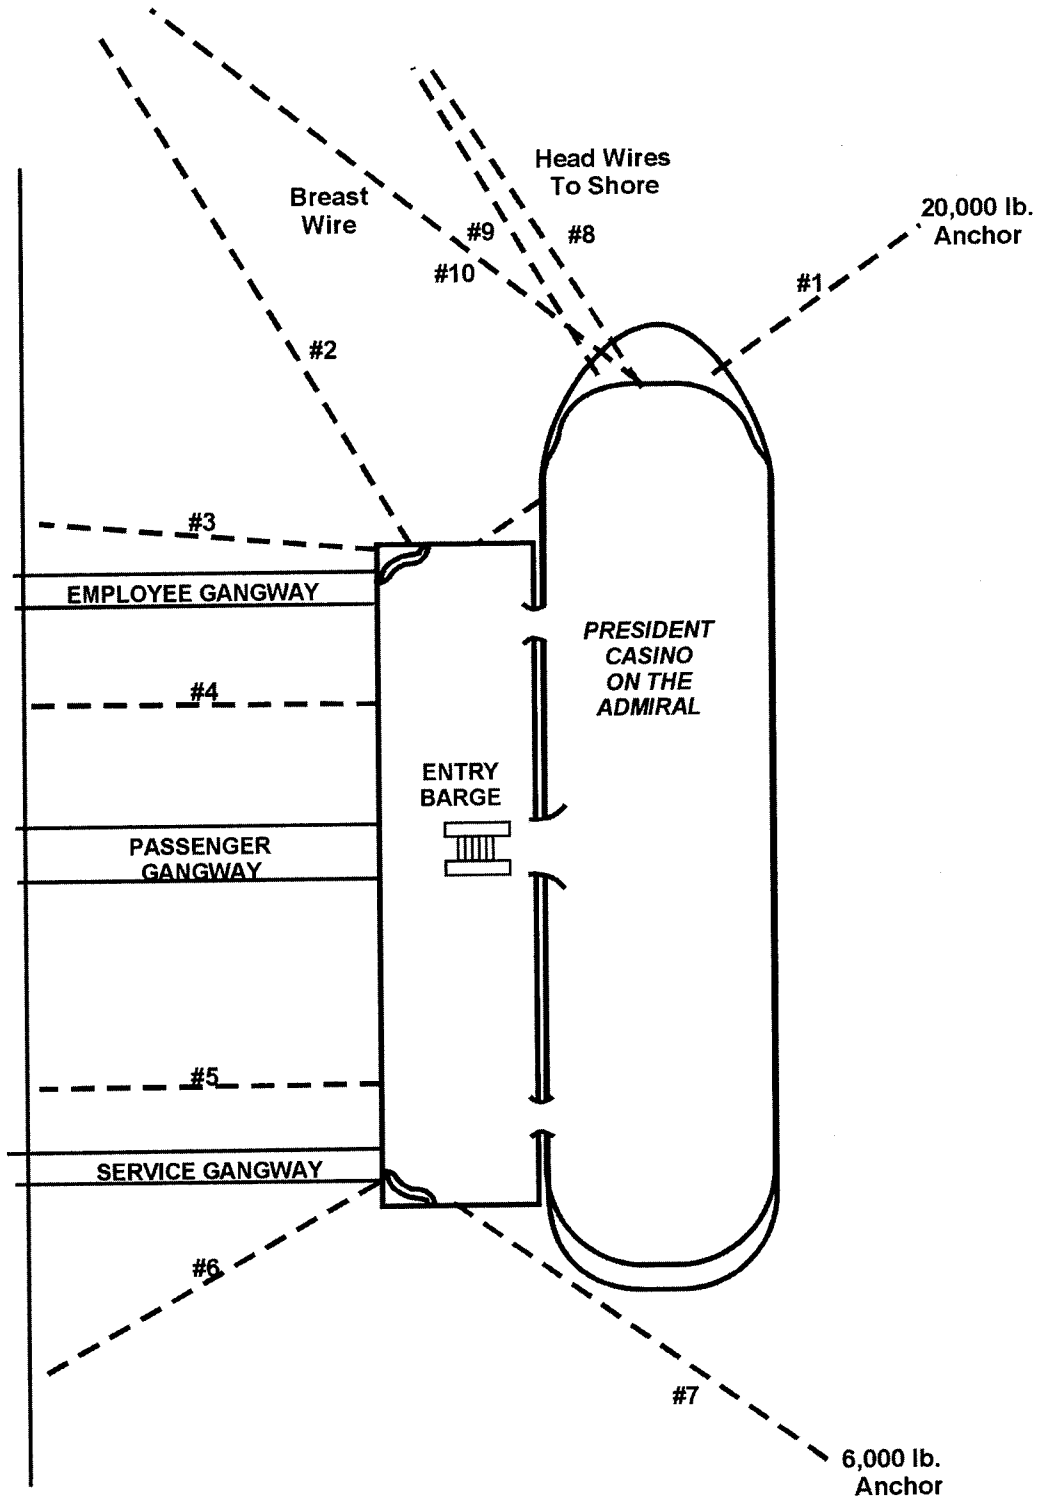
Figure 5. Schematic of the *Admiral* mooring arrangement

Shortly thereafter, the three barges from the *Anne Holly* drifted toward the *Admiral* and severed or severely damaged mooring line numbers 8, 9, and 10 at the *Admiral*'s bow, before colliding with the *Admiral*. At least two of the three barges struck the *Admiral*, and two barges drifted downriver. The third barge drifted toward shore and struck the sidewalk protection guards and the north gangway between the shore and the entry barge. The impact to the *Admiral* caused wire rope numbers 1, 2, 3, 4, and 5 to break. (Figure 5 details the mooring arrangement. Figure 6 shows two views of the complex.)

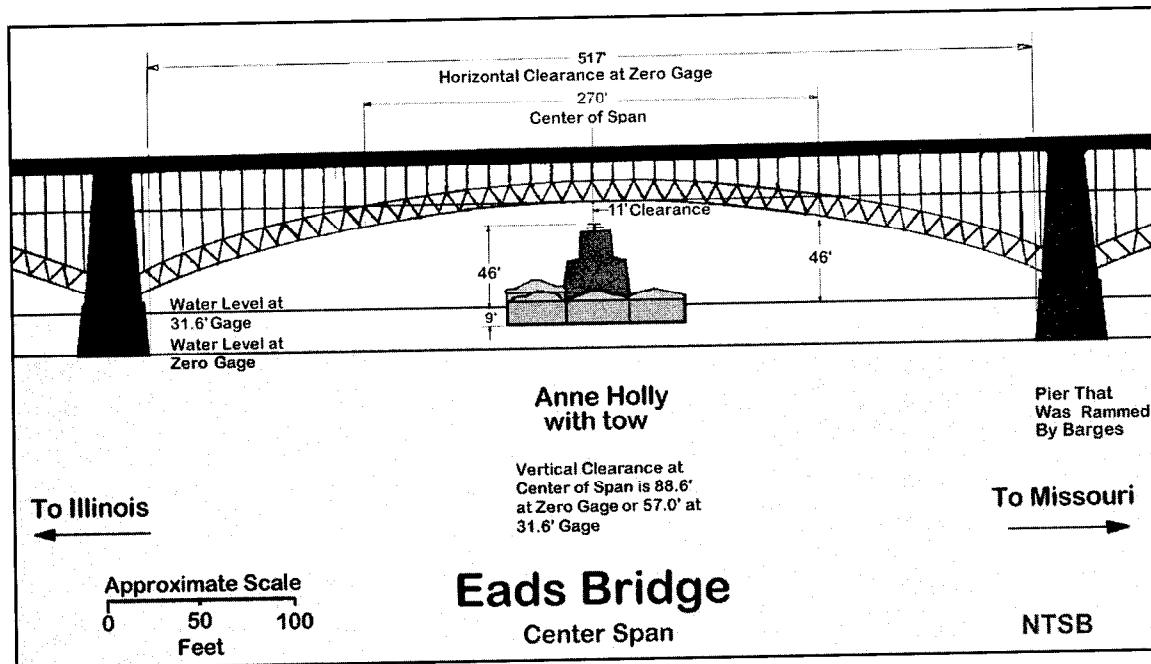
Figure 10. Schematic view of the *Anne Holly* tow under the Eads Bridge. (This figure is not representative of the actual path taken by the *Anne Holly*. The figure is used for illustrative purposes only, to show the heights of the bridge and the *Anne Holly*.)

down proportionately on each side of the arch. The bridge's red day markers were each 150 feet from the center of the bridge, leaving a horizontal space of 300 feet between them. At the time of the accident, 42.2 feet was between each marker and the river surface. Given its air draft, the *Anne Holly* required a minimum of 46 feet of vertical clearance. The flood conditions reduced the vertical clearance under the side portions of the Eads Bridge main arch so that a center navigation area of about 270 feet had 46 feet or more of vertical clearance. (See figure 10.)
