# NATIONAL TRANSPORTATION SAFETY BOARD

### Emergency Evacuation of Commercial Airplanes

## **Emergency Evacuation of Commercial Airplanes**

**NTSB/SS-00/01  
PB2000-917002  
Notation 7266  
Adopted June 27, 2000**

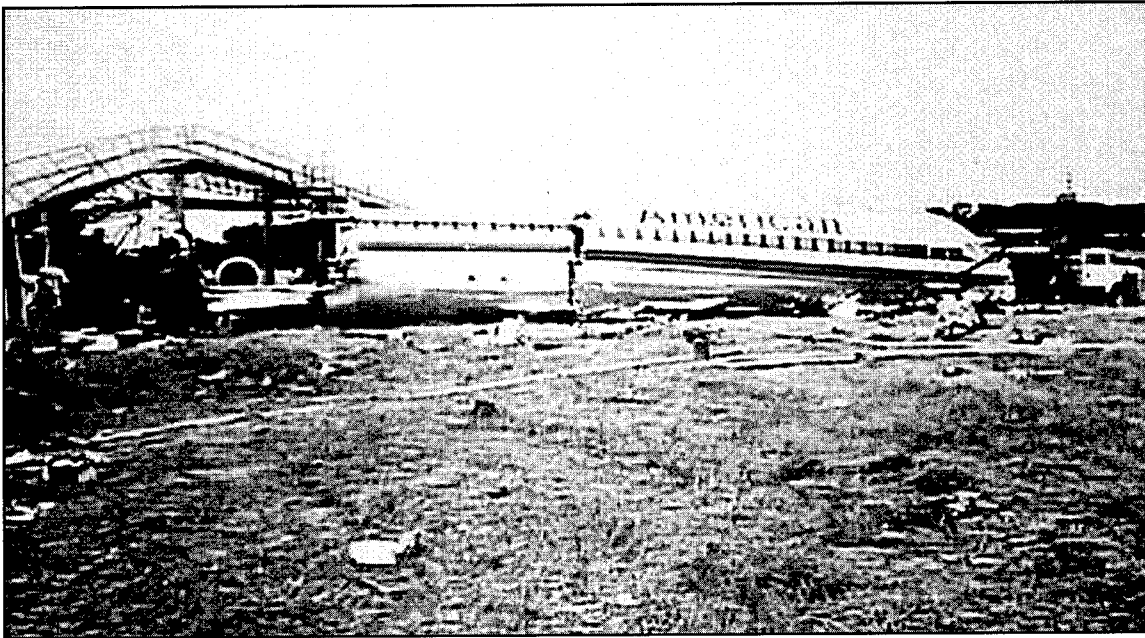
In the MD-82 accident in Little Rock, Arkansas (case 45), the crash forces caused seats to break free from their seat tracks and block aisles. In the forward portion of the cabin, passengers had to navigate around fallen overhead bins and across a severely deformed floor. Fortunately, the crash caused several gaps in the fuselage that passengers were able to use for egress. As seen in figure 5–3, the crash forces split the cabin in two separate sections divided at the wing.

**Figure 5–3.** View of the McDonnell Douglas MD-82 accident scene that involved evacuation on June 1, 1999, Little Rock, Arkansas (case 45).

Based on the circumstances of the evacuation in this accident, the Safety Board recommended that the FAA

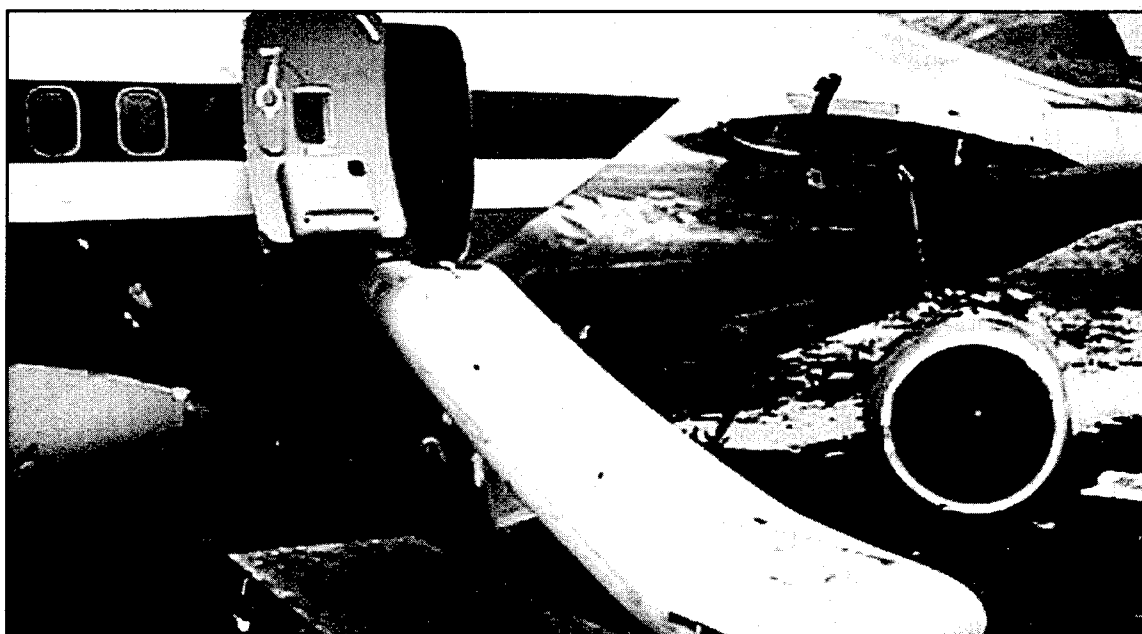
**Figure 5-4.** View of a slide used in the Boeing 727 evacuation on February 9, 1998, Chicago, Illinois (case 9).

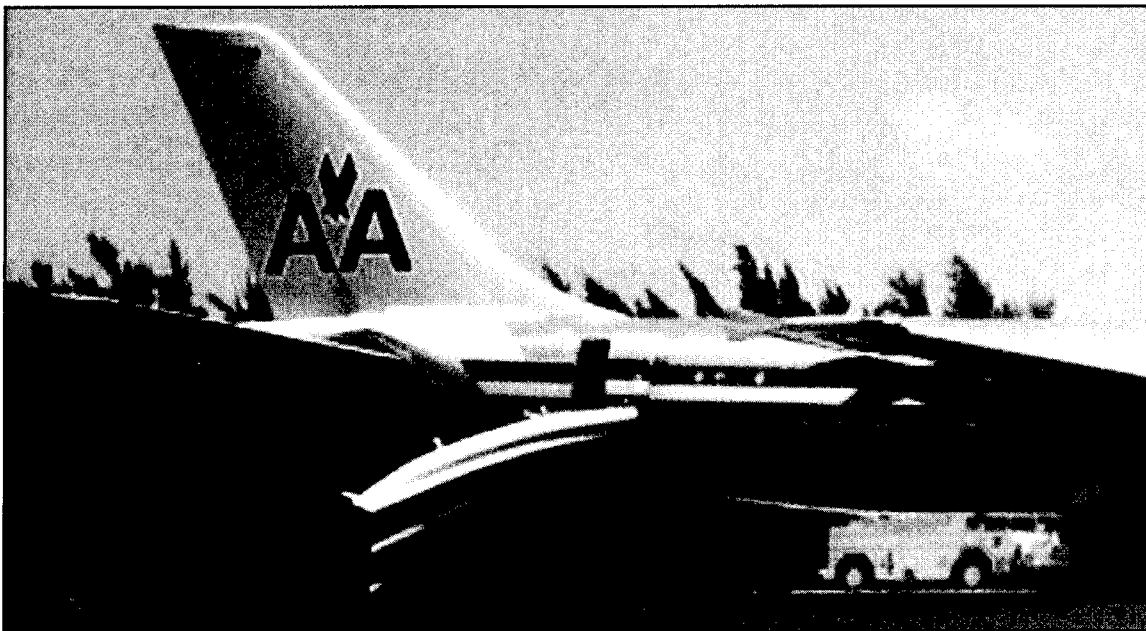
deploy the slides at R1, R2, and R4. However, there was a delay in deploying the R1 slide because of a failure of the power assist in the door. Also, the R3 door partially opened before jamming. The flight attendant tried repeatedly to open the door, but reported that he “knew [the slide] was caught up” in the pack. Postincident testing conducted by the Safety Board indicated that the malfunction might have been caused by a Velcro® fastener that became hooked on a clip on the inside of the decorative cover. In addition, the slide deployed at R4 was unusable for a period of time because winds were blowing the slide against the airplane (figure 5–9). During this time, the 234 passengers were exiting from only two of the eight exits on the A300.

**Figure 5–9.** View of the wind’s effect (25-knot gusts) on the evacuation slide used following the Airbus 300 accident on July 9, 1998, in San Juan, Puerto Rico (case 24). Passengers were able to use this exit after a person on the ground held the slide in place.
