**Research Report
KTC-90-25**

**EVALUATION OF GEOCOMPOSITE
PAVEMENT PANEL DRAINS INSTALLED
IN A SAND BACKFILL UNDER
REVISED INSTALLATION SPECIFICATION**

**Kentucky Transportation Center
College of Engineering
University of Kentucky
Lexington, Kentucky**

**December 1990
(Revised August 1991)**

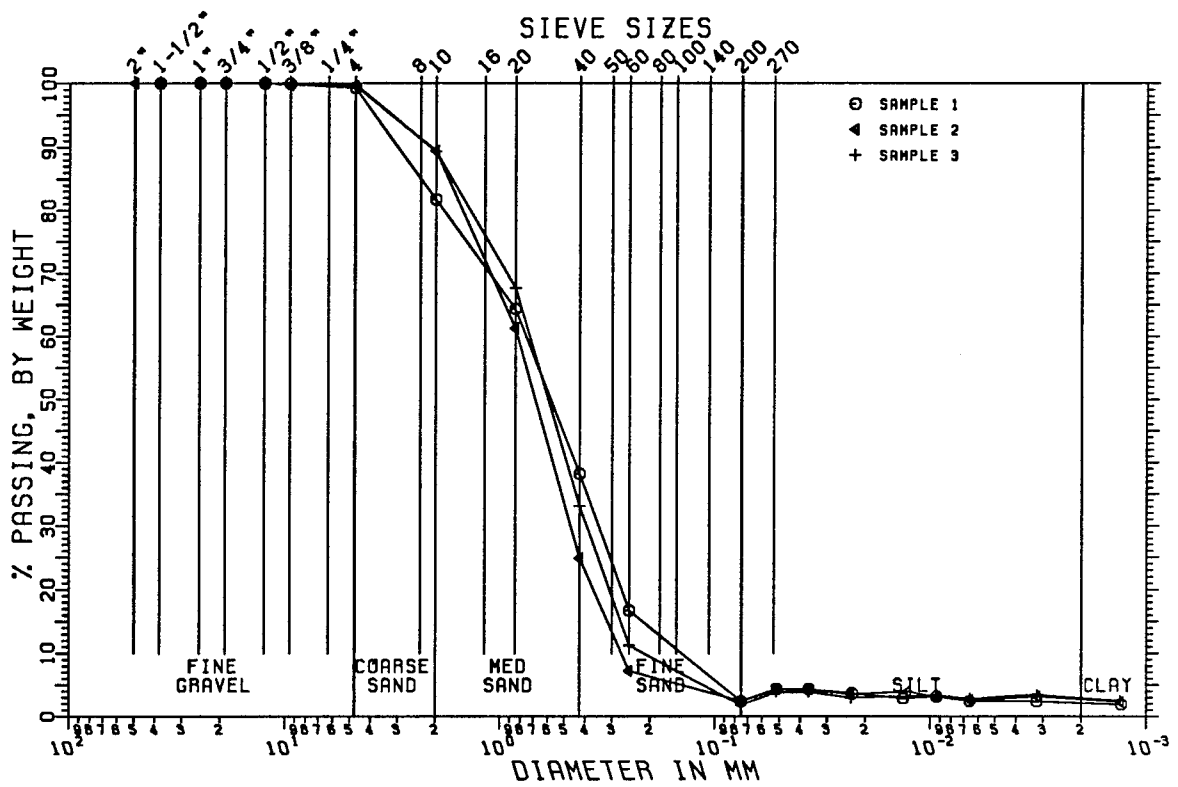
Figure 2. Gradation Comparison (Mountain Parkway)

The edge drains were inspected again in 1990, approximately a year after installation. There were no signs of compression in the core of either edge drain. A build up of calcium carbonate was occurring in the invert of both drainage systems (approximately 0.25 inch thick). The filter material around each panel appeared to be open. The sand backfill was inspected for blinding adjacent to the broken slab. The sand backfill appeared to be relatively clean. A sample of the sand backfill was obtained from three locations 1) the stockpile prior to installation, 2) directly above the panel, and 3) adjacent to the concrete slab. Grain size analyses were performed on the three samples. The gradation comparison for each sample is shown in Figure 2. It appears that there has been no significant change in the gradation of the sand backfill.

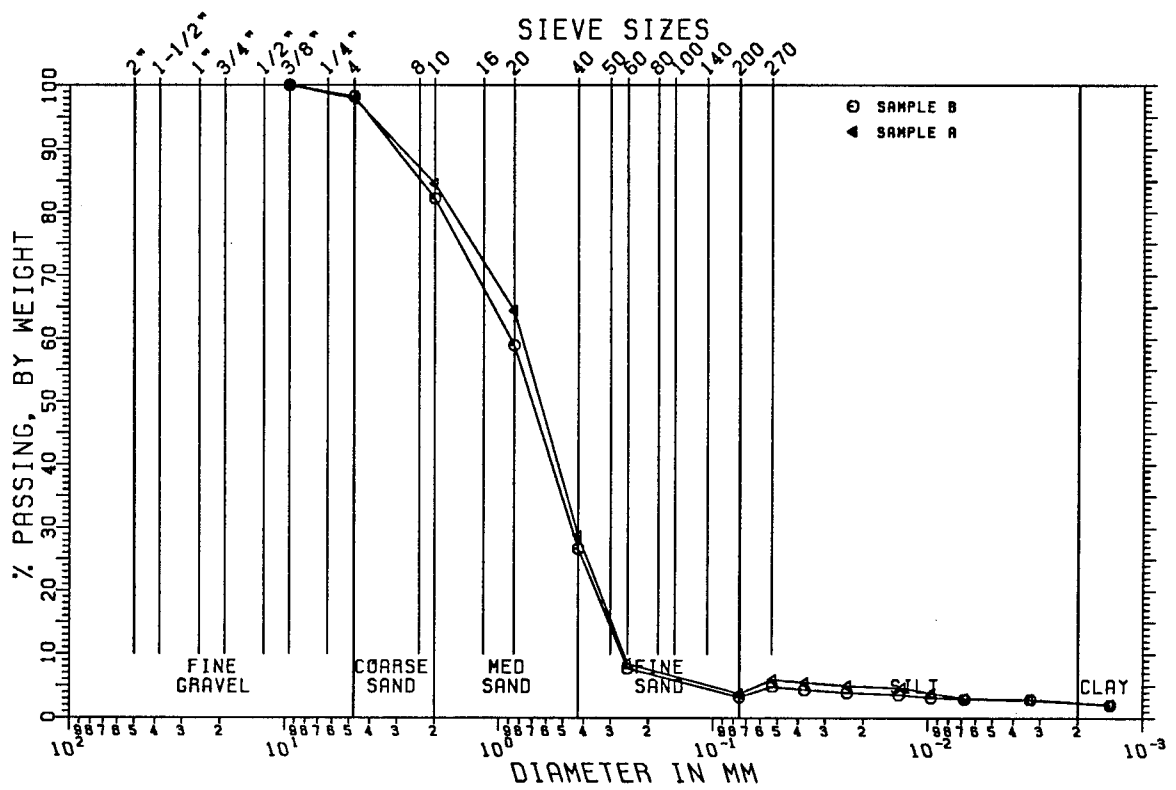
Figure 3. Gradation Comparison (Interstate 75)

During the excavation of the trench, the sand backfill was inspected for signs of blinding or clogging. A distinct layer approximately 1/4-inch thick of dark silted sand was observed adjacent to the concrete interface. The remainder of the sand between the panel appeared to be clean. The filter fabric surrounding the core of the drain was also clean. Gradation tests were performed on the two samples. Sample A was taken against the face of the concrete and sample B was taken from the center of the trench. A noticeable difference is apparent on the number 10 and 20 sieves. There appears to be a slight increase in minus two hundred material against the face. The gradation curves are shown in Figure 3.
