Research Report
KTC-90-23

GROUND MODIFICATION SYSTEMS
(STONE COLUMNS AND WICK
DRAINS IN JEFFERSON COUNTY)

SOUTH ABUTMENT WALL FAILURE

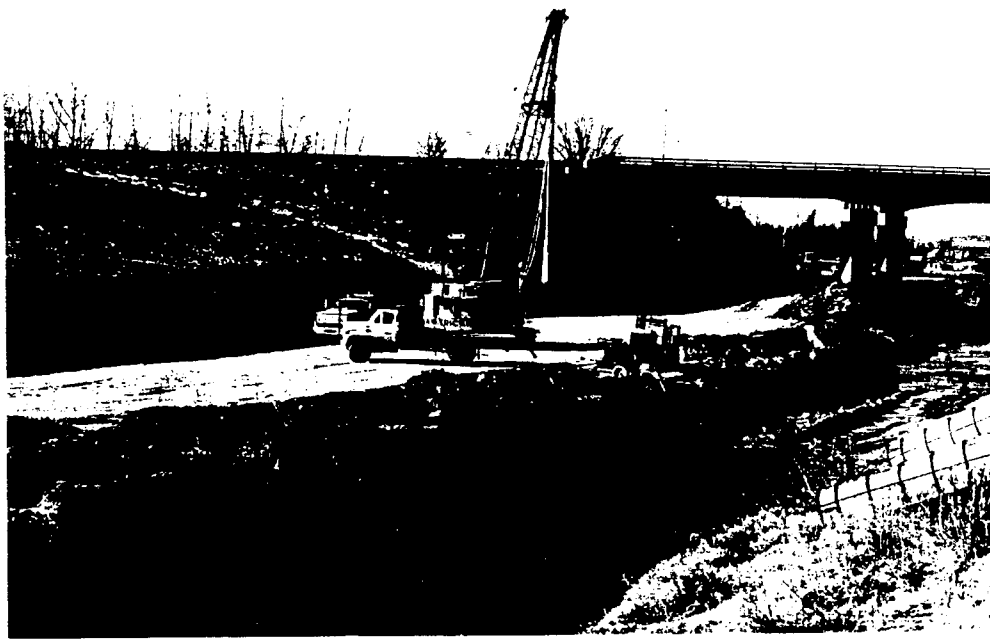
Figure 7. Abutment 1 Foundation.

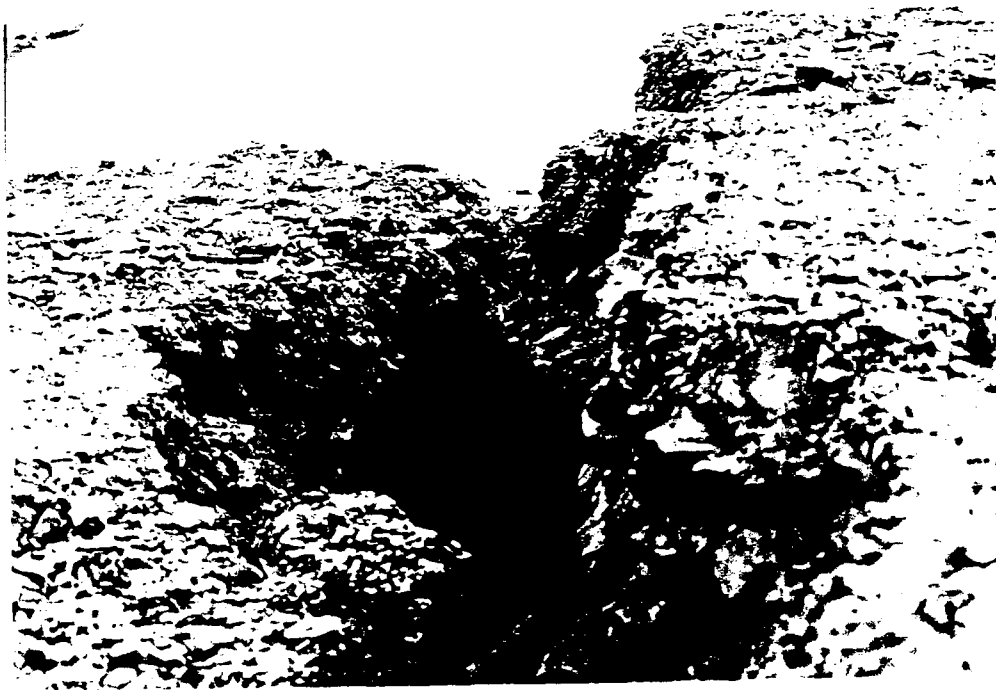
Construction of the south abutment reinforced soil wall began on or about February 20, 1986. The wall was approximately 30 ft high and was essentially complete in three weeks. A slope inclinometer indicated lateral movement of the foundation during construction; and by March 14, approximately three weeks after wall construction began, the reinforced wall and backfill had moved laterally as much as 5 ft and vertically as much as 1.5 ft. The wall tilted backward, toward the embankment, as much as 1 ft from vertical. The wall and backfill remained intact and moved away from the shale embankment. Large tension cracks developed at the backfill - embankment interface. Photographs of the failed wall are shown in Figures 7 through 10. Figure 7 shows the site, as viewed from the northeast, during construction of the stone columns. Figure 8 shows the toe of the wall and the upthrust foundation in the Northern Ditch. Figures 9 and 10 show the failed wall and embankment with the metal straps of the reinforced earth structure exposed in the fissure in Figure 9.

Figure 9. Failed Wall with Tension Cracks.

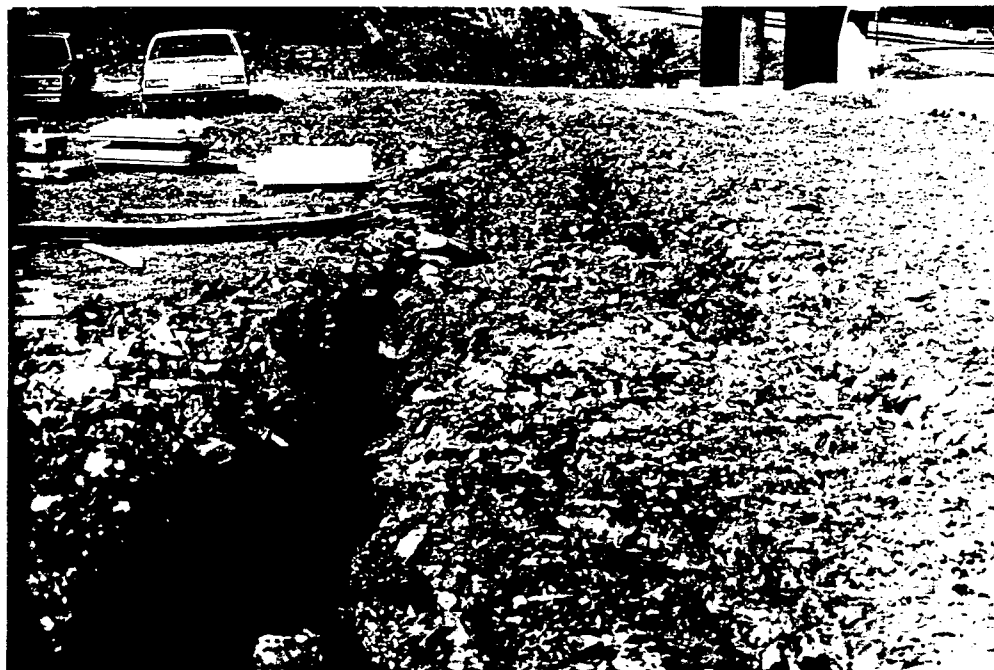
Figure 10. Failed Wall with Tension Cracks.

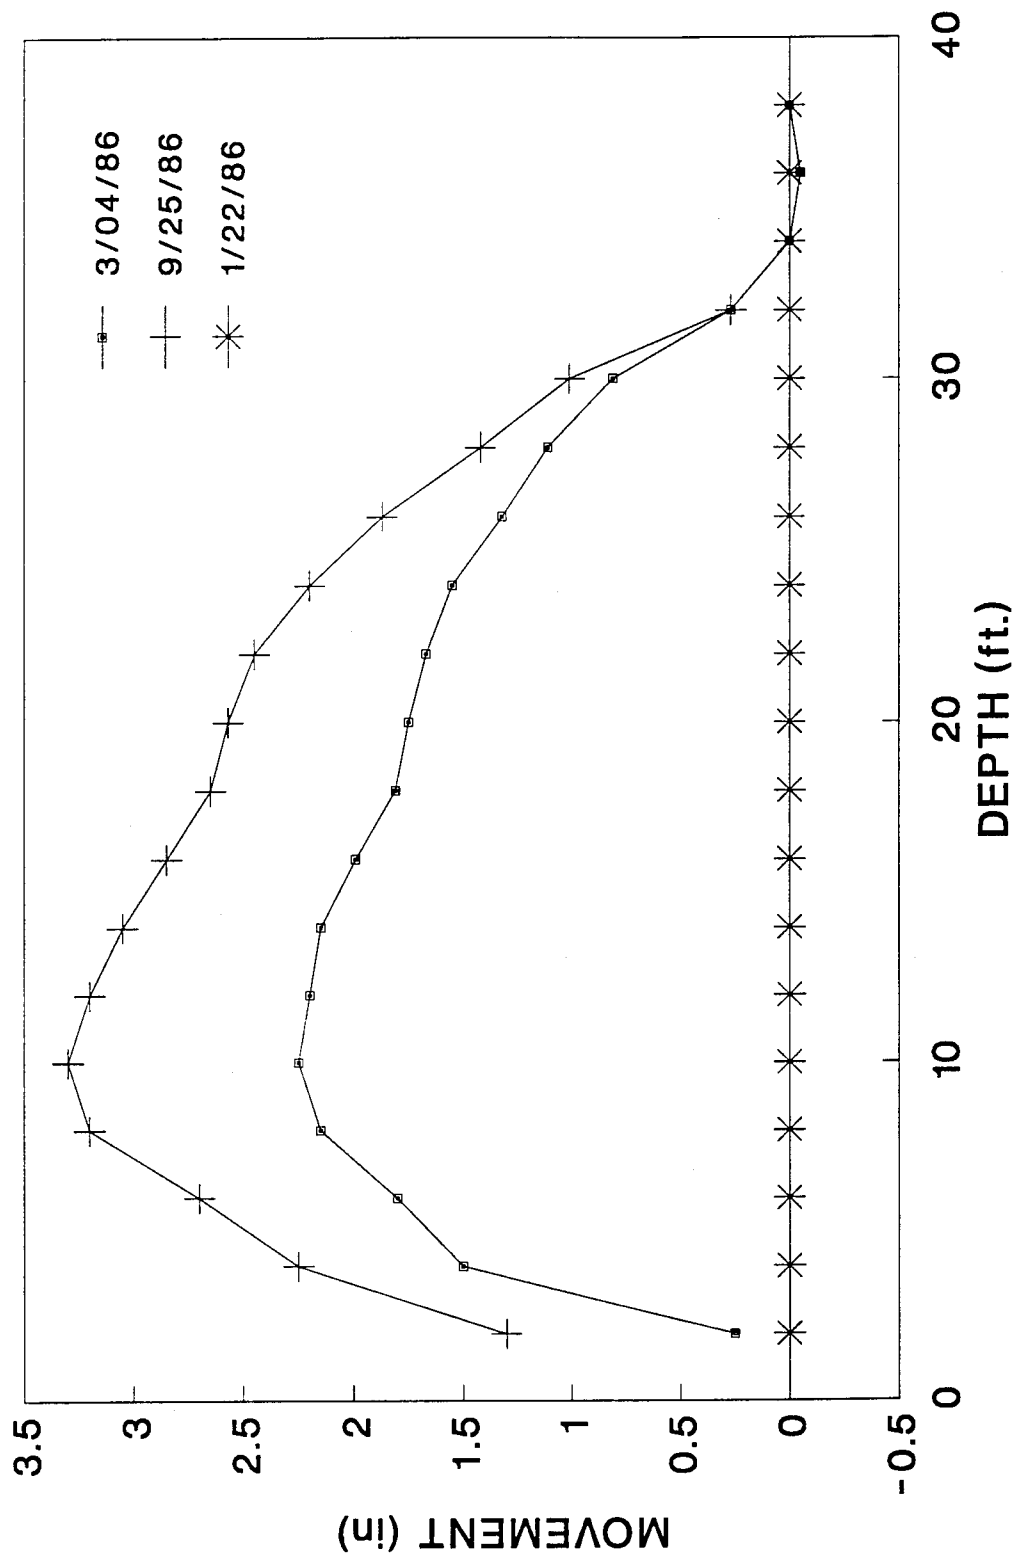
Horizontal displacements of the walls were monitored with slope inclinometers placed adjacent to the walls. Inclinometer 1 (north wall) indicated 3.3 in. of movement at a depth of 10 ft at 240 days after installation. This inclinometer was installed January 22, 1986 and approximately 2.3 in. of movement occurred in 40 days. Lateral movement at Slope Inclinometer 1 is shown in Figure 19.

Figure 19. Lateral Movement (S.I.1) of Foundation at Abutment 2.

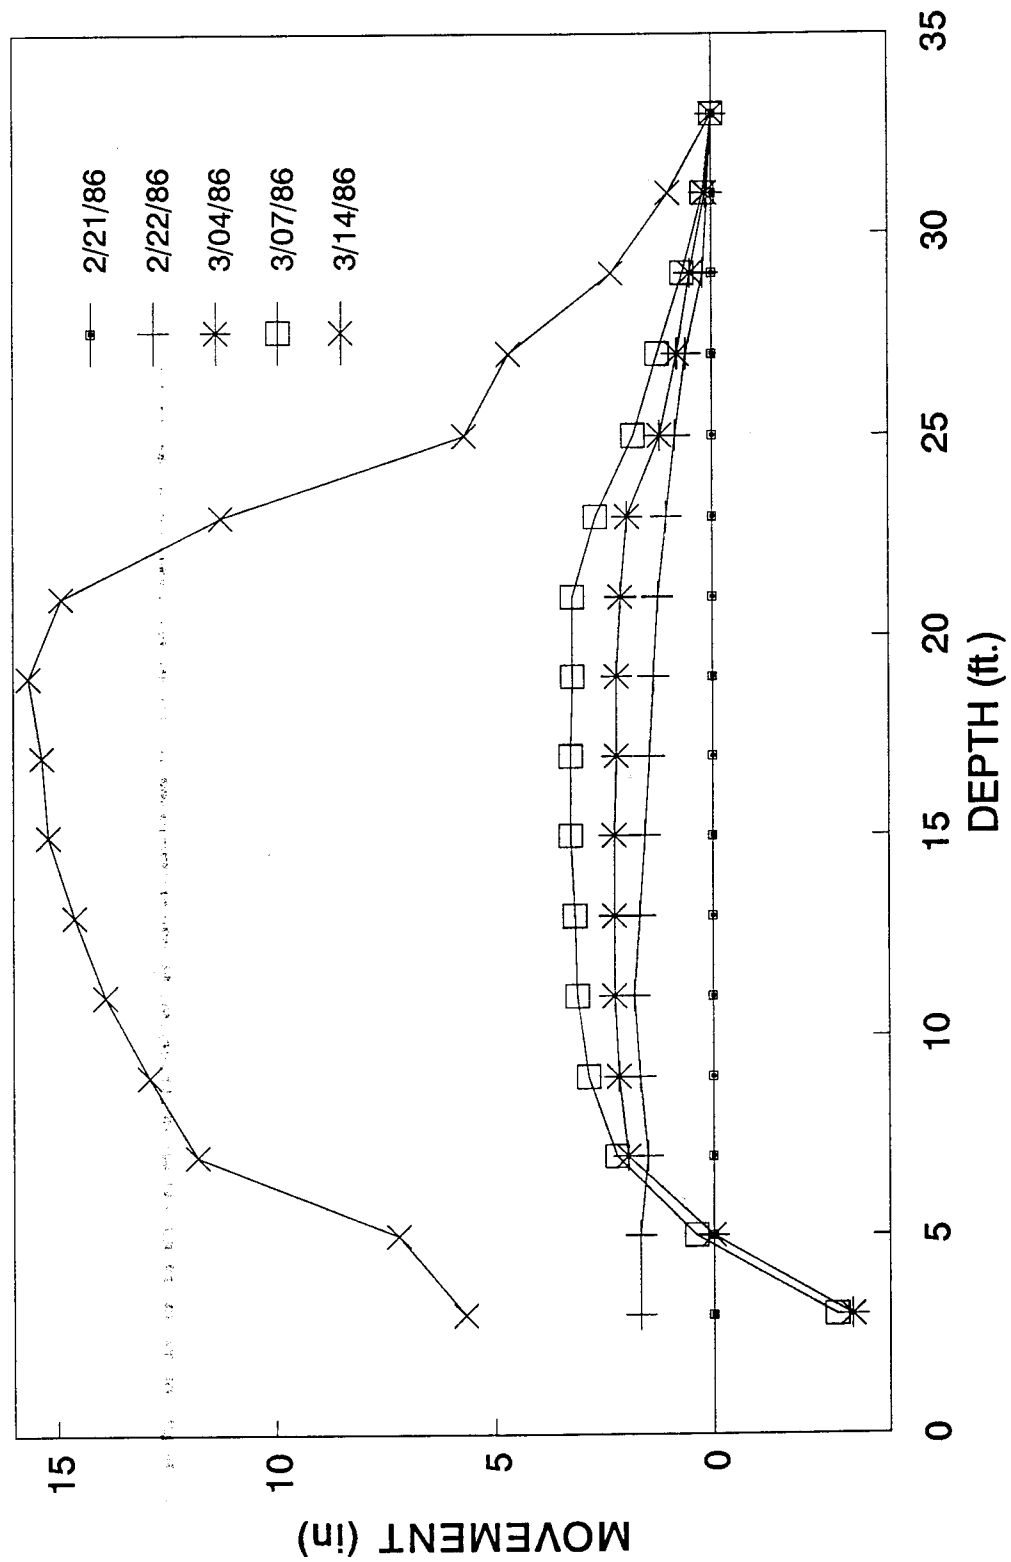
Slope Inclinometer 2 (south wall) was installed on February 21, 1986. The last data collected (March 14, 1986) before failure indicated lateral movement of nearly 16 in. Lateral movement at Slope Inclinometer 2 is shown in Figure 20.

Figure 20. Lateral Movement (S.I.2) of Foundation at Abutment 1.
