## TRUCK ROUTE ACCESS EVALUATION

Fulton County  
Hickman Riverport Area  
Site No. 16

Report No. KTC-98-35

“Freight Movement and Intermodal Access in Kentucky”  
SPR 98-189

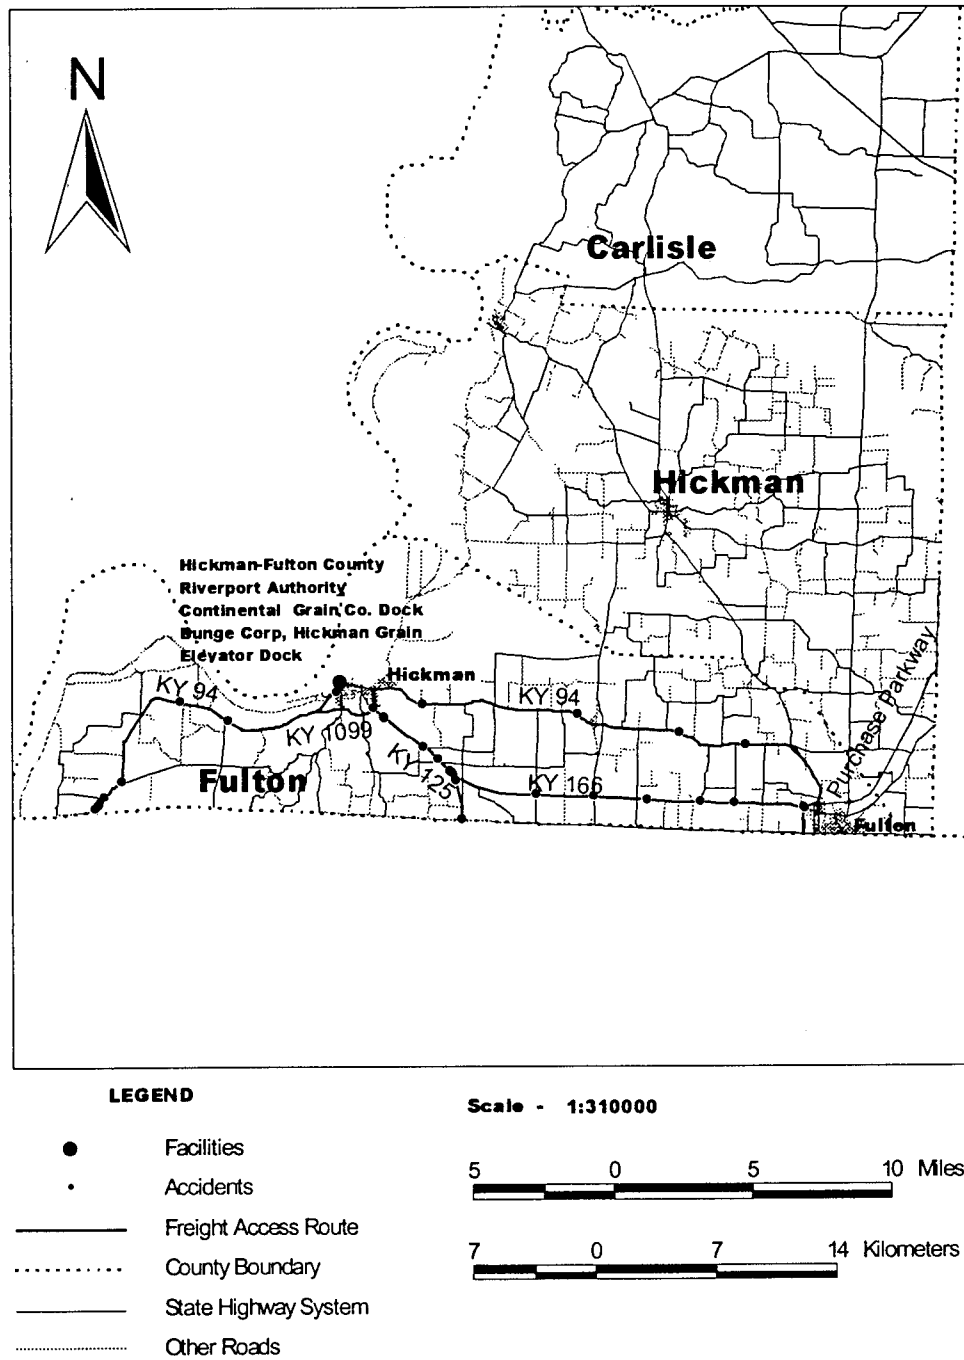
**Figure 6: Location of Accidents (1995-1997)**

Figure 6 shows the locations of accidents during the years 1995, 1996 and 1997. This map should be viewed with caution as only 45 of the 165 accidents during the three years had a milepoint reported in the state-accident database and could therefore be plotted here. A high number of accidents occurred in South Fulton on US 51 and KY 166 where overall traffic levels are higher than along other portions of these more rural routes (this intersection is listed for reconstruction in the Long Range Highway Plan). A large number of accidents occurred just north of the Tennessee border on KY 94. This section is discussed in section 3.5 and contains an intersection of two roads and a railway crossing on a sharp horizontal curve. Many accidents occurred near the intersection of KY 166 and KY 125. This non-ideal "Y" shaped intersection is described in section 3.4 which contains a drawing of the configuration. Overall, there was not a significant number of truck accidents as indicated in Tables 2 through 5. The tallies of accidents are presented for each route segment for the 1995 through 1997 three year period. Note that KY 309 did not have any accidents reported on it. Trucks represent between 8 and 11 % of the ADTs along these segments. Considering the magnitude of total accident numbers and the truck traffic percent, it would seem only KY 94 and US 51 between Hickman and the town of Fulton may require further investigation related to truck accidents and safety. The site visit revealed no apparent differences between this route segment and the others that would lead to higher accident levels. Furthermore, no sight distance or other safety hazards were noted.

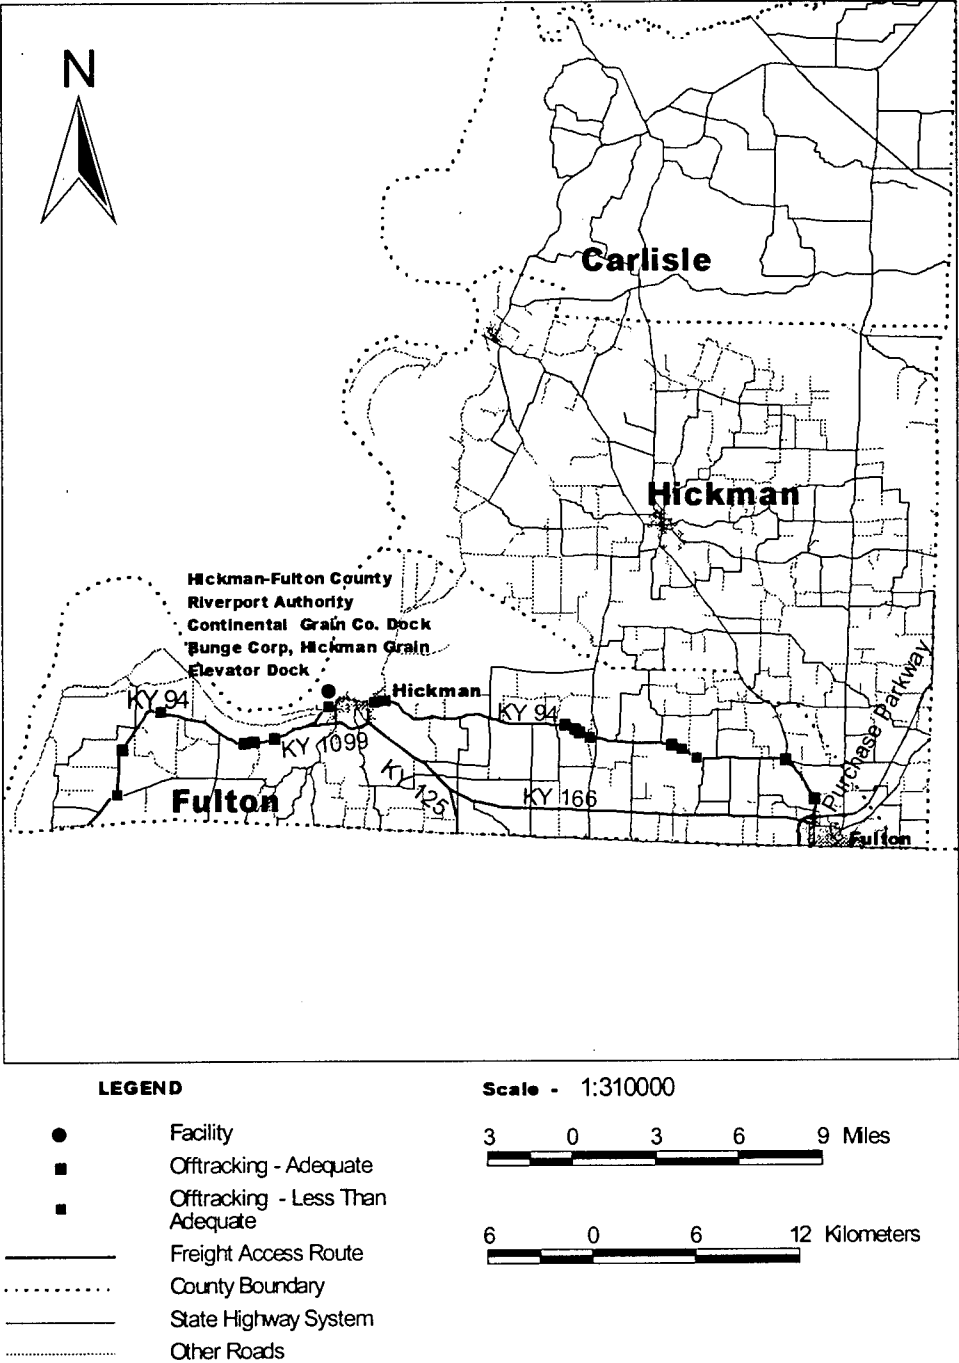
**Figure 11: Horizontal Curves with Potential Offtracking Problems**

Locations where offtracking may occur were estimated using wheel base lengths, horizontal curvature information from the HIS database and lane widths measured in the field. No curve widening was noted in the field. Locations of potential offtracking problems (19 in total) are shown in Figures 11 and 12, while details are listed in Appendix B. Only 7 of the curves on these routes (all on KY 94) also failed the ball bank reading guidelines when traveled at the speed limit or the posted advisory speed for these curves. These locations are shown in Figure 13.

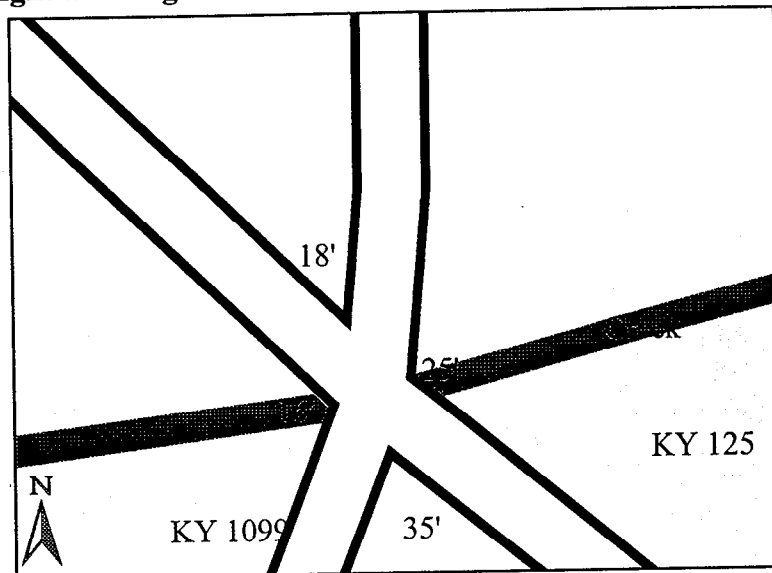
**Figure 14: Right Turning Radii at the Intersection of KY 1099 and KY 125.**

The right turning radii at two intersections within the town of Hickman are “less than adequate” for the trucks traveling these routes. A sketch of the intersection of KY 125 and KY 1099 is shown in Figure 14, while the intersection of KY 1099 and KY 309 is shown in Figure 15. Trucks were observed offtracking into opposing traffic lanes while making both left and right turns at these intersections. Figure 16 illustrates the tire marks on the road at the intersection of KY 309 and KY 1099 where trucks make right turns from KY 1099 (on the right in the picture) onto KY 309 as well as make left turns from KY 309 to KY 1099. The tire marks clearly indicate trucks moving out of their travel lanes.

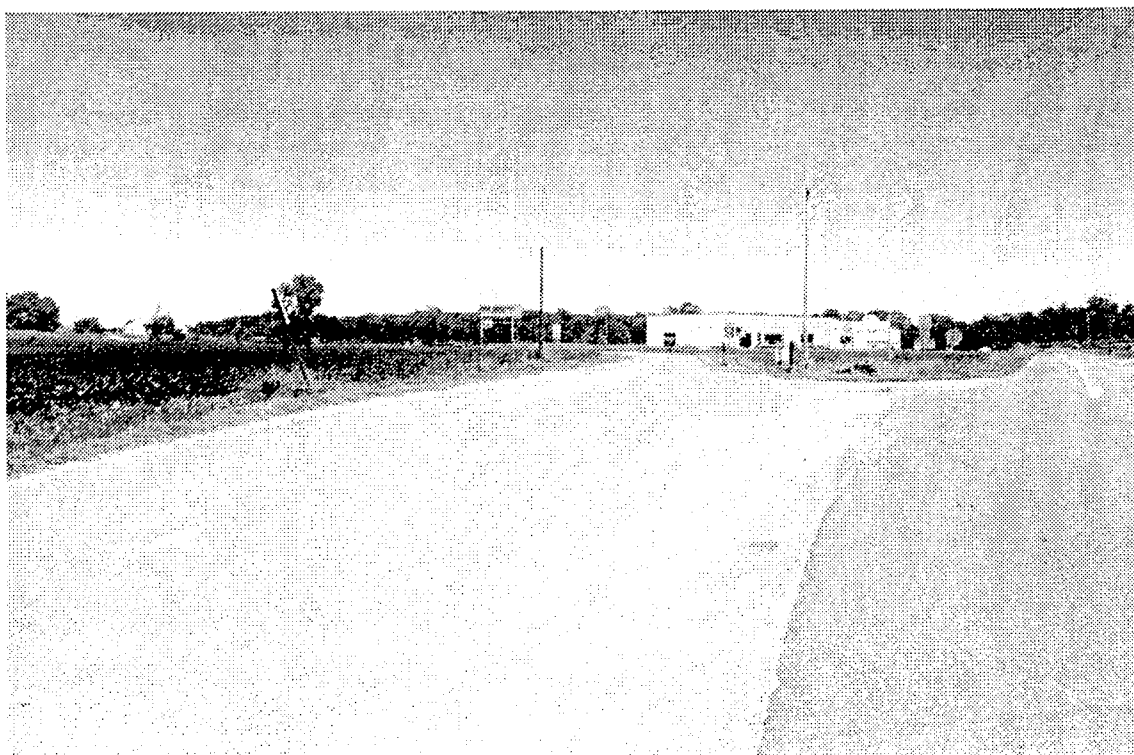
**Figure 17: Intersection of KY 94 and KY 1099**

Two intersections outside of Hickman were found to have limiting “Y” configurations as shown in Figure 17. Figure 18 illustrates the intersection of KY 94 and KY 1099 just west of the riverports. Figure 19 illustrates the intersection of KY 125 and KY 166 between Hickman and Fulton just north of the Tennessee border. Turning radii for the current dominant truck travel routes are not problematic. For example, westbound trucks on KY 1099 do not turn right onto KY 94. Likewise, northbound trucks on KY 125 do not turn right on KY 166. However, changes in truck travel patterns or addition of new facilities in the area might require improvements to these intersections. Furthermore, if the intersection of KY 1099 and KY 94 were different trucks might be able to use this route as an alternative to traveling through the residential neighborhood along KY 309 (mentioned in phone surveys). Owing to the travel patterns of trucks accessing the facilities under study, neither of these intersections is rated less than “preferred”.

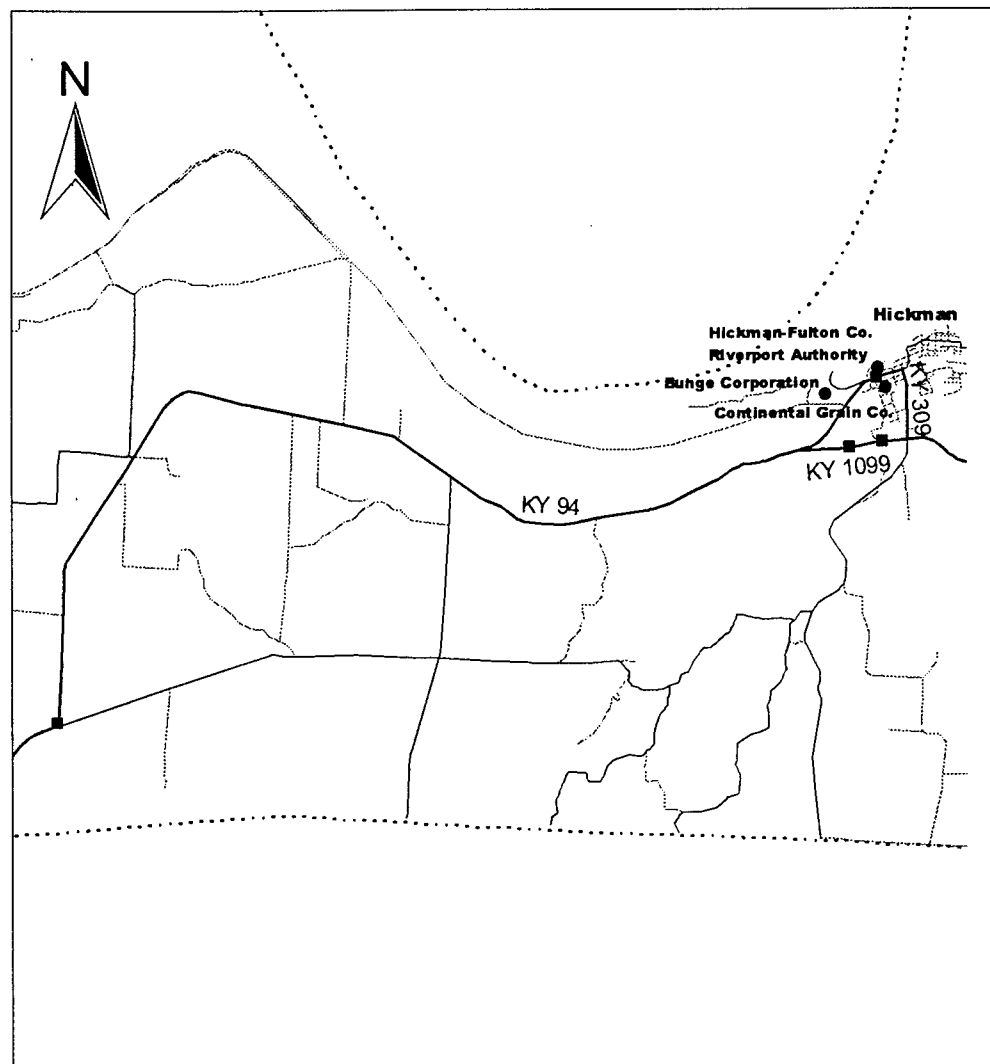
**Figure 20: Railway Crossings**

There were four at-grade railway crossings along these routes as shown in Figure 20. The rail crossings on KY 1099 have no warning signs, lights or gates. There is poor sight distance in one direction at each crossing. The rail lines appear unused so are not rated “less than adequate” in the tallies provided in section 4. This assessment is further confirmed by the tracks being paved over on KY 94 at the riverports (shown in Figure 20). All three of these crossings have good smooth pavement surfaces. The rail crossing immediately north of the Tennessee border on KY 94 occurs on a sharp corner as shown in Figure 21. Although there is sufficient sight distance, the crossing could be confusing or awkward. The surface is very rough and might pose problems for trucks. Although this rail line may not be used by trains the configuration and surface quality indicates it be assigned a “less than adequate” rating.

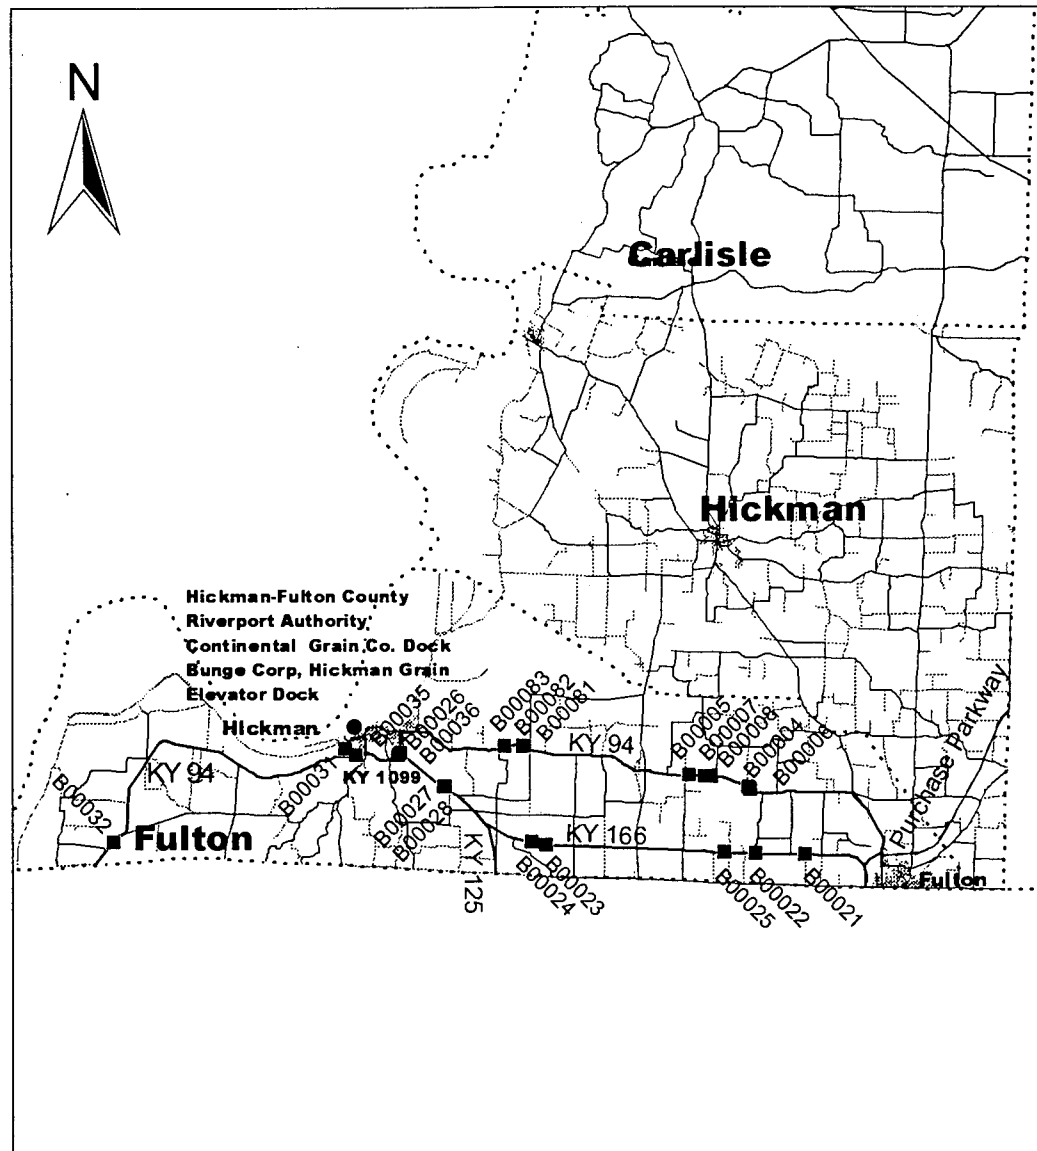
**Figure 22: Bridge Locations**

The locations of the bridges along this route are shown in Figure 22. Bridge sufficiency ratings were available from the KYTC Division of Planning as shown in Table 6. The far right column of Table 6 indicates how these sufficiency ratings translate into the adequacy indicators used in this project.
