## HIGHWAY ACCIDENT REPORT

COLLISION OF CSXT FREIGHT TRAIN  
AND MURRAY COUNTY SCHOOL  
DISTRICT SCHOOL BUS  
AT RAILROAD/HIGHWAY  
GRADE CROSSING  
CONASAUGA, TENNESSEE  
MARCH 28, 2000

**NTSB/HAR-01/03  
PB2001-916203  
Notation 7415  
Adopted December 11, 2001**

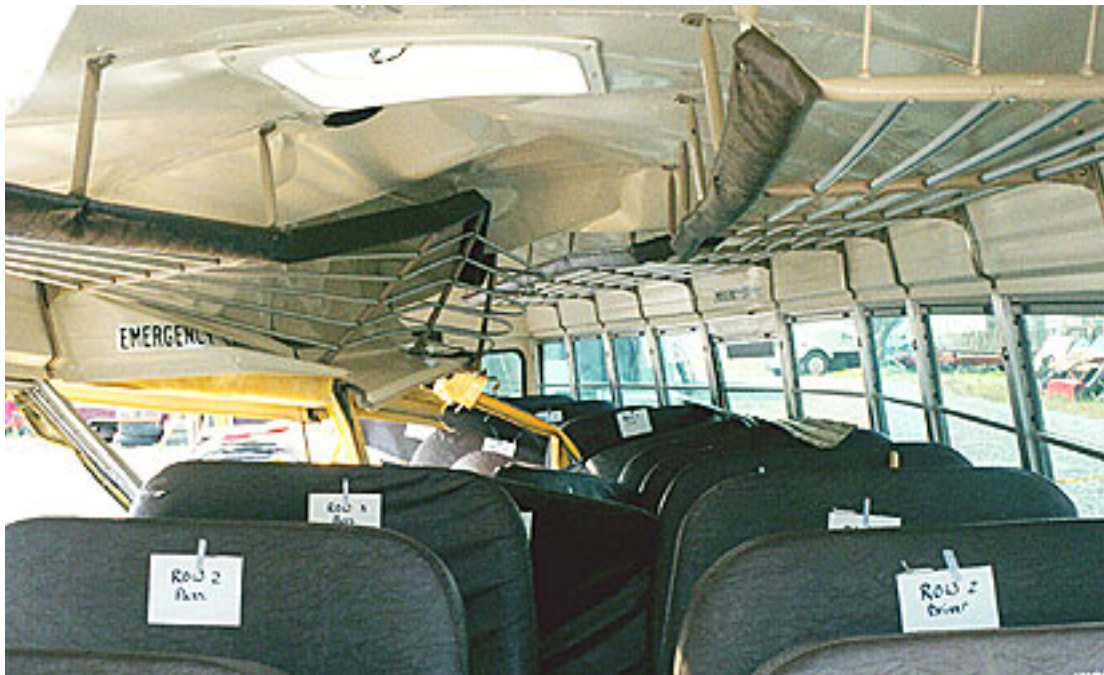
**Figure 6.** Roof rack.

protected the aisle side of the rack. Five metal bars formed the rack along the length of the bus. According to Blue Bird Corporation, the racks were 61.13 inches above the floor. They were located outside the head protection zone, as defined by Federal Motor Vehicle Safety Standard (FMVSS) 222 (49 CFR 571.222.5.3.1.1),<sup>22</sup> and thus were not required to comply with head protection requirements.

Severe damage to the roof rack was noted on the passenger side of the bus. Damage to the sidewall and roof of the bus caused the rack to rotate approximately 90 degrees, with the opening into the rack facing the top of the roof. Although twisted and bent after the accident, the racks remained securely attached to the bus body. The rack on the driver side of the bus was almost completely intact, except near seats 6 and 7, where induced deformation was present. This deformation was near the area of maximum intrusion.

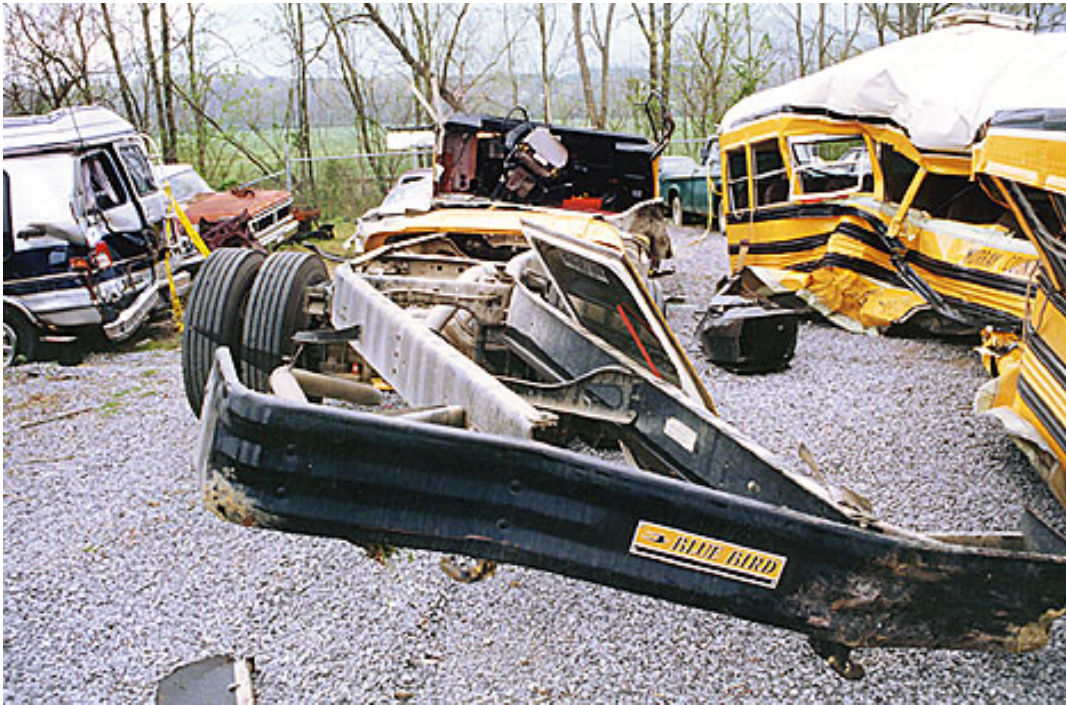
**Figure 7.** Bus chassis.

The school bus body separated from the chassis at the engine compartment cowling<sup>23</sup> and the forward roof panel above the windshield. The driver's seat, windshield, engine cowling, entrance stairwell, firewall, and dash controls remained attached to the part of the bus body still attached to the chassis. The chassis' main frame rails were deformed rightward from the drive axle rearward; maximum deformation was 44.63 inches. The drive axle was displaced leftward 7.8 inches. Frame rail cross members and rear bumper supports were also damaged (see figure 7).

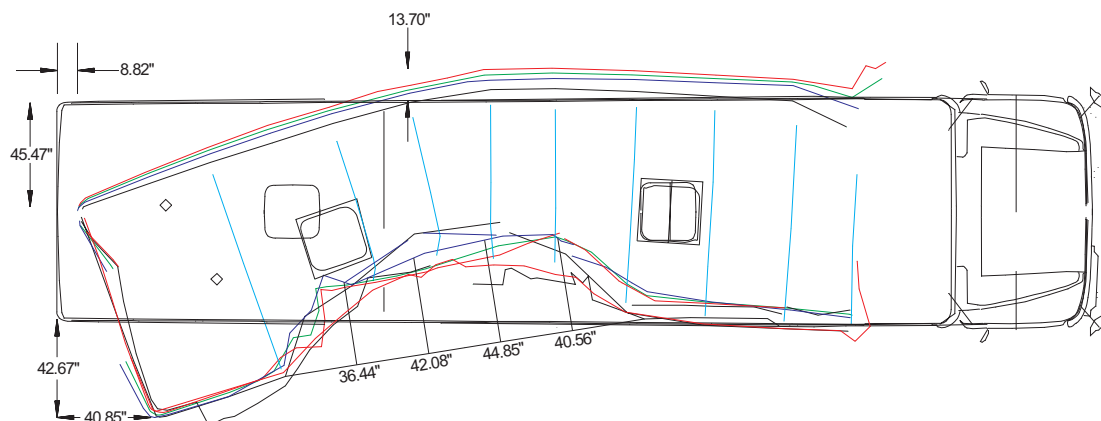
**Figure 8.** Bus body deformation.

Damage to the bus body was extensive in the immediate area of impact; maximum intrusion was 44.85 inches (figure 8). In addition, induced damage, in the form of bowing of the body structure, was substantial. The right rear corner of the bus was skewed rightward 42.67 inches and forward 40.85 inches (see figures 9 and 10).

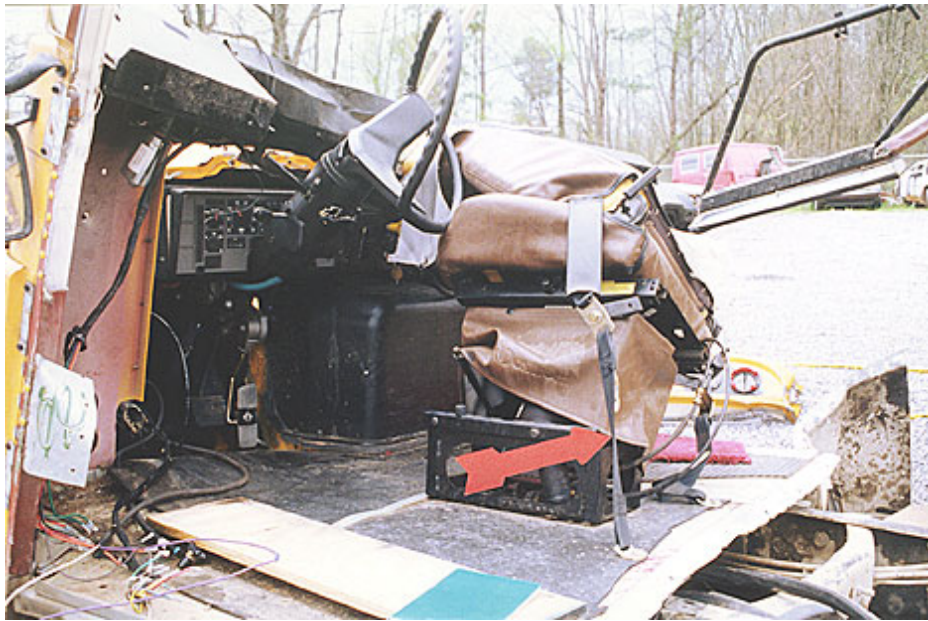
**Figure 11.** Driver's seat.

Postaccident inspection showed the driver's seat tilted toward the passenger side of the bus (see figure 11). The left lap belt segment extended from the edge of the seat cushion to the floor of the bus and was taut, while the right lap belt segment extended from the edge of the seat cushion to the floor of the bus and was slack. The driver's seat and the floor anchorages remained attached to the body flooring, which was in turn attached to the chassis. The shoulder belt passed through the D-ring, and the D-ring and the emergency retractor were located on the sidewall of the bus body (see figure 12). The shoulder belt webbing was torn, some of it remained with the driver's seat, and the rest remained with the sidewall-mounted retractor.

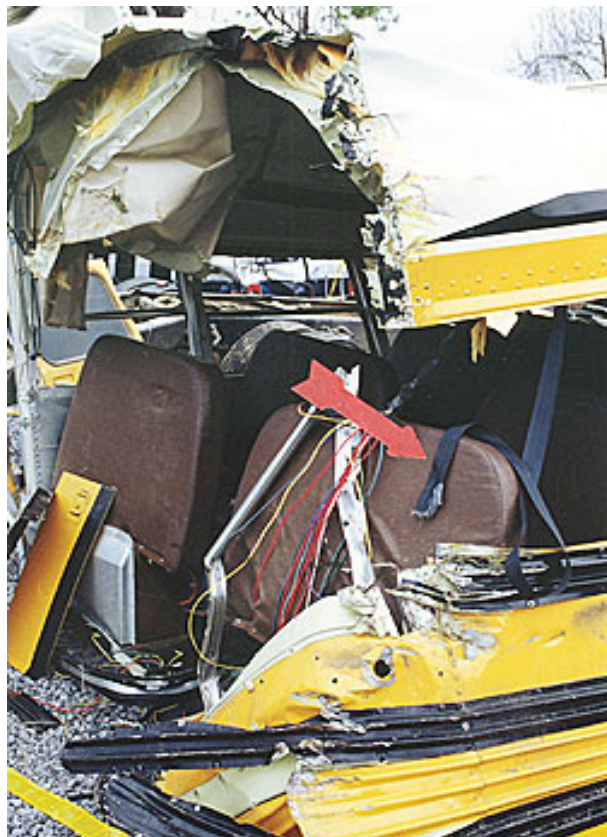
**Figure 12.** Portion of driver's shoulder belt attached to bus body.

The driver's lap/shoulder belt webbing was severed near where it passed through the free-sliding latch plate, which remained secured in the latch plate receiver on the chassis. Loading marks<sup>33</sup> were noted on the latch plate of the lap/shoulder belt and were visible on the D-ring. Striations in the plastic cover where the webbing passed through the latch were present along the length of the plastic.

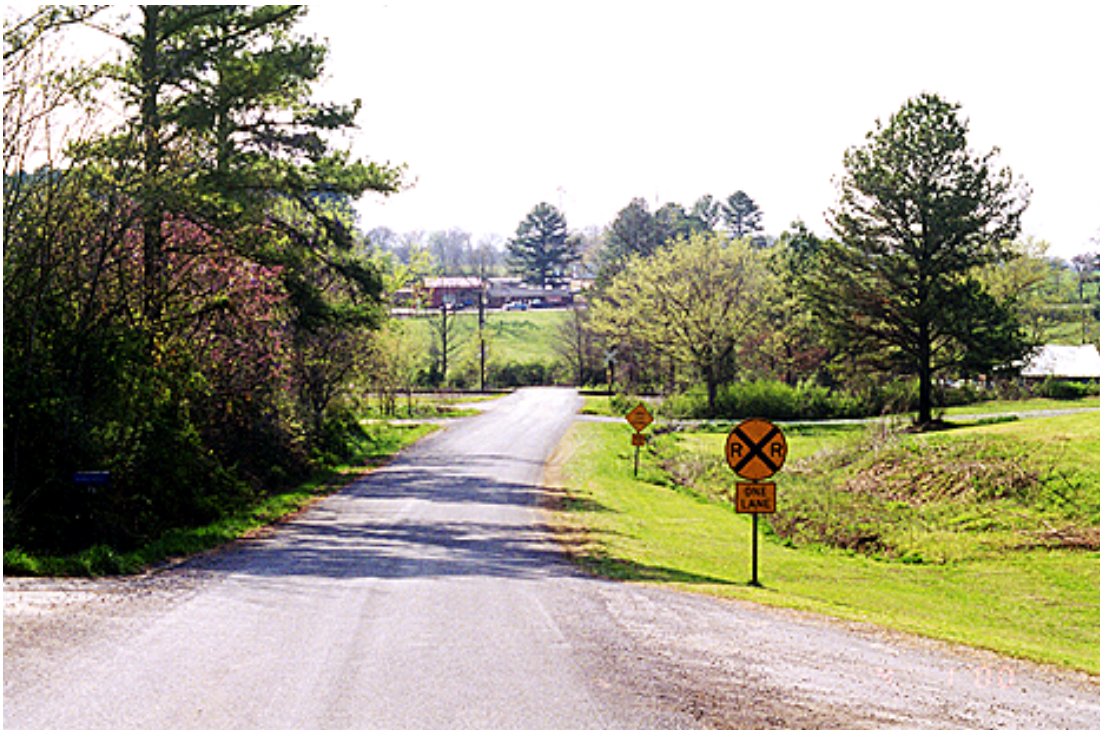
Liberty Church Road is an 18-foot wide, two-lane road without a centerline that winds about 1.8 miles in a “U” shape from Route 411 in Georgia back to Route 411 in Tennessee. No street name signs identify it as Liberty Church Road, nor do street signs mark any other roads in Polk County, Tennessee. At the time of the accident, two advisory signs were present as vehicles approached the crossing. One was a round railroad advance warning sign<sup>24</sup> 314 feet east of the nearest rail, and the other was a diamond-shaped warning sign<sup>25</sup> 200 feet east of the nearest rail that stated “LIMITED SIGHT DISTANCE,” below which was a supplemental advisory speed sign<sup>26</sup> that stated “10 MPH.” At the crossing was a railroad crossing sign (crossbucks) on the right side of the roadway (see figure 13). According to the Polk County Superintendent of Highways, an engineering study regarding the selection and placement of the advance warning signs and placards for the Liberty Church Road grade crossing had not been conducted.

**Figure 13.** Driver's view of Liberty Church Road approaching the crossing.
