REAR-END COLLISION OF NATIONAL RAILROAD  
PASSENGER CORPORATION (AMTRAK) TRAIN P286  
WITH CSXT FREIGHT TRAIN Q620 ON THE CSX  
RAILROAD AT SYRACUSE, NEW YORK  
FEBRUARY 5, 2001

**Rear-End Collision of National Railroad  
Passenger Corporation (Amtrak) Train P286  
with CSXT Freight Train Q620 on the CSX  
Railroad at Syracuse, New York  
February 5, 2001**

**NTSB/RAR-01/04  
PB2001-916304  
Notation 7411  
Adopted November 27, 2001**

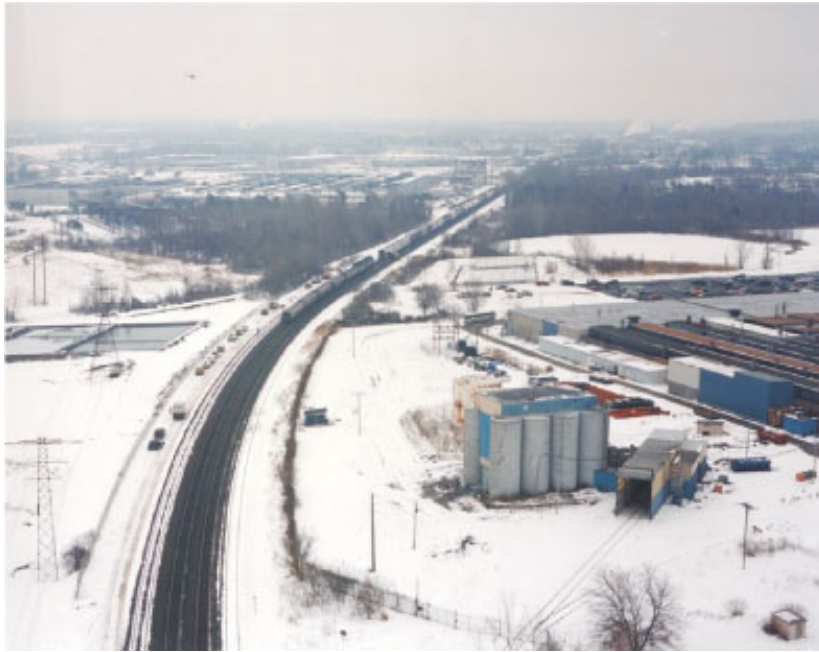
According to locomotive event recorder data, Amtrak train 286 went into emergency braking at about 57 mph about 840 feet from the rear of train Q620. At impact, the Amtrak train was traveling 35 mph. The freight train, which had proceeded again after stopping, was then moving eastbound at 7 mph, resulting in an effective impact speed of about 28 mph. The accident occurred about 11:40 a.m. (See figures 3 and 4.)

**Figure 3.** Looking east shortly after the collision, with the Syracuse China plant and parking lot on the right.

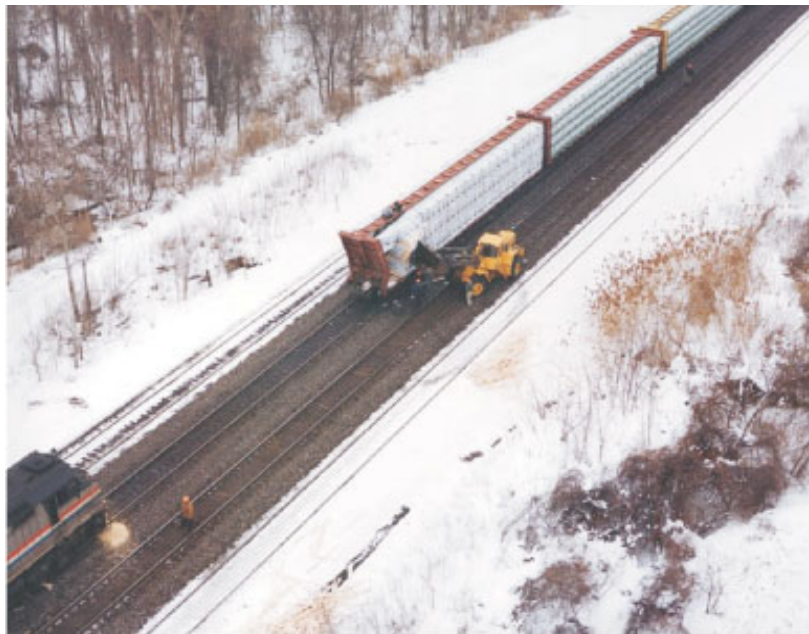
**Figure 4.** Postaccident positions of the end of the CSXT freight train and the lead Amtrak locomotive unit.

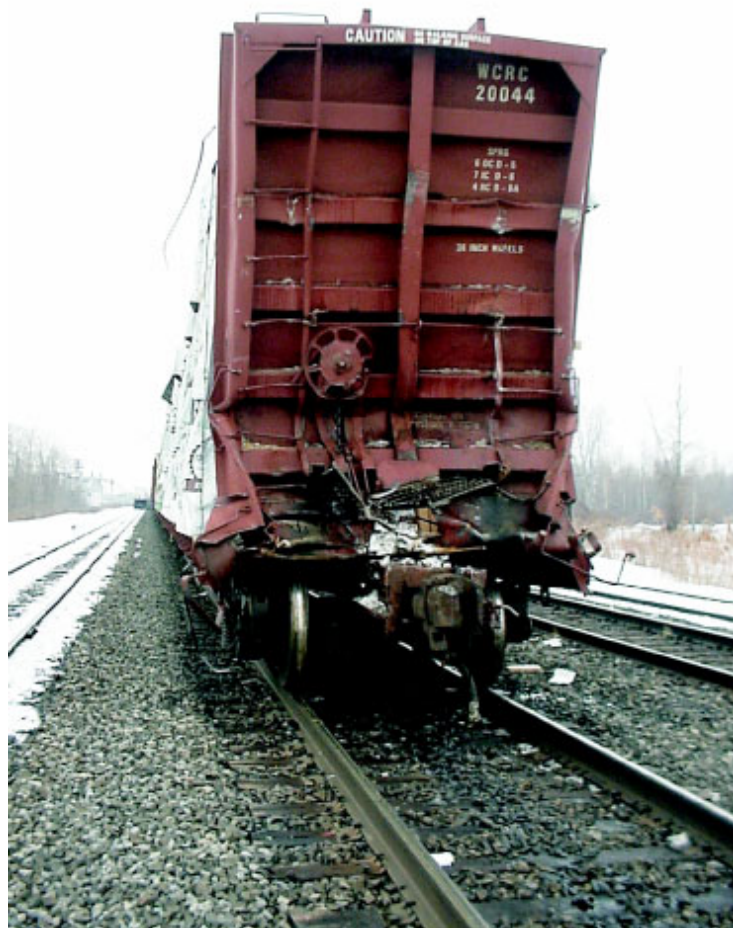
Upon impact, the CSXT freight train end-of-train device was destroyed. The brake pipe on the last car was also severed, which caused the CSXT train brakes to apply in emergency. The rear truck of the last freight car derailed. The last freight car lost a portion of its load of lumber. (See figure 5.) Total CSXT damage was \$7,581 for cars and lading. Except for a section of track that had rolled onto its side under the derailed rear freight car, the track structure remained relatively undisturbed with no significant change in track structure or geometry. Cost of repositioning and re-spiking the rolled rail was estimated at about \$600.

**Figure 5.** Damaged rear freight car of CSXT freight train Q620.

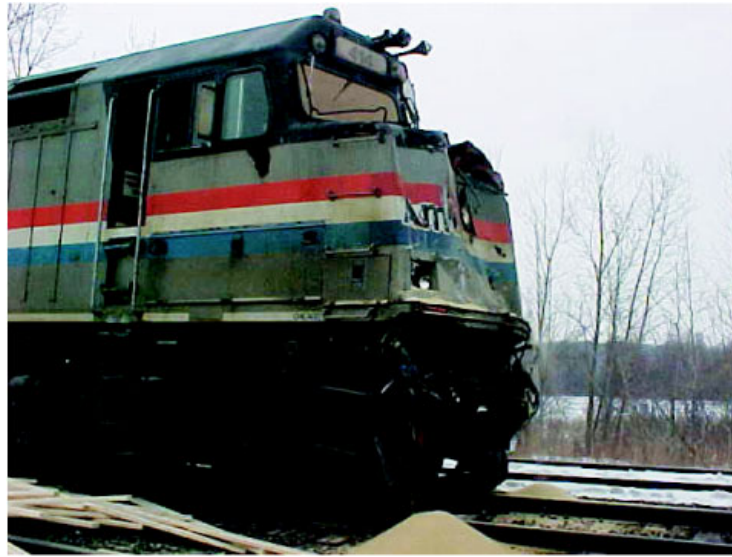
The Amtrak lead locomotive, Amtrak 414 (figure 6), suffered damage to the nose, pilot, plow, front coupler, draft gear, coupler pocket, front collision post at deck level, electrical wiring and associated conduits, front trucks and derailed right and left No. 2 wheels, and No. 1 traction motor. Total damage was estimated to be \$200,000.

**Figure 6.** Damaged lead locomotive of Amtrak train 286.

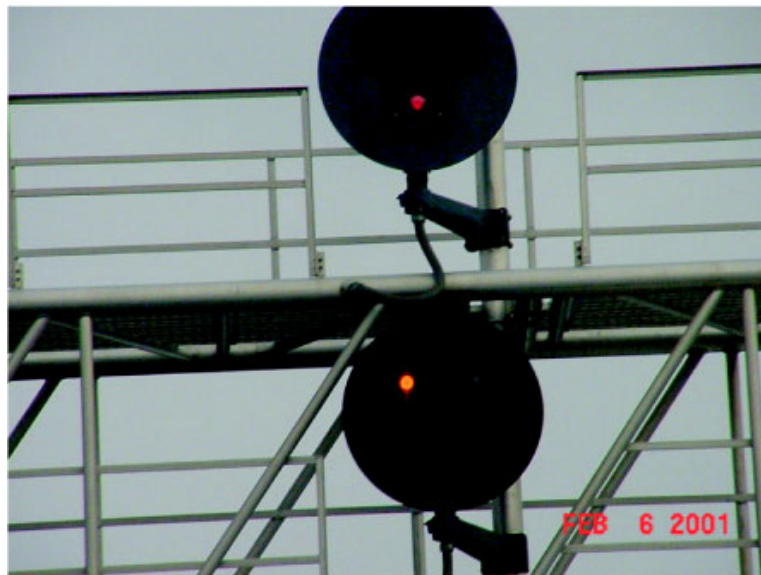
The signal designated “6E” at the entrance to CP 290 used two US&S model CR-2 triangular color light signal heads mounted one above the other. (See figure 7.) Each of the two signal heads was mounted on a 36-inch-diameter circular background. The signal heads themselves consisted of a square housing with three 8 3/8-inch-diameter clear Lexan lenses in a triangular configuration. Behind each clear lens was a 5-inch-diameter colored lens of red, yellow, or green. Behind each of the three colored lenses was a GE SC-11 light bulb of a nominal 10 volts d.c. and 18 watts.

**Figure 7.** Close-up view of signal 6E. (Signal intensity not representative of actual appearance.)

After the accident, the bulb for the red display on the top signal head of signal 6E (which was lighted at the time Amtrak train 286 passed the signal) was measured at 9.6 volts d.c. The bulb for the yellow display of the bottom signal head (lighted for train 286) was measured at 9.4 volts d.c. The flasher relay that causes a signal bulb to flash for certain signal aspects was found to be working as designed.
