## RAILROAD ACCIDENT REPORT

COLLISION OF NATIONAL RAILROAD PASSENGER CORPORATION (AMTRAK)  
TRAIN 59 WITH A LOADED TRUCK-SEMITRAILER COMBINATION AT A  
HIGHWAY/RAIL GRADE CROSSING IN  
BOURBONNAIS, ILLINOIS, MARCH 15, 1999

**NTSB/RAR-02/01  
PB2002-916301  
Notation 7168A  
Adopted February 5, 2002**

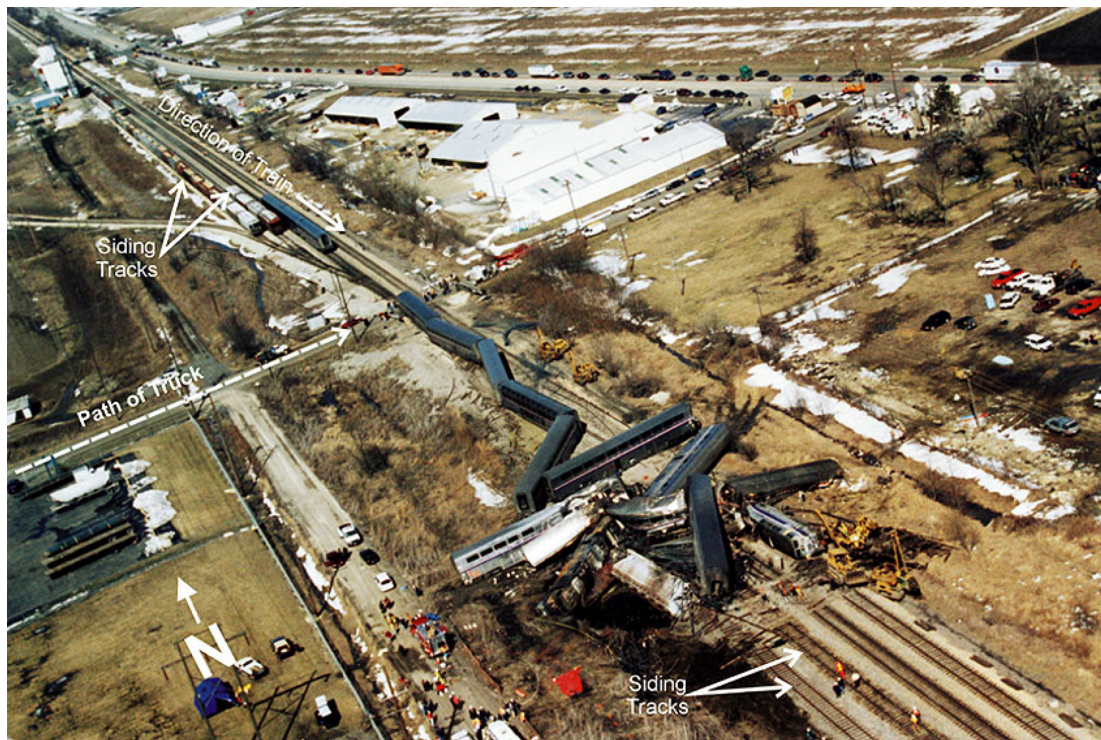
The train 59 engineer, who was the only person in the locomotive cab at the time, stated that he saw the truck slowly moving over the crossing, and he sounded the train horn to warn the truckdriver. He said that when he realized that the truck would not clear the crossing before the train arrived, he initiated emergency braking.<sup>2</sup> Traveling at 79 mph, the train did not have sufficient distance to stop and struck the left rear of the semitrailer. (See figure 2.) The time was about 9:47 p.m.

**Figure 2.** Aerial view of crash scene.

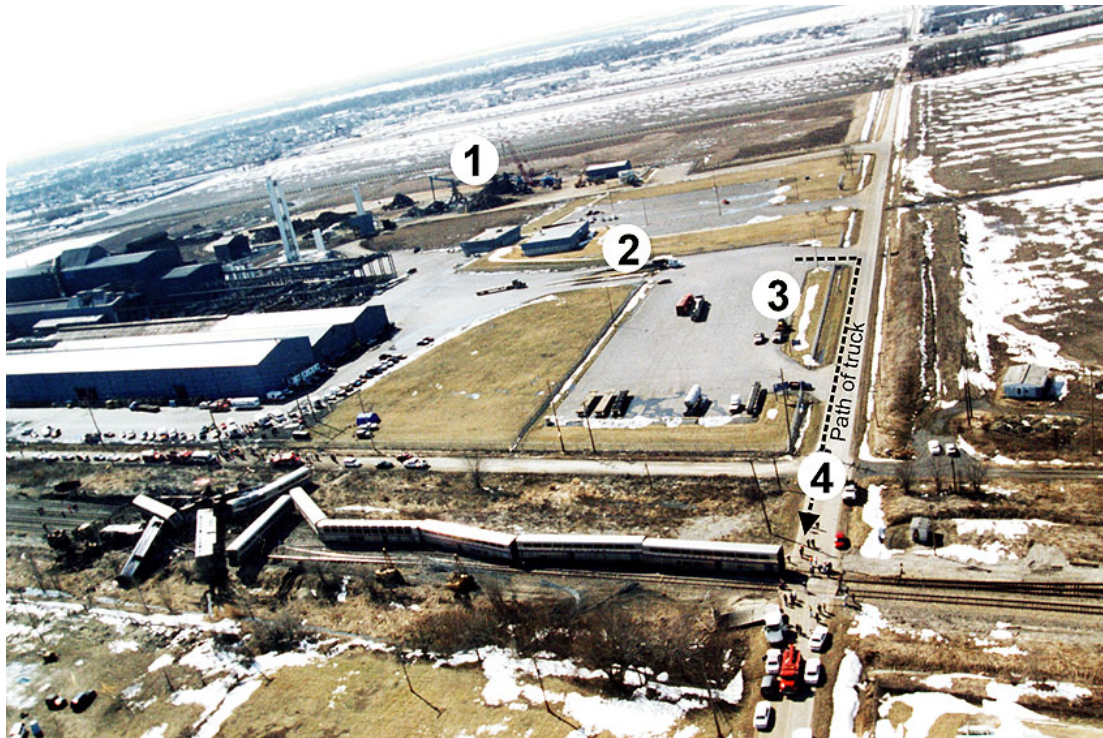
**Figure 3.** Aerial view of crash scene showing locations of witnesses to accident: 1. crane operator; 2. two people in scale house, 3. truckdriver affixing tarp to his load; and 4. motorist behind accident truck.

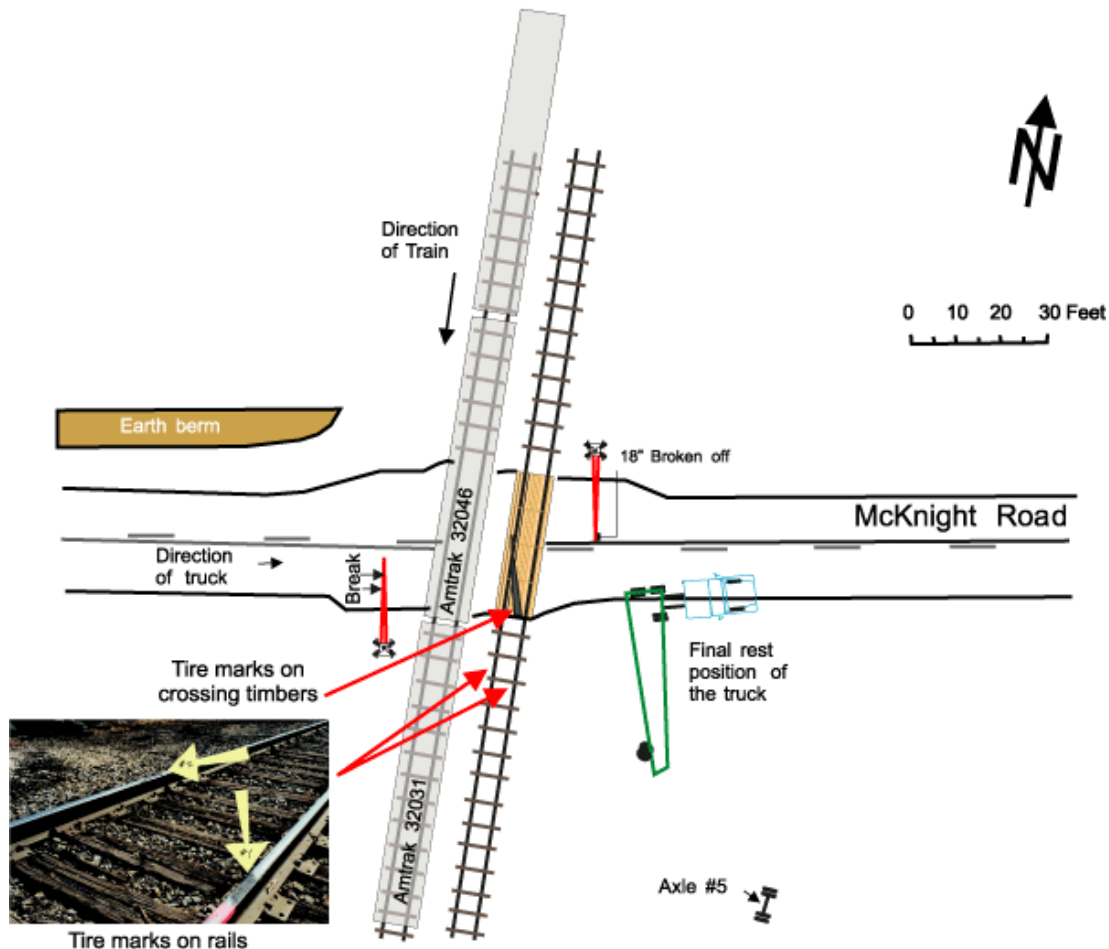
track. (See figure 5.) One end of the tire mark began just west of the west rail north of the centerline of the roadway. It ran over the west rail and continued diagonally between the rails to the edge of the crossing timbers near the east rail and ended on the east rail, about 4 feet from the edge of the timbers.

**Figure 5.** McKnight Road grade crossing showing damage features and tire marks.

Two additional tire marks were found on the passing siding track rails south of the crossing timbers. The first of these was found on the west rail about 12 feet from the timbers. The second mark was found on the east rail about 18 feet from the timbers.

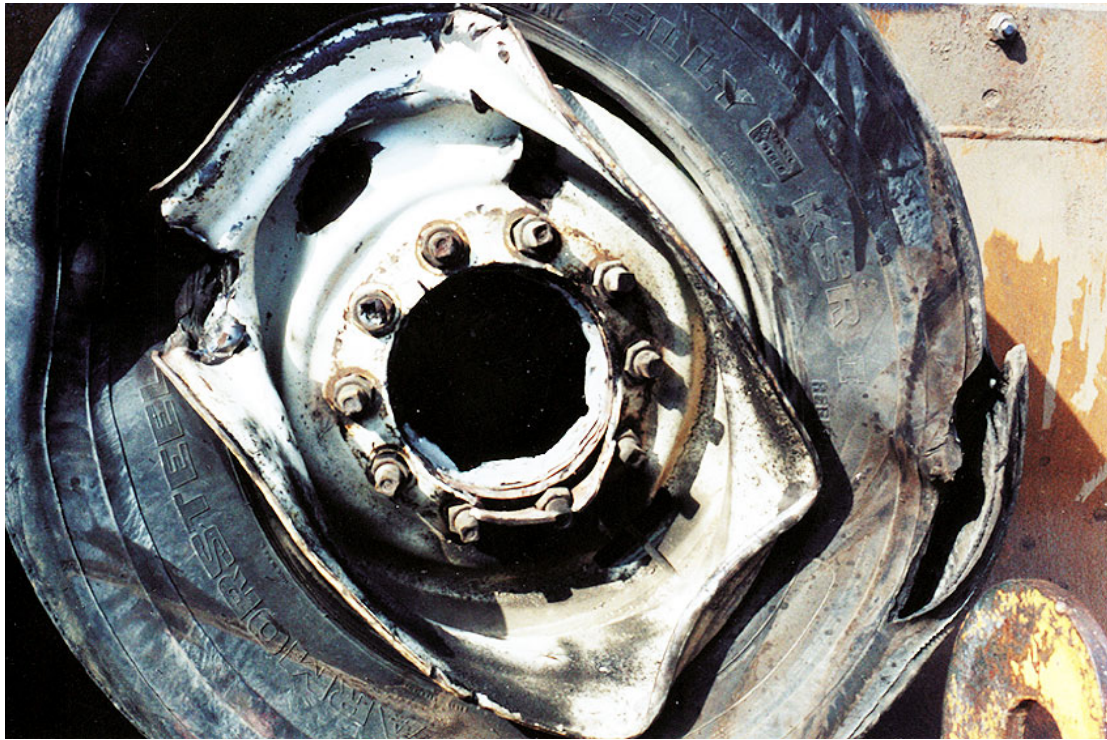
The northerly end of the black tire mark on the timbers of the easterly track indicates the position of the tires when the truck was hit by the train. The only tires showing sideways sliding were those on the left side of the fourth axle. It was therefore concluded that the marks were made from the left tires of the fourth axle. A 10-foot measurement (distance between the fourth and fifth axles) indicated that the fifth axle had to be at the center of the southbound tracks at impact. This was confirmed by noting the damage to the left outside wheel of the fifth axle, which was consistent with the geometry of the locomotive's front coupler. (See figure 6.)

**Figure 6.** Left-side fifth axle of semitrailer at point of impact.

The left wheel rim and drum assembly of the semitrailer's No. 5 axle had heavy impact damage that matched the Amtrak locomotive's coupler in size and conformation. The hub was destroyed, and the brake shoes and air chamber were dislodged. This was the only wheel assembly on the semitrailer that showed evidence of impact damage. The left side dual tires on axle No. 4 showed surface abrasions in one section of the tread area, with striations perpendicular to the tread.

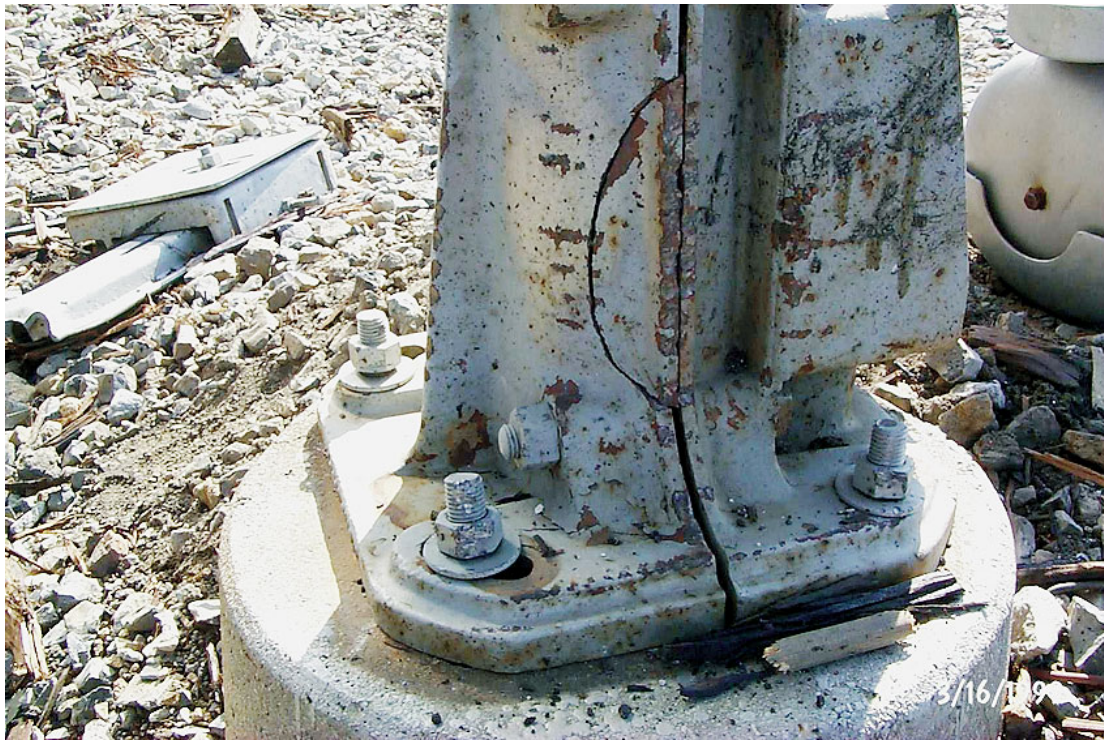
The base of the west crossing gate signal mast was cracked. This was the gate that was on the approach side of the crossing from the perspective of the accident truckdriver. The front edge of a flange on the case metal base and a section of the base itself bore a series of indentations. Witness marks on the concrete under the base of the crossing signal mast indicated that the cast-metal gate mast base had been moved about 1 inch to the west and south of its original position. (See figure 7).

**Figure 7.** Cracked cast metal base of the west-side crossing gate.

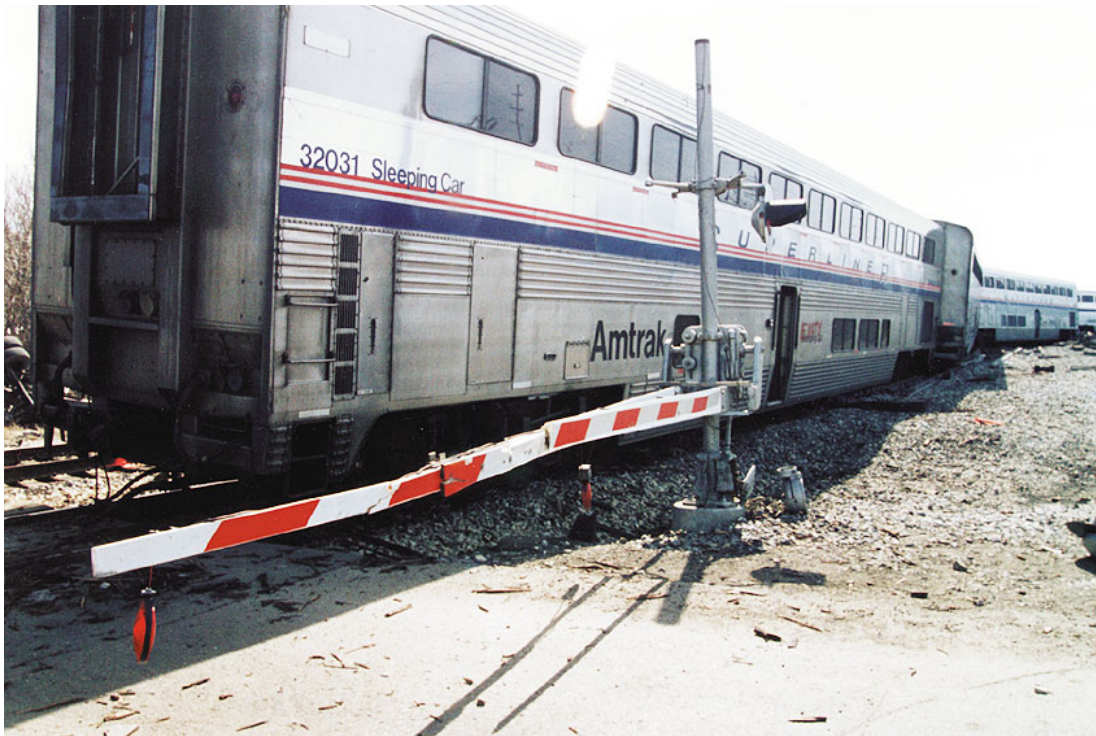
An area of missing paint, where the outer coat was removed while the base or primer coat was left, was found on the west face of the gate at the tip. The gate counterweight, three of the four large signal lights, and the bell had broken off the signal mast. In addition, the gate arm was fractured but not broken off; the mountings for the three lights on the gate arm were broken; and the tip light and base light remained hanging from the gate arm. (See figure 8.) Safety Board investigators were unable to locate the lens for the gate arm center light. The east crossing gate was broken off, in an inward and downward direction, at a point 19 inches from the tip.

**Figure 8.** West (approach) crossing gate.

As a part of the accident scene cleanup, the IC replaced the damaged west gate arm mechanism. The gate mechanism was discarded and remained in outside storage in Gilman, Illinois, until September 15, 1999, when the Safety Board asked that it be sent to Washington, D.C., for testing. The Safety Board received the mechanism on October 5, 1999. Details of the initial testing and examination of the gate arm mechanism are discussed in further detail in the “Tests and Research” section of this report.

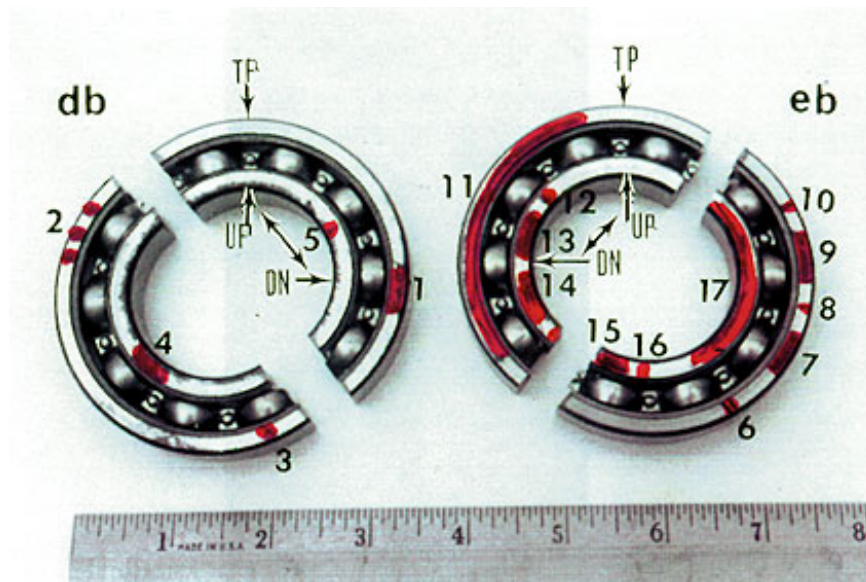
**Figure 10.** West crossing gate arm mechanism main shaft bearings. Numbered markings on inner and outer races indicate location of Brinell marks.

To determine whether the Brinell marks on the bearing surfaces might have resulted from normal operations, investigators examined a set of bearings from another, similar gate arm mechanism. The ball grooves of the inner and outer races of the comparison bearings bore signs of the balls' rotation in the grooves and of minor surface corrosion. The comparison bearings did not show evidence of Brinell marks on any surface. The rotational signs in the grooves of the inner and outer race aligned to indicate the range of the gate's movement; these were more prominent on the bearing that supported the counterweight arm.
