# NATIONAL TRANSPORTATION SAFETY BOARD

## RAILROAD ACCIDENT REPORT

**Derailment of CSX Transportation Coal Train V986-26  
at Bloomington, Maryland, January 30, 2000**

**NTSB/RAR-02/02  
PB2002-916302  
Notation 7445  
Adopted March 5, 2002**

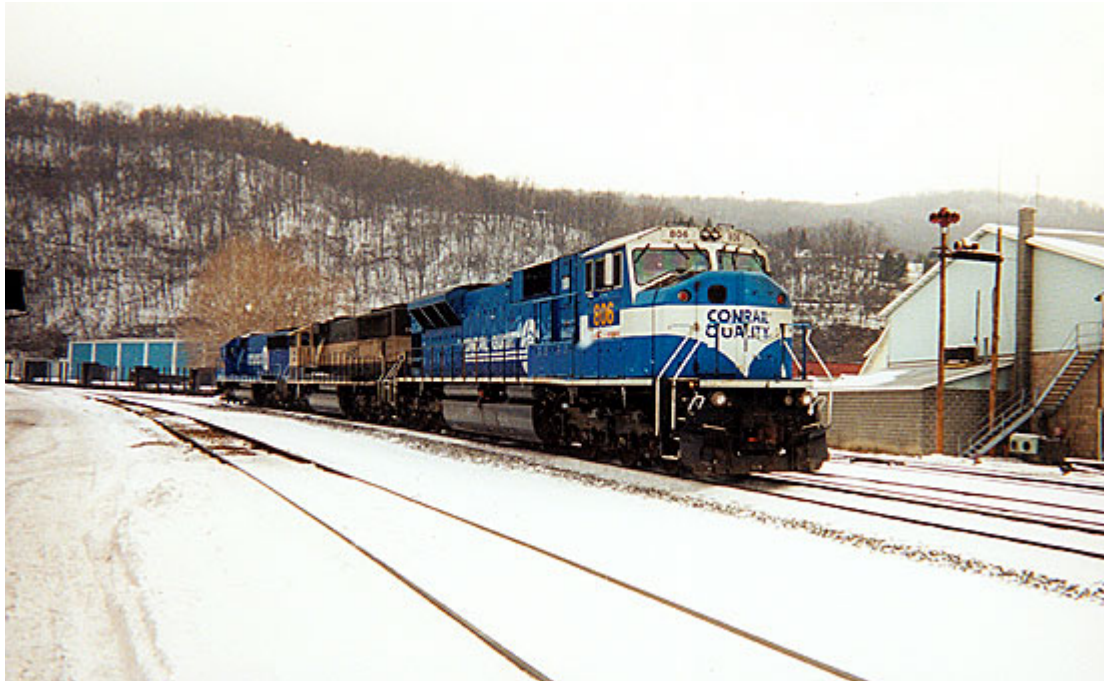
**Figure 2.** Accident locomotive consist.

Mechanical personnel from the Cumberland locomotive shop tested the dynamic braking system about 1:30 p.m. on January 31 at Westernport, Maryland. The testing was under the auspices of FRA inspectors. The No. 24 pin socket of the multiple-unit cable between the first and second locomotive units was defective. The defect prevented the dynamic brake excitation voltage of the lead unit from reaching the two trailing units. Thus, only the lead unit produced dynamic braking. Testers replaced the defective multiple-unit cable and performed both a static and running test of the dynamic brake system of the locomotive consist. The system then worked properly.

Dynamic braking on the two trailing locomotive units, while available, could not be activated because of the defective multiple-unit cable between the first and second locomotive units. Because he did not have the benefit of full dynamic braking, the engineer had to increase the air brake application beyond what normally would have been expected in order to control speed. By so doing, he unwittingly overheated the tread-brake system. Further, the maximum authorized speed for the accident grade had been established based on the assumed availability and use of dynamic braking. Judging from the CSXT's experience of successfully negotiating 17-mile grade at the maximum authorized speed, the combination of dynamic and air braking was, in fact, adequate to hold a train at or under the established maximum authorized speed as the train progressed down the grade. The Safety Board concludes that if all the available dynamic braking could have been activated on the accident train, the derailment probably would not have occurred.

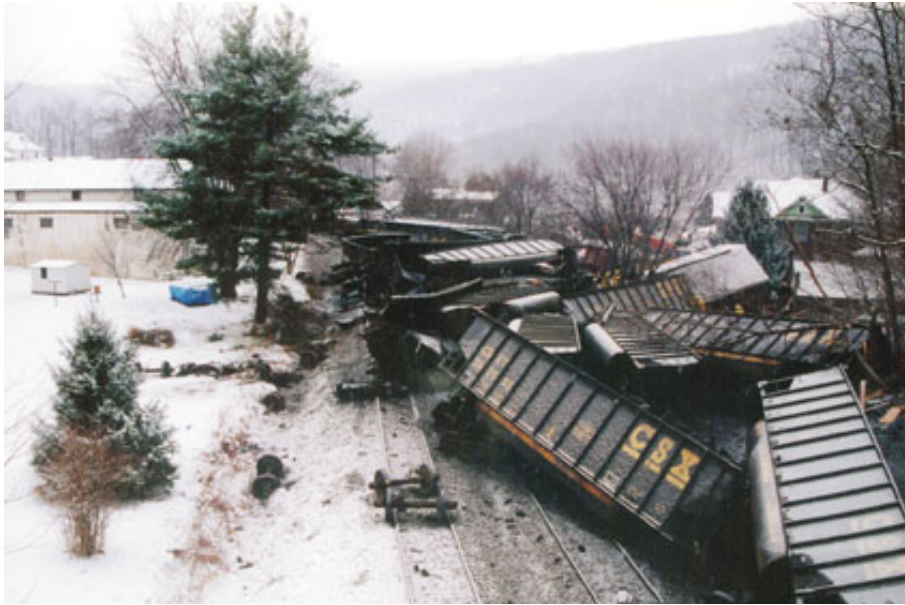
The train ultimately reached a speed of 59 mph. The train broke apart and derailed at curves in three separate segments, starting from the rear end. At MP 210.6, the first group of 20 cars separated, and 17 of the 20 cars derailed. At MP 209.8, another 18 cars separated and derailed. Finally, at MP 208.2, the remaining 42 cars separated, and 41 of

the 42 derailed in a general pileup. (See figure 3.) Some of the 41 derailed cars struck a nearby occupied residence, destroying the house and killing a 15-year-old boy and seriously injuring his mother. (See figure 4.) Three other occupants of the house escaped with minor or no injuries. Some of the 41 cars also broke a gas pipeline inside a transfer building near the track; as a result, about 101 customers of Columbia Gas of Maryland temporarily lost natural gas service.

**Figure 3.** Pileup of derailed coal cars.

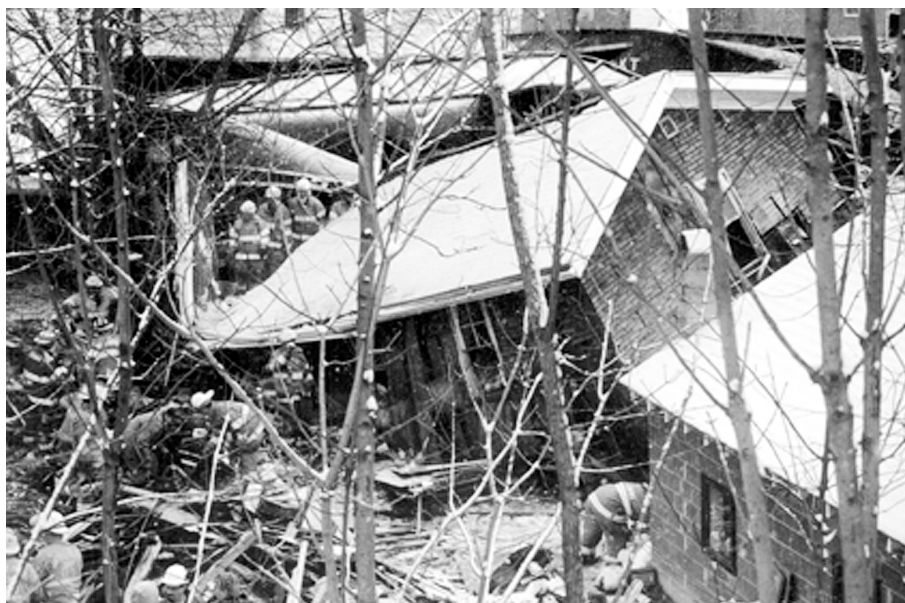
**Figure 4.** Destroyed residence where one fatal and one serious injury occurred.
