DERAILMENT OF UNION PACIFIC RAILROAD TRAIN  
QFPLI-26 AT EUNICE, LOUISIANA, MAY 27, 2000

**NTSB/RAR-02/03  
PB2002-916303  
Notation 7450  
Adopted April 2, 2002**

The National Transportation Safety Board determines that the probable cause of the May 27, 2000, derailment of Union Pacific train QFPLI-26 was the failure of a set of joint bars that had remained in service with undetected and uncorrected defects because of the Union Pacific Railroad's ineffective track inspection procedures and inadequate management oversight.

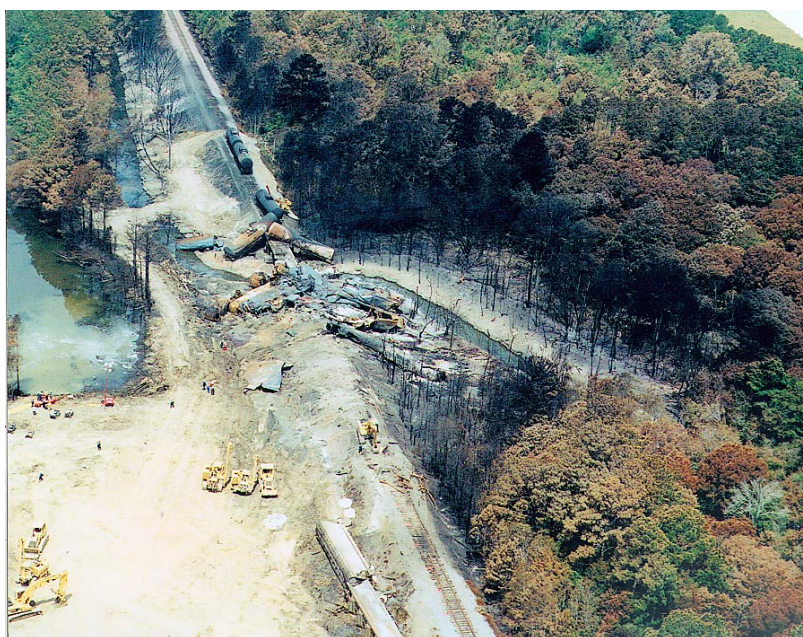
**Figure 1.** Looking west at accident scene.

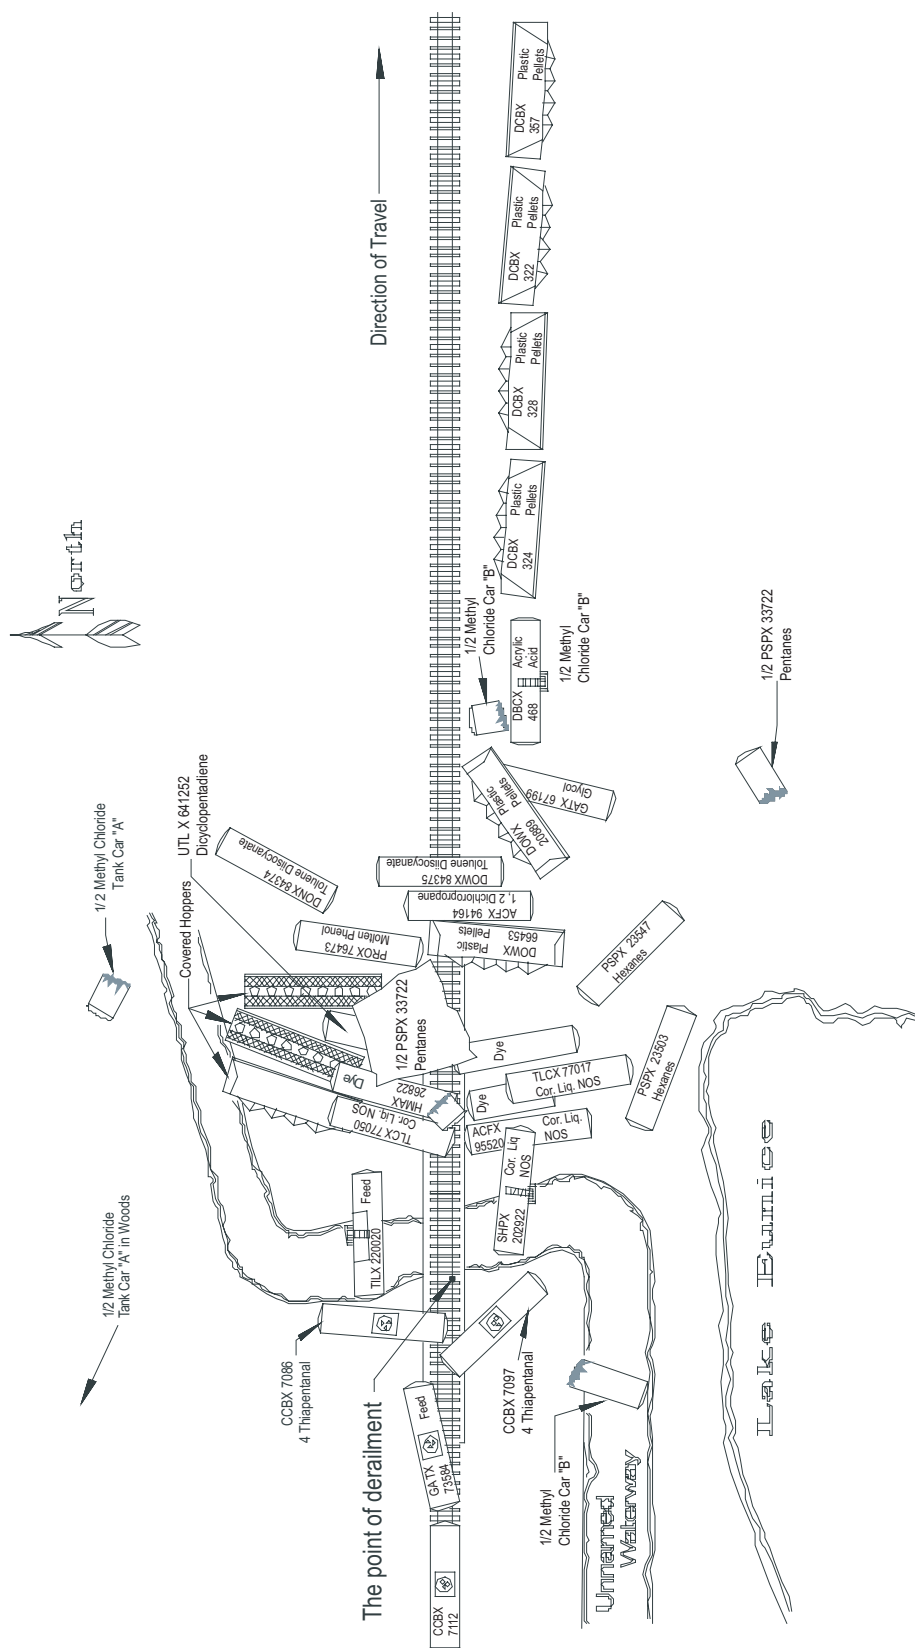
### Figure 4. Wreckage

In general, pressure tank cars are designed to provide greater damage protection through use of increased wall thickness and head shields. They are used to transport flammable gases and other materials determined by the U.S. Department of Transportation (DOT) to present the greatest hazards if released during transportation. Pressure tank cars are also required to have a thermal protection and a pressure relief system that will allow the car to survive a pool fire for 100 minutes, which allows time for emergency responders to evacuate the area. Witnesses stated that in this accident, the first of two major explosions occurred 1 hour and 43 minutes after the derailment and fire. The two explosions likely involved the two tank cars filled with methyl chloride (a flammable gas). Both of these cars were found torn in half, and portions of the cars were found to have been thrown from 50 to 700 feet from their original resting positions. (See figure 4.)

Damage to the tank cars caused by the derailment and by the subsequent fire resulted in the release of most of their contents. The tank cars released about 43,700 gallons of flammable gas, 944,150 pounds of corrosive liquids, and 167,685 gallons of miscellaneous flammable liquids and poisons. To eliminate the risks posed by damaged cars that were still loaded with hazardous materials, one car of acrylic acid and two cars of toluene diisocyanate were explosively breached by emergency responders. Most, if not all, of the released product from these three cars was burned.

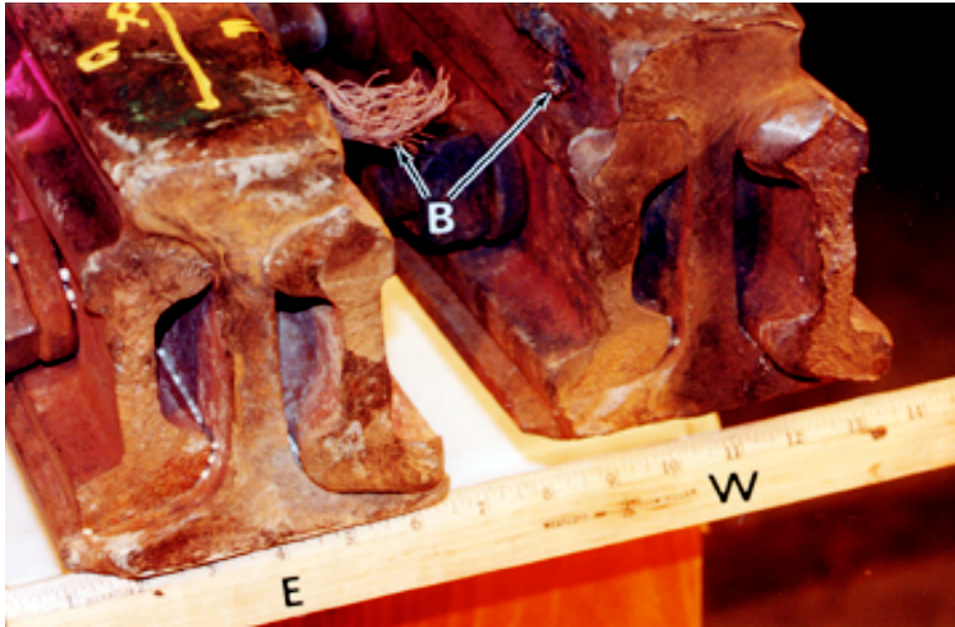
Raised characters on each joint bar identified the bars as having been manufactured in 1951 by the Colorado Fuel & Iron Corporation. Although some of the fracture surface was obliterated by postfracture damage, a portion of the remaining fracture surface of each joint bar showed the chevron patterns and radial marks that are typically found in overstress fractures. From these markings, the initiation of the overstress region in each bar could be traced to a relatively smooth, dark region with a curving boundary, which is typical of fatigue.

**Figure 6.** The accident joint bars. The east and west sections of the joint bars are indicated by "E" and "W." The location of the bond wires is indicated by "B." The bond wires are on the field side (outside) of the joint.

An examination of the surface of the fractured areas of the joint bars revealed that both fractured surfaces displayed evidence of contact damage to the mating fractured surface. In general, the greater damage was on the field side of the west surfaces and on the gage side of the east surfaces, indicating that the separated joint bars had shifted in relation to each other after they had fractured.

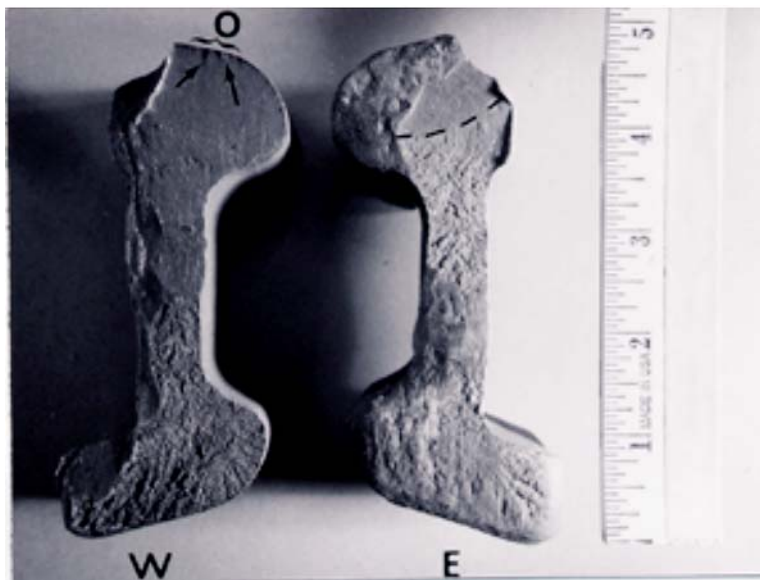
On the field-side joint bar shown in figure 7, the fatigue region was on the upper portion. A portion of the boundary was visible on the east surface, as indicated by the dashed line. Ratchet marks were visible on the west surface, indicating multiple origins at the top of the bar in the area marked by bracket "O." The depth of the fatigue region was approximately 0.813 inch. On the gage-side joint bar shown in figure 8, the fatigue region was on the lower gage-side corner of the bar. For each mating surface shown in figures 7 and 8, a dashed line indicates the fatigue boundary, and bracket "O" indicates the fatigue origin area. The depth of the fatigue region was approximately 0.308 inch.

**Figure 7.** The field side (outside) joint bar from the accident joint. The area of the fatigue crack boundary is shown as a dashed line. The letter "O" indicates the fatigue origin area.

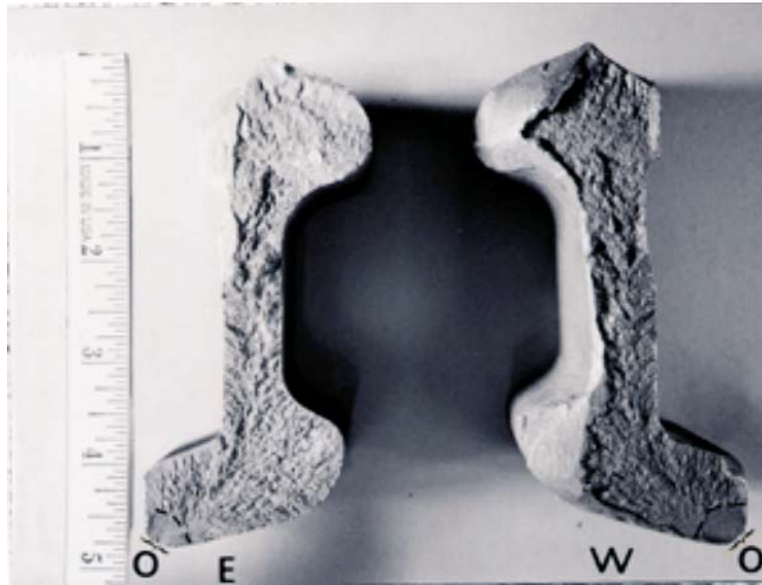
**Figure 8.** The gage side (inside) joint bar from the accident joint. The area of the fatigue crack boundary is shown as a dashed line. The letter “O” indicates the fatigue origin area.
