# MONITORING AND EVALUATION OF THIN BONDED OVERLAYS AND SURFACE LAMINATES FOR BRIDGE DECKS

# Interim Report

## Monitoring and Evaluation of Thin Bonded Overlays and Surface Laminates for Bridge Decks

**August 1997**

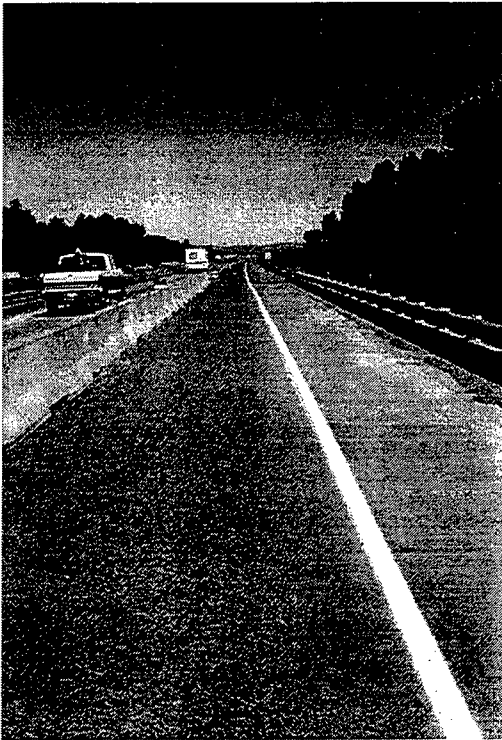
**Photo 1: Pre-installation, westbound Gallatin.**

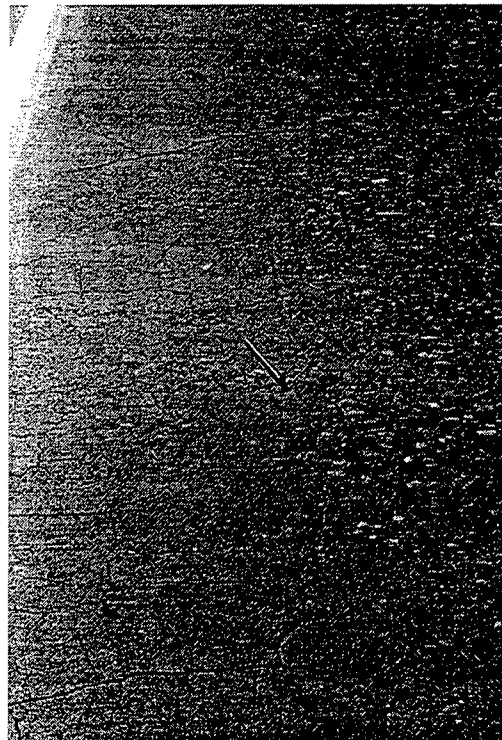
**Photo 2: Pre-installation, typical driving surface, Gallatin.**

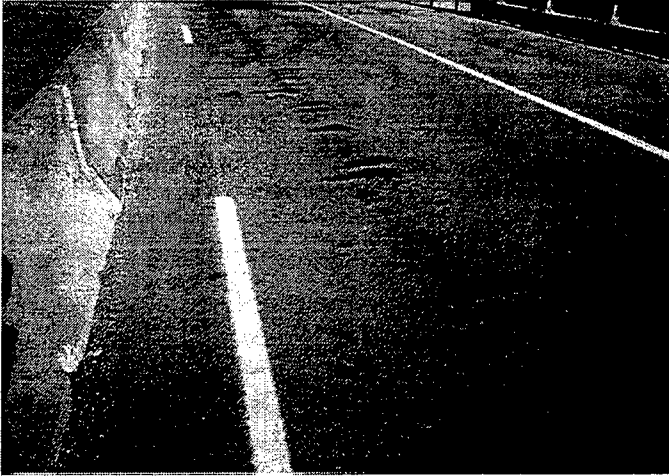
**Photo 5: Pre-installation, westbound West Garrison.**

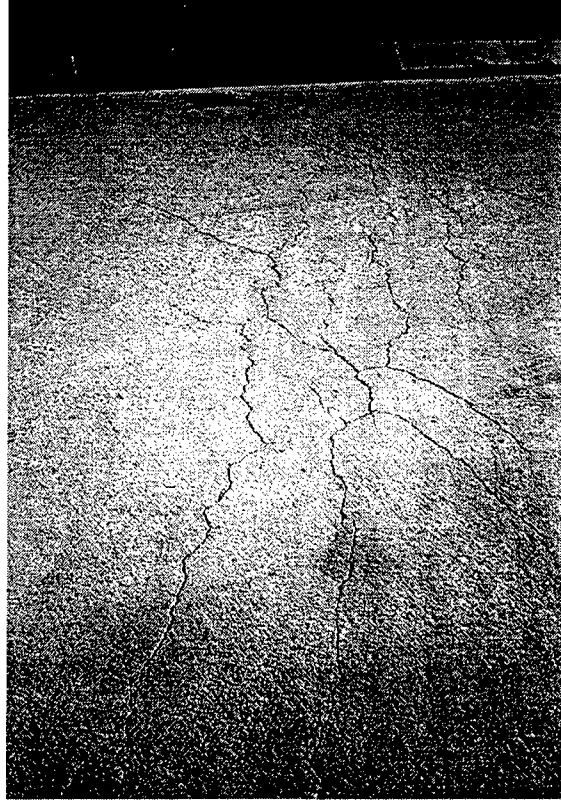
**Photo 6: Pre-installation, typical driving surface, West Garrison.**

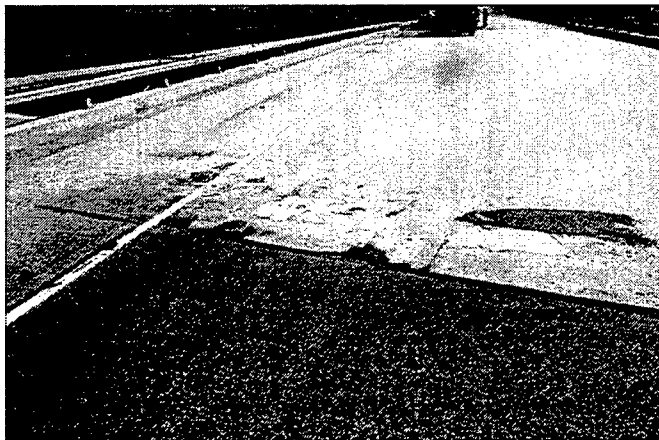
**Photo 8: Pre-installation, westbound Galen.**

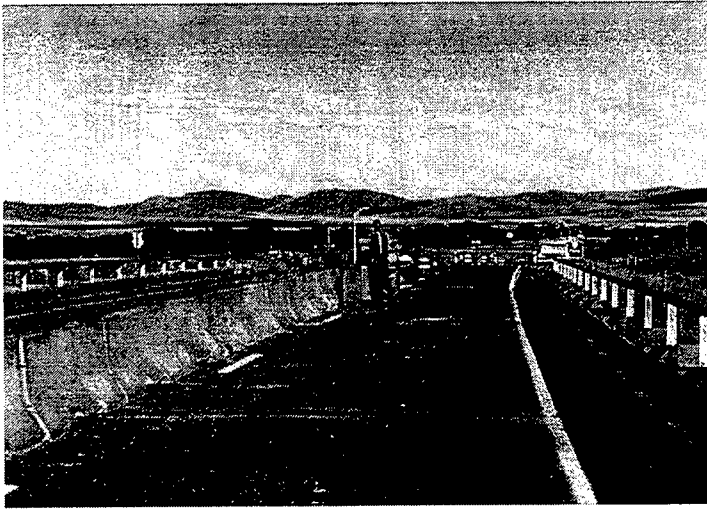
**Photo 11: Pre-installation, westbound Madison.**

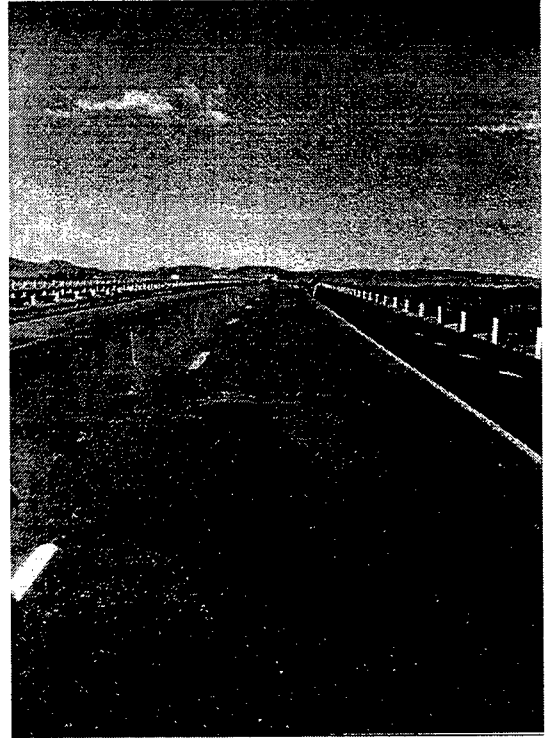
**Photo 12: Pre-installation, westbound Madison.**

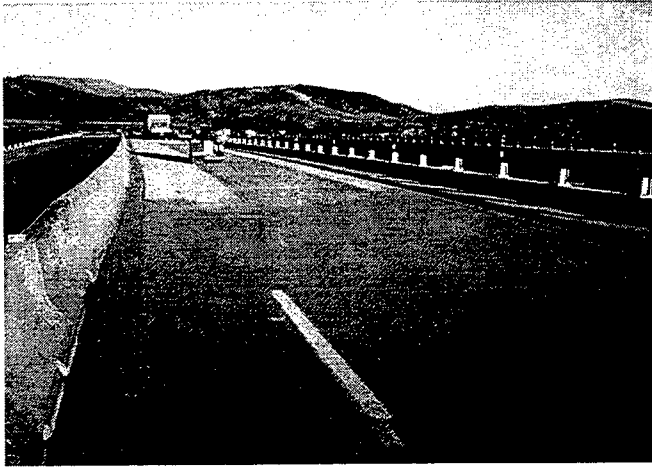
**Photo 14: Pre-installation, eastbound East Garrison**

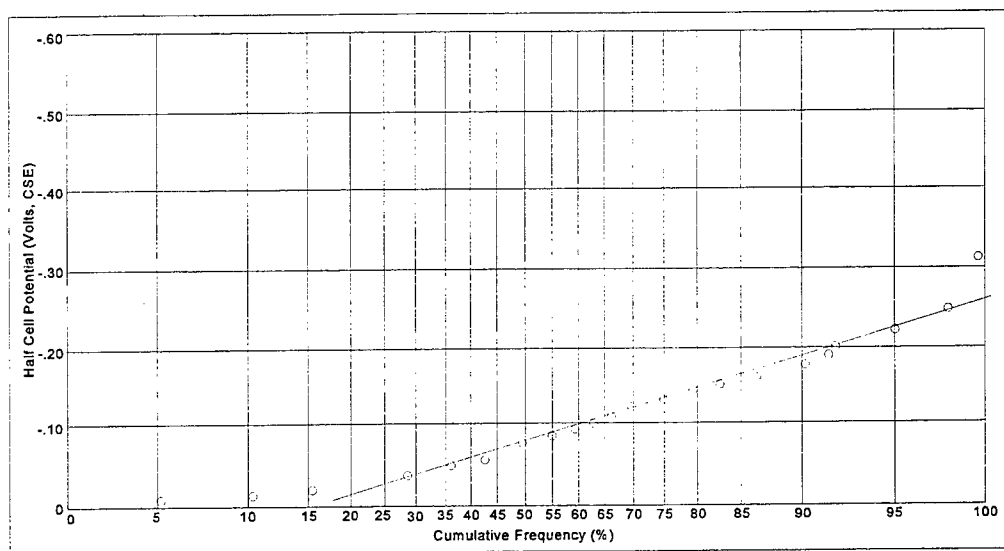
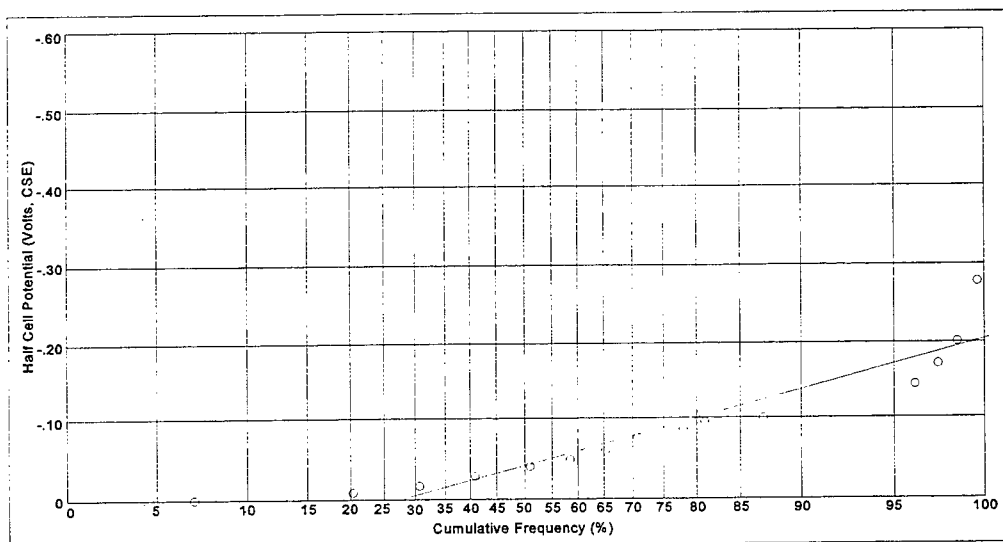
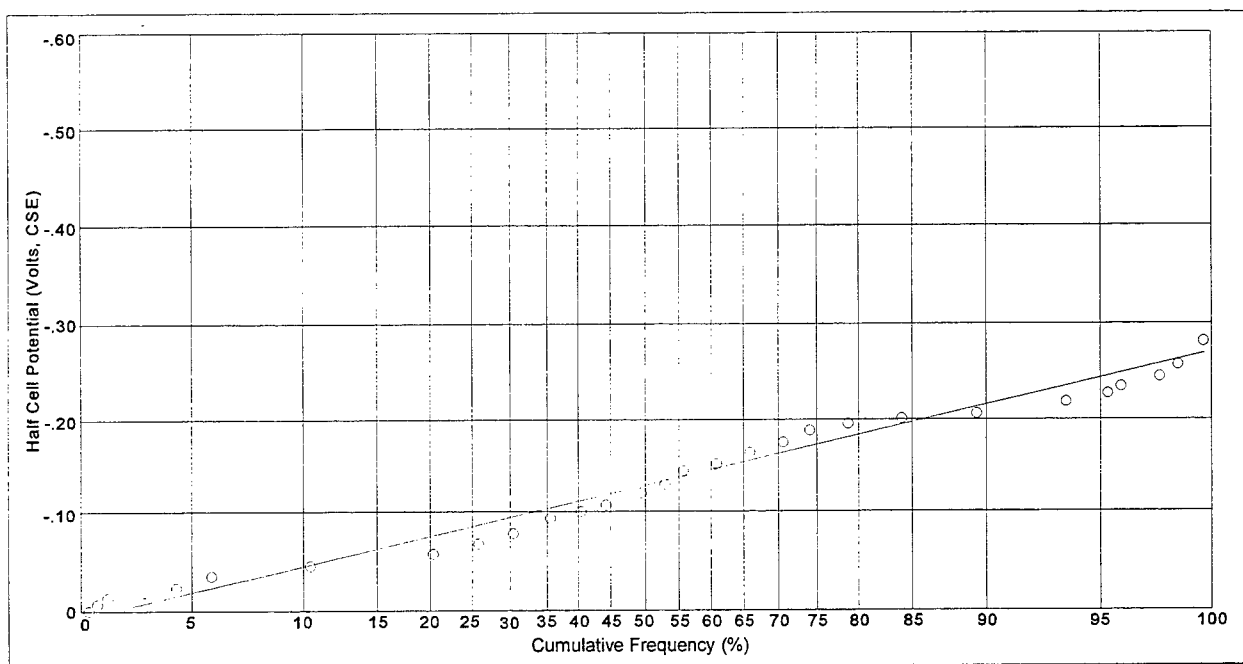
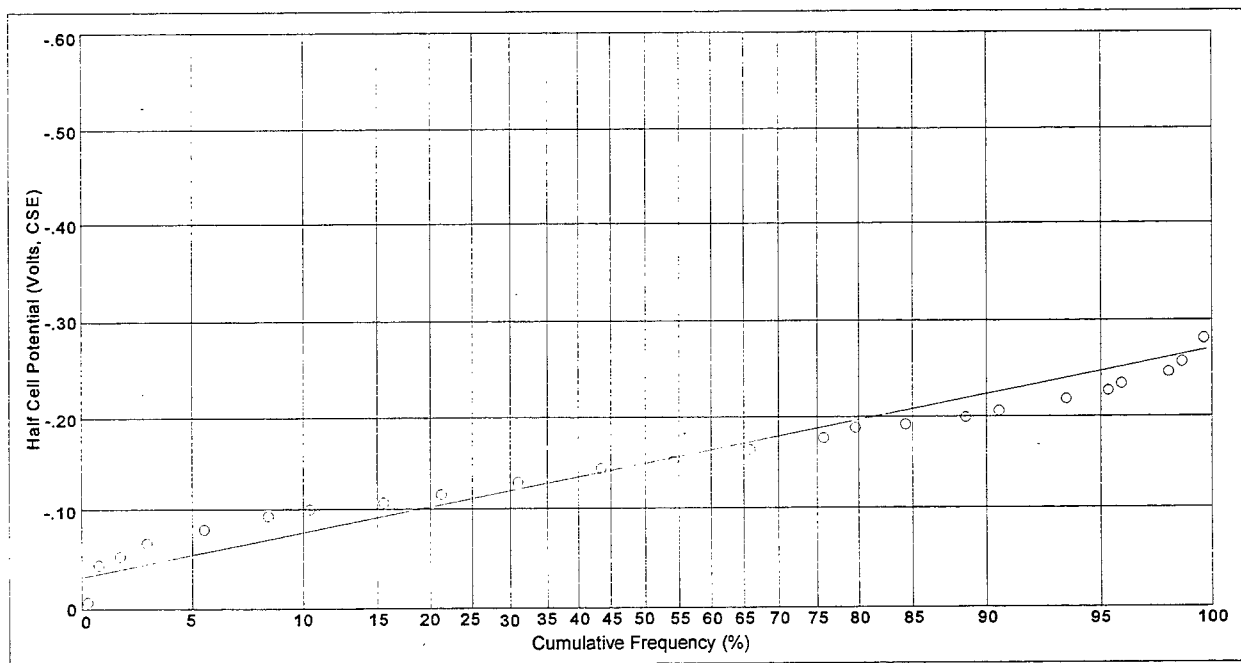
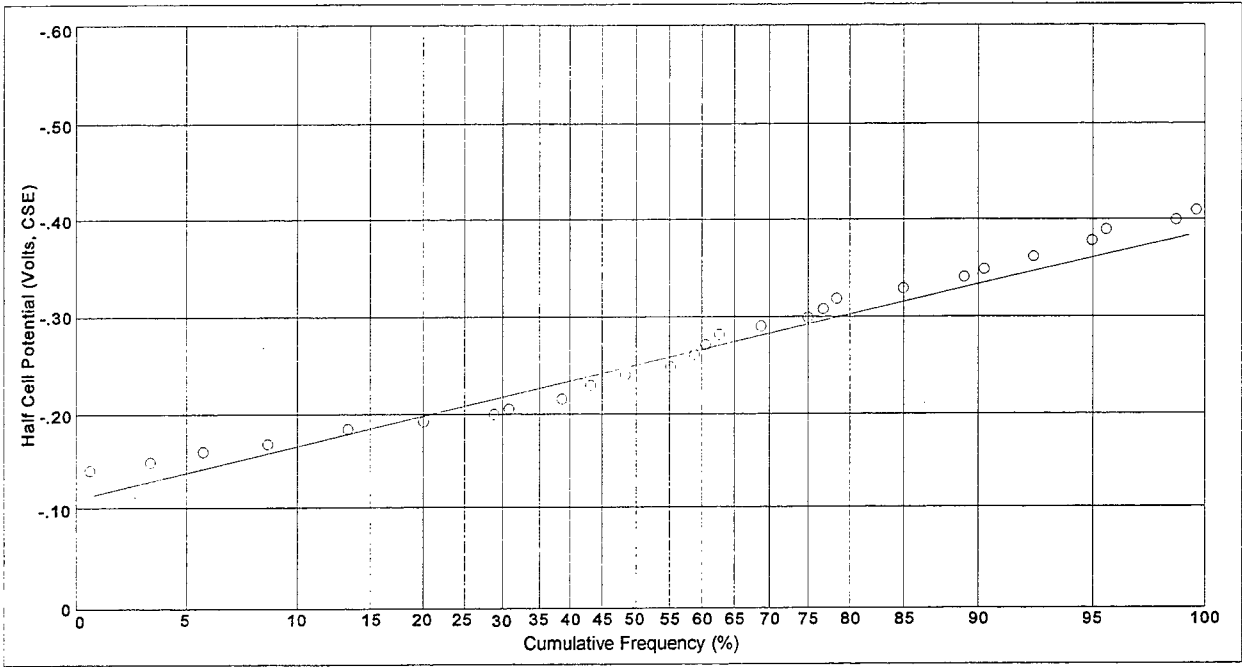
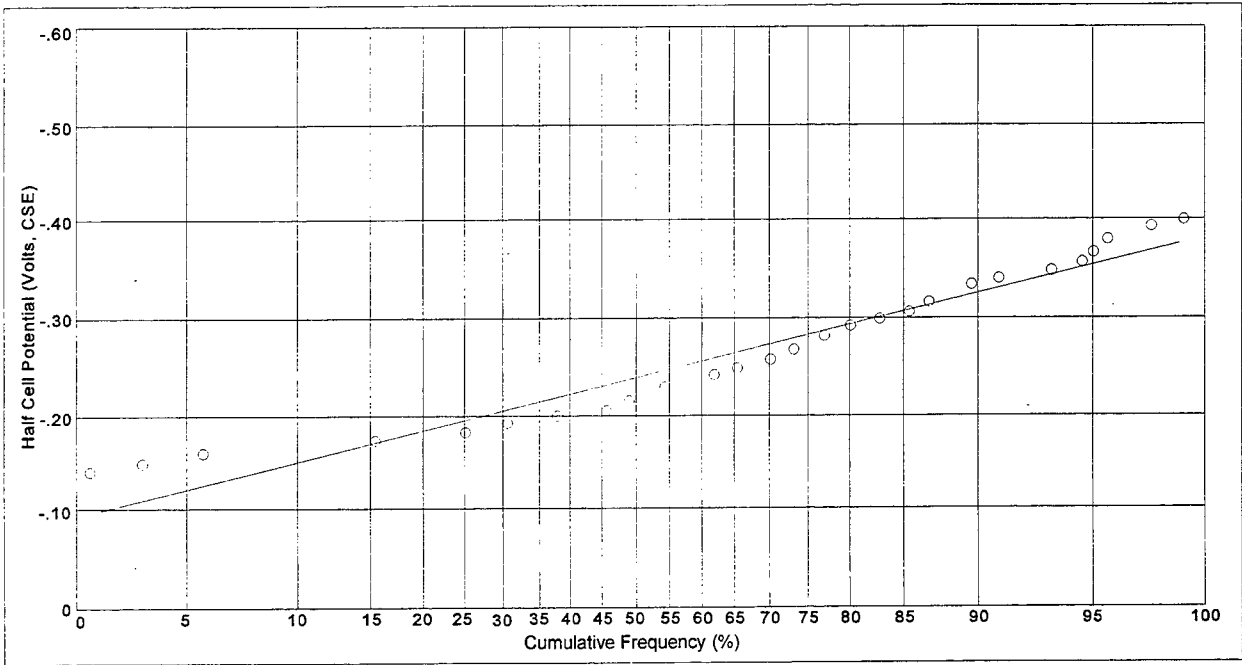
thresholds, the occurrence of corrosion is uncertain. Reviewing Figures 4.1.5 to 4.1.10, the occurrence of corrosion is unlikely over most of the West Garrison and Gallatin structures, as at least 85 percent of the reading were above -0.20 V CSE and 100 percent of the reading were above -0.35 V CSE. Some of the readings from the Galen structures indicate that corrosion was likely to have been occurring on parts of the decks when the readings were taken. Readings that would indicate corrosion activity ( $< -0.35$  V CSE) occurred over approximately 7 percent of the deck surface.

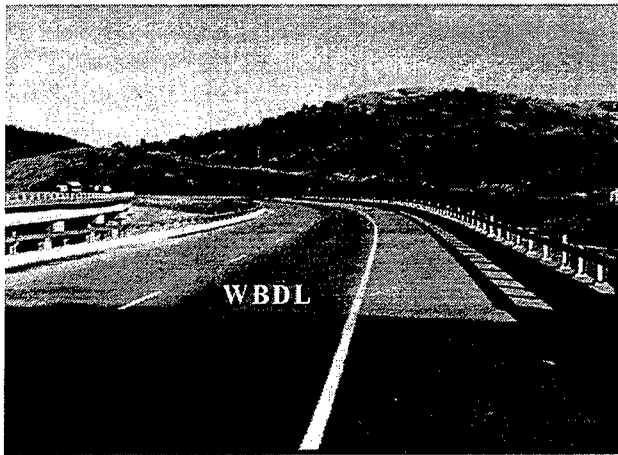
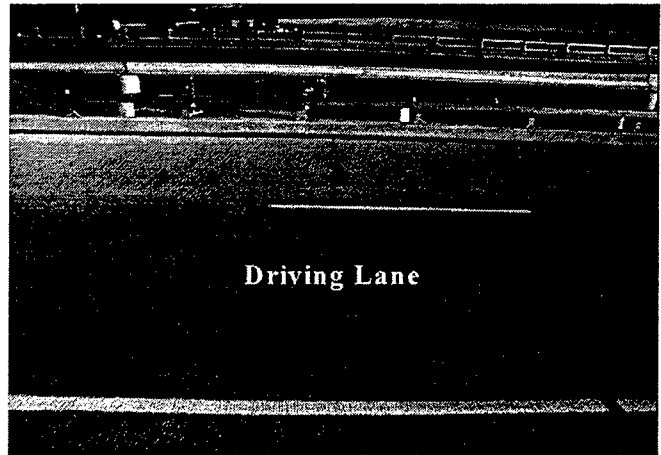
Figure 5.1.2 shows the condition of the Thorotop HCR structures at the West Garrison Interchange at the time of their first annual evaluation. Many of the distresses noted for the Gallatin bridges were also observed on these structures. Wheel paths were evident in the driving lanes. The pattern of smoothness observed in the wheel paths was similar to that of the Gallatin bridges. A number of delaminations were noticed at the expansion and construction joints. Additional delaminations were seen on the shoulders and on the driving surface on the westbound structure. Further analysis of the delamination locations revealed no correlation with pre-installation distresses. Marring from snow plow activity was seen. No cracking was observed on these bridges.

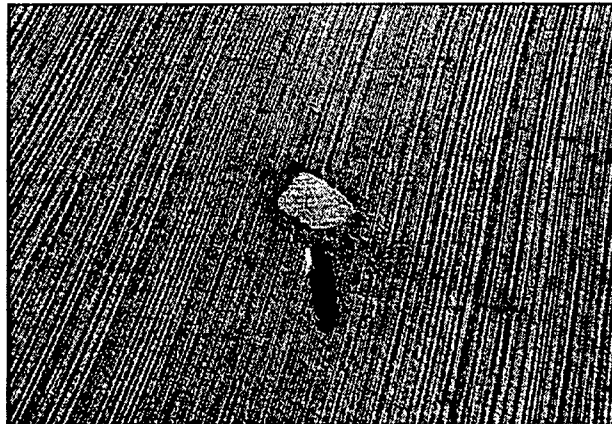
**Photo 24: West Garrison, delamination.**

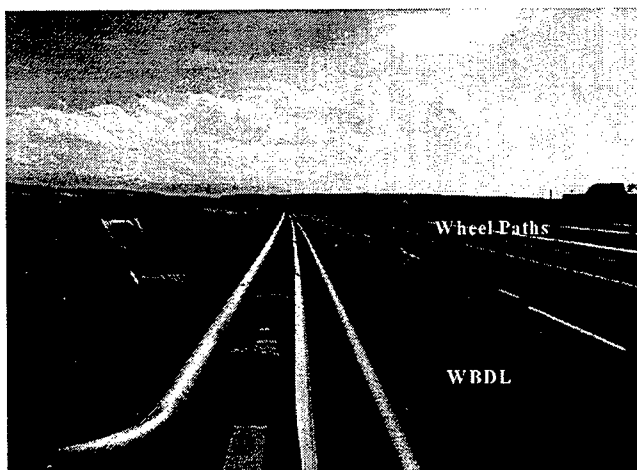
The first of the Flexolith 216 bridges evaluated was the westbound bridge at the Madison River near Three Forks (see Figure 5.1.3). As had been the case with all of the Thorotop HCR bridges, wheel paths were visible in the driving lanes, and the surface of the deck was smoother in these areas compared to the rest of the structure. This smoothness appeared to result from the loss of surface aggregate in the wheel paths. None the less, the Flexolith 216 wheel paths were noticeably rougher to the touch than the Thorotop HCR wheel paths. Areas where the aggregate coverage appeared inadequate at the completion of construction were conspicuous after one year. All construction seams were visible. Some reflective cracking could be seen above two of the bents in the driving lanes. An oval shaped crack, 12 inches by 18 inches, was found on the west end of the passing lane (see Figure 5.1.3, Photo 26). Surface marring, perhaps from snowplowing, was also seen. This marring was less extensive and less severe than was observed on the Thorotop overlays.

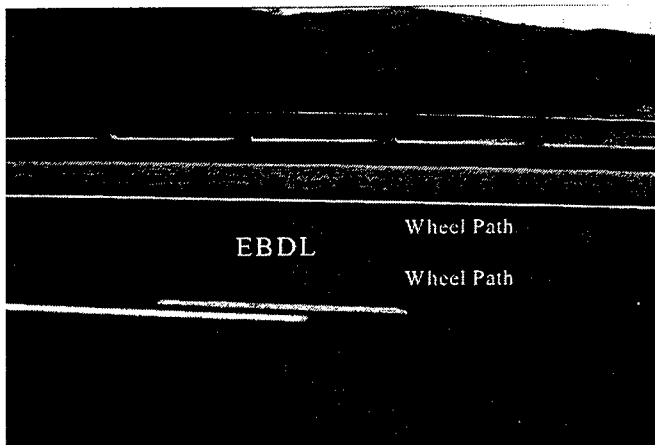
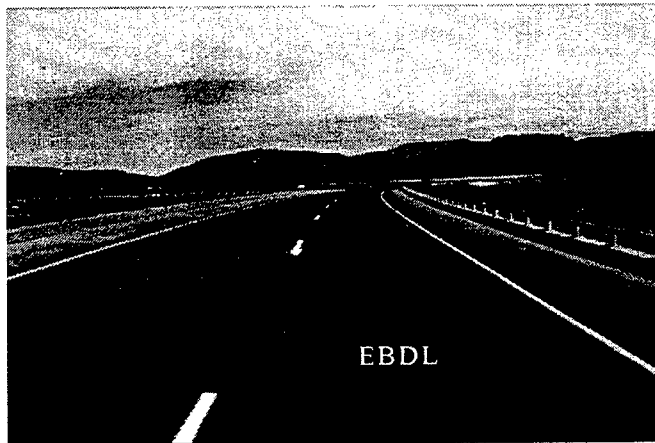
The westbound and eastbound East Garrison bridges had many of the same distresses as had been seen on the Madison bridges. Removal of aggregate in the wheel paths once again resulted in a visibly smoother surface in these areas. A minimal amount of snow plow marring had occurred on both structures. No cracking was seen. Figure 5.1.4 further documents the condition of the East Garrison bridges.

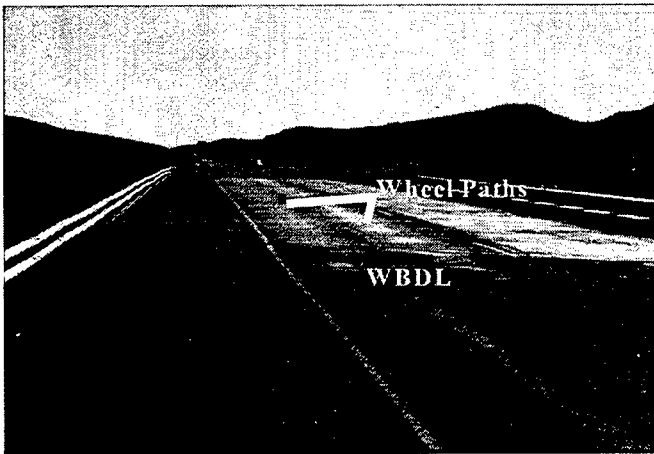
The only structures evaluated in 1996 that had received a Degadur MMA overlay treatment were those near the Fairmont Interchange. Both of the eastbound and westbound structures at Fairmont were performing in a similar fashion. While wheel paths were evident in the driving lanes, from general wear, the surfaces of the bridges were uniformly smooth to the touch across the entire structure. This condition appeared to be a result of the seal coat more so than poor aggregate coverage or removal. Popouts, as described in SHRP-P-338 (15), were noted on the surface of the overlays of both decks. Delaminations were found on both structures. Three delaminations were located on the westbound bridge; only one, on the eastbound bridge. While the sizes of these delaminations were not measured due to the high volume of traffic at the time of the evaluation, these areas were roughly 4 to 6 inches in diameter. The only crack found was on the westbound deck. It extended through the entire depth of the overlay at the approach guard angle.

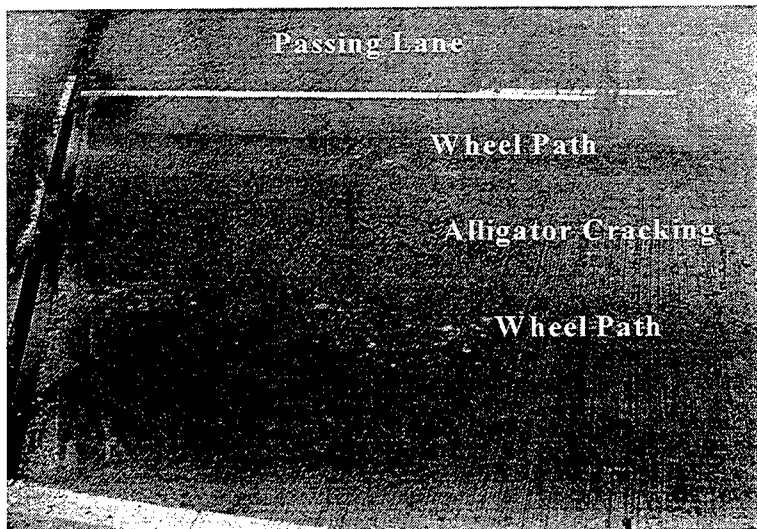
**Photo 31: Gallatin, typical driving surface.**
