**CONCRETE BRIDGE DECKS  
WITH ISOTROPIC REINFORCING  
SHORT TERM EVALUATION**

**Final Report  
OR-EF-99-06**

*Oregon Department of Transportation*

September 1998

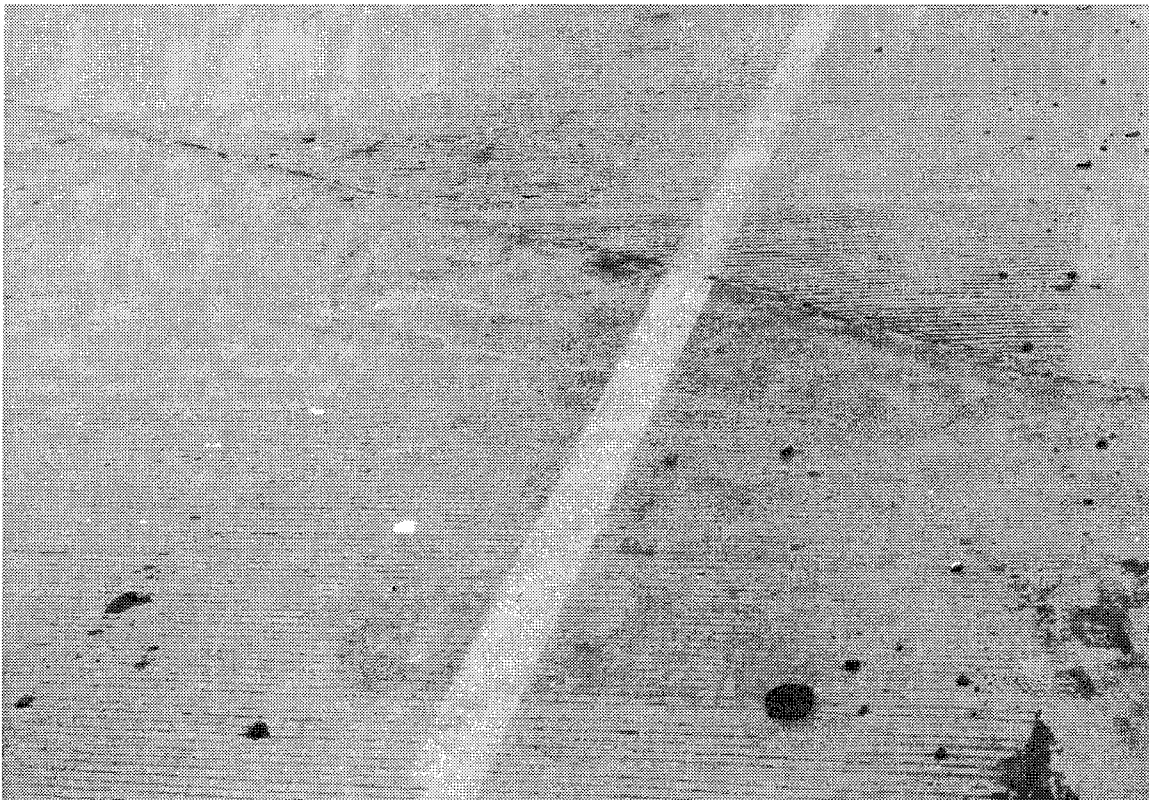
Some cracking near the bents was found and photographed, shown in Figure 3.1. Other cracking was also mentioned. However, a detailed crack map was not made, due to traffic on the southbound side and the contractor's equipment on the northbound side.

Figure 3.1: Cracks parallel to bents (April 1993).

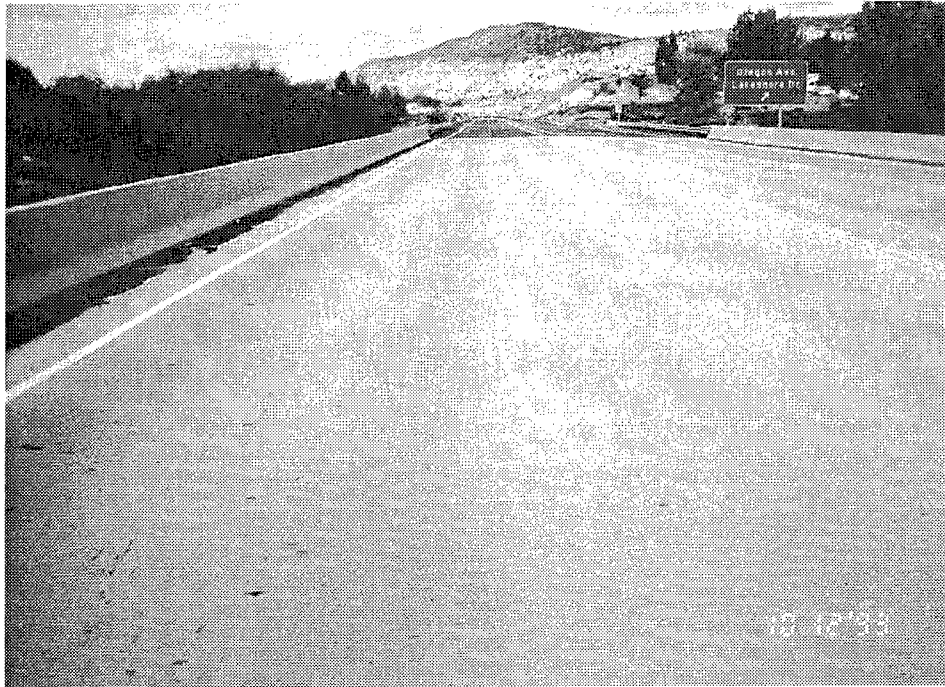
Figure 3.3: Transverse cracking was not visible (October 1993).

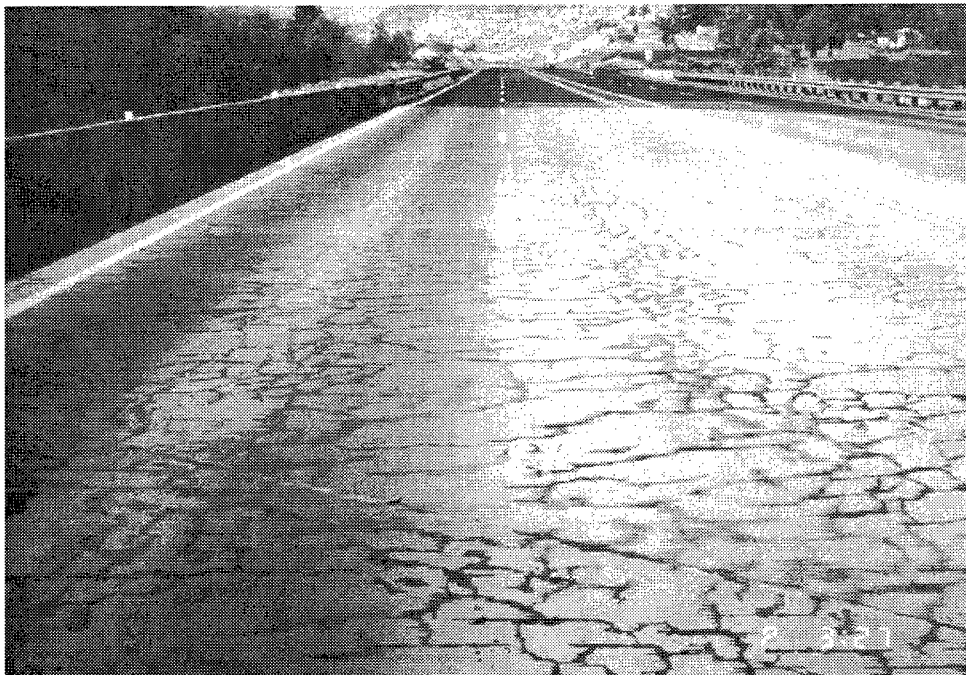
Figure 3.4: Sealed cracks in October 1995 distorted cracking severity.

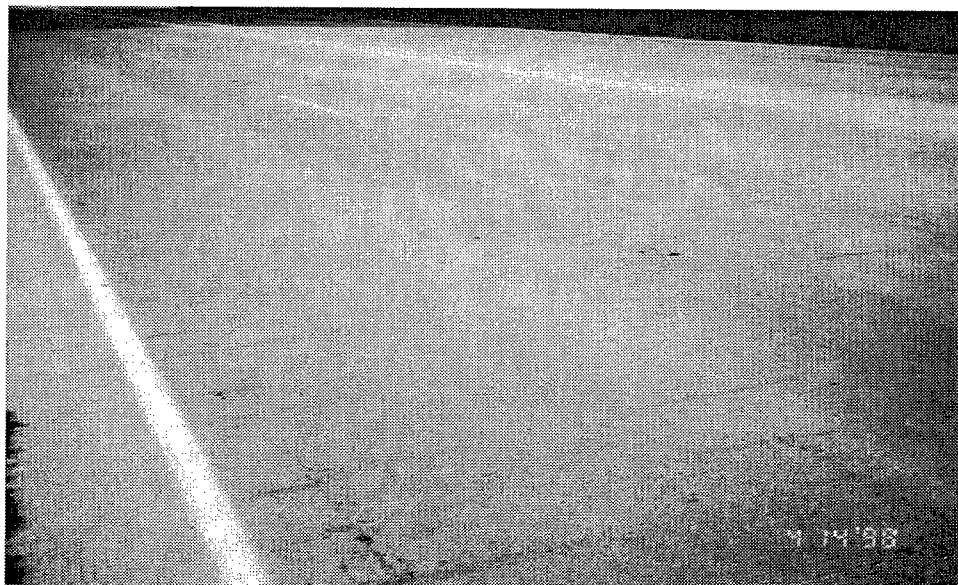
On April 14, 1998, a detailed survey of the deck was made. It included a crack map, photographs, and depth of cover for the reinforcing steel. Most of the cracks were difficult to find because the crack widths were very narrow. Cracks previously sealed with methacrylate were easier to spot. Some large cracks were found parallel to the bents. The bents on the USBR are at a skew angle of about sixty degrees (see crack map in Appendix A). Typical transverse cracking is shown in Figure 3.5, while cracking parallel to the bents is shown in Figure 3.6.

Figure 3.5: Typical transverse cracks (April 1998).

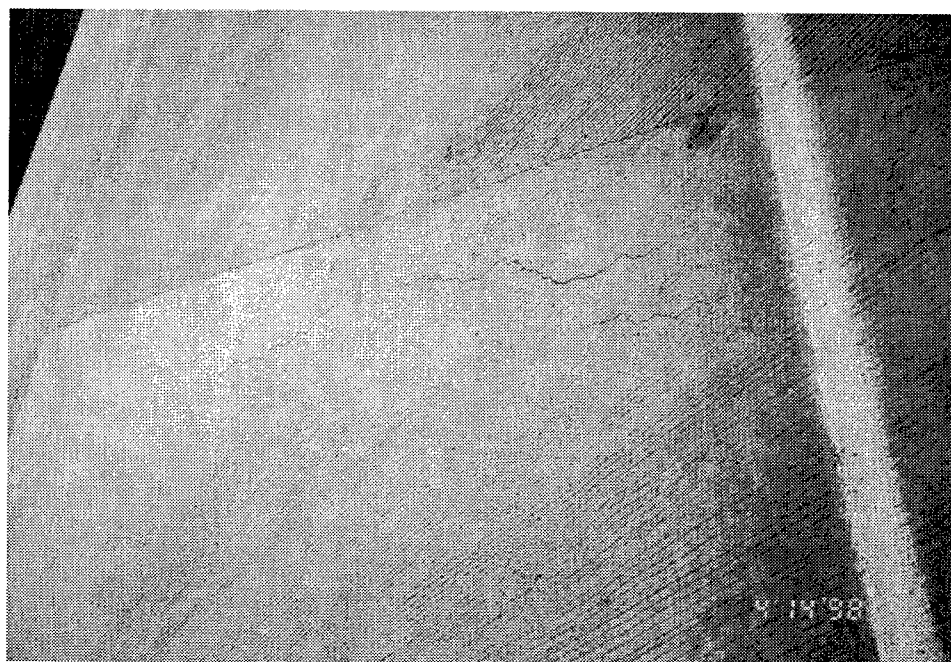
Figure 3.6: Small changes in transverse cracks parallel to bents (April 1998).

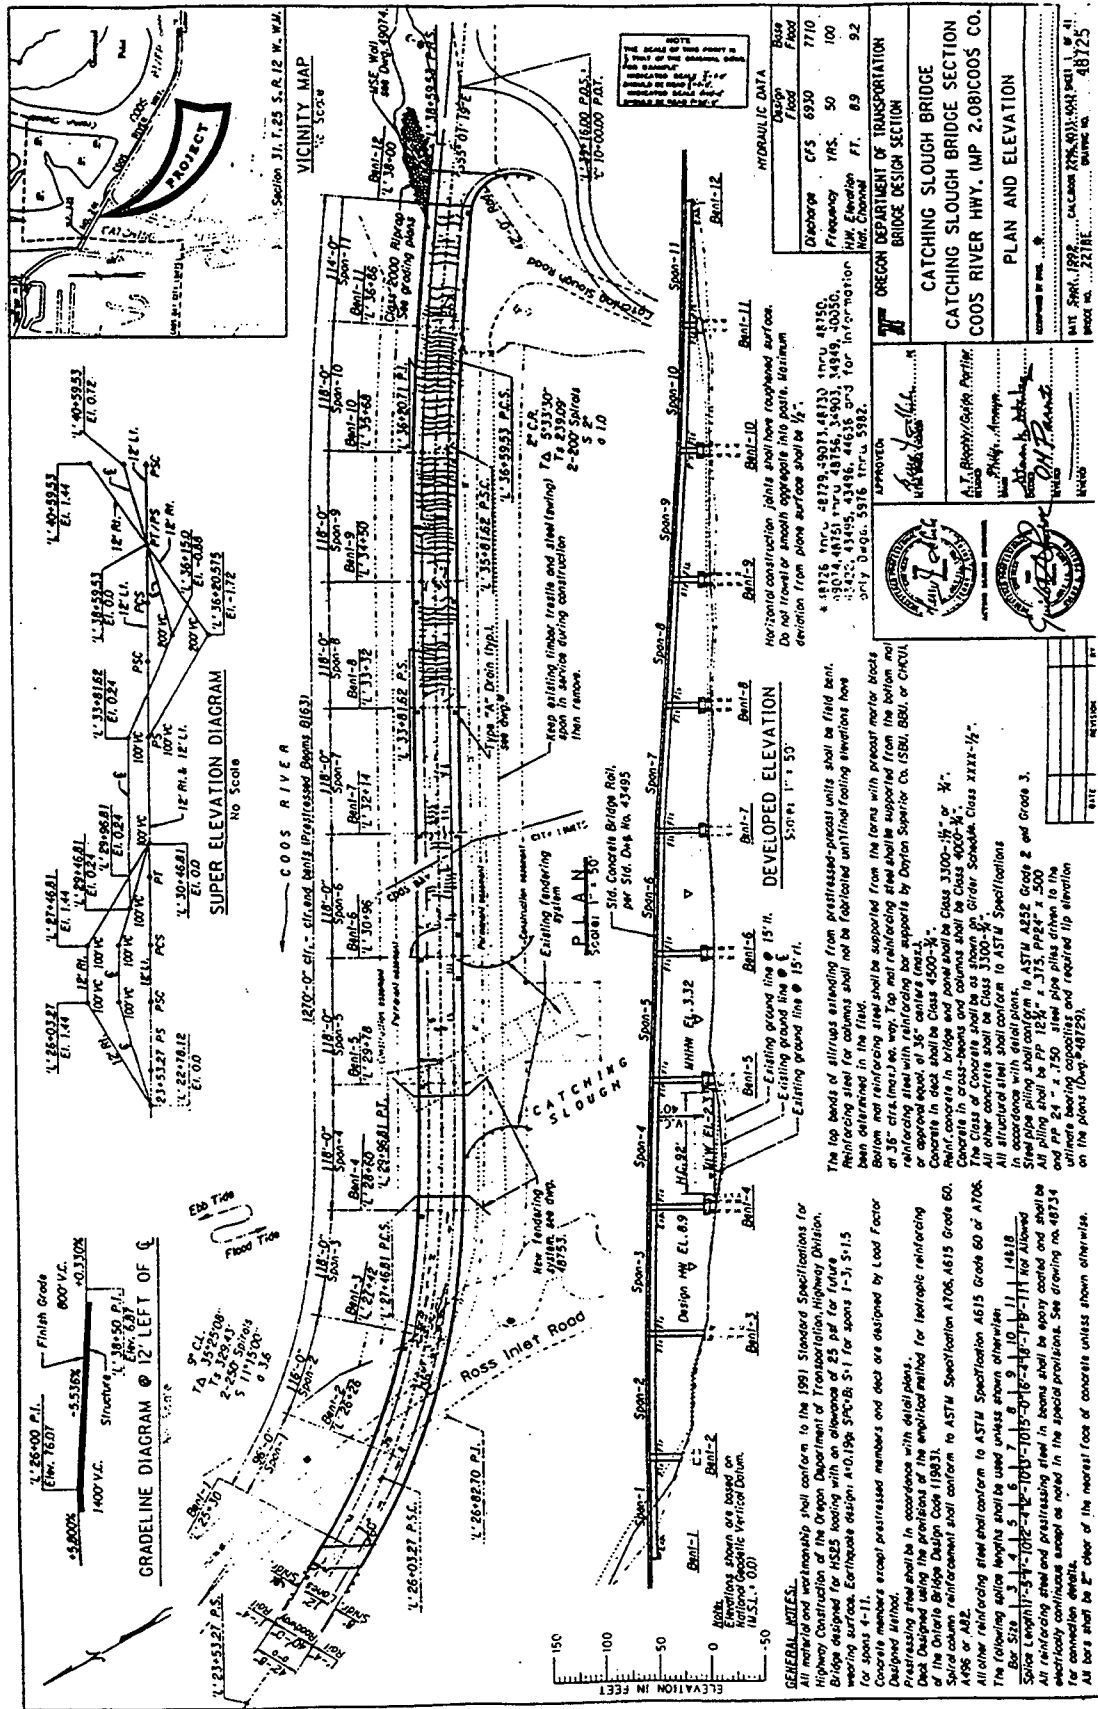
Cracking on the surface was concentrated at the east end of the bridge. The columns on this end are shorter and, as noted by the bridge designer, Guido Portier, “...all the interior columns are fixed to the superstructure except for bent 4. When spans are restrained and no movement is allowed, the possibility of concrete deck shrinkage will increase. These shrinkage cracks occur when the deck is unable to shorten due to stiffness of the shorter columns. Longer columns are more flexible and allow more shortening of the deck.”

Figure 3.7 is a crack map superimposed on the top view of the deck along with a profile view. Note the tallest column at bent 4 is about 13.7 m (45 ft) above the pier. This section had the least cracking. See Appendix A for a detailed crack map. A majority of the cracks had very narrow widths and were difficult to see.

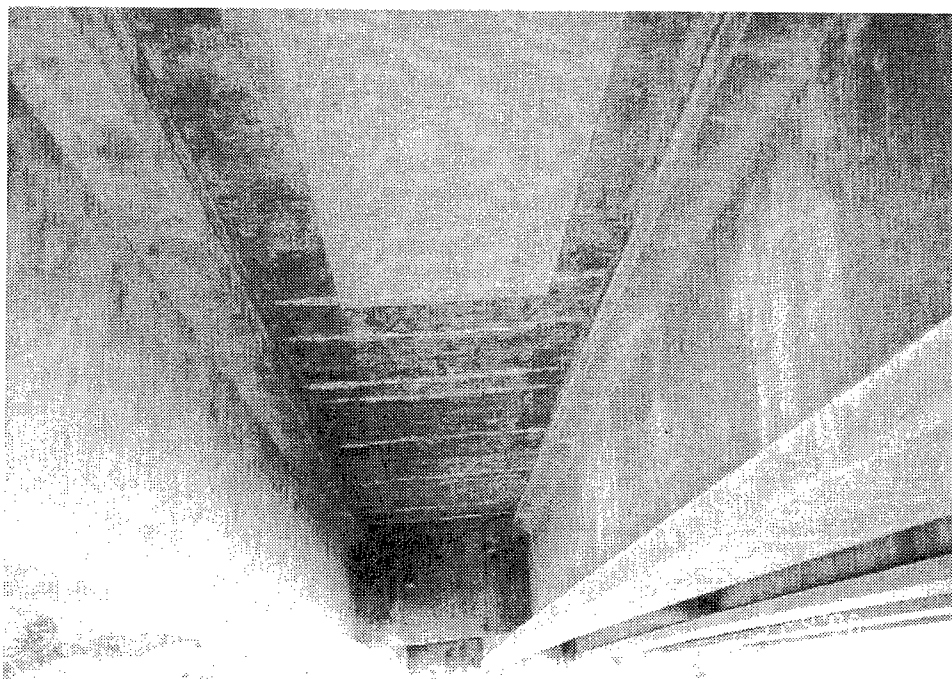
Although mapping cracks on the underside of the deck was not done because of the bridge height, photographs were taken. Most of the serious cracking was found near the east end on the bottoms of spans 8 through 11, as seen in Figure 3.8. Large transverse cracks with efflorescence were located near the diaphragms at center span. The taller columns near the west end did not have large visible cracks, as seen in Figure 3.9.

Figure 3.8: Transverse cracks were found on the bottom of the deck near center of span.

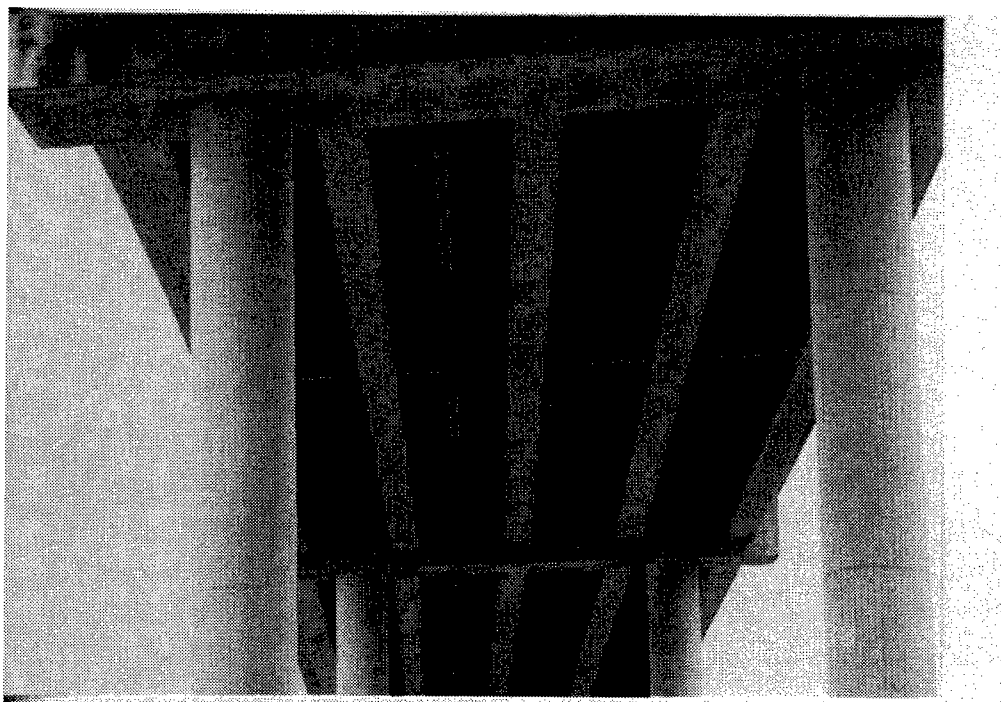
Figure 3.9: Transverse cracking is not found under the deck at the higher section of the structure.

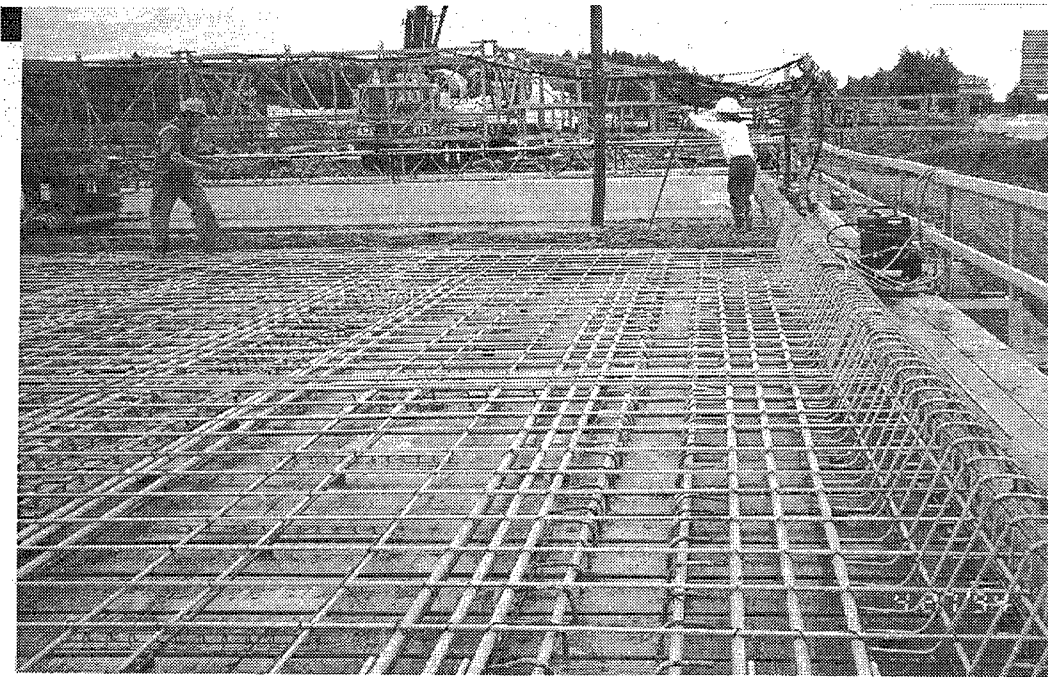
Figure 3.10: The deck of Santiam Overflow No. 4 was placed in April 1994. Note the isotropic layout of the rebar.

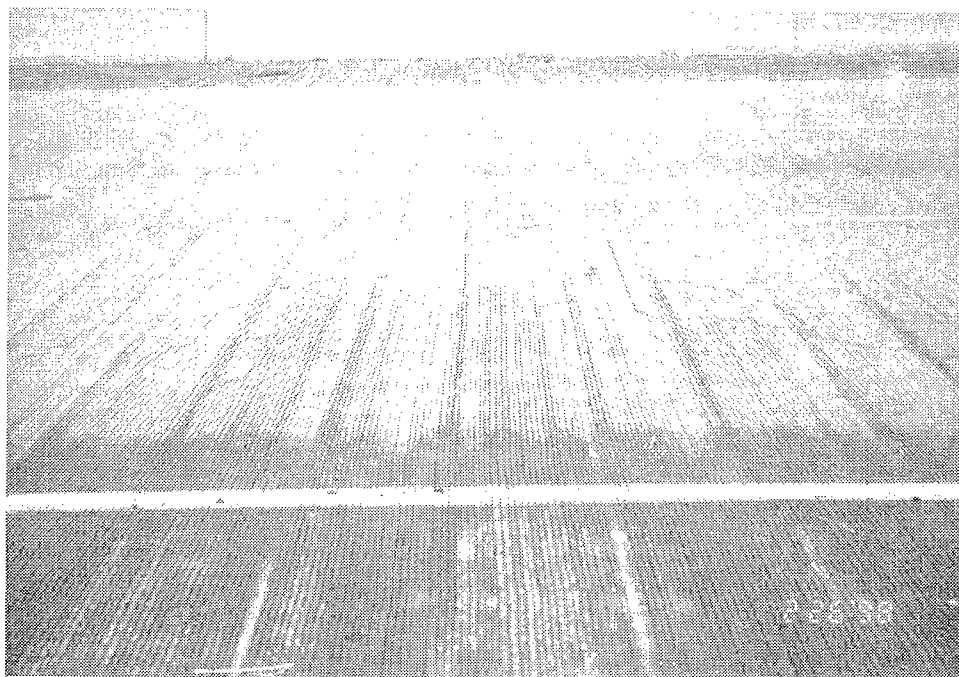
On February 26, 1998, the Research Unit, with the help of bridge designer Larry Bush and Region 2 Bridge Inspector Jeff Swanstrom, made a detailed inspection of the deck of Santiam Overflow No. 4. Both the top and bottom of the deck had transverse and longitudinal cracks, as shown in Figures 3.11 and 3.12. The bottom of the deck had large cracks, many even went through the deck. Stains on beams from water running through the cracks were found. A trench was also noted in the sand under the deck, apparently caused by water running from the surface through a large crack in the deck. Cracking on the underside of the deck was found over almost the entire surface with the frequency of cracking greater near the bents

Figure 3.11: Cracking on the top of the deck.

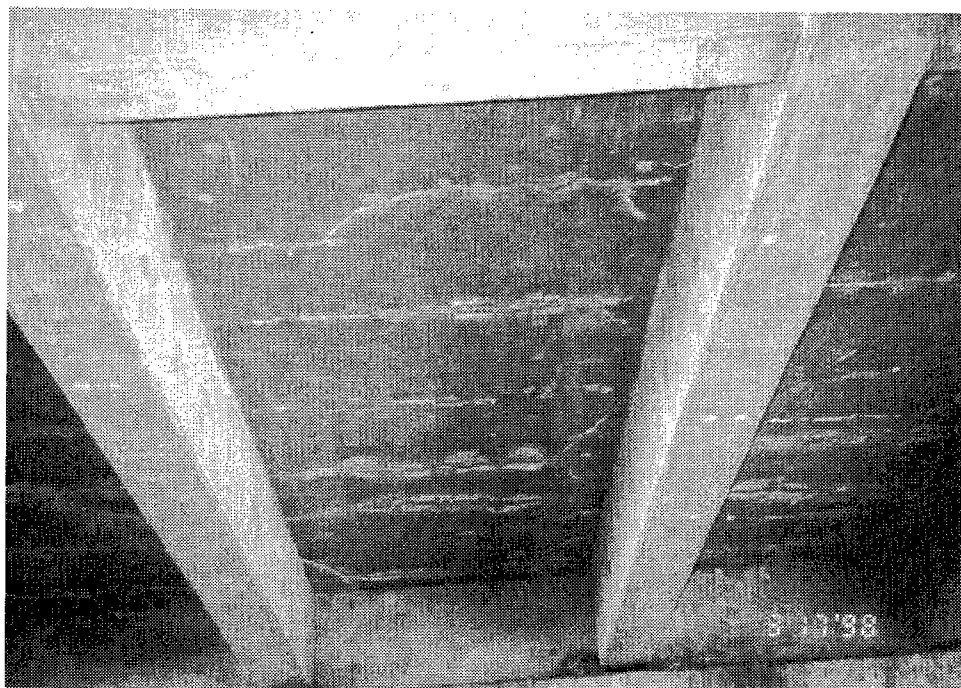
Figure 3.12: Cracks on the bottom of the deck were outlined by efflorescence stains.

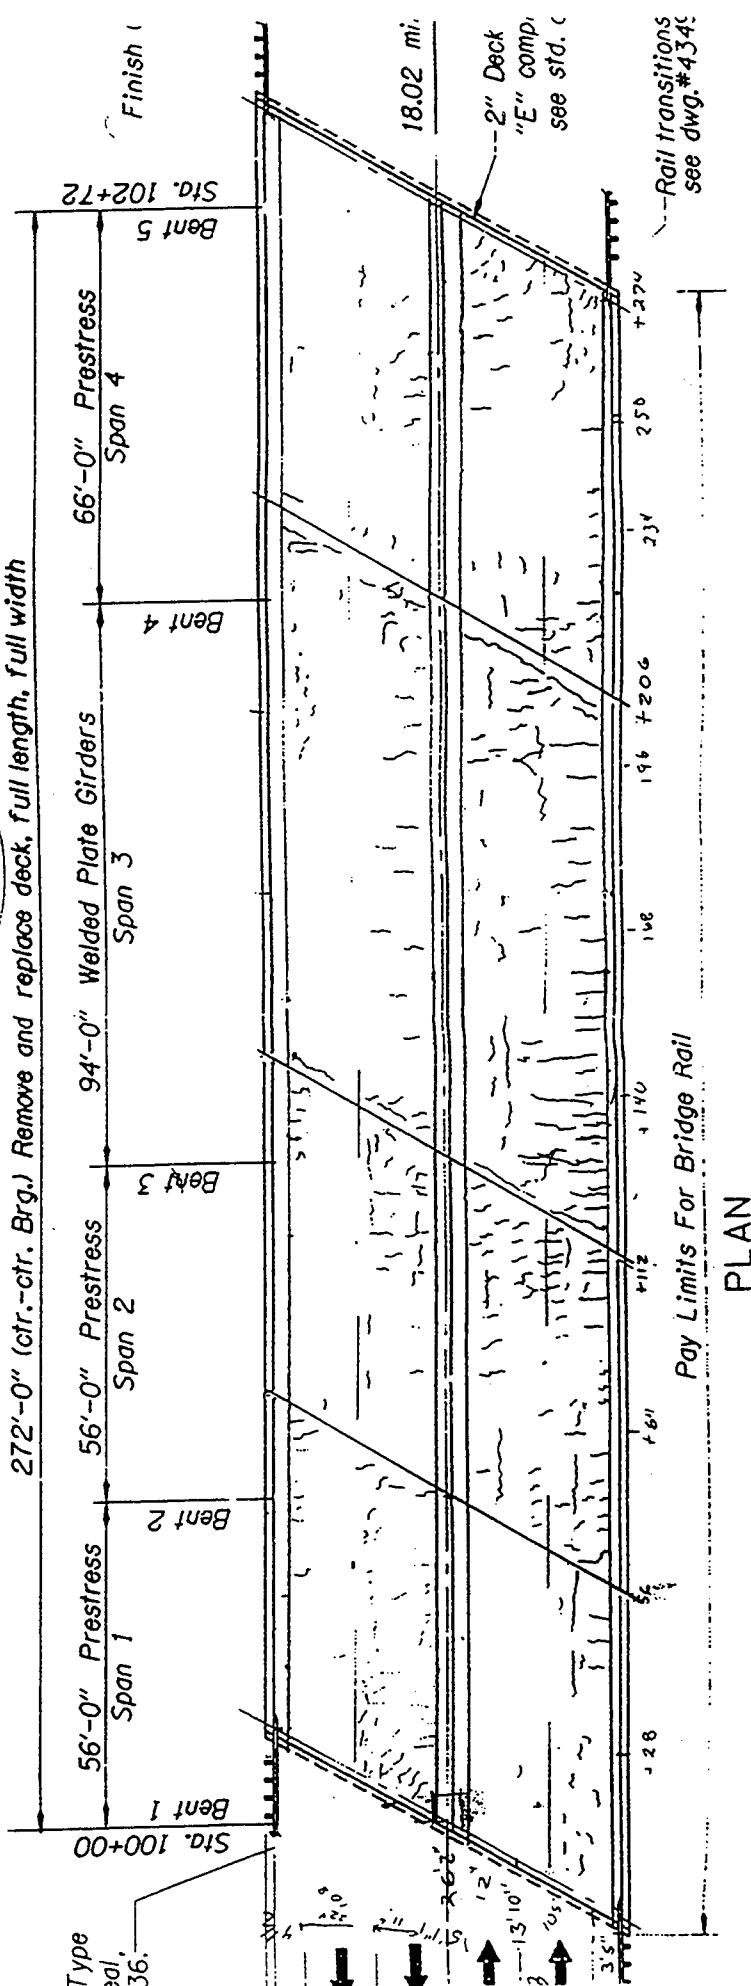
A-1

Top view of USBR Deck as seen April 1998.

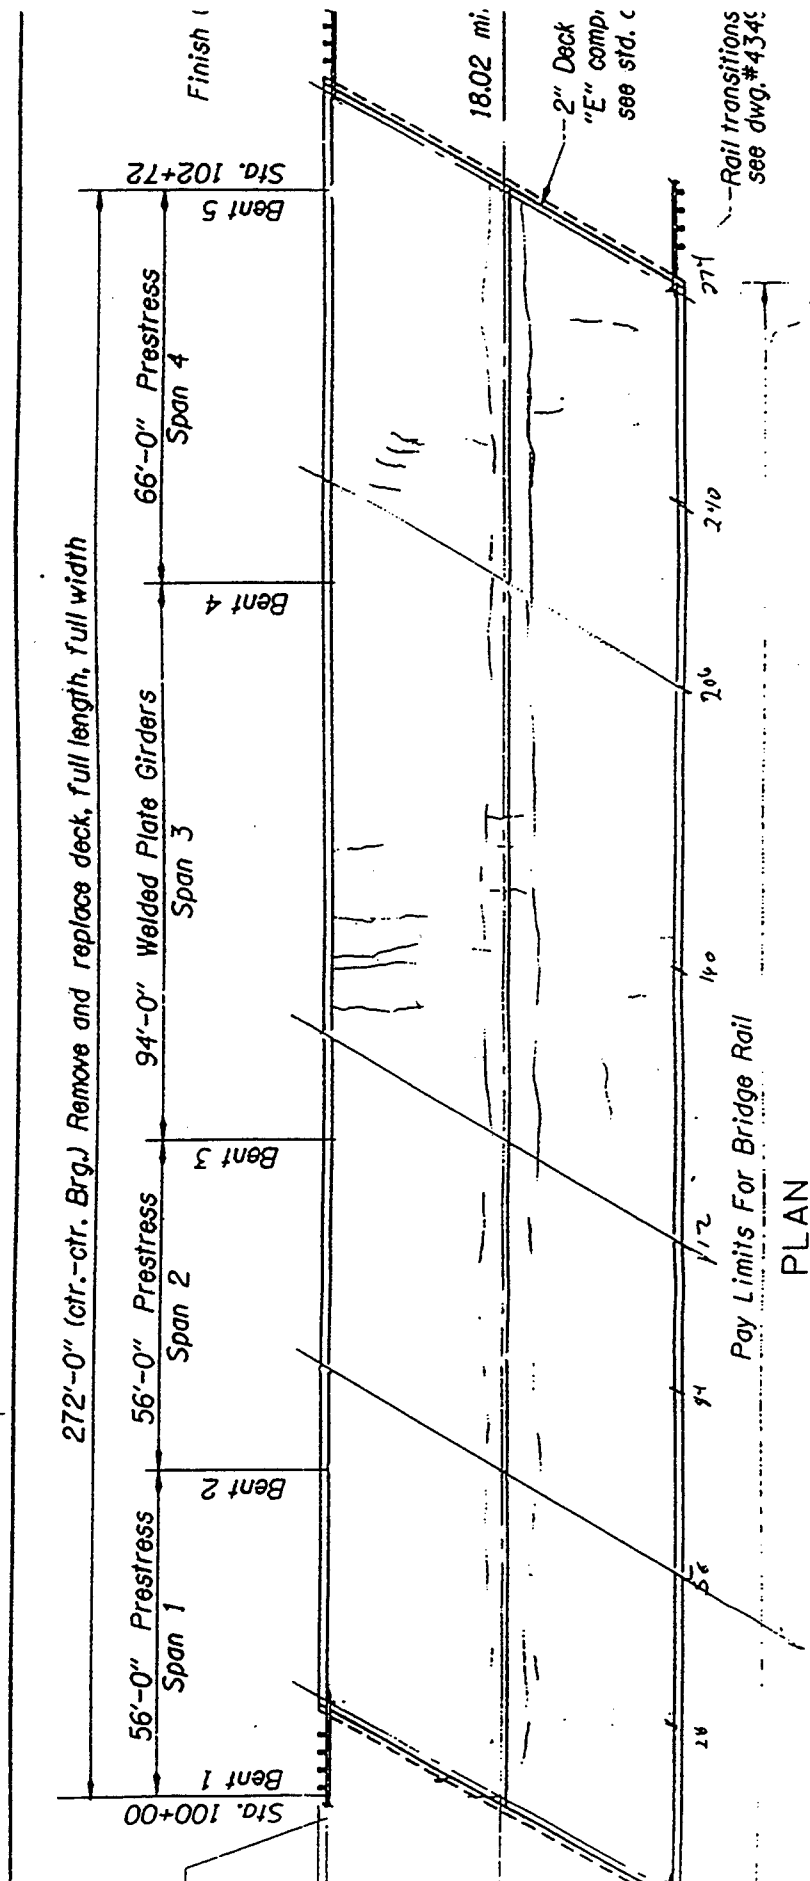
Bottom of USBR Deck as seen April 1998 through the top.

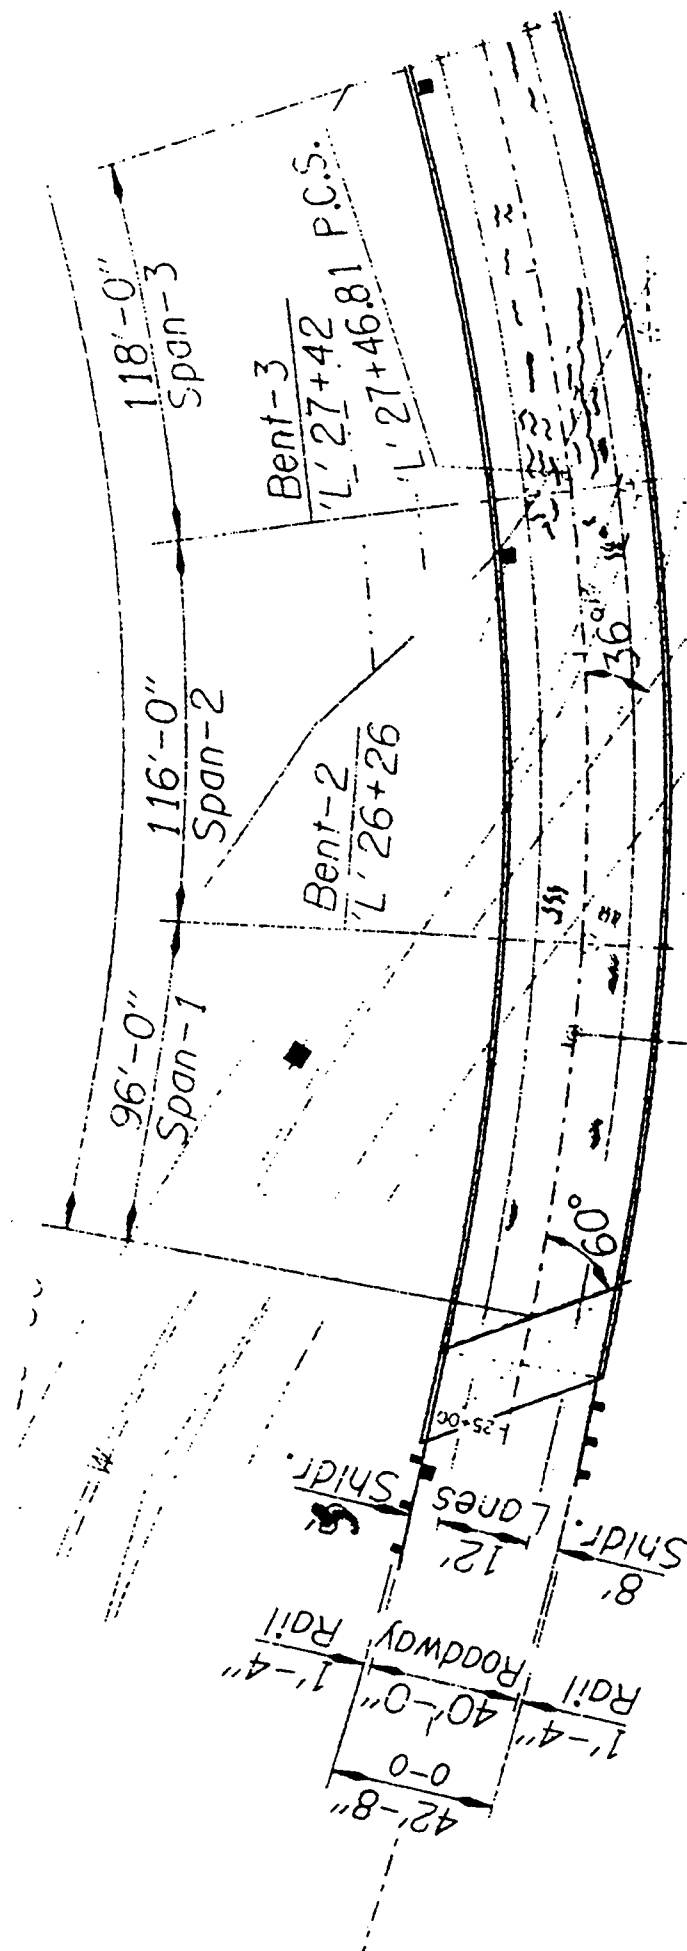
Top view of Catching Slough deck, spans 1 through 3

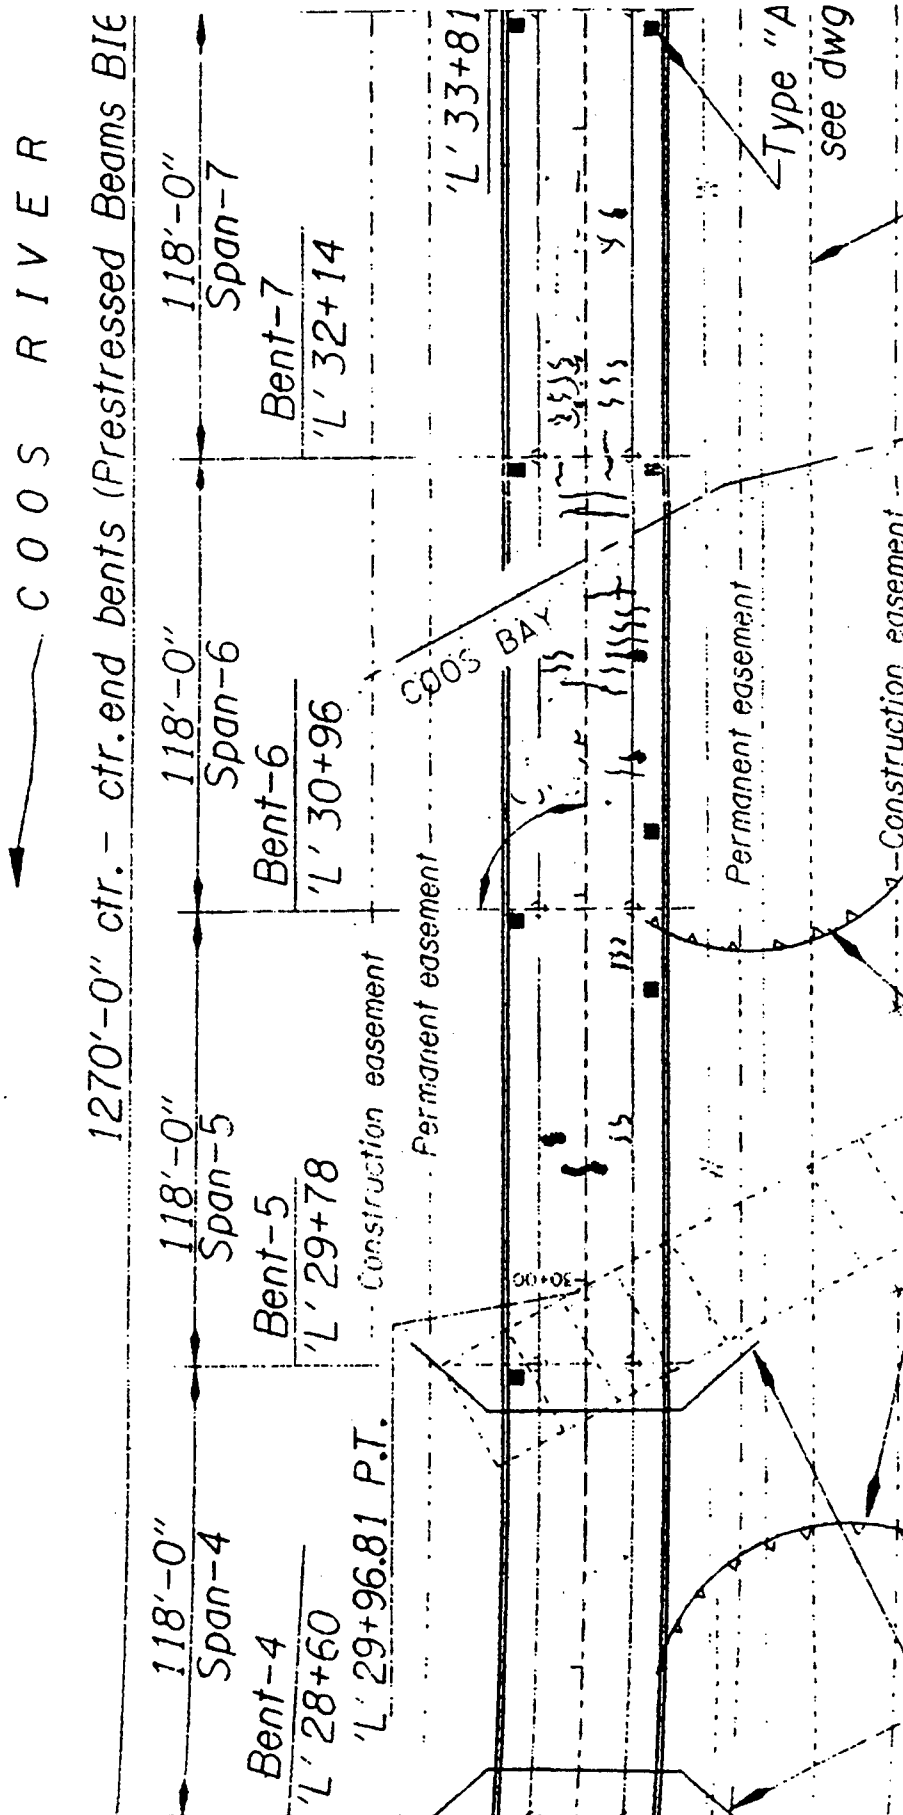
Top view of Catching Slough deck, spans 4 through 7.
