EVALUATION OF PREFABRICATED EDGE DRAINS (PED) IN OHIO

Final Report

Report No. UT-CE/GG 98-102

November, 1998

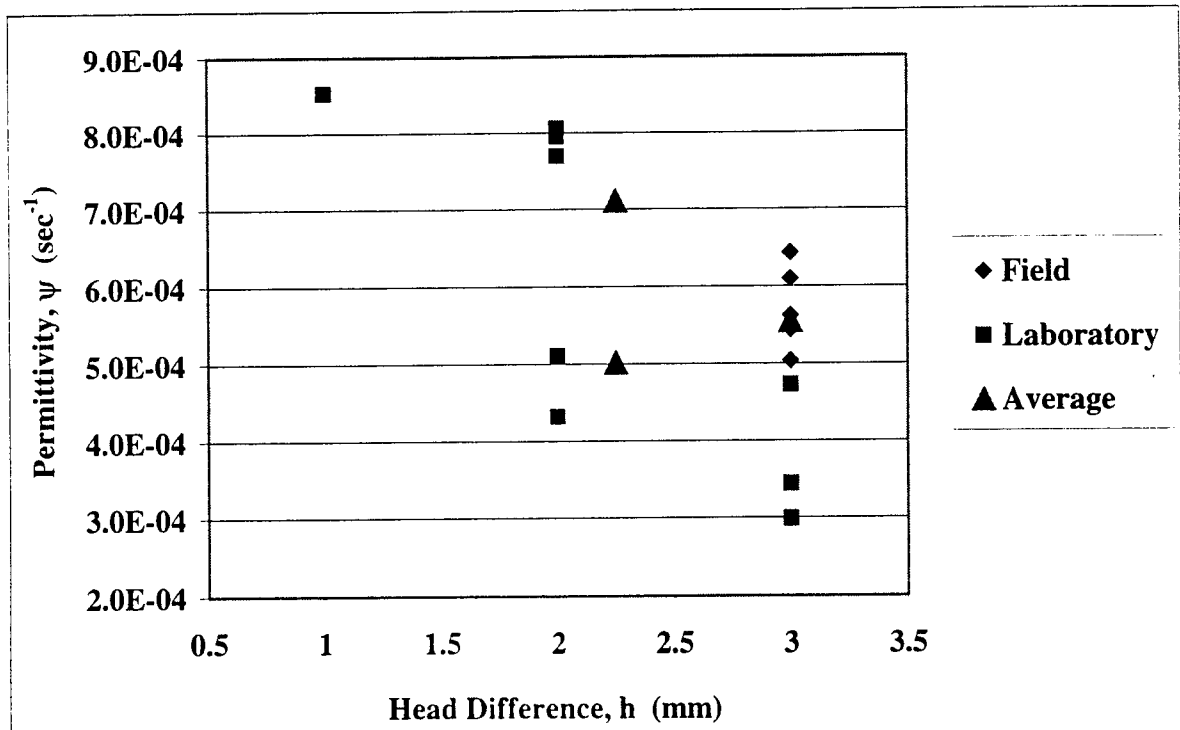
Figure 4.4 - Permittivity Test, Hancock County

Permittivity testing was conducted at the test site using the test apparatus as described in Section 4.2. The results of the testing are shown in Figure 4.4 and Table 4.2. The sample of PED used for the testing was very clean. Therefore it was very difficult to maintain a head difference of 3 mm. Consequently, there is considerable data scatter in the plot with no consistent trend of increasing or decreasing permittivity with change of head difference. A test apparatus with better controls over the hydraulic conditions would be required for the permittivity testing. The results of this test are compared with tests on PED samples obtained from manufacturers in Chapter 5.

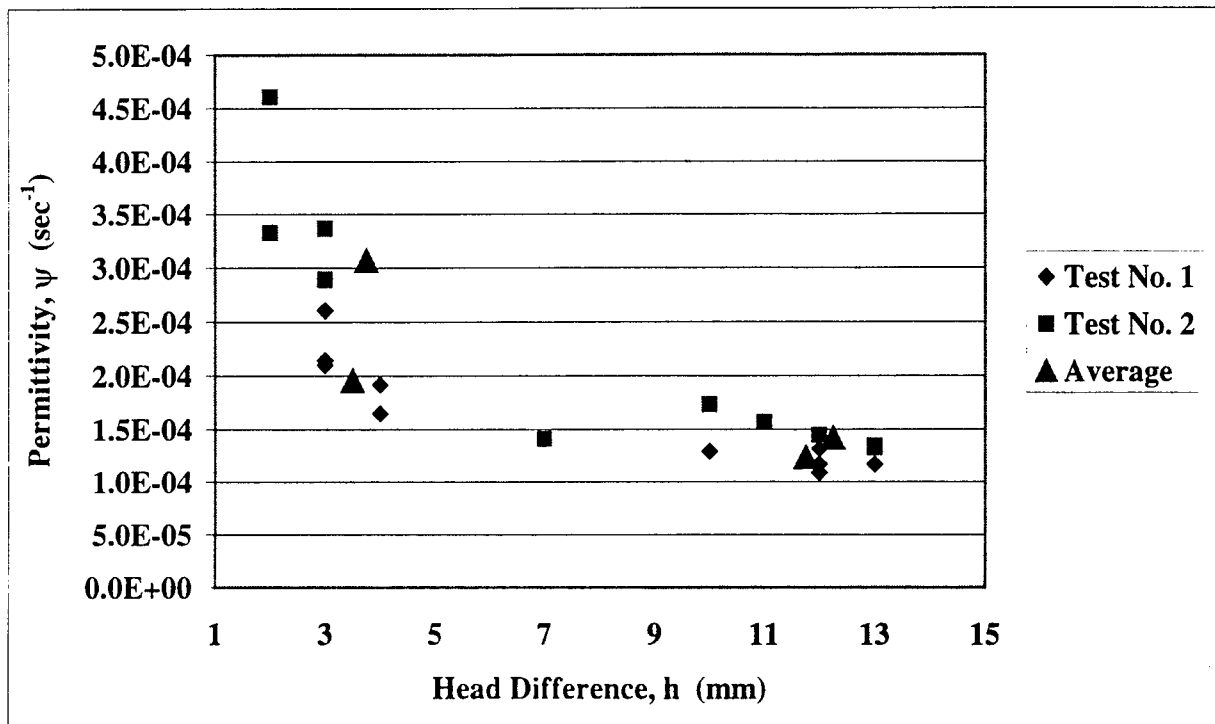
Figure 4.7 - Permittivity Test, Ottawa County

The results of the testing are shown in Figure 4.7 and Table 4.5. There were two samples of PED tested, one from each excavation. The samples were very dirty both inside and out. The tests were conducted by establishing a small head difference across the fabric material and measuring the discharge rate. After five trials at low head differences, the discharge level was adjusted so that there would be a larger head difference and the testing was repeated. Since the fabric material was so dirty, it was possible to maintain head differences of up to 12 mm. According to Figure 4.7, the permittivity decreases as the head difference increases.

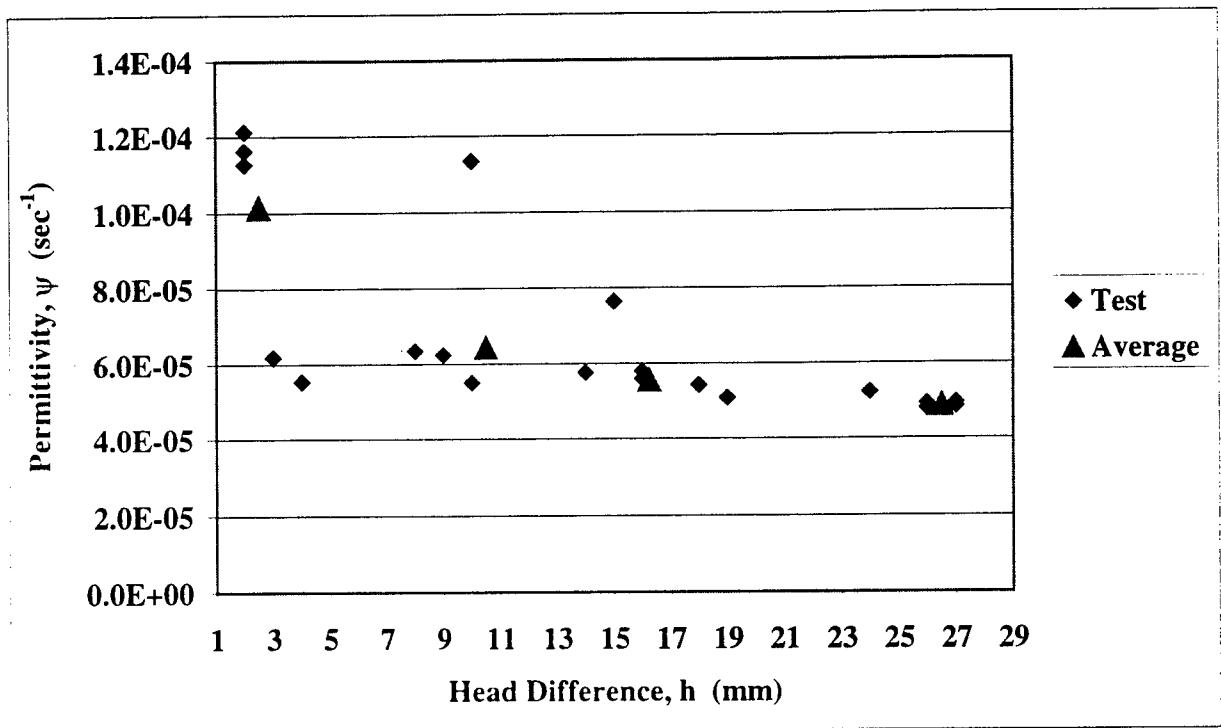
Figure 4.10 - Permittivity Test, Warren County

The results of the testing are shown in Figure 4.10 and Table 4.7. The PED sample was very dirty with fines on both sides of the fabric. Because of condition of the fabric it was possible to establish up to 27 mm of head difference. According to Figure 4.10, the permittivity decreases as the head difference increases.

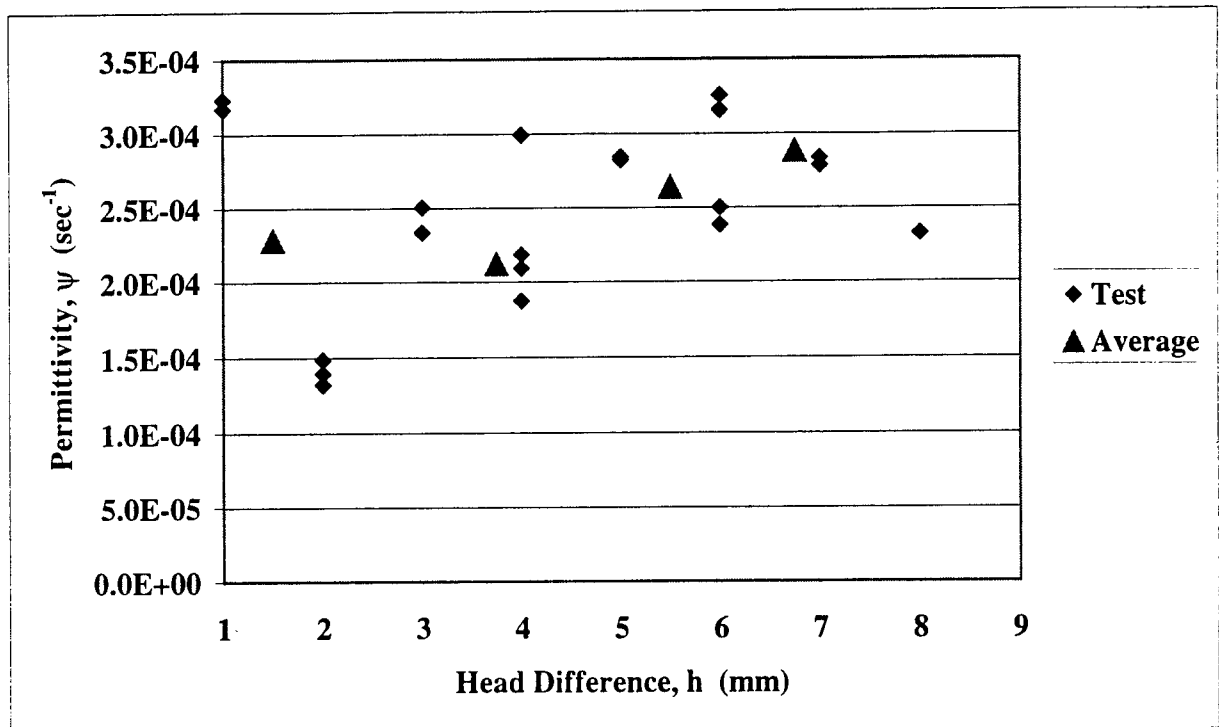
Figure 4.13 - Permittivity Test, Athens County

The results of the testing are shown in Figure 4.13 and Table 4.9. The samples were dirty both inside and out however it was only possible to establish up to 7 mm of head difference. As shown in Figure 4.10, there is considerable variation in the test data. There is no consistent trend between permittivity and head difference.

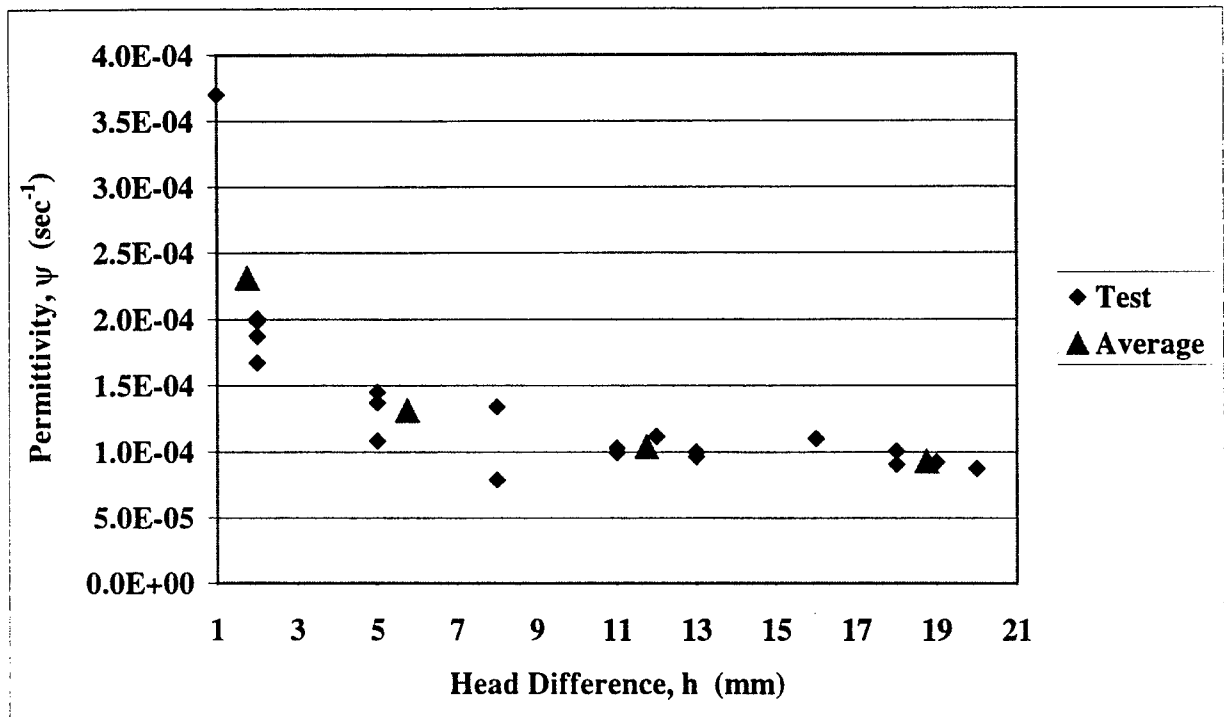
Figure 4.16 - Permittivity Test, Jackson County

The results of the testing are shown in Figure 4.16 and Table 4.11. The samples were dirty and it was possible to establish up to 19 mm of head difference. The variation in permittivity shown in Figure 4.16 is small. The permittivity decreased as the head difference increased.

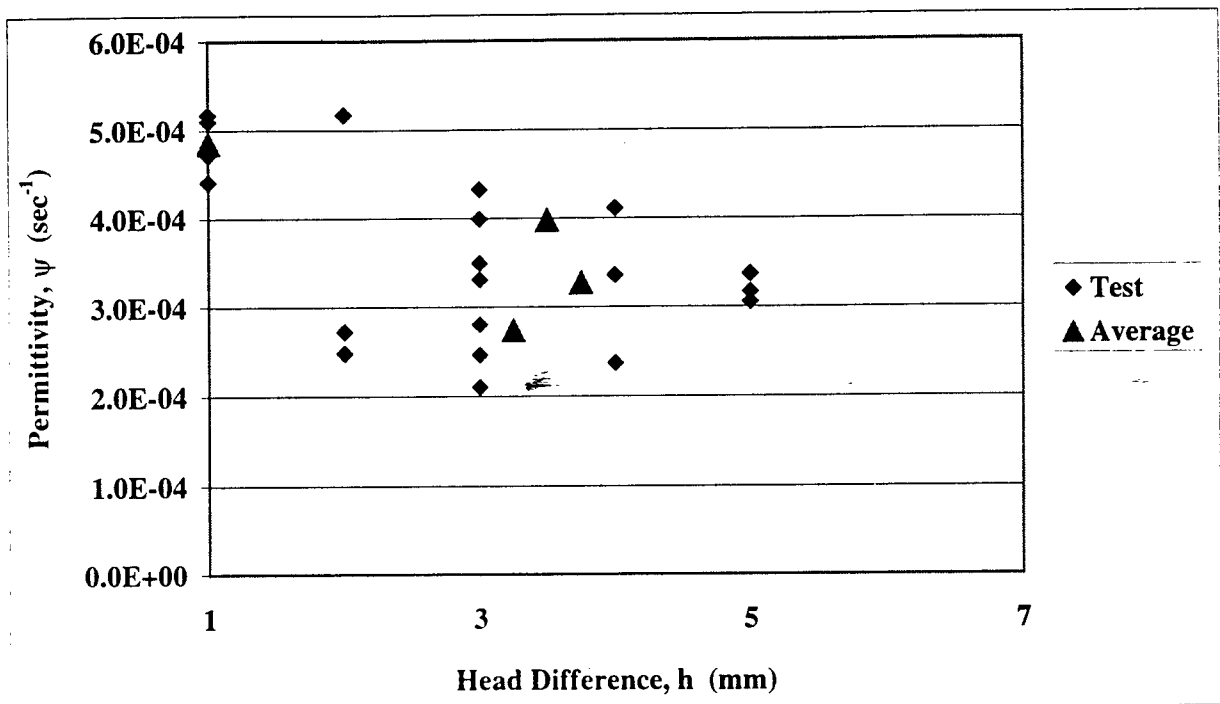
Figure 4.19 - Permittivity Test, Licking County

The results of the testing are shown in Figure 4.19 and Table 4.13. The sample appeared to be very dirty. However, it was only possible to establish 5 mm of head difference. There is significant variation in the data shown in Figure 4.19. In spite of the variation, the permittivity can be seen to decrease as the head difference increases.
