# **DEVELOPMENT OF THE *MIDWEST GUARDRAIL* SYSTEM (MGS) FOR STANDARD AND REDUCED POST SPACING AND IN COMBINATION WITH CURBS**

MwRSF Research Report No. TRP-03-139-04

September 1, 2004

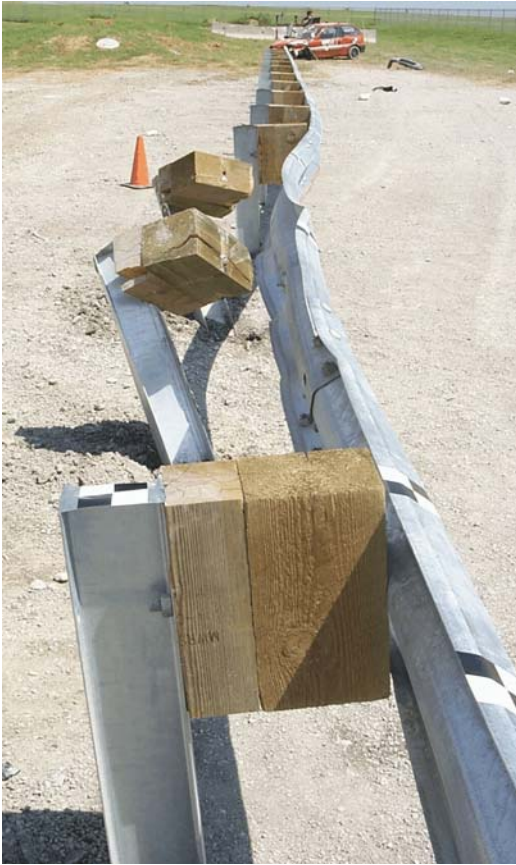
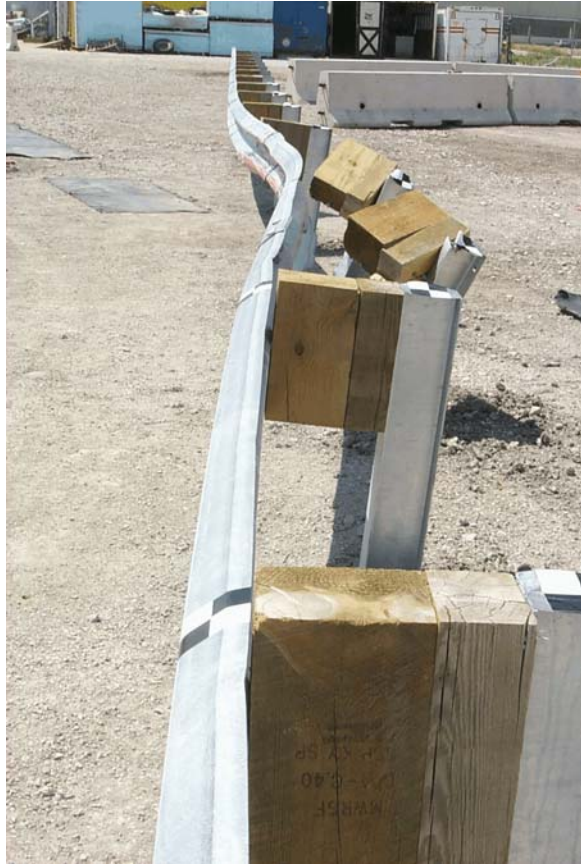
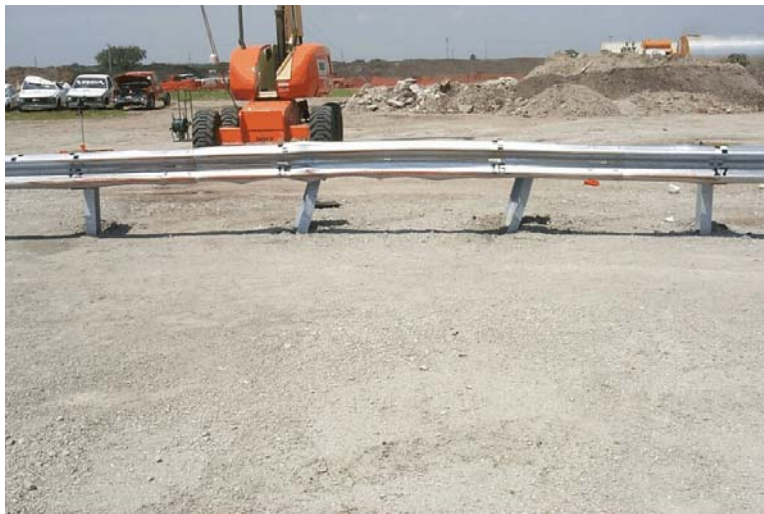
Figure 43. System Damage, Test NPG-1

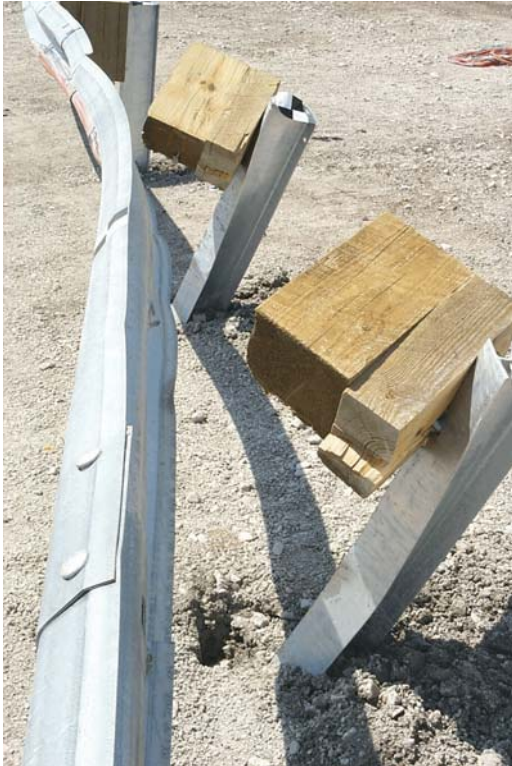
Figure 44. Post Nos. 15 and 16 Damage, Test NPG-1

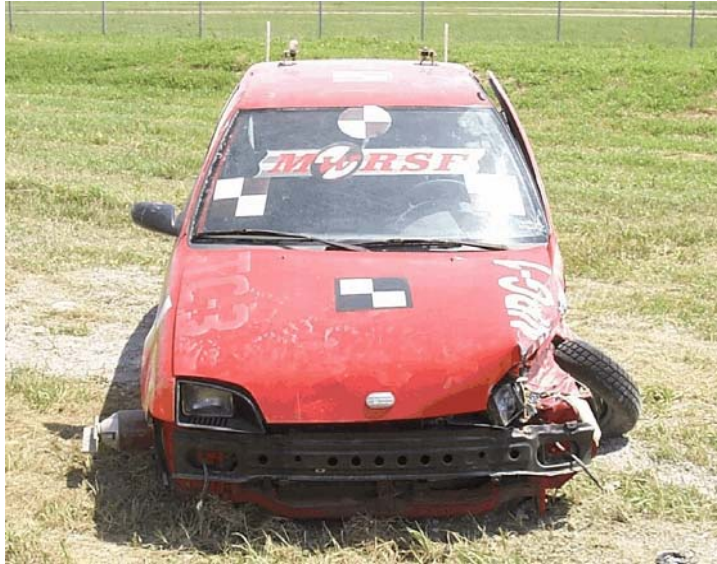
Figure 46. Vehicle Damage, Test NPG-1

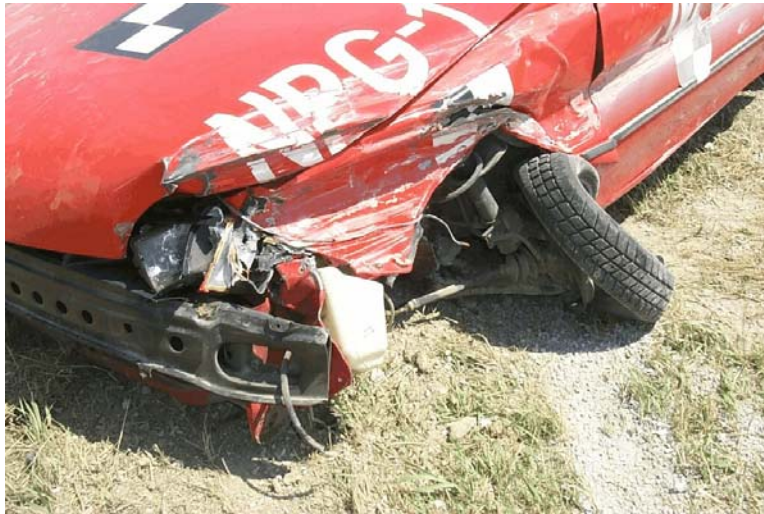
Figure 47. Vehicle Damage, Test NPG-1

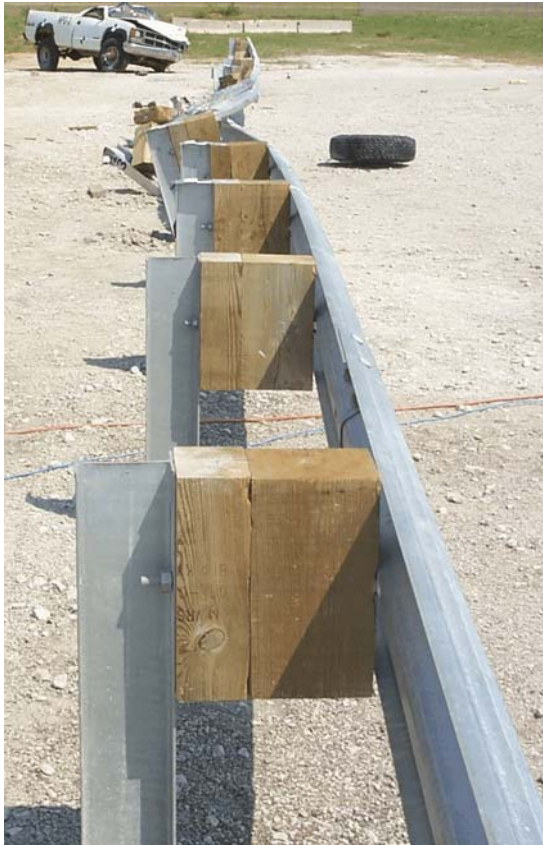
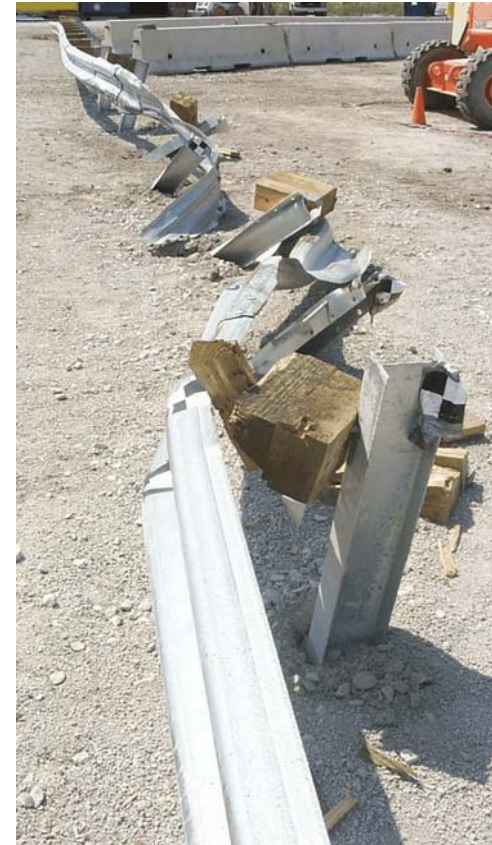
Figure 64. System Damage, Test NPG-2

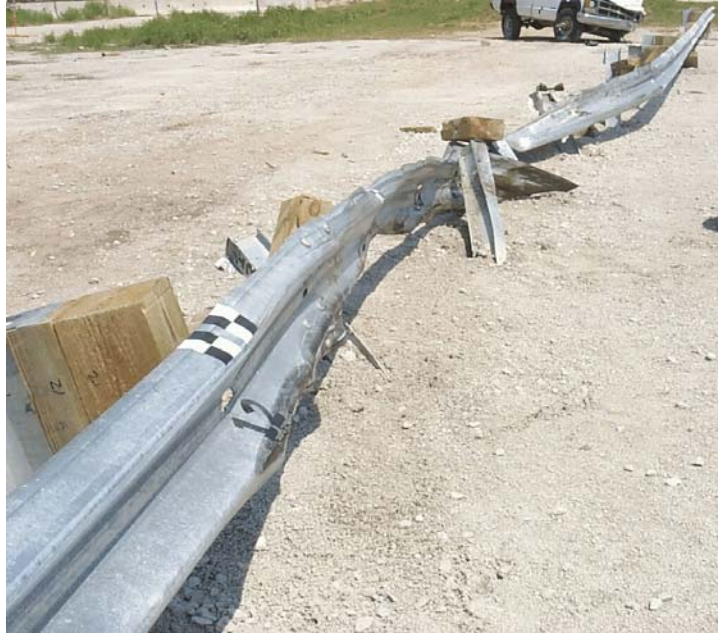
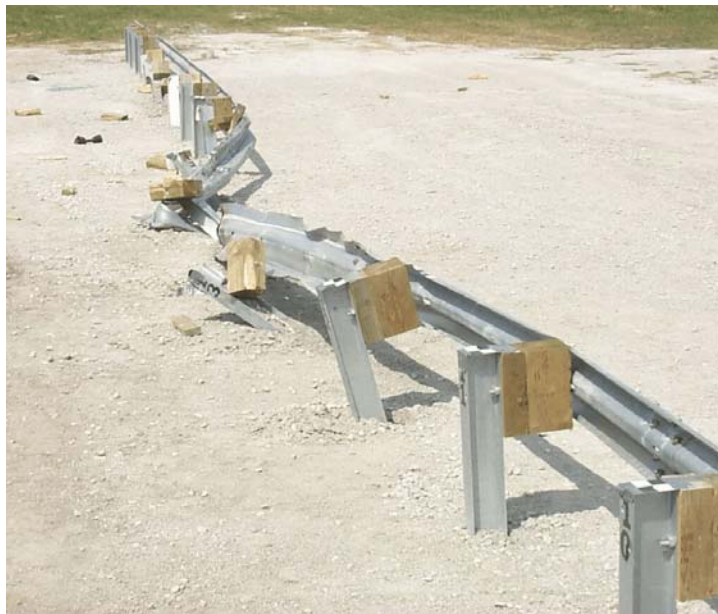
Figure 65. System Damage, Test NPG-2

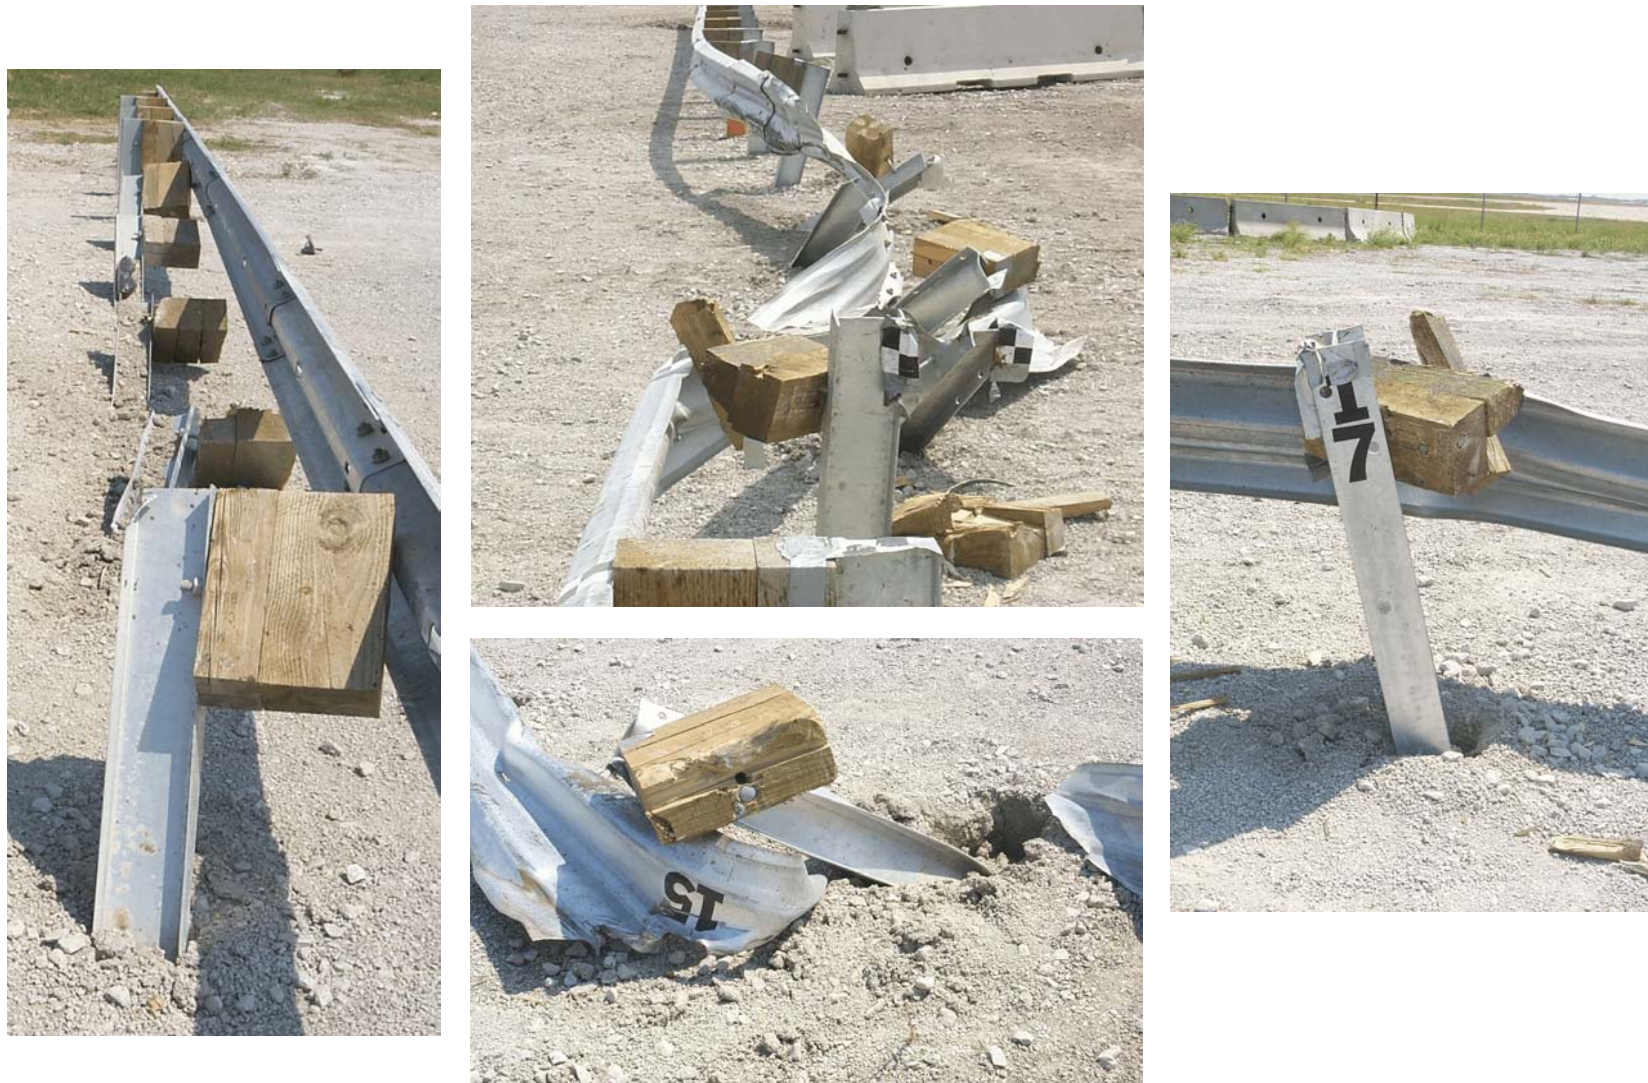
Figure 66. System Damage, Test NPG-2

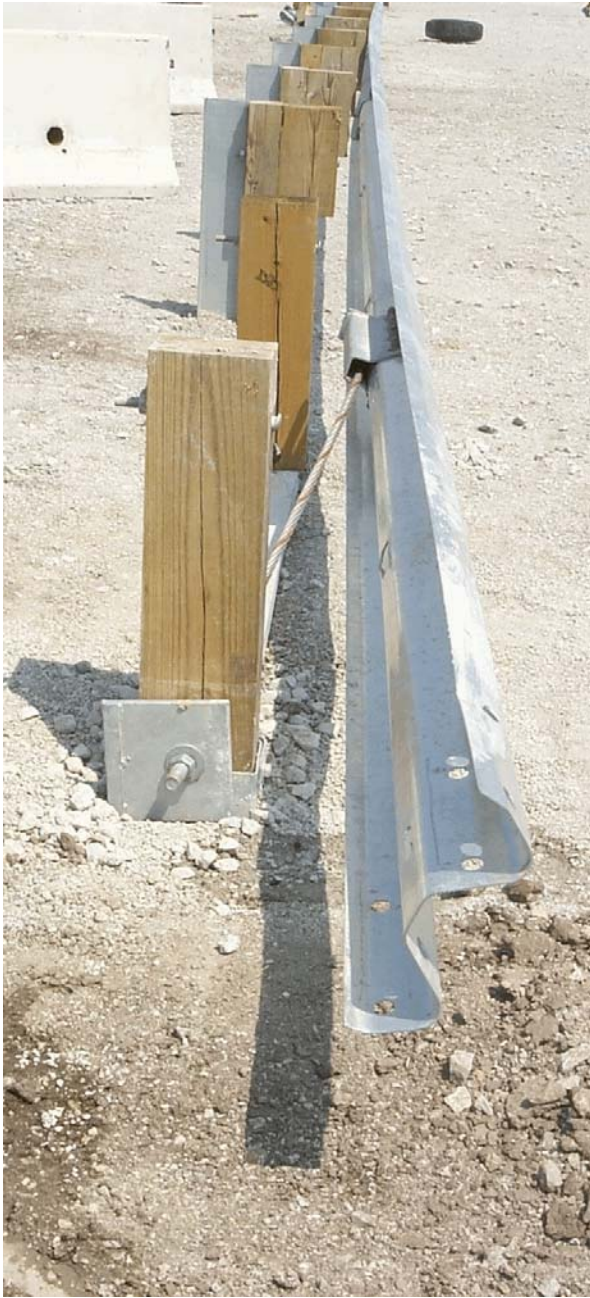
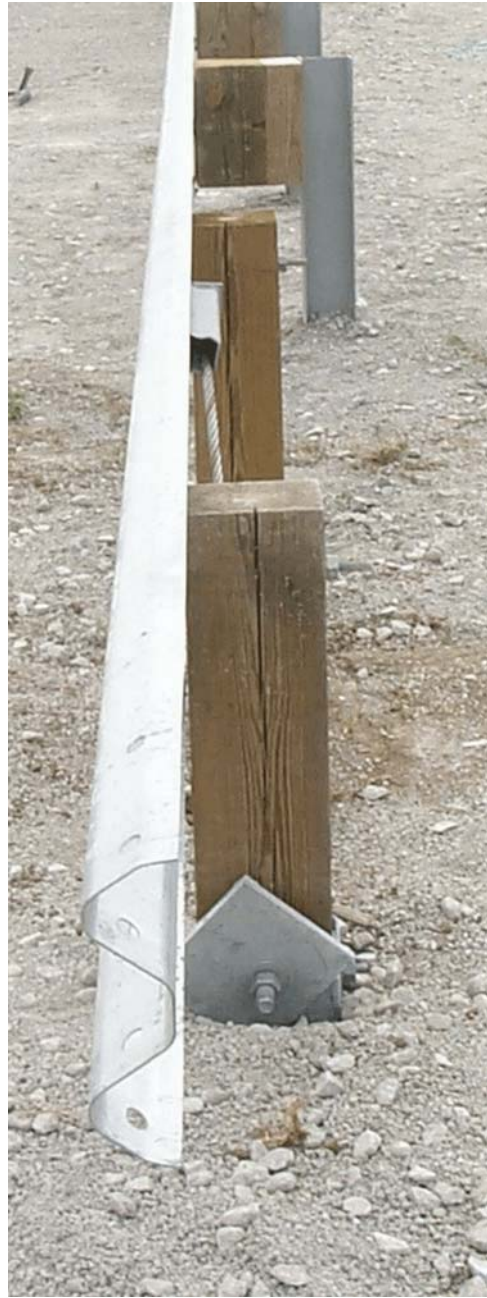
Figure 67. System Damage, Test NPG-2

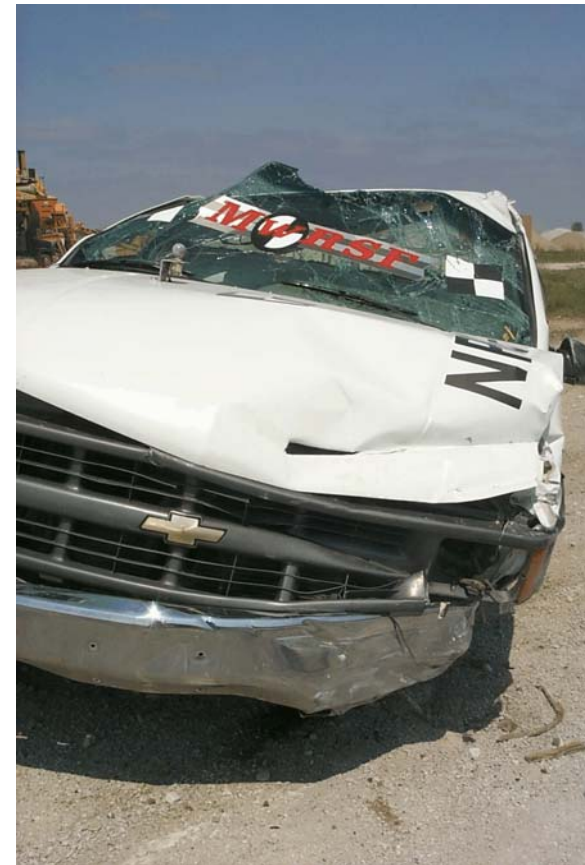
Figure 68. Vehicle Damage, Test NPG-2

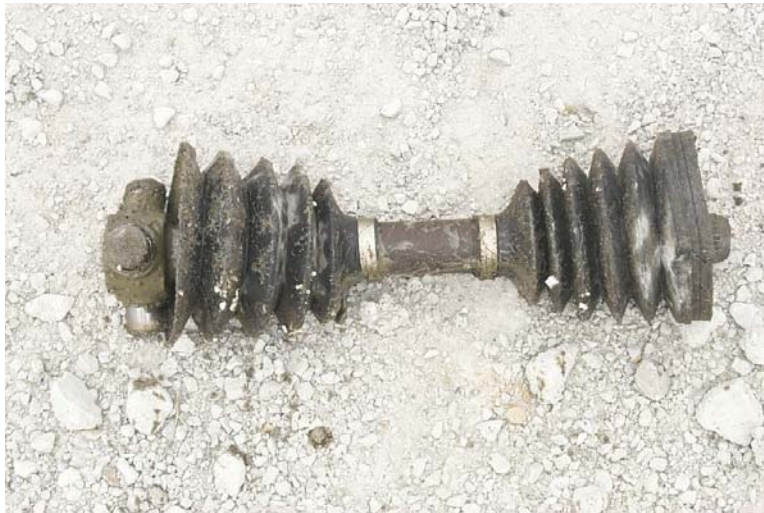
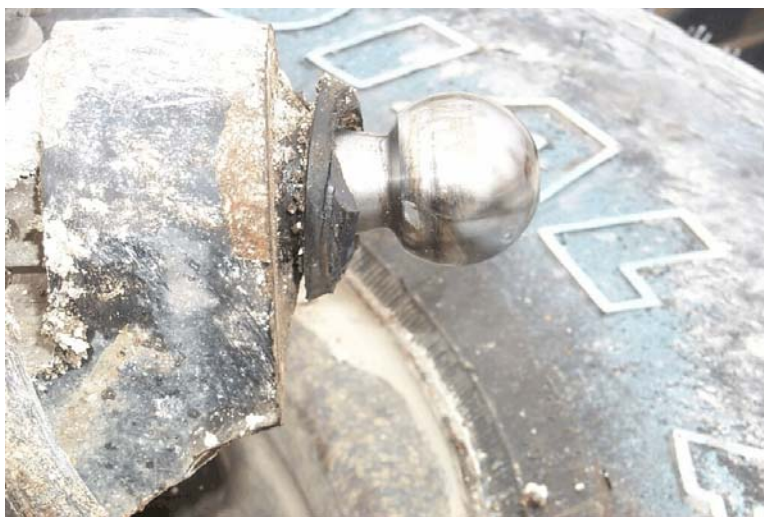
Figure 69. Vehicle Damage, Test NPG-2

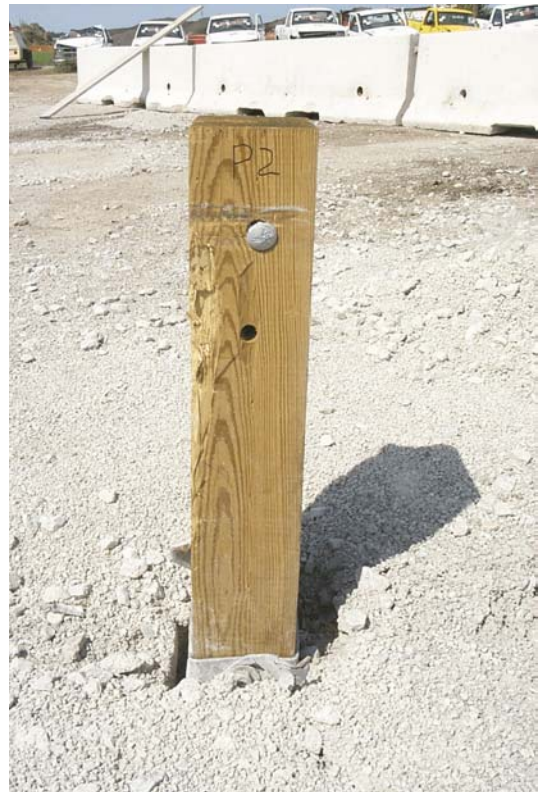
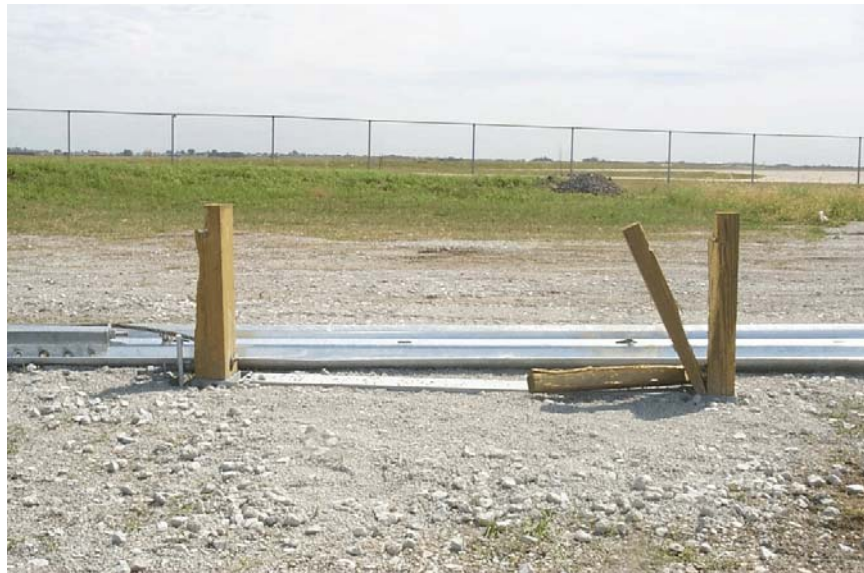
Figure 80. System Damage, Test NPG-3

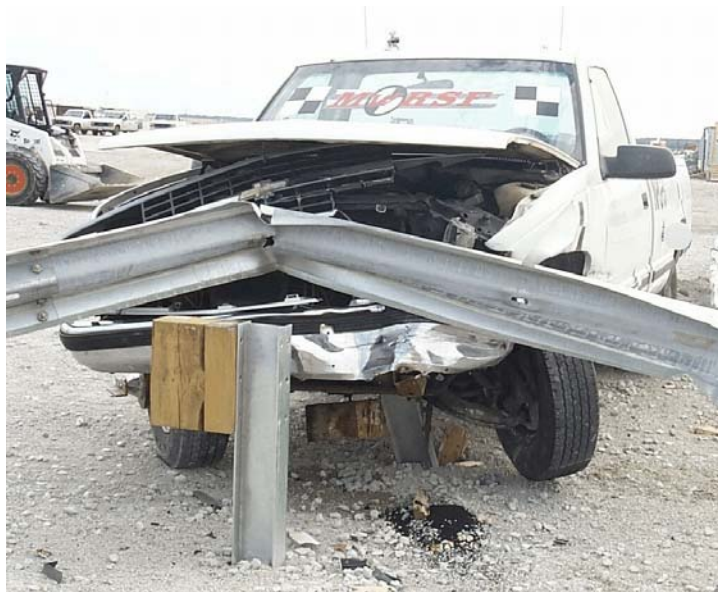
Figure 81. Vehicle Damage, Test NPG-3

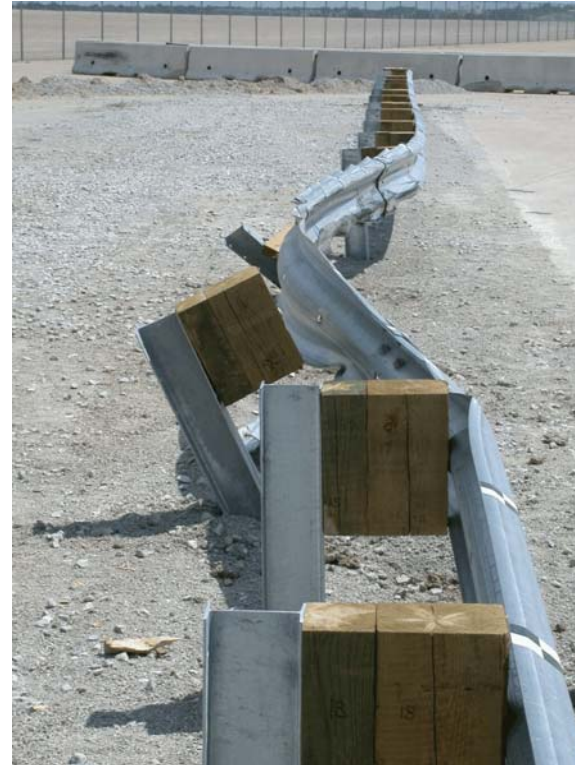
Figure 94. System Damage, Test NPG-4

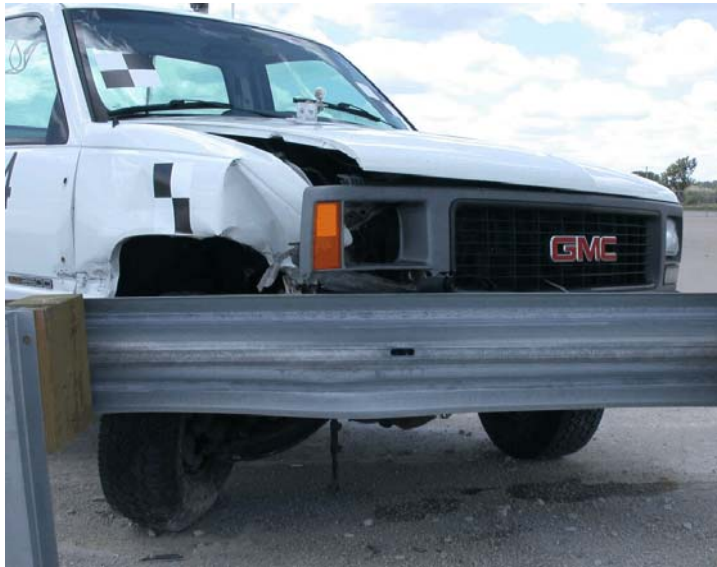
Figure 98. Vehicle Damage, Test NPG-4

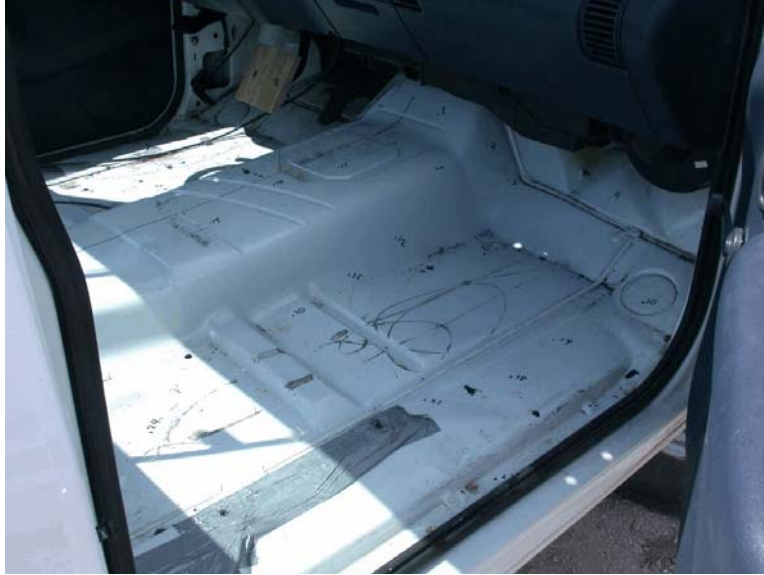
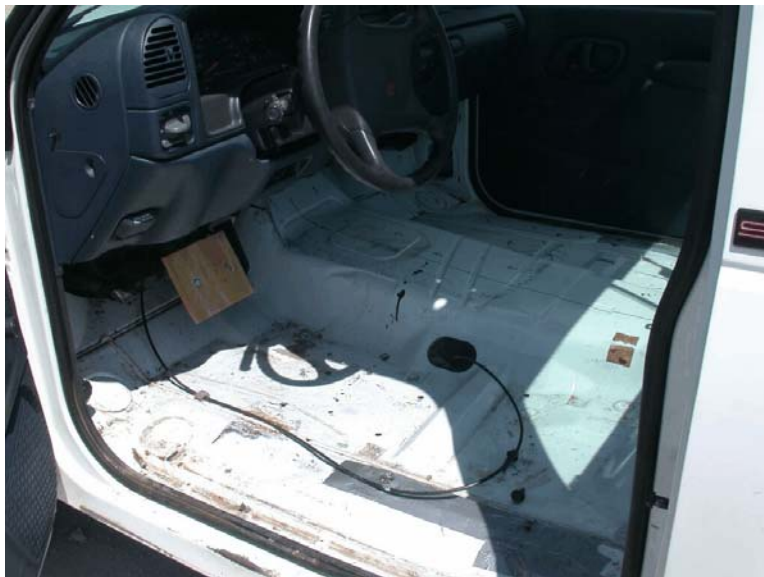
Figure 100. Occupant Compartment Damage, Test NPG-4

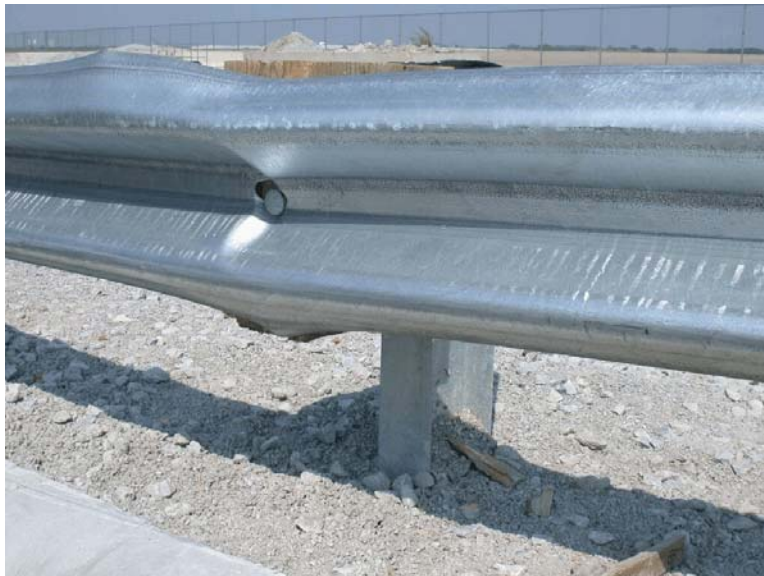
Figure 114. System Damage, Test NPG-5

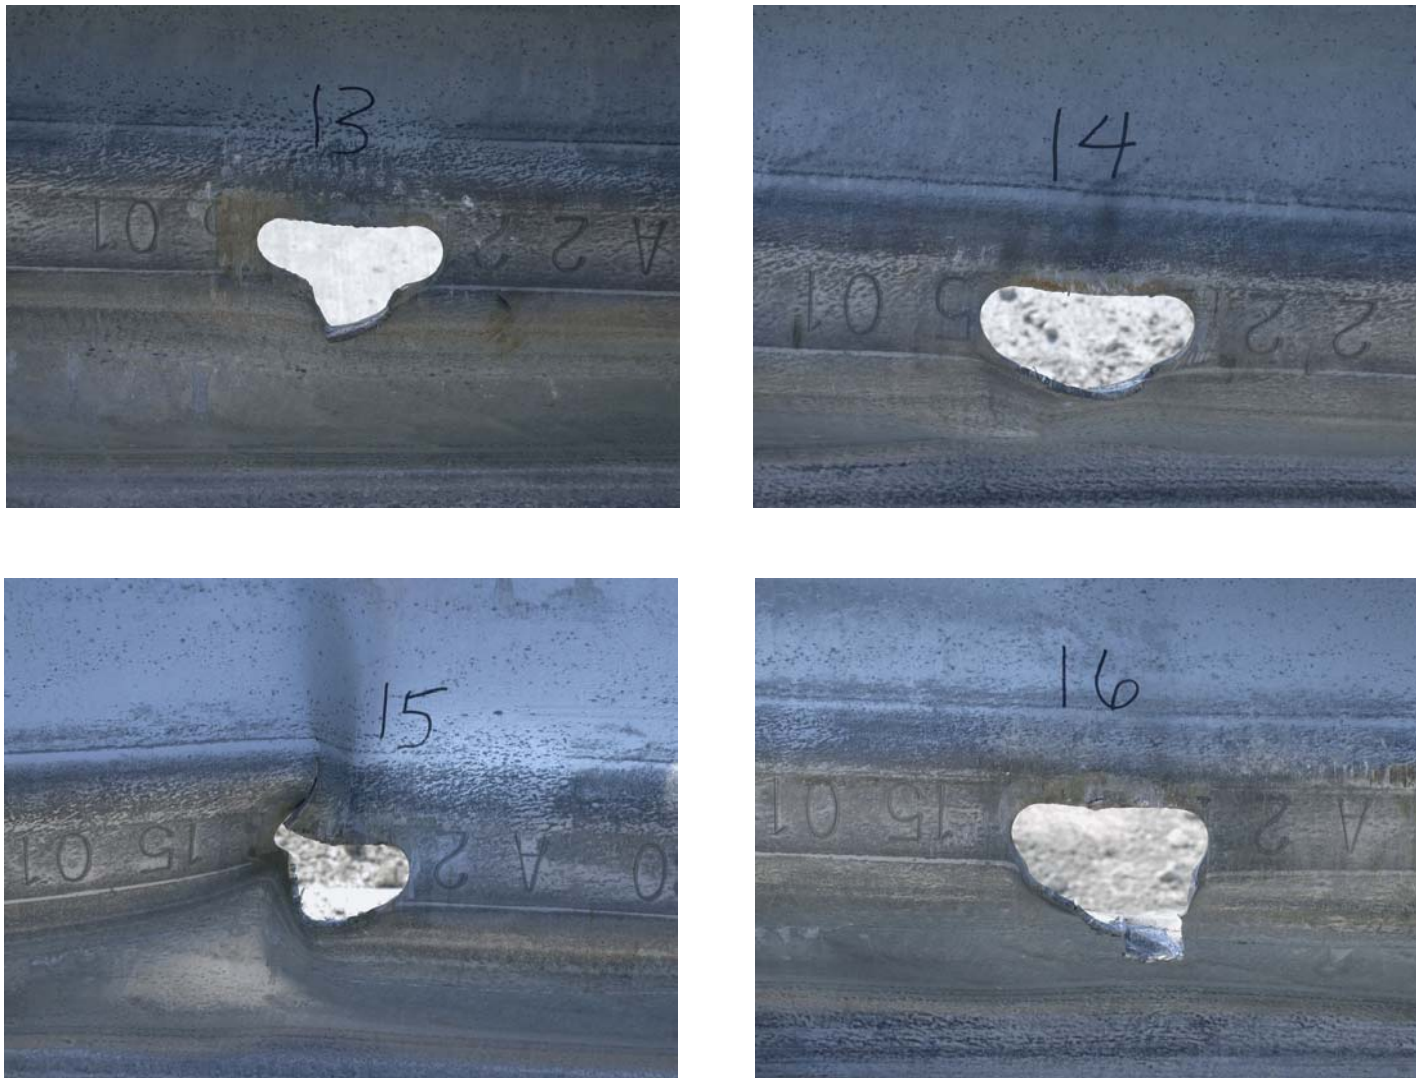
Figure 115. System Damage, Test NPG-5

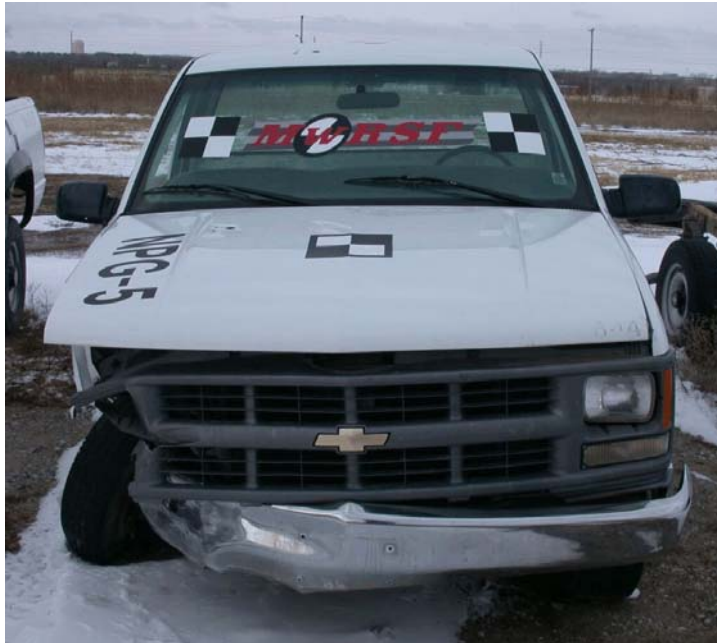
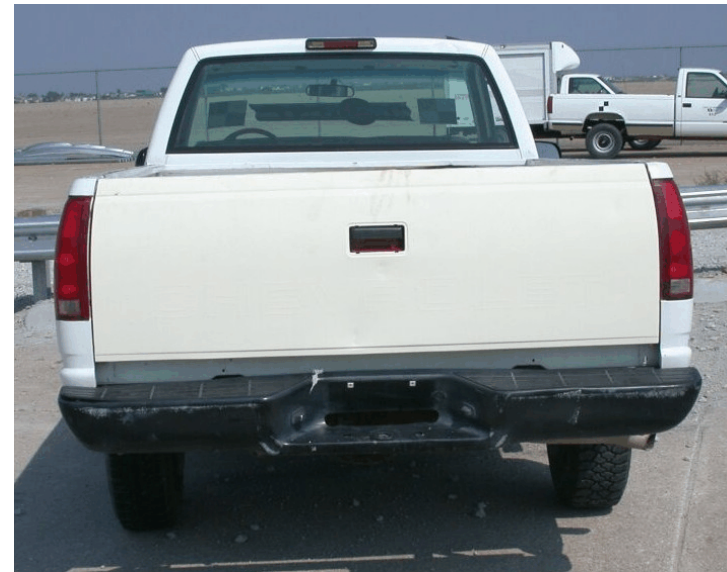
Figure 117. Vehicle Damage, Test NPG-5

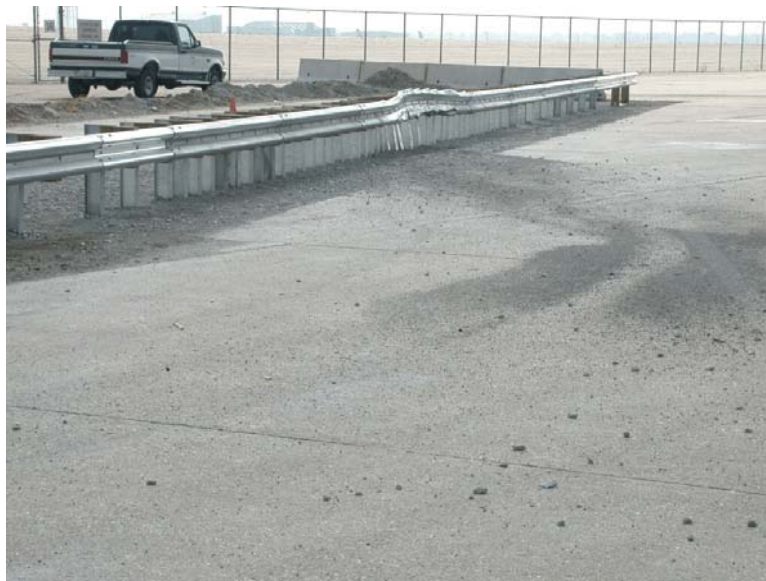
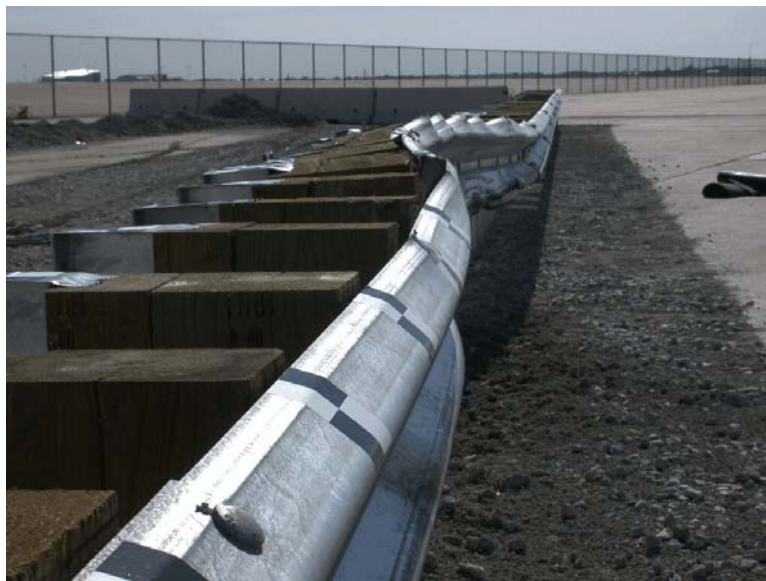
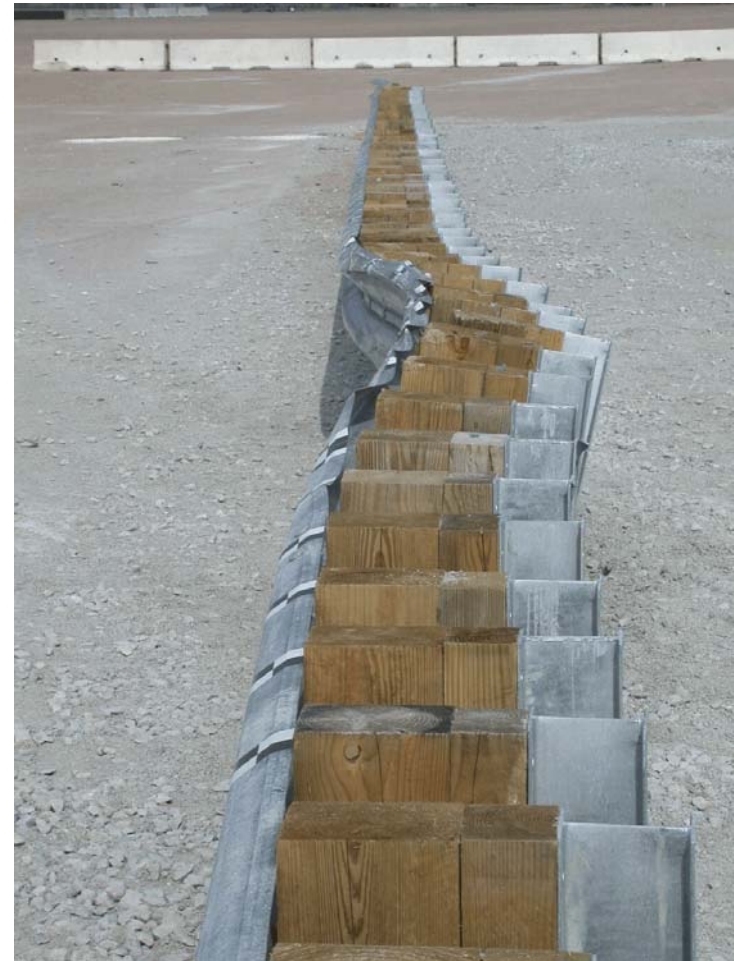
Figure 131. System Damage, Test NPG-6

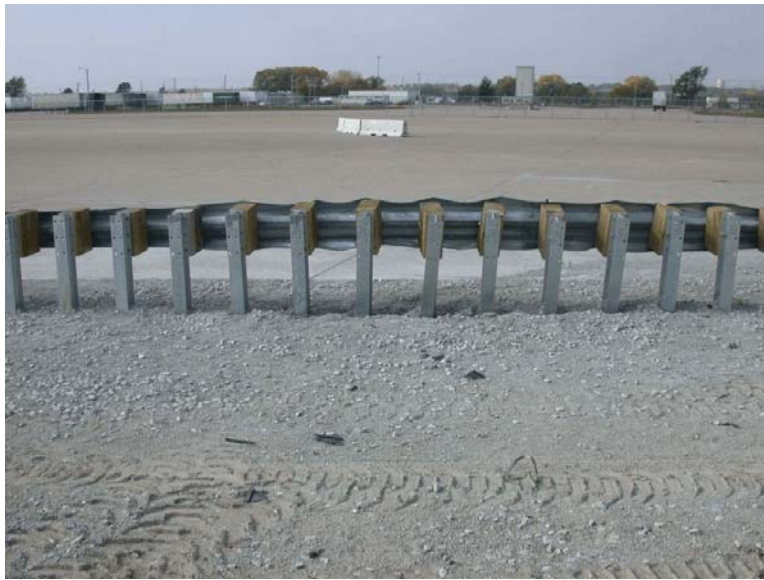
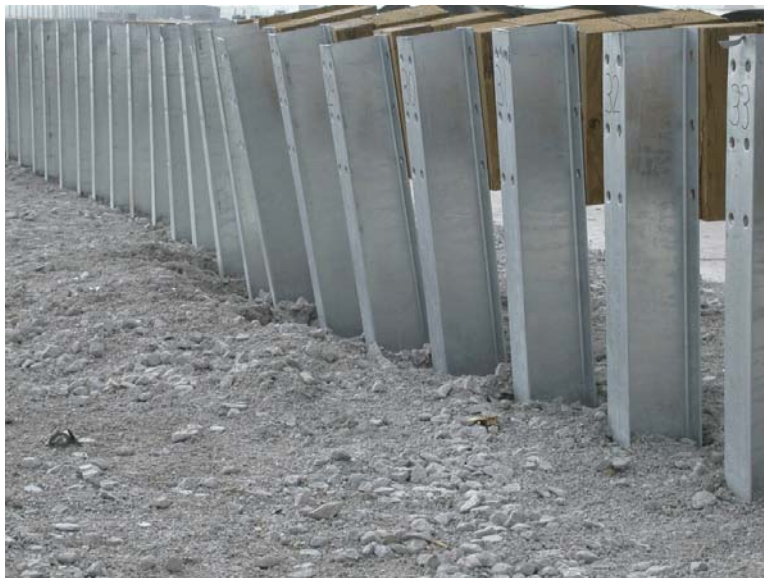
Figure 132. System Damage, Test NPG-6

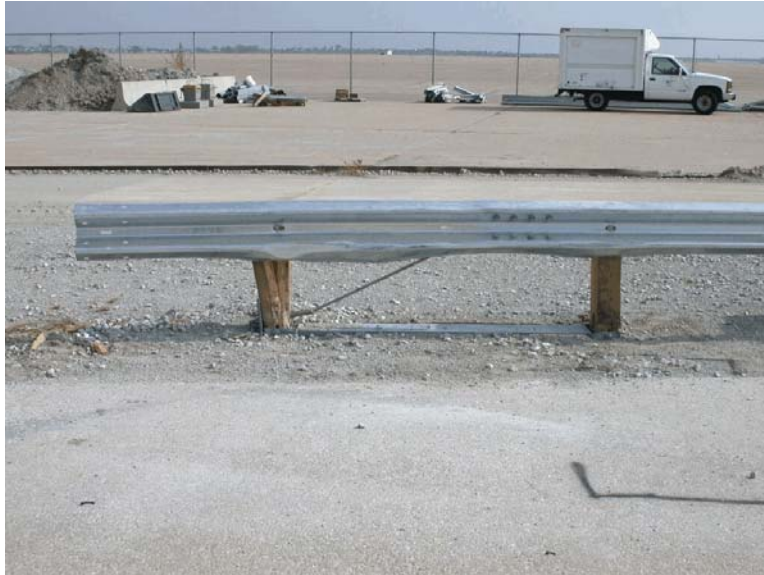
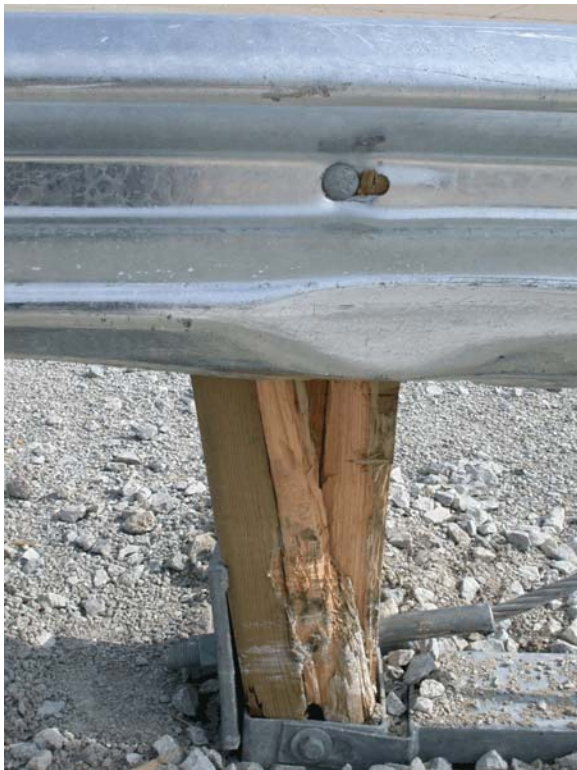
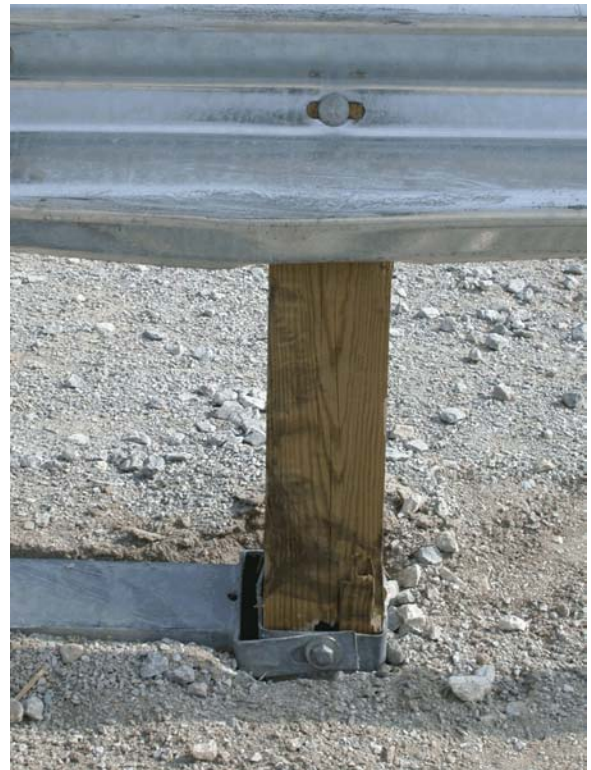
Figure 133. System Damage, Test NPG-6

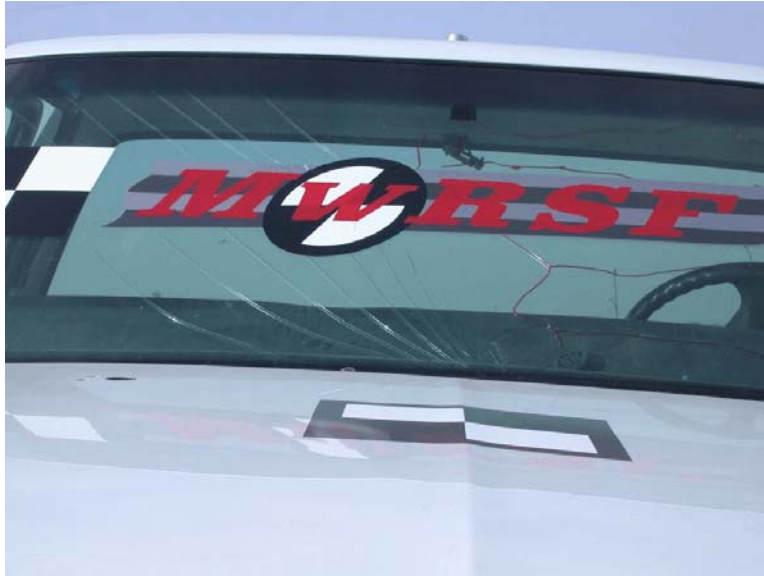
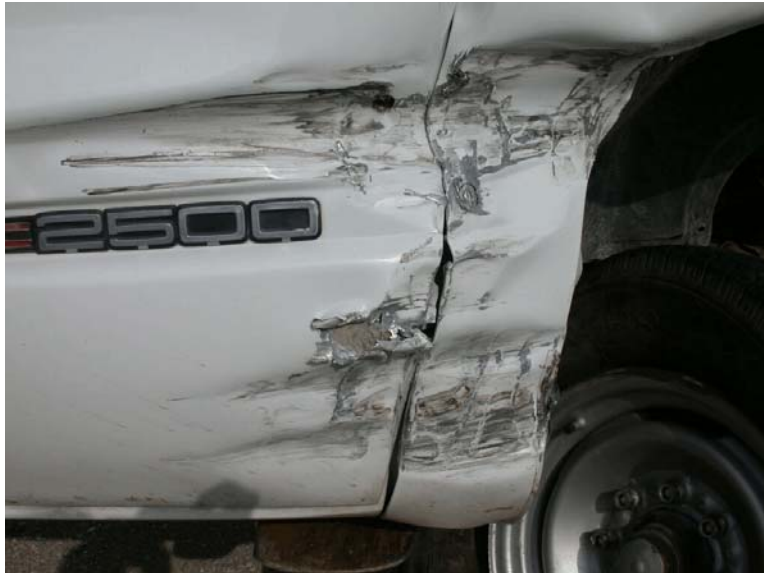
Figure 136. Vehicle Damage, Test NPG-6
