JRC2011-56132

CRASHWORTHINESS ANALYSIS OF THE JANUARY 26, 2005 GLENDALE, CALIFORNIA RAIL COLLISION

Daniel Parent
David Tyrell
Karina Jacobsen
Kristine Severson
Volpe National Transportation Systems Center
United States Department of Transportation
Cambridge, Massachusetts, USA

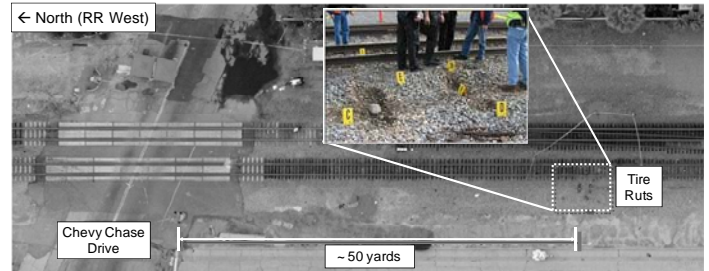
Fig. 1. TIRE TRACKS LEFT BY THE SUV SOUTH OF CHEVY CHASE DRIVE GRADE CROSSING

The catalyst for this series of events was the SUV, which entered the right-of-way at the Chevy Chase Drive grade crossing and proceeded to drive roughly fifty yards south. The vehicle, identified as an early model Jeep Cherokee Sport, then drove up onto the westernmost track such that the vehicle was facing perpendicular to the track, with the front tires between the rails and the rear tires on the right-of-way. Fig. 1 shows two ruts that were dug in the ballast. Reports from the scene indicated that the driver had exited the vehicle as the southbound train approached, leaving the Jeep on the track [6].

Debris from the Jeep was found south of the point where the tire ruts were located, and there was notable damage to the ties of the westernmost track starting two ties south of the ruts. The Jeep was damaged significantly during this impact, spewing debris along the right-of-way as the passenger train pushed it down the track. As the mass of a Jeep is significantly less than that of a passenger train, the speed of the passenger train was not noticeably affected by this impact. However, the large portion of the remains of the Jeep traveled down the track with the southbound train, and it is believed to have interacted with the lead truck of car 625.

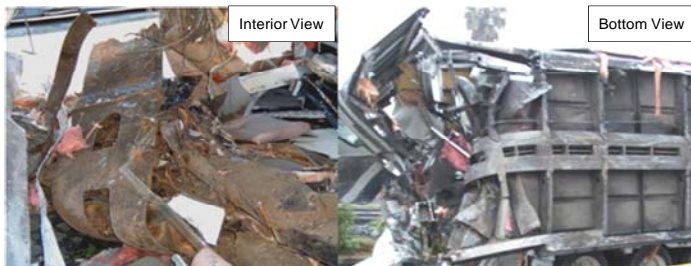
Fig. 4. DEFORMATION OF THE CENTER FRAME OF THE CAB CAR OF THE SOUTHBOUND PASSENGER TRAIN

Upon impacting the locomotive, the front of car 625 underwent gross structural buckling and crushed roughly 26 feet. The mode of deformation of the center frame of the cab car suggests that the locomotive overrode the cab car (Fig. 4), as the gooseneck portion of the center frame aft of the body bolster bent into an "S"-shape. Additionally, a fire consumed some portions of the lead end of the cab car, though it is unclear whether this fire began at initial impact with the highway vehicle or during the interaction with the cab car and the freight locomotive. The interaction of the southbound cab car and the freight locomotive, in turn, lifted the freight locomotive off of the tracks, rotated it thirty degrees with respect to the locomotive it was coupled to, and dropped it on its side on a parking lot adjacent to the siding track. Impact with the parking lot caused lateral deformation of the roof and engineer's compartment of the locomotive. Saw-tooth buckling initiated in the trailing cars of the southbound train, and escalated to larger-scale lateral buckling in the connection between the cab car and the first coach car. The rear truck of car 625 and the front truck of car 133 both derailed and rotated such that the neck of the coupler shaft of car 625 fractured and the cars uncoupled.

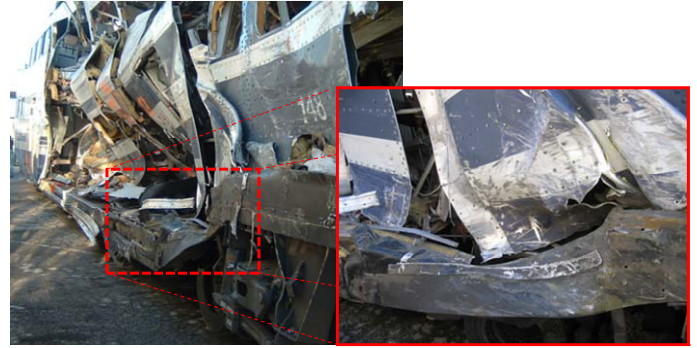
deformation of the sidewalls of car 148, penetrating up to the aisle of both the upper and lower level of the car and destroying several rows of seats (Fig. 3). As the raking continued along the side of the car to the body bolster, where the side sill of the car increases in height to transition between the lower level and the mezzanine level, the amount of intrusion decreased since this structure offered more resistance to crush than the sidewall alone. This interaction caused car 148 to derail, and markings on the side of the car indicate that

Fig. 3. DAMAGE TO THE SIDE SILL AT THE BODY BOLSTER OF CAR 148 OF THE NORTHBOUND TRAIN

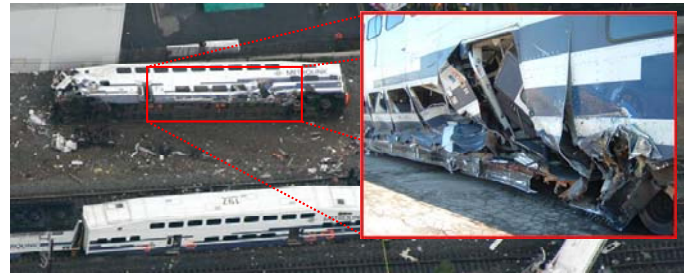
As car 148 had rolled to its side, car 623 remained mostly upright, exposing its left front corner as car 148 rolled to its right. As the ends of cars 625 and 133 reached the front of car 623, the impact was severe enough to compromise the occupant compartment and cause cars 623 and 148 to decouple. As car 623 separated and began to roll to its right side, the rest of the northbound train uncoupled and continued up the track. The interaction of the jackknifed ends of cars 625 and 133 continued as car 623 was in the process of rolling, which is evident in the damage to the lower portion of the sidewall and the local deformation of the side sill just in front of the body bolster (Fig. 5).

Fig. 5. DAMAGE TO THE NORTHBOUND CAB CAR 623 AS A RESULT OF IMPACT WITH CARS 133 AND 625 OF THE SOUTHBOUND TRAIN

As with car 148, the penetration into the side sill stops at the body bolster of car 623, suggesting that the car was pushed off of the track at this point. Car 623 then rotated completely onto its side and slid down the right-of-way. In the process, its lead truck detached and landed upright. The final resting position of the rail vehicles is shown in schematic in Fig. 6.

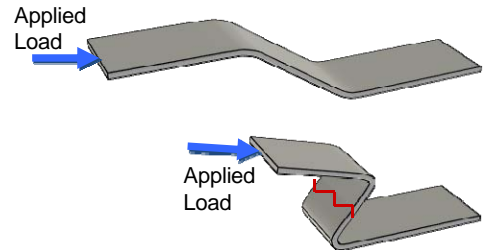
Deformation of the center beam at the gooseneck structure occurred at two plastic hinges (Fig. 7). These hinges formed due to the moments created in the process of reacting against the collision force, which is likely to have exceeded 4 million pounds. Rotation about these hinges produced large amounts of longitudinal, as well as lateral, deformation of the car body structure. The longitudinal deformation resulted in roughly 26 feet of crush, which encompassed the entire forward mezzanine (or intermediate) level and the first three to four rows of seats on the upper and lower levels.

Fig. 7. SCHEMATIC OF THE DEFORMATION TO THE GOOSENECK OF THE FRONT OF CAB CAR 625

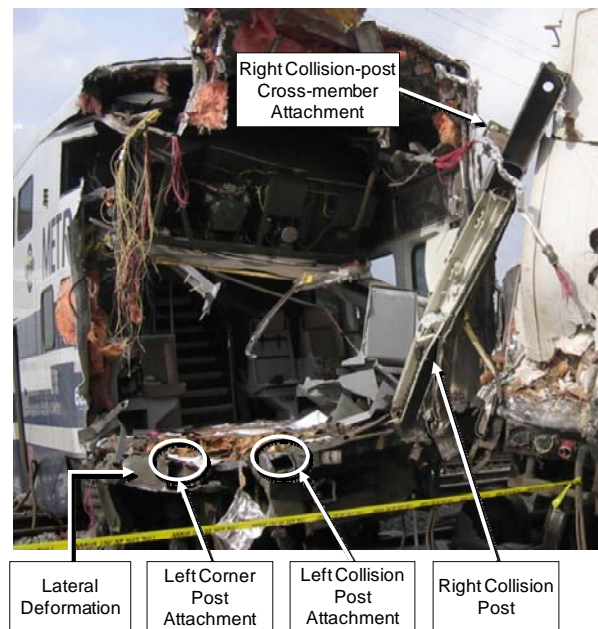
As the trailing end of cab car 625 and the leading end of coach car 133 raked the northbound train, significant damage to the end frames occurred (see Fig. 9 and Fig. 10). The primary mode of deformation of the rear end frame of car 625 was shear at a roughly thirty-degree angle from lateral. The left corner

Fig. 9. DAMAGE TO THE TRAILING END FRAME OF CAB CAR 625 OF THE SOUTHBOUND TRAIN

and collision posts detached completely from the end frame structure. The right collision post remained attached at the base, though the top detached from the roof structure (Fig. 9). The right corner post remained mostly intact.

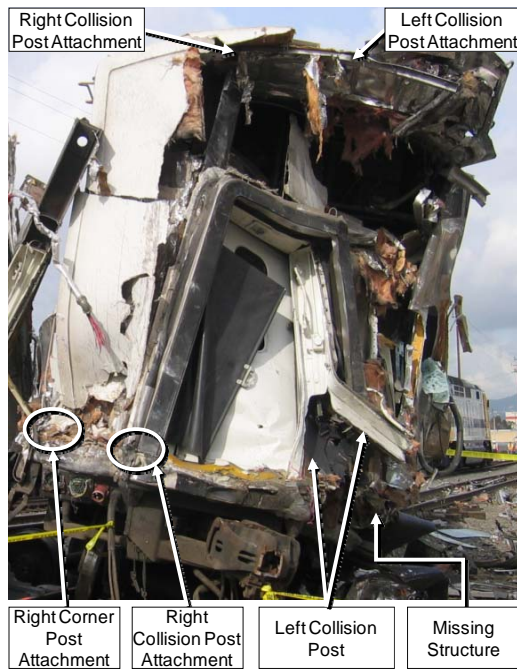
Fig. 10. DAMAGE TO THE LEADING END FRAME OF COACH CAR 133 OF THE SOUTHBOUND TRAIN

The mode of deformation of the end frame of car 133 was also shear, but at an angle closer to halfway between longitudinal and lateral due to the geometry of the impacting vehicles. The right corner and collision posts remained attached at the floor and room, though there was some deformation due to the interaction with the rear of car 625 and the connection to the left collision post. The left collision post was fractured roughly two feet from its base, detached from the roof connection, and deformed into the occupied volume (Fig. 10). Interaction of the jackknifed ends of cars 625 and 133 caused car 148 to list to its right side, exposing the left front corner post of car 623. Upon impact, the corner post fractured near its vertical midpoint (Fig. 11).

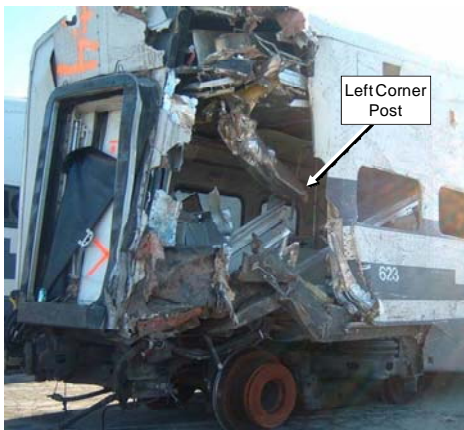
Fig. 11. DAMAGE TO THE FRONT CORNER POST OF CAR 623

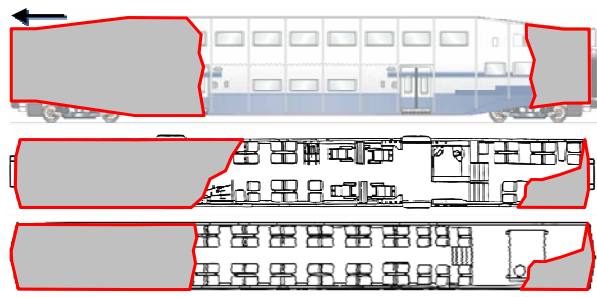
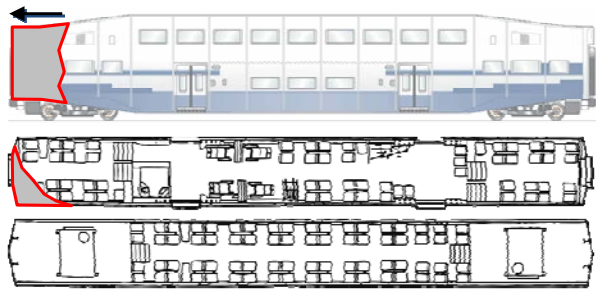
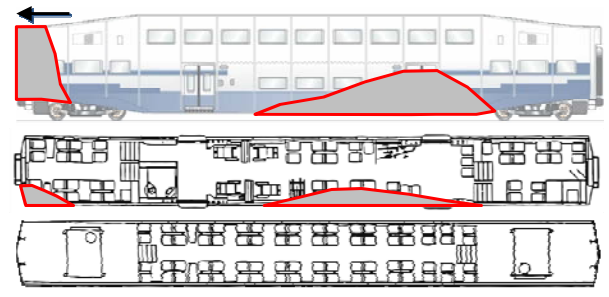
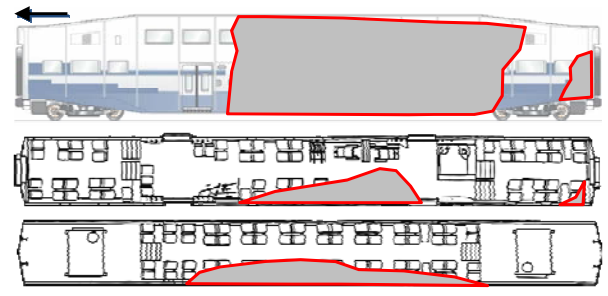
Fig. 12. LEFT: SOUTHBOUND TRAIN; RIGHT: NORTHBOUND TRAIN

The largest loss of survival space occurred in car 625 of the southbound passenger train, where there was roughly 26 feet of crush at the front of the car and additional shearing at the trailing end. The front mezzanine level was lost entirely, along with its fifteen seats. Debris from the mezzanine level was pushed back into the lower level, destroying seven seats and damaging six others. In the upper level, the front fourteen seats were lost and an additional four seats were damaged. In the right corner of the rear mezzanine level, eight seats were lost and two others were damaged. In the front corner of car 133, the second car in the southbound passenger train, four seats were lost and two others were damaged. The loss of survival space for cars 625 and 133 of the southbound train is summarized in Fig. 12.

The raking of the northbound train resulted in a significant loss of survival space in cars 148 and 623. In car 148, a total of 18 seats were lost and 16 seats were damaged. The upper level was the most affected, losing 95 square feet of survival space, while the lower level lost almost 80 square feet and the rear mezzanine level lost 5 square feet. In car 623, the front right corner lost 11 square feet of survival space, including six seats, while two other seats were damaged. The lower level of car 623 lost 10 seats and 40 square feet of survival space. The loss of survival space for cars 623 and 148 of the southbound train is summarized in Fig. 12.

Car 625	Front Mezzanine	Upper Level	Lower Level	Rear Mezzanine
Space Lost		180 ft ²	95 ft ²	125 ft ²	40 ft ²
Seats Lost		15	14	7	8
Seats Damaged			4	6	2

Car 133	Front Mezzanine	Upper Level	Lower Level	Rear Mezzanine
Space Lost		20 ft ²			
Seats Lost		4			
Seats Damaged		2

Car 623	Front Mezzanine	Upper Level	Lower Level	Rear Mezzanine
Space Lost		11 ft ²		40 ft ²	
Seats Lost		6		10	
Seats Damaged		2

Car 148	Front Mezzanine	Upper Level	Lower Level	Rear Mezzanine
Space Lost			95 ft ²	77 ft ²	5 ft ²
Seats Lost			8	10	
Seats Damaged			8	6	2

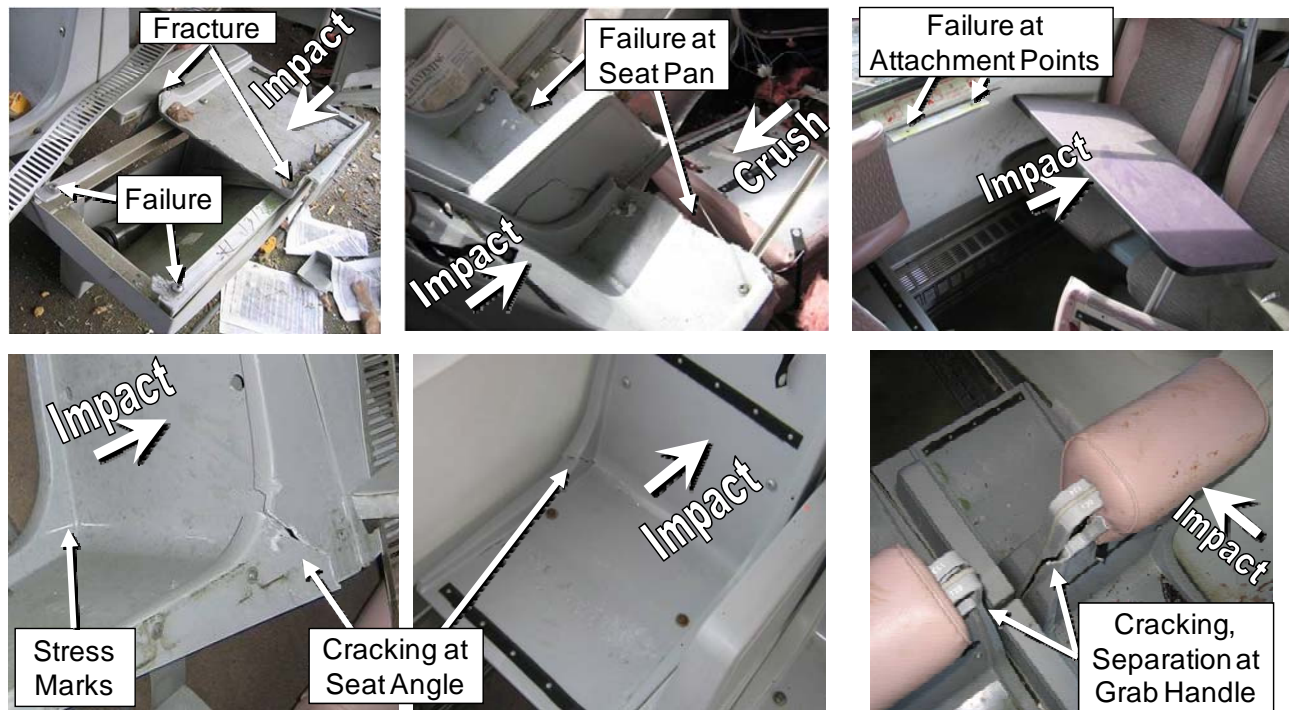
In areas where the occupant volume was not compromised, damage to the interior structures due to impact by unrestrained, seated occupants was less severe. One common sign of impact was cracking at the transition between the seat bottom and the seat back (Fig. 13, bottom left, middle). Another common sign of impact was separation and cracking of the seat shell at the

transition between the headrest and the seatback (Fig. 13, bottom right). While these failures can present sharp edges to the occupants, there is no indication that these sharp edges resulted in severe injury.

Fig. 13. DAMAGE TO THE INTERIOR OF THE PASSENGER CARS
