**JRC2011-56077**

## **FUEL TANK CRASHWORTHINESS: LOADING SCENARIOS**

Volpe National Transportation Systems Center  
US Department of Transportation  
Cambridge, MA 02142  
[www.volpe.dot.gov](http://www.volpe.dot.gov)

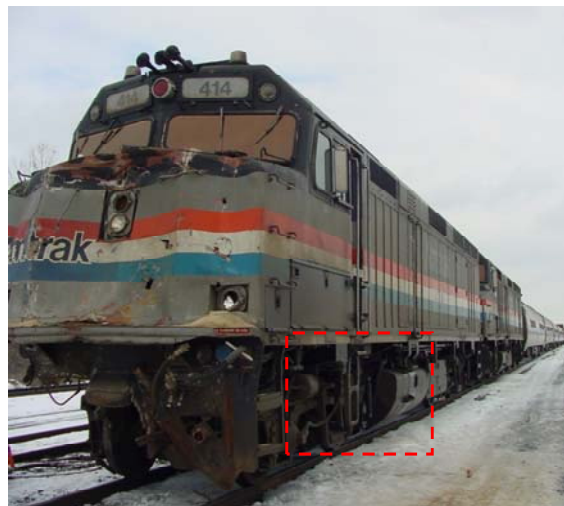
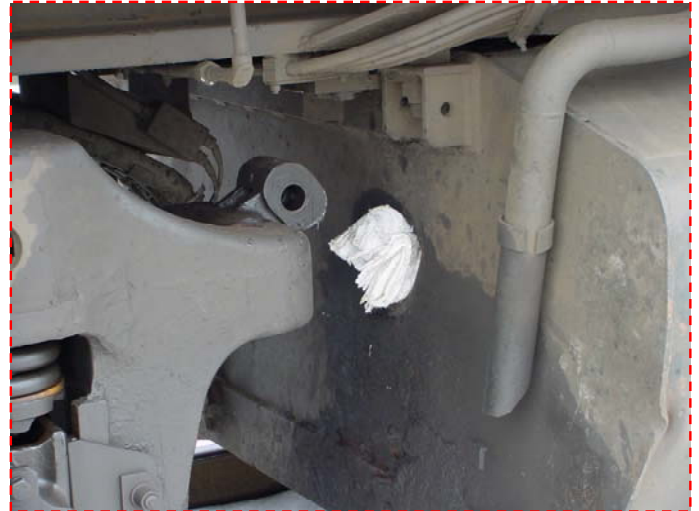
The fuel tank of the lead passenger locomotive was breached during accident. The car-to-car interaction between the impacting equipment caused a sequence of events that deformed the substructure of the locomotive. The flatcar construction consists of a stiff underframe and a bulkhead sheet making up the end structure. As the locomotive impacted the bulkhead flatcar, the flatcar's underframe structure, including the draft sill and coupler remained essentially intact, while the bulkhead crushed by approximately 6 feet, conforming to the shape of the locomotive platform and hood. The flatcar's coupler and draft sill penetrated beneath the locomotive floor, first tearing off the locomotive coupler and draft gear box, then loading the lead traction motor and front of the body bolster. As a result, the front locomotive truck detached and impacted the adjacent fuel tank. Figure 3 shows the adjacent truck lug that punctured into the fuel tank.

**Figure 3. Post-accident photographs: Top, showing the EMD F40 passenger locomotive and bottom, showing a close-up view of the punctured front face of the fuel tank.**

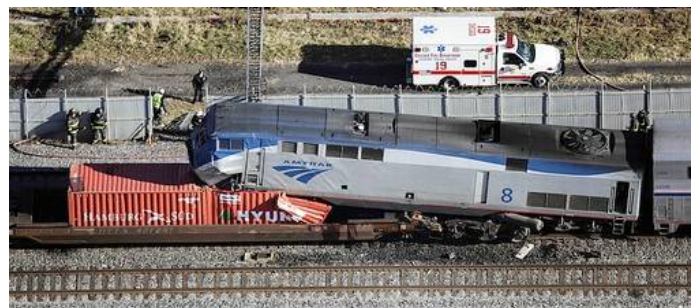
**Figure 4. Post-accident photograph, passenger train locomotive overrode flatcar.**

The fuel tank of the passenger locomotive was breached during the accident. Upon impact of the locomotive and loaded flatcar, the locomotive draft gear bottomed out and the freight car draft sill deformed downward, causing a catapult mechanism and instigating the overriding motion from the locomotive. The locomotive striker plate impacted the flatcar bolster and with the failure of the draft gear housing the locomotive nose deformed back and upward. The lead truck essentially became pinned between the freight car and the locomotive and with the continued overriding of the

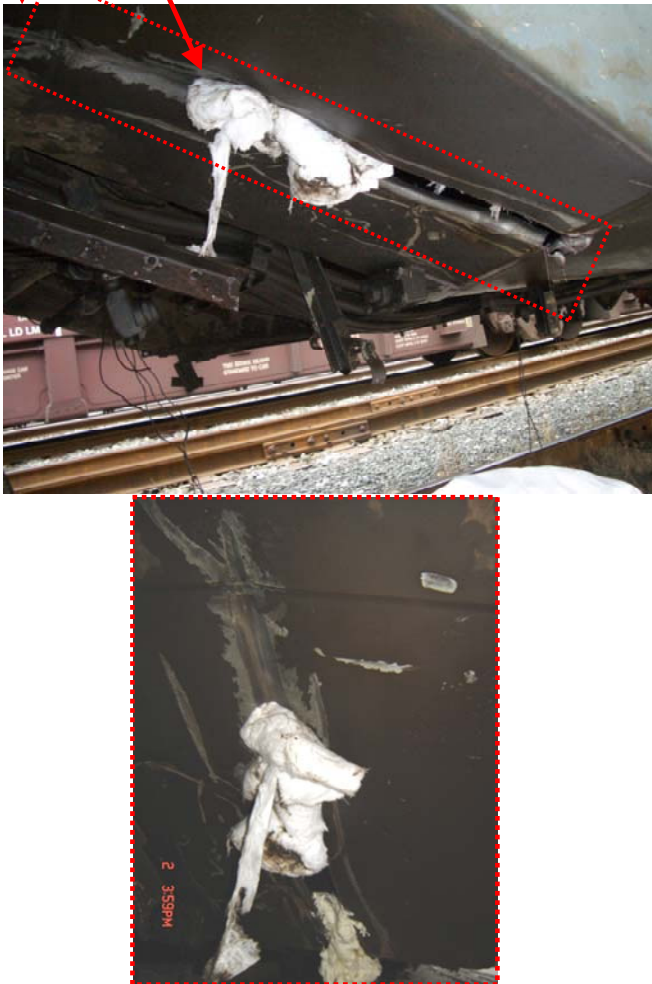
locomotive, the truck attachments failed. As the locomotive was dragged against the truck, the wheels impacted the slope sheet of the fuel tank. Figure 5 shows two views of the front face of the Amtrak Genesis fuel tank. On this design, the front face is known as the slope sheet. The photos show the initial scarring and progressive puncture from the impact with the truck wheel. The tear in the fuel tank was approximately two feet. About 300 gallons of diesel fuel spilled from the tank.

Truck wheel rubbed then fractured  
slope sheet of fuel tank

**Figure 5.** Post-accident photographs of the fuel tank: Top, side-view of the front face “slope sheet” of fuel tank and bottom, close-up of fractured slope sheet.

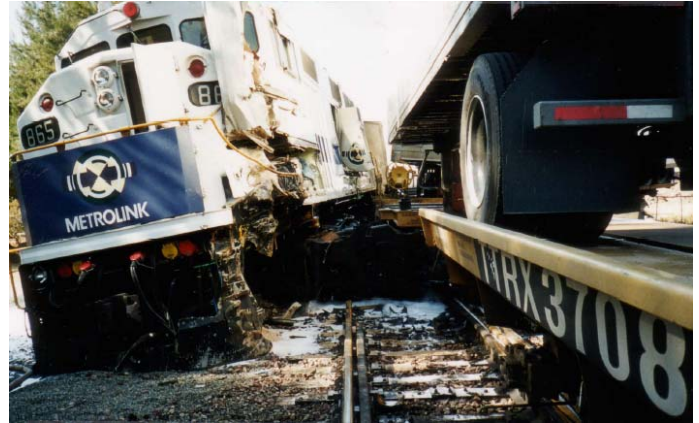
length. The passenger train struck the flatcars at the middle of the freight consist as they traversed the switch. The passenger locomotive derailed but all the following passenger cars remained on the tracks. The freight train had four overturned cars and six derailed. Figure 6 shows the final position of the derailed locomotive and two adjacent freight cars.

**Figure 6.** Post-accident photograph of colliding equipment.

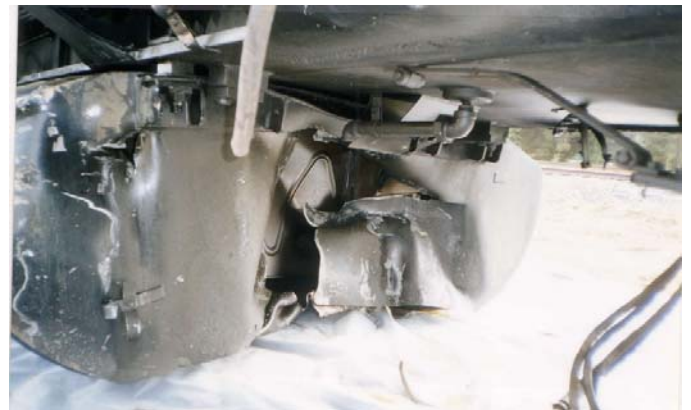
As the passenger locomotive obliquely impacted the back of the freight train, the locomotive raked along the side of the trailing flatcars. The locomotive derailed, the lead locomotive truck became detached and rotated back, impacted and piercing the adjacent fuel tank, as shown in the photograph of Figure 7. An unknown quantity of fuel spilled from the breached fuel tank. A fire started but was extinguished by firefighters.

**Figure 7.** Post-accident photograph of front face of lead passenger locomotive fuel tank.

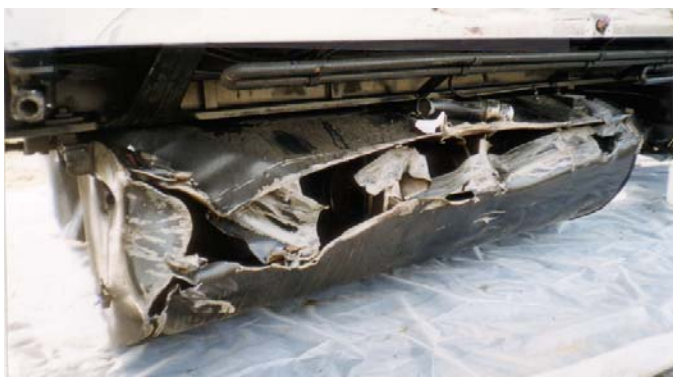
As the two pieces of equipment continued to rake against each other, the side structure of the flatcar pierced into the left side of the fuel tank, as shown in Figure 9. The fuel tank tore open along the top edge of the left side and along the front seam between the front panel and the left side panel. The internal baffles are visible, oriented laterally across the full width of the tank.

**Figure 9 Post-accident photograph of left side of passenger locomotive fuel tank showing tear marks.**

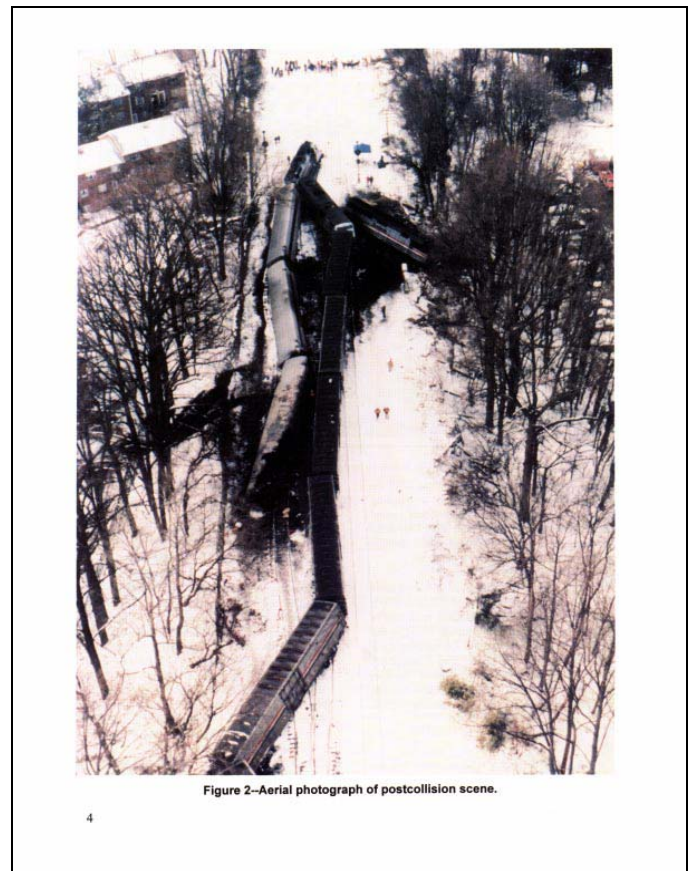
**Figure 10. Photograph showing an aerial view of the Silver Spring, MD accident. (Image from NTSB report [13].)**

The severity of the impact and the progressive raking collision caused the lead locomotive fuel tank to be punctured. The initial collision caused the locomotive to deform and the front truck to push back into adjacent fuel tank. As the equipment deflected past each other and the raking interaction took place, the cab car main structure, which is lower than the locomotive main platform, essentially stripped the under-hanging equipment off of the locomotive, gouging into the side of the

fuel tank. The locomotive platform structure simultaneously pierced into the side structure and occupant compartment of the cab car, tearing into about a third of the car length. These two events caused the exposed interior of the cab car to be sprayed by fuel. Fire broke out and fire fighters reported the fire had enveloped the commuter cab car when they arrived on-scene; the fire was put out in 10 minutes [13] but it consumed the interior of the cab car. There were 11 fatalities, all on the cab car. The coroner attributed three of the eleven fatalities to the post-collision fire.

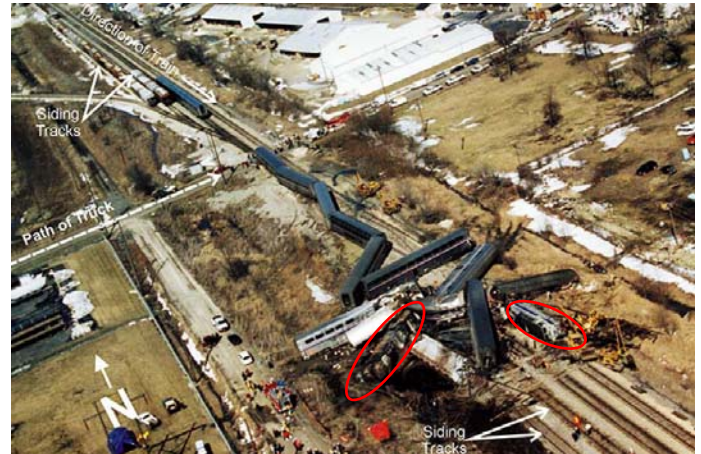
**Figure 12. Post-accident aerial photograph of Bourbonnais, IL accident showing pile-up of passenger railcars.**

During the progression of the collision and resulting pile-up, both locomotives experienced significant structural damage, including ruptured fuel tanks. The lead locomotive was significantly damaged on the left side. The fuel tank had multiple punctures. The Genesis locomotive fuel tanks are integrated in the locomotive underframe, spanning the full width of the locomotive and framed by the side sills. The second locomotive was damaged such that the back third of the underframe was bent into a 'W' shape and the equipment stripped off. The fuel tank was punctured in multiple locations. An unknown amount of fuel spilled from the locomotive fuel tank(s) and a fire ensued. Nearby civilians applied water until fire fighters arrived. There were 11 fatalities, all in the second passenger car, near the portion of car that was bent around the second locomotive. The coroner attributed at least five of the eleven injuries of these fatalities to the fire [14].

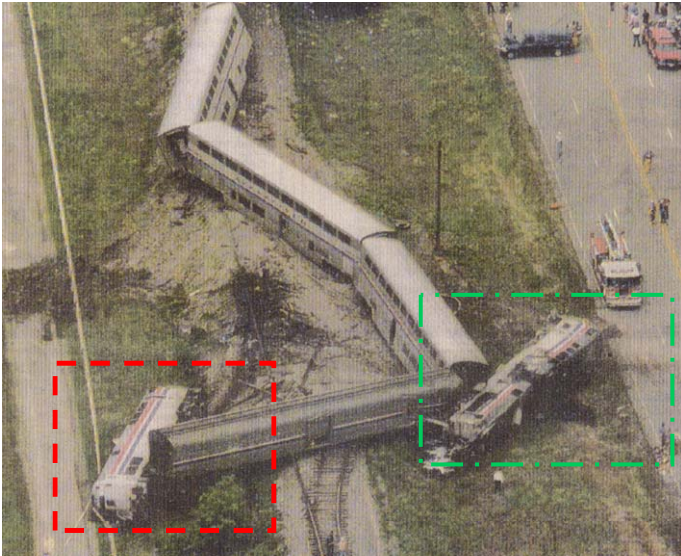
On May 5, 1998 an intercity passenger train traveling at approximately 51 mph struck a garbage truck at a grade crossing [15, 16]. The passenger train was led by two GE P-42 DC locomotives, followed by 7 coach cars, all of which derailed during the incident. The top photograph in Figure 13 shows the post-collision wreckage. The two passenger locomotives are on their sides and located in the photograph by boxes. The lead locomotive is indicated by a green dashed-

dotted box on the right of the photo. The coupled ends of the first and second passenger cars are resting against the locomotive underframe. The second locomotive is indicated by a red dashed box on the left side of the photo. The front of the first passenger car is leaning against the underframe of the locomotive.

**Figure 13.** Post-accident photograph of Hutto, TX accident showing an aerial view of the wreckage. The green dashed-dotted box indicates the lead locomotive and the red dashed box indicates the second locomotive.

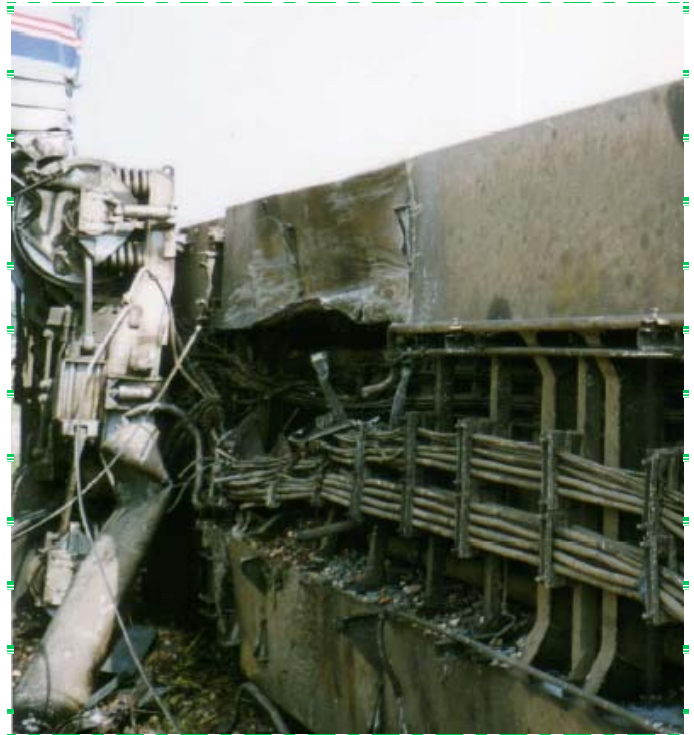
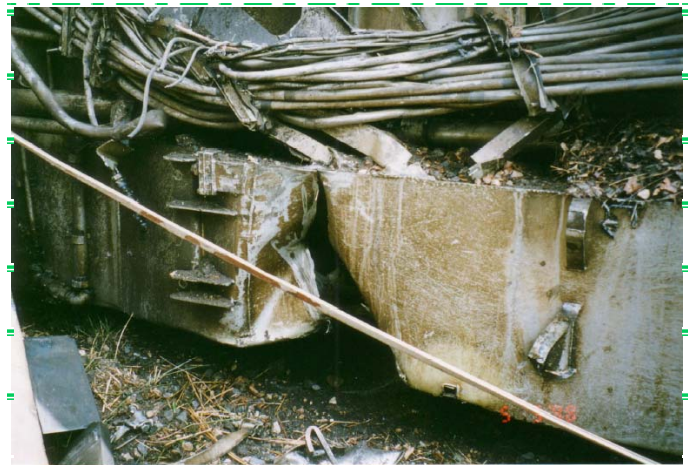
Rollover of the lead locomotive, followed by an impact of the trailing passenger cars caused the fuel tank to be ruptured by a blunt impact to the bottom. Figure 14 shows two photographs of the punctures in the lead locomotive fuel tank. This fuel tank is integrated into the underframe. Figure 15 shows a photograph of the orientation of the second locomotive and an adjacent passenger car. In this overturned position, the impact by the passenger car impacted the bottom of the fuel tank. A small fire broke out, but was extinguished by firefighters.

**Figure 14.** Photographs of the underframe of the lead locomotive unit showing punctures to both sides of fuel tank.

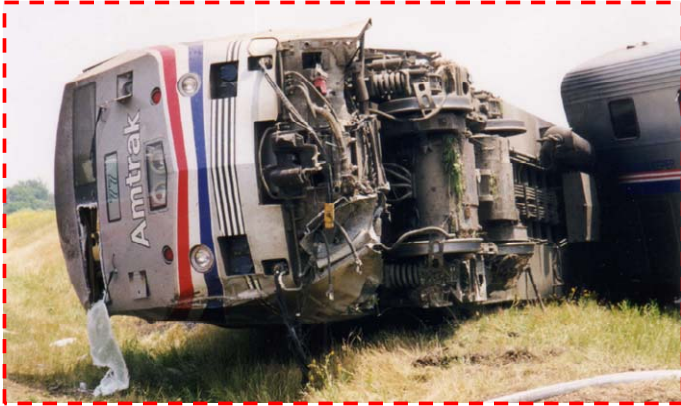
Figure 15. Post-accident photograph showing the overturned second locomotive and the passenger car leaning against the locomotive underframe.

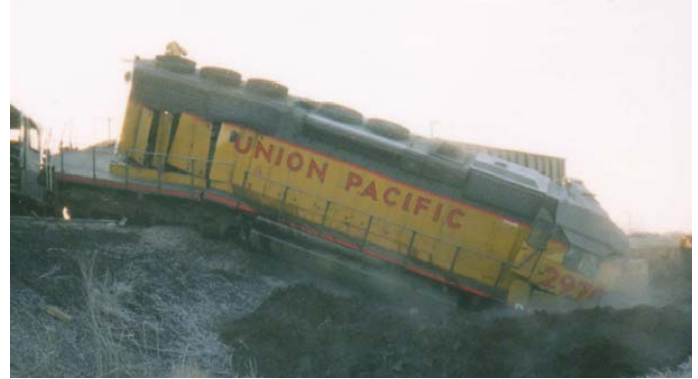
An accident in Bradford, Illinois is an example of a collision that challenged the fuel tank with multiple impact conditions. On January 2, 2002 two freight trains collided while one was midway into a siding, with a closing speed of approximately 44 mph [11]. This is another example of a side/raking incident from a train-to-train collision. The photograph shown in Figure 17 shows the EMD-SD40-2 locomotive derailed and resting on the ground. This collision example illustrates a combination of loading to the fuel tank. The fuel tank was likely dragged along the ground before the train came to its final position shown in the photograph. During this event the truck struck the fuel tank, causing the front face of the fuel tank to rupture.

Figure 17. Bradford, IL post-accident photograph of locomotive.

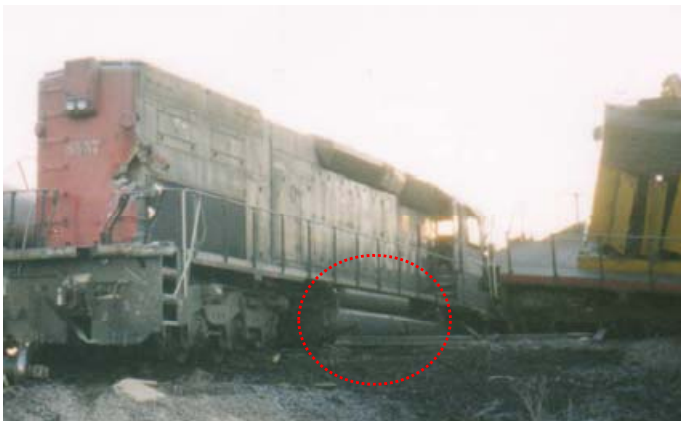
As described in the last section, the incident in Bradford, Illinois may fall into multiple categories for possible fuel tank loading types. The photograph shown in Figure 17 shows the EMD-SD40T-2 locomotive jack-knifed and oriented laterally across the rails. The fuel tank, circled in this photograph, spilled approximately 3,000 gallons of the 4,000-gallon capacity. The fuel tank sustained tears in the side sheet and bottom sheet which were likely caused by a combination of impacts with the rail and adjacent trucks or structural components during the collision event.

**Figure 19. Bradford, IL post-accident photograph of locomotive straddling the rail.**
