**Federal Railroad  
Administration**

## **Collision of Amtrak Passenger Train and Norfolk Southern Freight Train—November 30, 2007, Chicago, Illinois**

| 1. AGENCY USE ONLY (Leave blank) | | 2. REPORT DATE<br>October 2013 | | 3. REPORT TYPE AND DATES COVERED<br>Final Report |
| 6. AUTHOR(S)<br>Patricia G. Llana, David Tyrell, Karina Jacobsen | | | | |

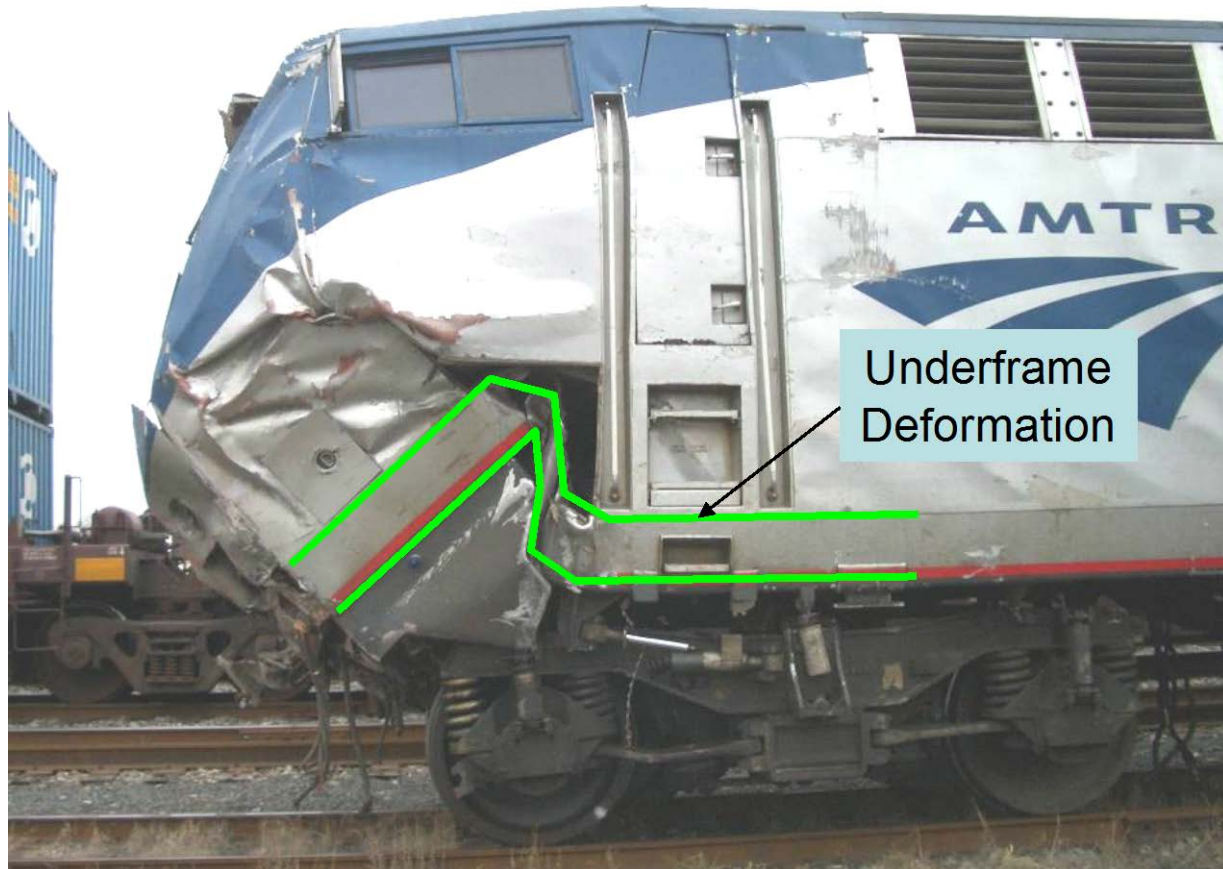
Figure 6 is a photograph of the impact locomotive after it had been separated from the freight car and the lead truck had been moved back under the front end. The locomotive was reduced in length by approximately 5 feet. The collision caused the underframe to deform into a 'Z' pattern, as illustrated in the figure. This deformation promoted the locomotive overriding the freight car, and also pushed the floor of the engineer's cab upward by approximately 1½ feet. The majority of the deformation was in the longitudinal and vertical directions, with very little lateral deformation.

**Figure 6. Locomotive nose and underframe deformed inward and upward.**

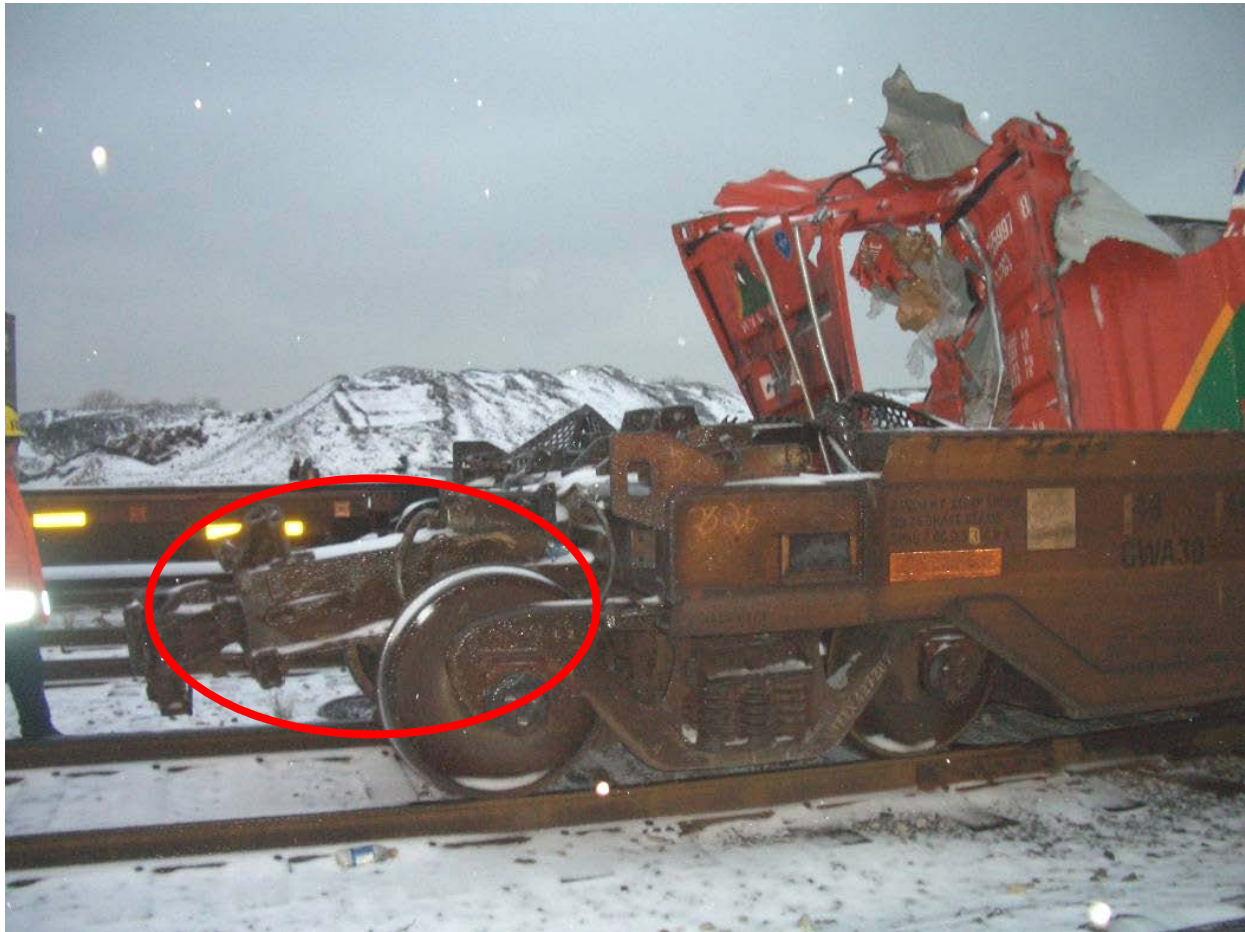
Figure 7 shows the impacted end of the rear freight car. The draft sill is deformed downward at a slight angle. It is likely that this downward deformation occurred when the locomotive began to climb the freight car. The downward deformation of the freight car draft sill along with the 'Z' deformation of the locomotive underframe likely promoted override of the freight car by the locomotive. Normally, there is a transverse walkway at the end of the freight car. This walkway does not carry suspension or train loads and was completely destroyed during the impact. Other than the slight downward bend of the draft sill, there was no significant structural damage to the freight car body. The body bolster and side sills remained essentially intact, and the truck remained attached. However, there was significant damage to the rear intermodal container and some damage to the front intermodal container. The structure of the intermodal containers is not intended to carry train or suspension loads and is weak compared with the locomotive and freight car structures. The rear intermodal container held bags of sand, which likely provided little crush resistance during the impact. Video taken of the accident indicates that the freight train did not move as a result of the collision.

**Figure 7. Deformed draft sill of freight car.**

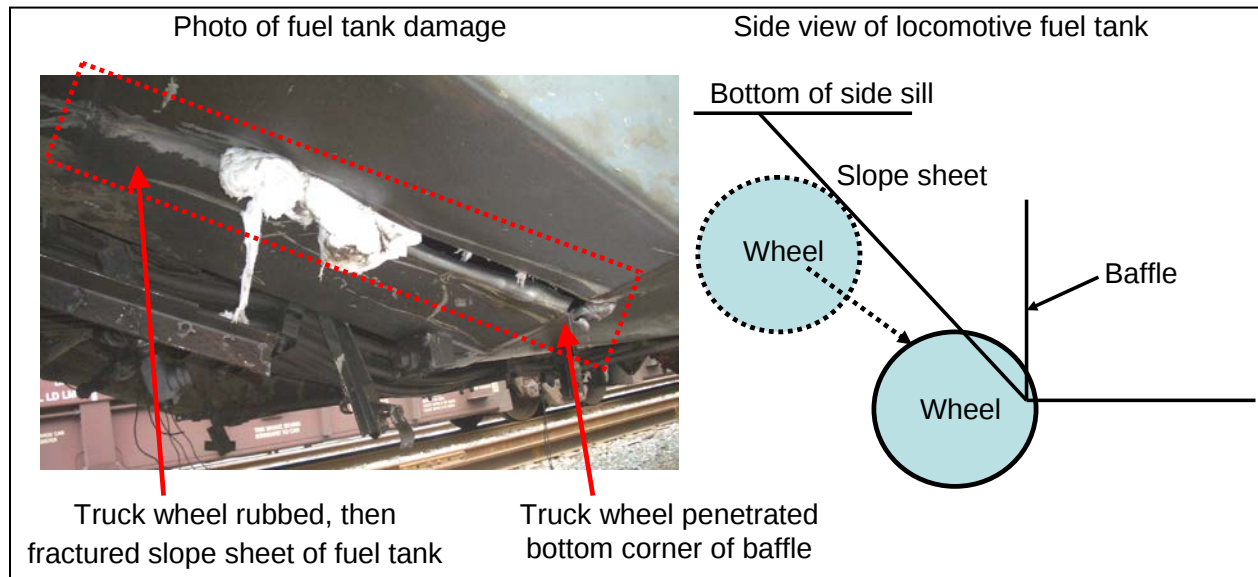
During the collision, the locomotive fuel tank was breached by the rear wheel of the front truck as the locomotive climbed the freight car. The damage to the fuel tank, along with a diagram of how the damage occurred, is shown in Figure 8. The rear wheel of the locomotive front truck was still spinning when it contacted the slope sheet of the fuel tank. As the locomotive climbed the freight car, the spinning wheel fractured the slope sheet then penetrated the corner of the fuel tank baffle. Approximately 300 gallons of diesel fuel spilled from the tank as a result [1].

**Figure 8. Fuel tank damage.**

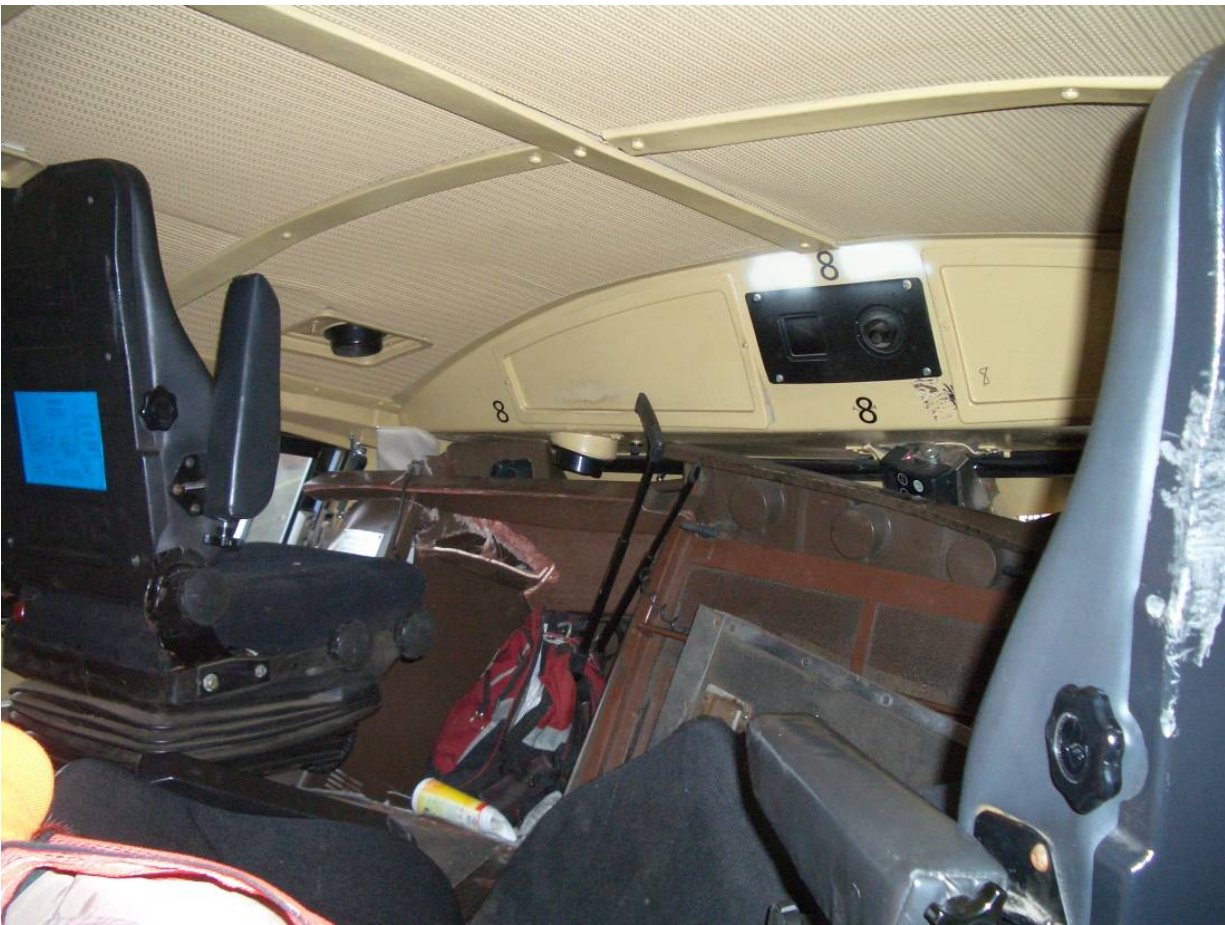
The impact between the locomotive and the freight car caused the nose of the locomotive to roll under and push up, causing the underframe to buckle upward towards the engineer's cab. The deformation of the underframe caused failure of the floor of the cab, resulting in the floor and the seats in the cab to be pushed upward. As can be seen in Figure 9, the floor of the cab is raised sufficiently for the operating engineer's and the relief engineer's seats to be pushed into the ceiling of the cab. The deformation of the underframe and cab floor also caused the desktop components of the cab to roll forward and push through the front windows of the cab compartment, as shown in Figure 9. The interior damage is described in more detail with photographs in Appendix B.1.

**Figure 9. Locomotive interior cab damage and raised floor from impact.**

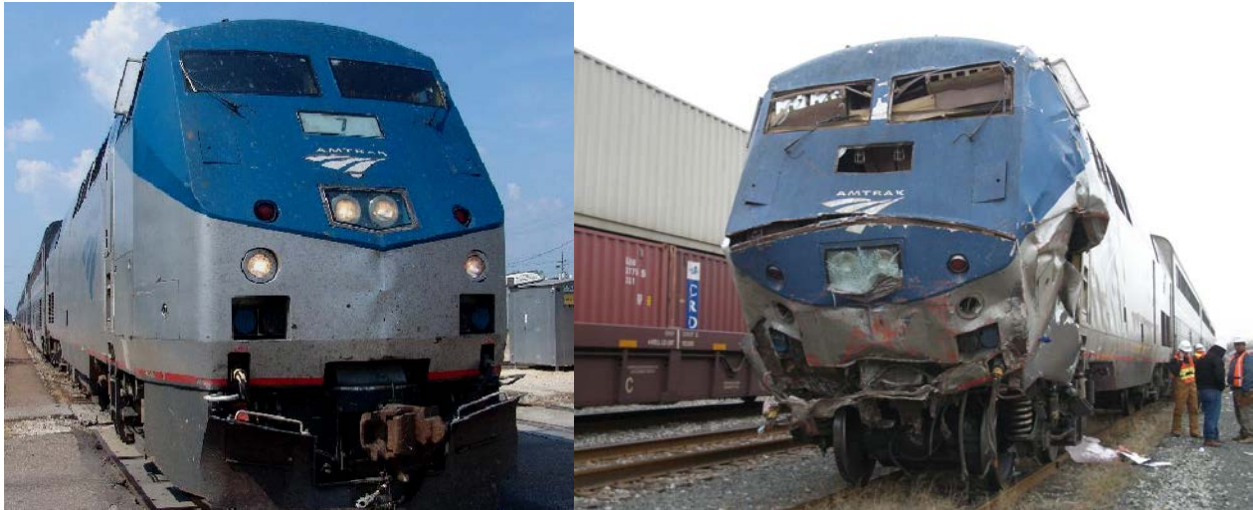
The photograph on the left in Figure A-1 shows an undamaged locomotive very similar to the one involved in the accident. The photograph on the right in Figure A-1 shows the damage incurred by the locomotive as a result of the accident.

**Figure A-1. Undamaged locomotive (left) [13] and locomotive involved in the accident (right).**

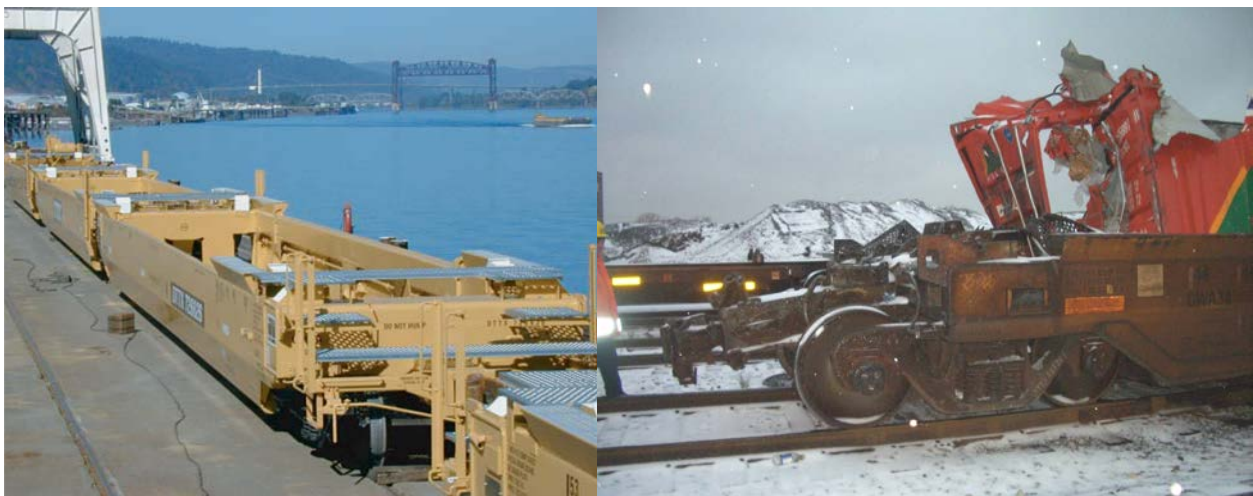
The photograph on the left in Figure A-2 shows an undamaged freight car very similar to the equipment involved in the accident. The photograph on the right in Figure A-2 shows the damage incurred by the freight car as a result of the accident.

**Figure A-2. Undamaged freight car (left) [14] and freight car involved in the accident (right).**

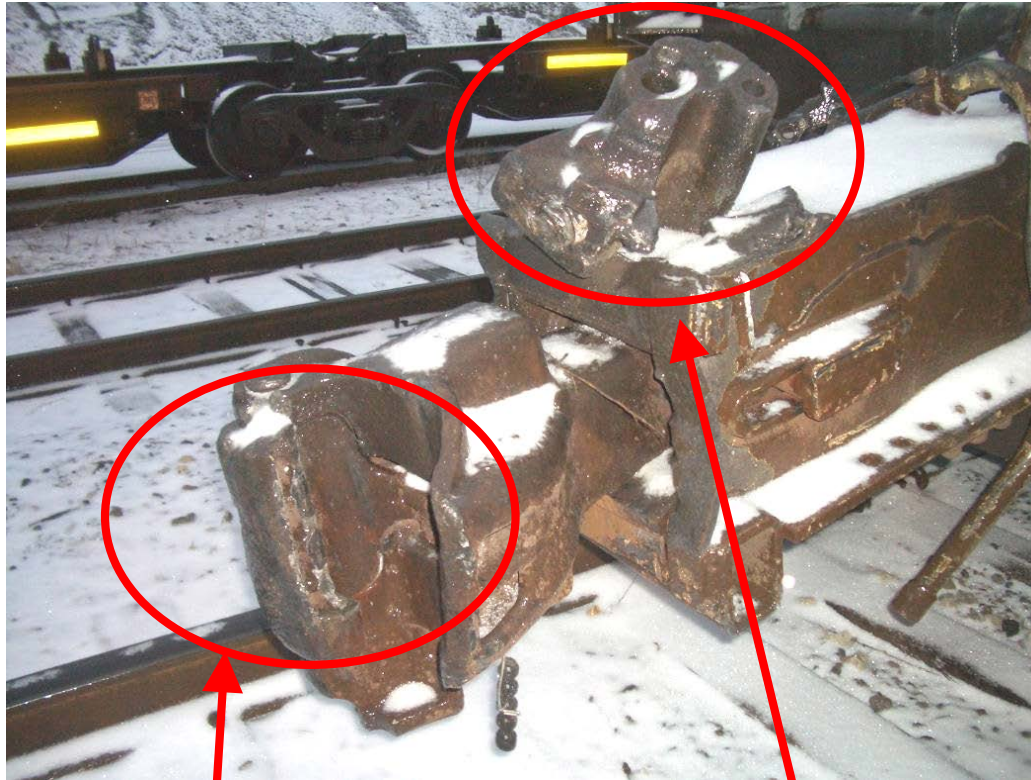
In Phase 1, there was knuckle-to-knuckle contact of both couplers, as shown in Figure A-4. The knuckle of the locomotive coupler broke off and a piece of the knuckle of the freight car also broke off. Figure A-5 shows what remained of both couplers after the accident.

Broken knuckle of  
freight car

Piece of broken  
knuckle of  
locomotive

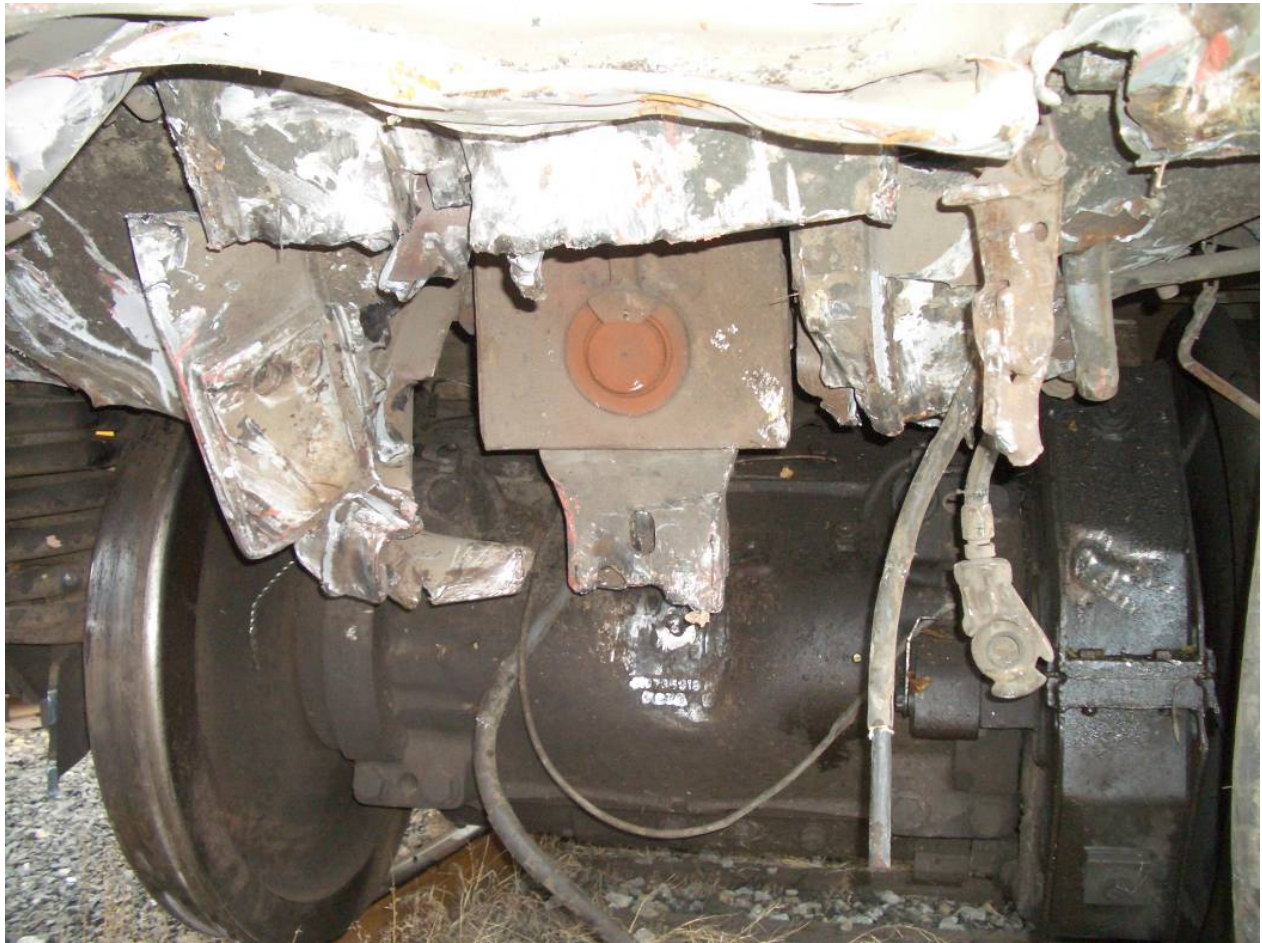
In Phase 2, the locomotive and the freight car couplers moved straight back and both draft gears bottomed out, as shown in Figure A-4. Both couplers remained in line and did not swing out laterally. There is little damage to either bellmouth. This was instrumental in keeping both trains mostly in line during the collision sequence. Had either of the couplers swung out, it is very likely that the passenger train would have derailed laterally. This lateral motion would have caused the passenger train to collide with the trains passing by on the adjacent tracks, resulting in a much more severe accident. Figure A-6 shows the broken coupler shank of the locomotive.

**Figure A-6. Deformed locomotive draft gear housing and coupler.**

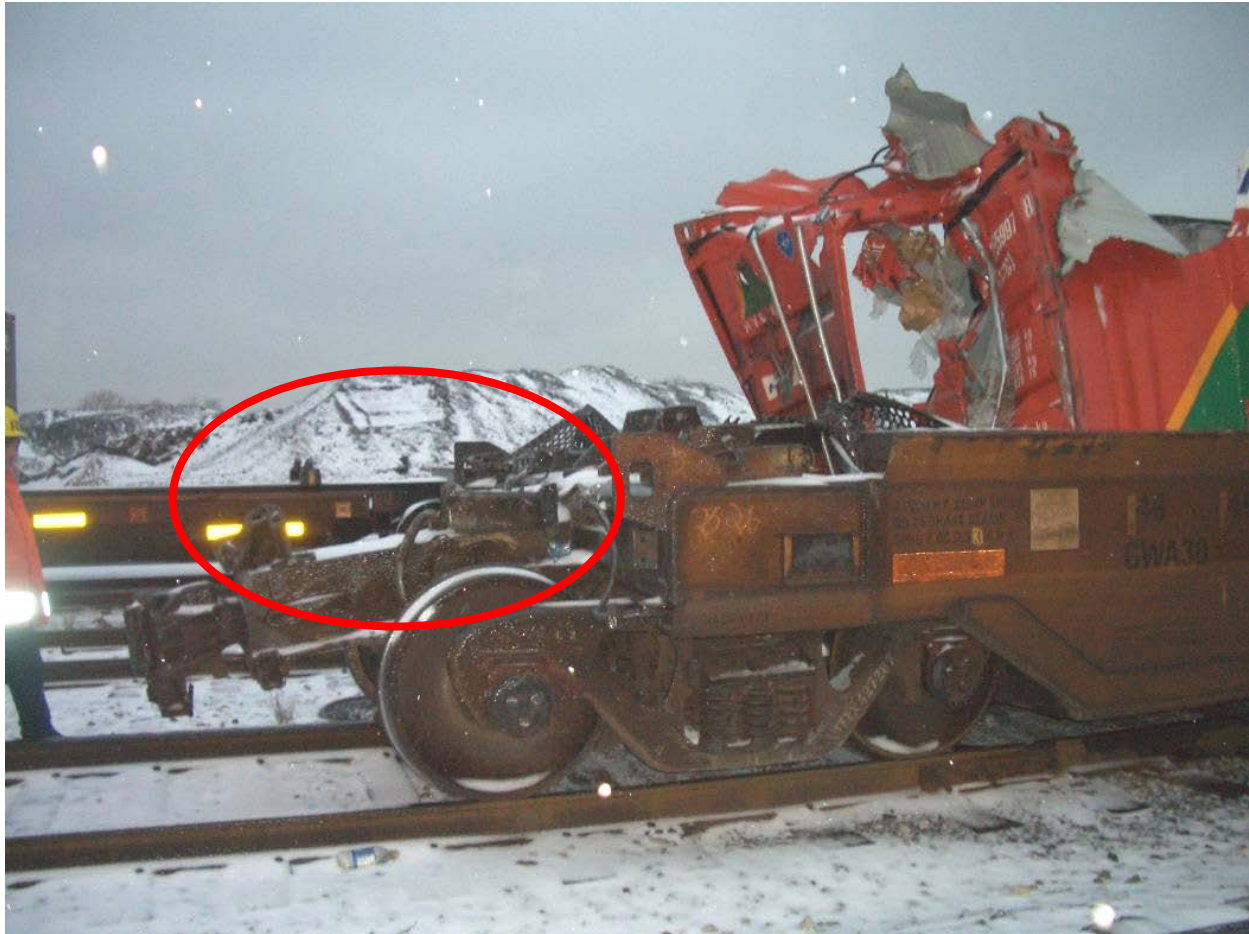
**Figure A-8. Deformed draft sill of freight car.**

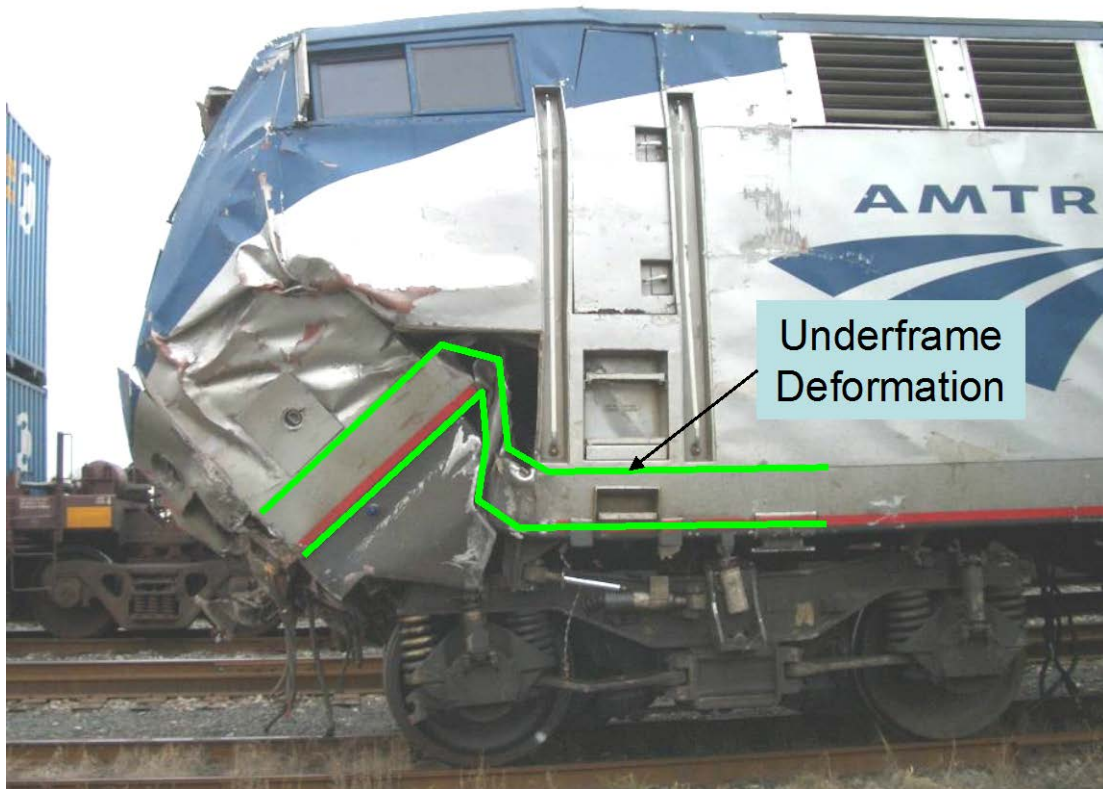
**Figure A-9. Locomotive nose and underframe deformed inward and upward.**

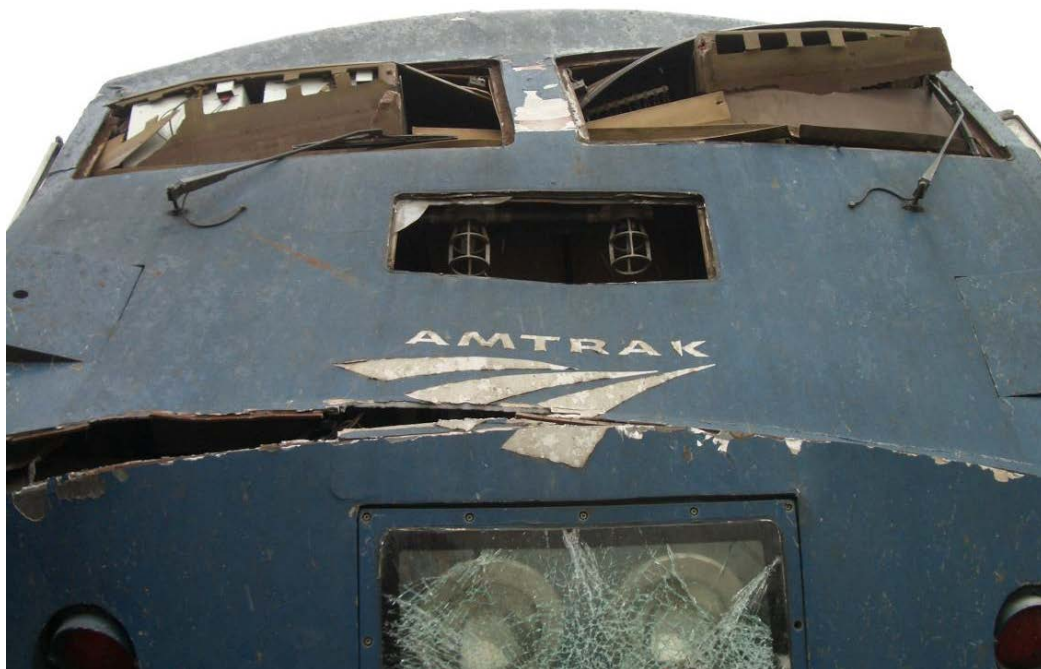
**Figure A-10. Desktop components pushed through windows of locomotive cab.**

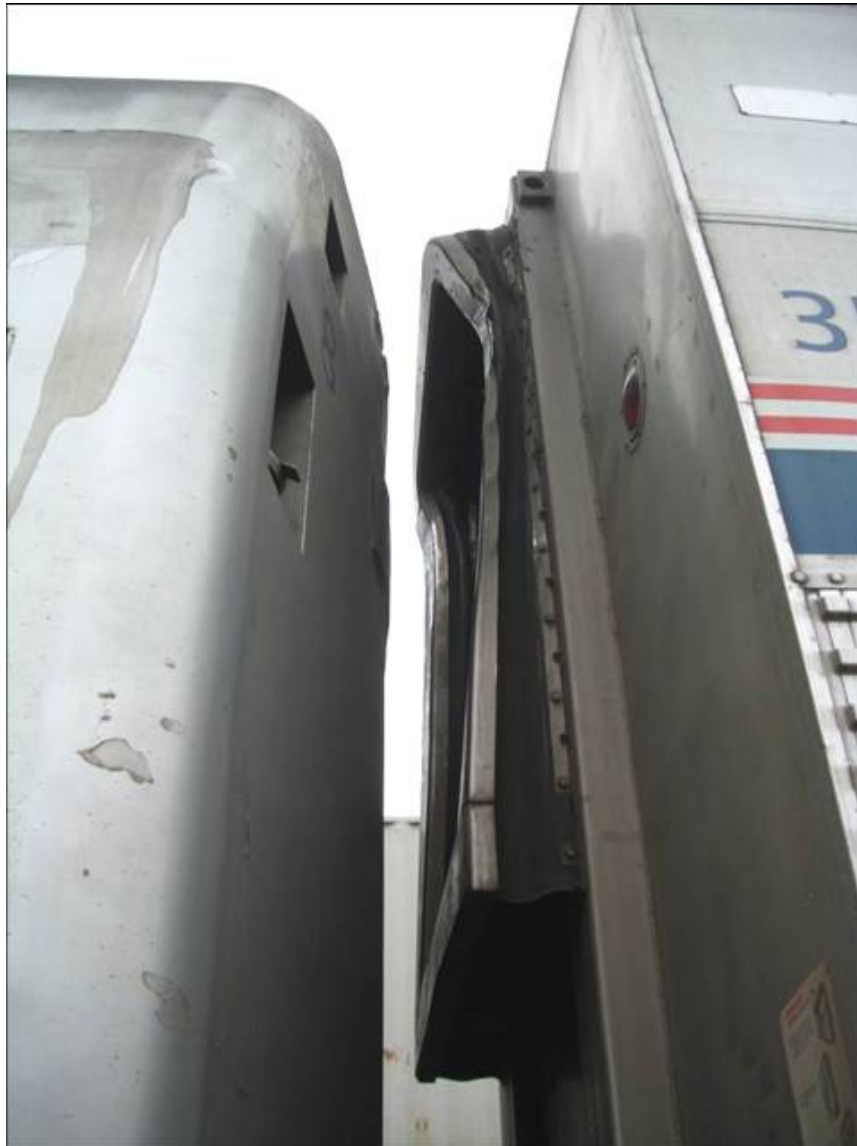
In Phase 5, the locomotive striker engaged the freight car bolster, the lead truck of the locomotive was sheared off, and the rear of the roof of the locomotive engaged the lead passenger car collision posts as the locomotive tilted in its climb. The damage to the diaphragm of the first passenger car is shown in Figure A-11. This was the extent of the exterior damage incurred by the coach cars; there was no other exterior damage. The coach cars and their couplers stayed in line for the duration of the accident with no damage occurring at the coach car interfaces.

**Figure A-11. Damage to diaphragm of first passenger car.**

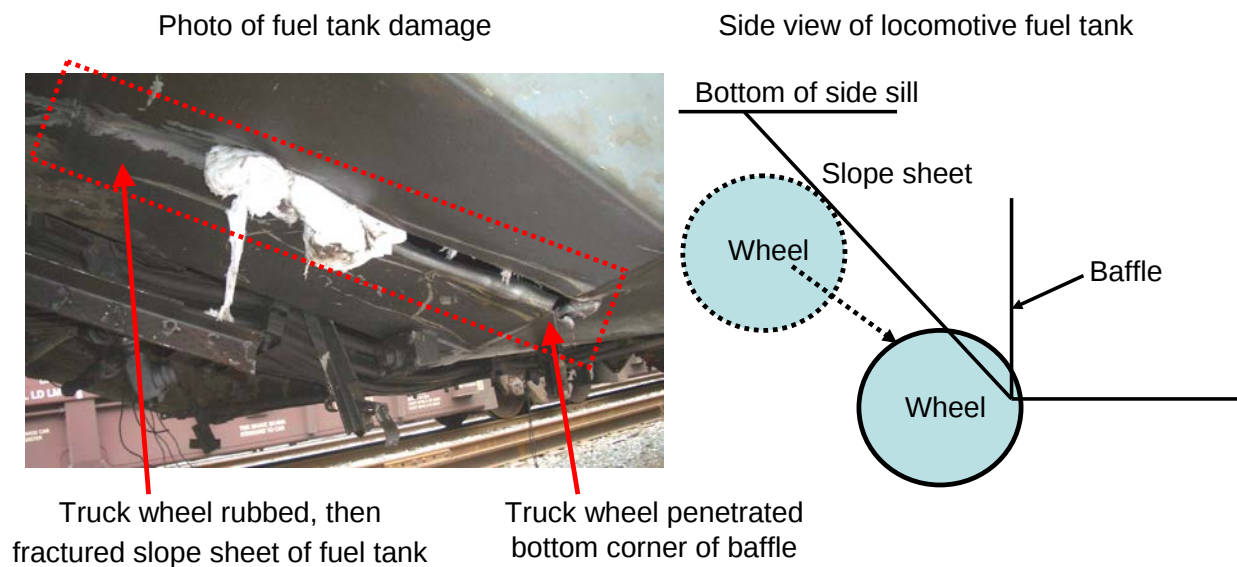
In this phase, the locomotive fuel tank was damaged by the rear wheel of the front truck as the locomotive climbed the freight car. The damage to the fuel tank, along with a diagram depicting how the damage occurred, is shown in Figure A-12. The rear wheel of the locomotive front truck was still spinning when it contacted the slope sheet of the fuel tank. As the locomotive climbed the freight car, the spinning wheel fractured the slope sheet then penetrated the corner of the fuel tank baffle. Approximately 300 gallons of diesel fuel spilled from the tank as a result [1].

**Figure A-12. Fuel tank damage.**

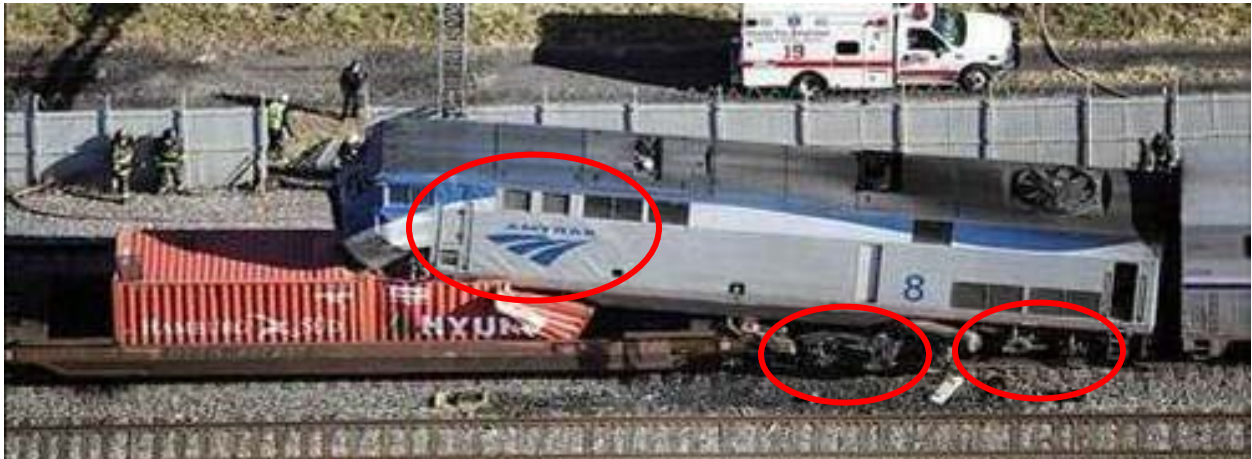
The post-impact locations of the lead and rear trucks of the locomotive are indicated by the two small red circles in Figure A-13. The lead truck was left behind as the locomotive climbed over the rear of the freight car. The photograph shows the lead truck of the locomotive located underneath the locomotive, just in front of the rear truck.

**Figure A-13. The locomotive lead truck was sheared off and left behind.**

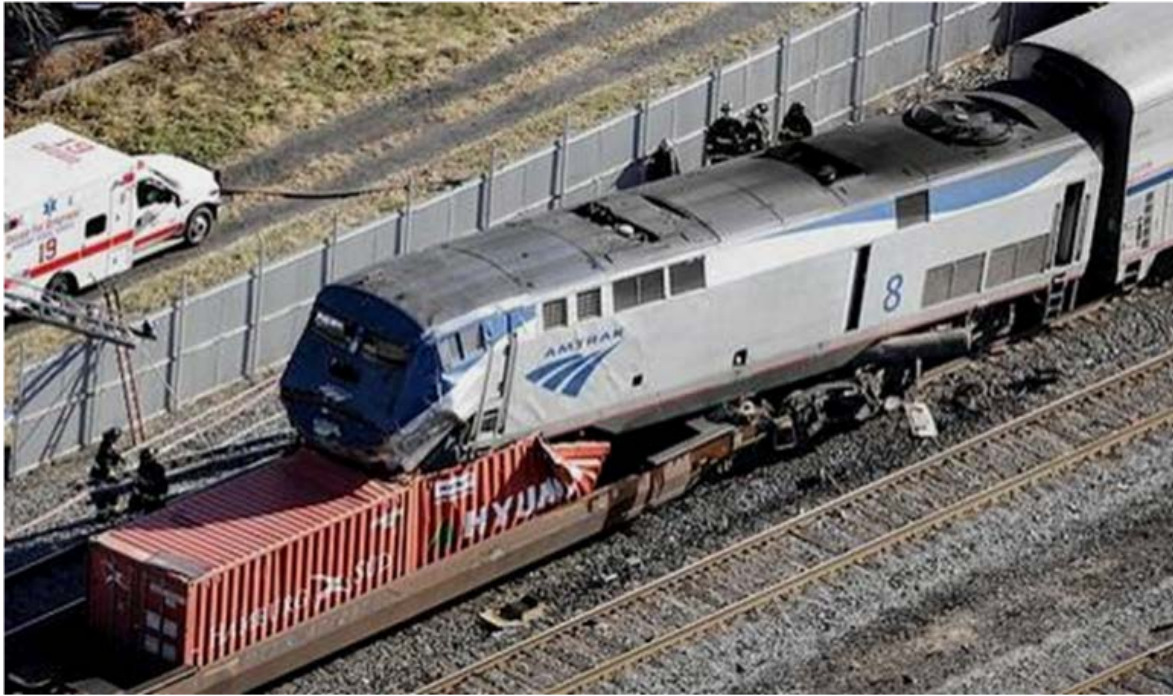
Figure A-14 shows the adjacent tracks on both sides of the trains involved in the collision. At the time of the collision, there were trains running on both adjacent tracks. Had the passenger train not climbed the freight car, the couplers would have caused the cars to sawtooth laterally. This lateral buckling is typical and if it had occurred in this accident, the passenger train could have impacted the trains running on both adjacent tracks, resulting in a more severe accident.

**Figure A-14. The locomotive came to a stop on top of the freight car [4].**

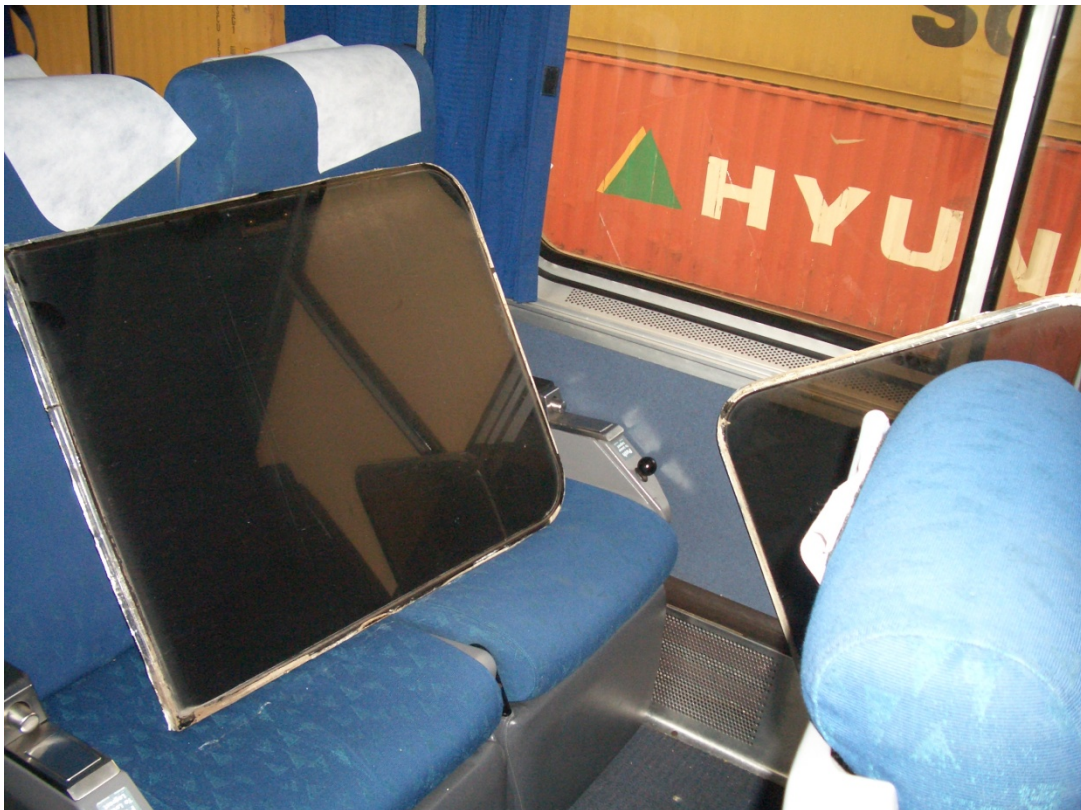
Since the passenger cars remained upright throughout the impact, most of the passengers were able to exit through the doors with no difficulty. However, a total of four emergency windows were pulled, with at least one pulled in each coach car. Figure A-15 shows evidence of the two emergency windows pulled in the first coach car, Figure A-16 of the emergency window pulled in the second coach car, and Figure A-17 of the emergency window pulled in the third coach car. The egress situation was very different for the two engineers located within the locomotive cab. Despite the large upward displacement of the locomotive cab floor, the engineers were not pinned within the cab. However, the position of the locomotive on top of the freight car made rescue more difficult. Because of the damage to the locomotive, the rescue crew was unable to open the doors on either side of the cab at the front of the locomotive, but was able to gain access through the rear left side door. Since the right-side cab window was broken, the relief engineer climbed out through this window and climbed down the emergency ladder. The operating engineer walked back through the engine room to the door at the rear of the locomotive. He was helped into a rescue basket and lowered to the ground. Details of their experience in the cab and the injuries they sustained can be found in the phone interview information of Appendix B.2.

**Figure A-15. Emergency windows pulled in first coach car.**

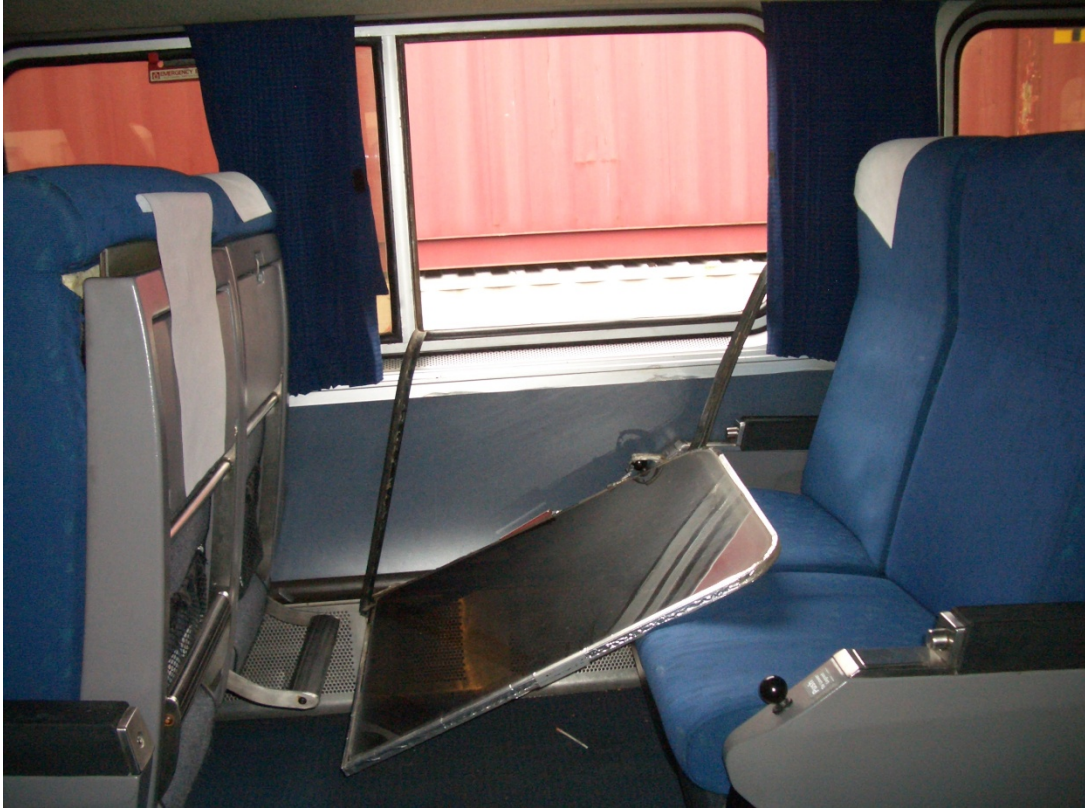
**Figure A-16. Emergency window pulled in second coach car.**

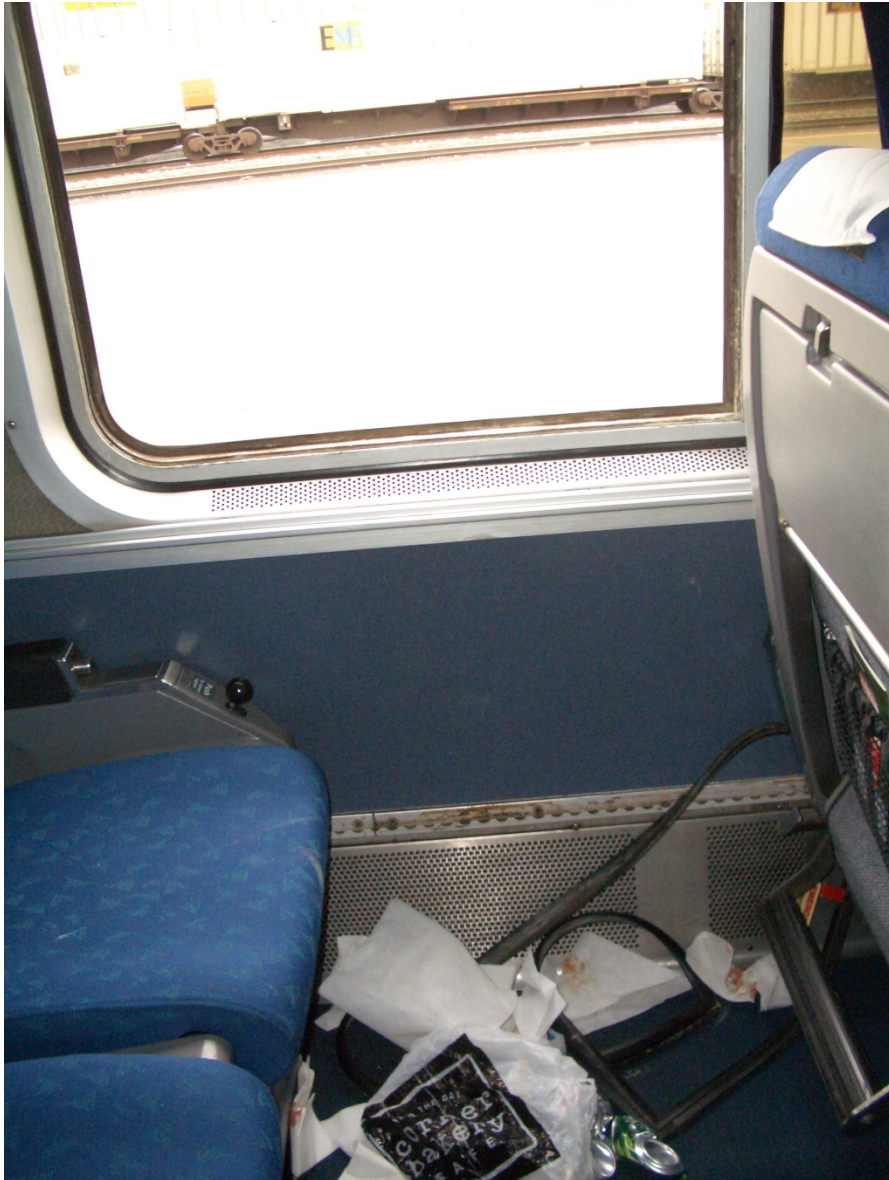
**Figure A-17. Emergency window pulled in third coach car.**

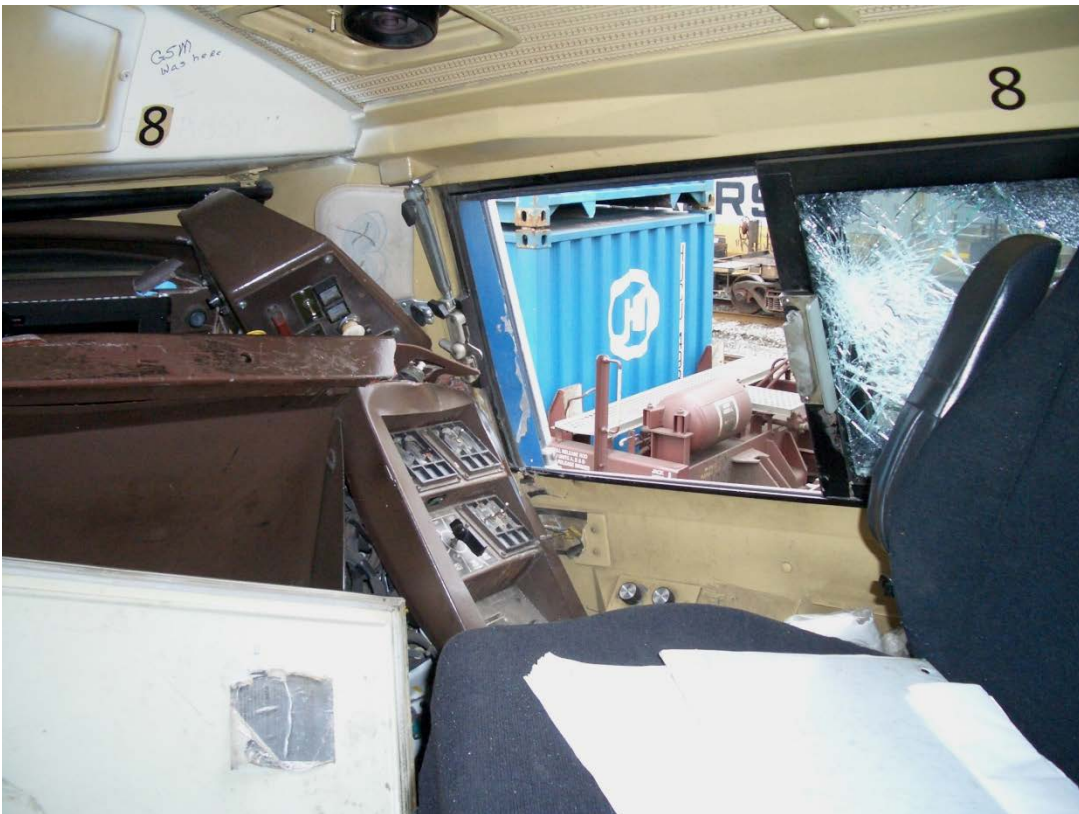
**Figure A-19. Operating engineer's desk and seat.**

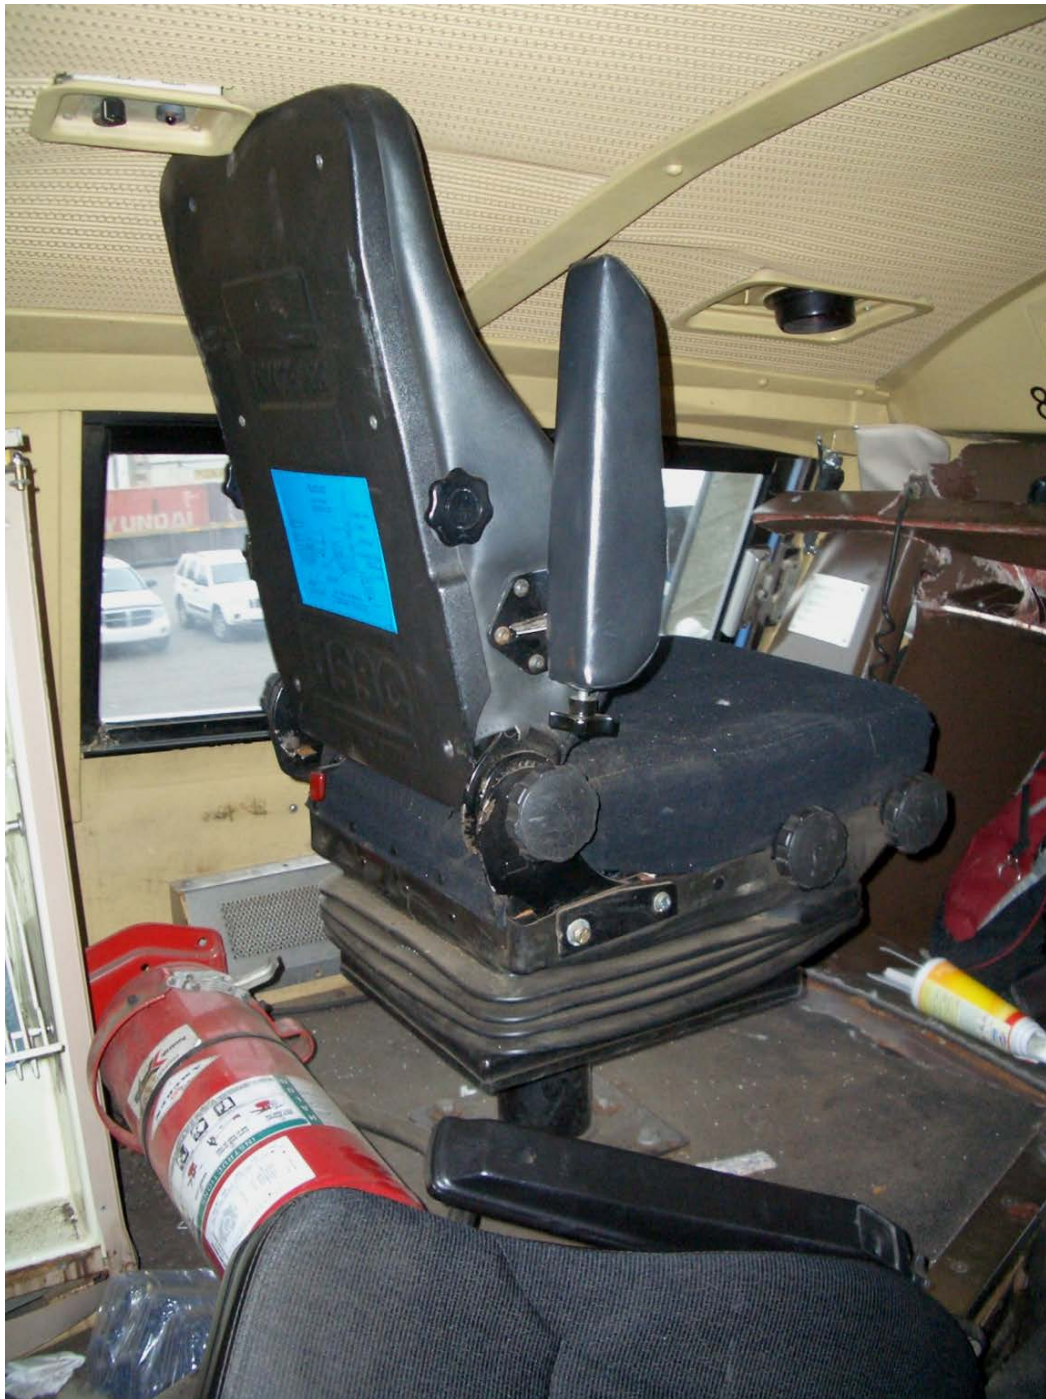
**Figure A-20. Relief engineer's seat pushed into ceiling of locomotive cab.**

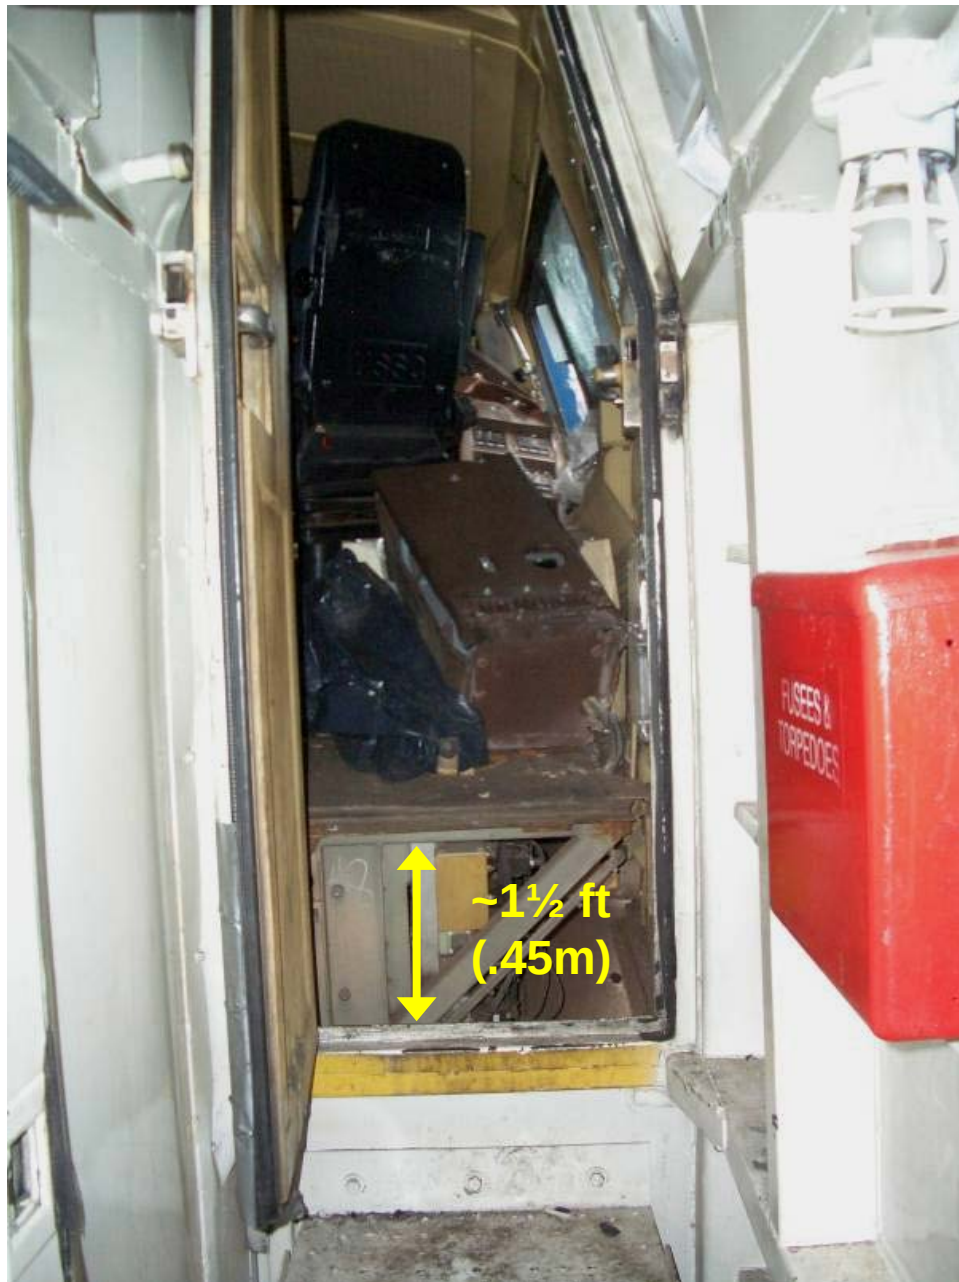
Figure A-21 shows the distance, approximately 1½ ft (0.45 m), the floor of the cab was raised at the location of the door. Measurements taken of the cab interior indicated that the floor was raised approximately 27 in on the left side and 24 in on the right side. Figure A-22 shows a wrinkle in the floor of the locomotive engine room. The longitudinal position of this wrinkle corresponds to the position of the wrinkles in the side walls of the locomotive seen earlier in Figure A-13. Details of the operating and relief engineers' injuries can be found in the phone interview information of Appendix B.2.

**Figure A-21. Side view of raised floor of locomotive cab interior.**
