**Federal Railroad  
Administration**

## **Collision of Amtrak Passenger Train and Norfolk Southern Freight Train—November 30, 2007, Chicago, Illinois**

| 1. AGENCY USE ONLY (Leave blank) | | 2. REPORT DATE<br>October 2013 | | 3. REPORT TYPE AND DATES COVERED<br>Final Report |
| 6. AUTHOR(S)<br>Patricia G. Llana, David Tyrell, Karina Jacobsen | | | | |

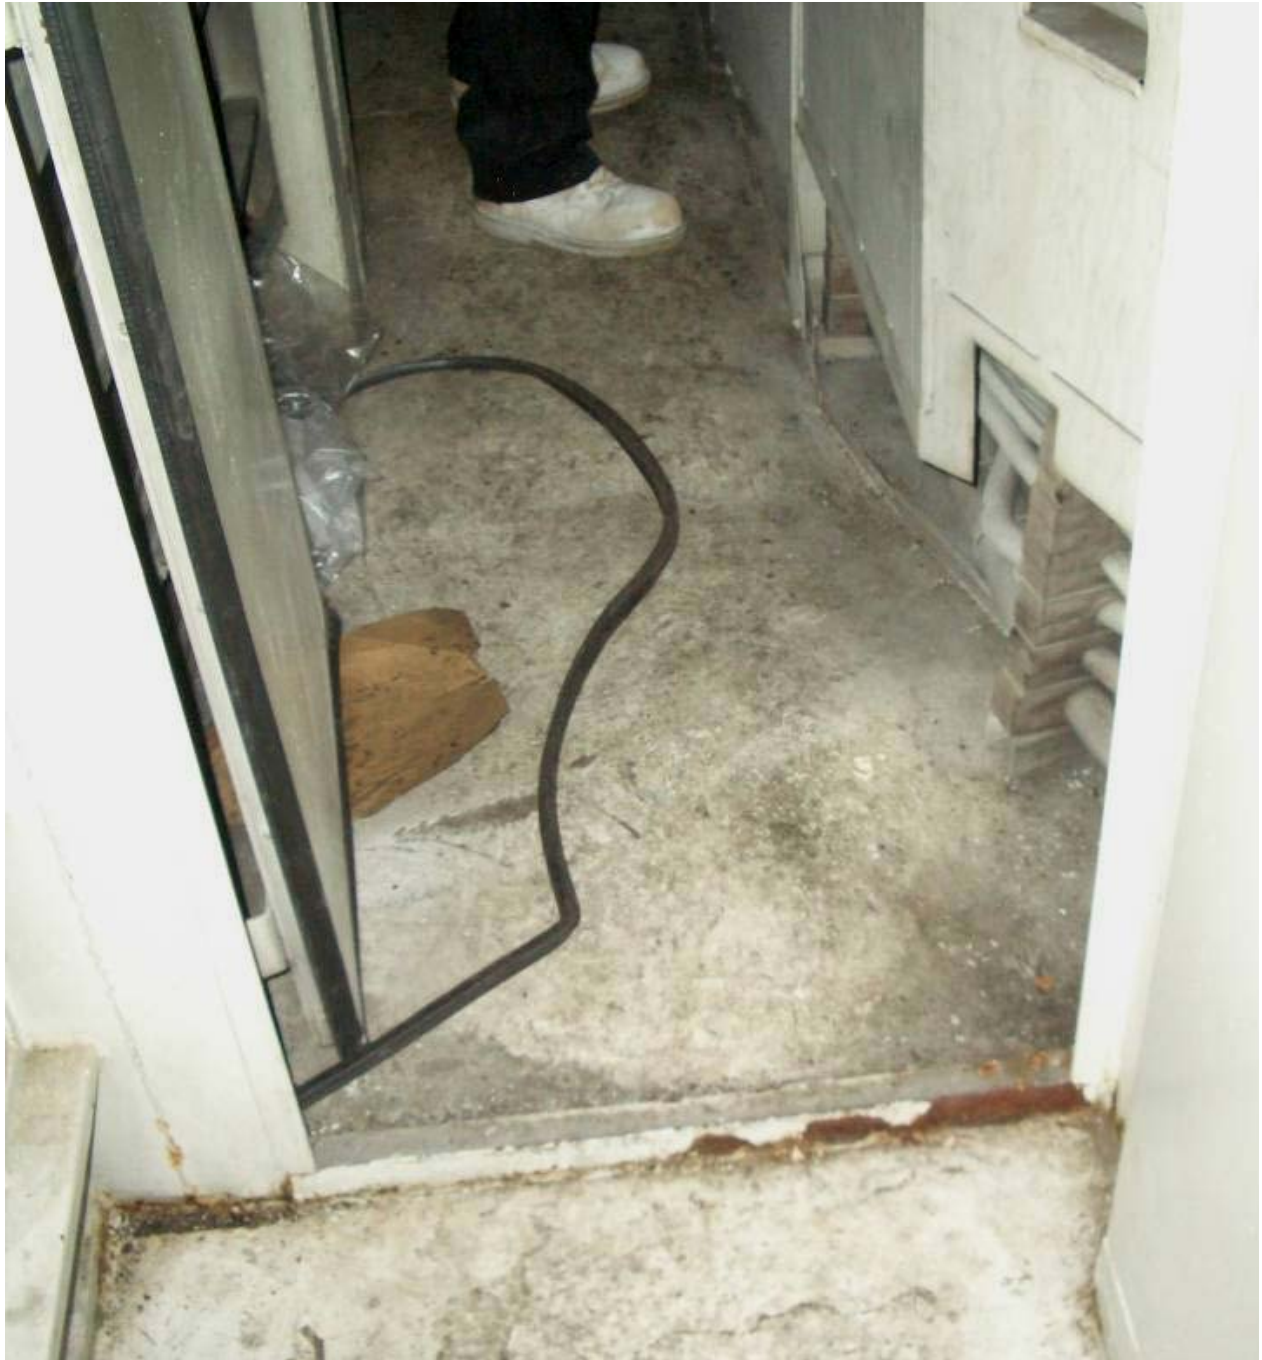
**Figure A-22. Wrinkle in floor of locomotive engine room.**

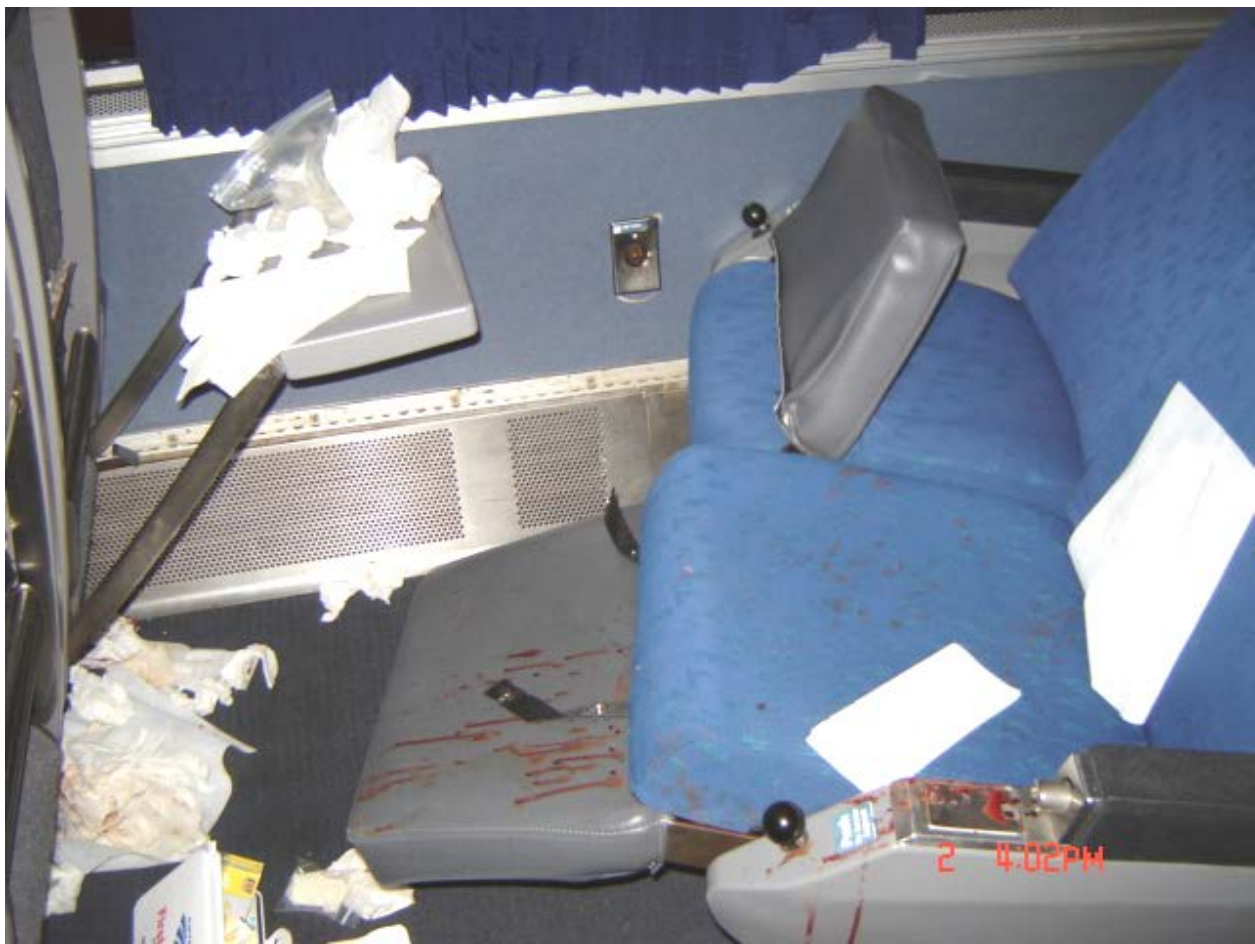
The structural damage to the interiors of the coach cars was minor compared with the damage to the locomotive interior. All of the coaches were equipped with seat pairs that can be rotated 180 degrees to face either forward or backward. After the accident, two seat pairs in the first coach car, three seat pairs in the middle coach car, and three seat pairs in the last coach car were rotated with respect to their original positions. It appeared that the seat latches had failed to secure the seat pairs in the locked position. However, it is difficult to determine if the collision actually caused the seat latch failures. There is no positive feedback to suggest that the seat latch was engaged after the seat rotated; therefore, the seat latches on the rotated seats may not have been engaged at the time of the collision, allowing the force of the collision to rotate the seats out of position. Details on the seats and their locking mechanism can be found in Appendix D. Figure A-23 shows one of the rotated seat pairs in the third coach car.

**Figure A-23. Rotated seat pair in third coach car.**

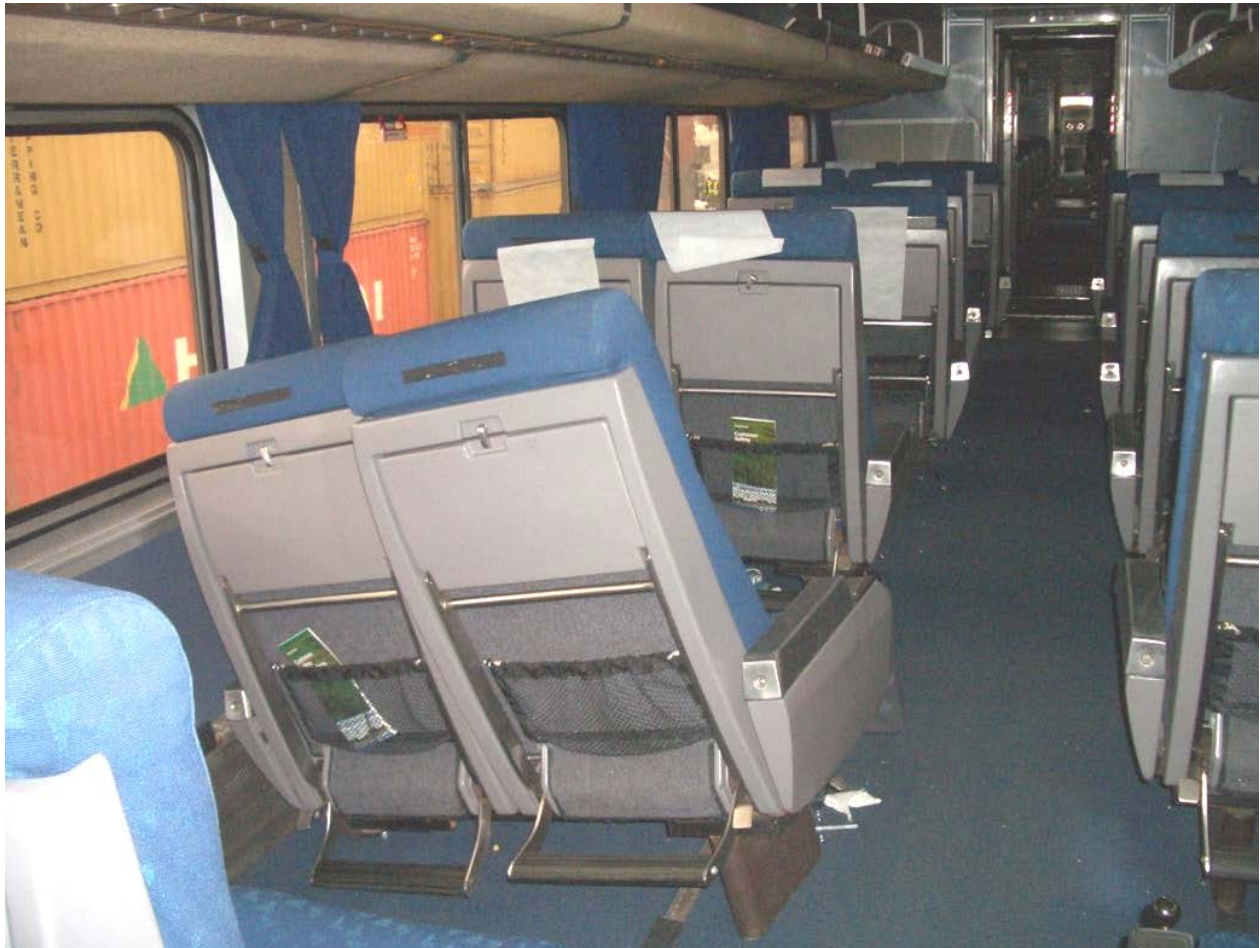
**Figure A-24. Failed seat pair in middle coach car.**

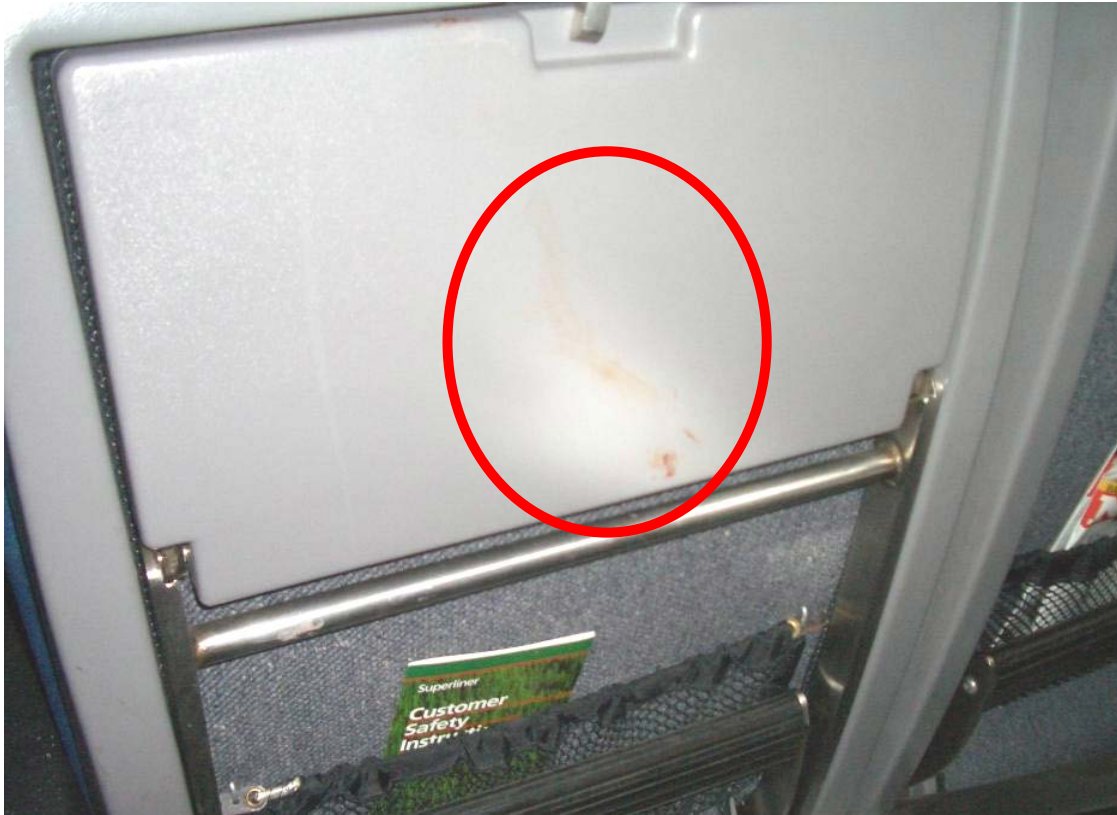
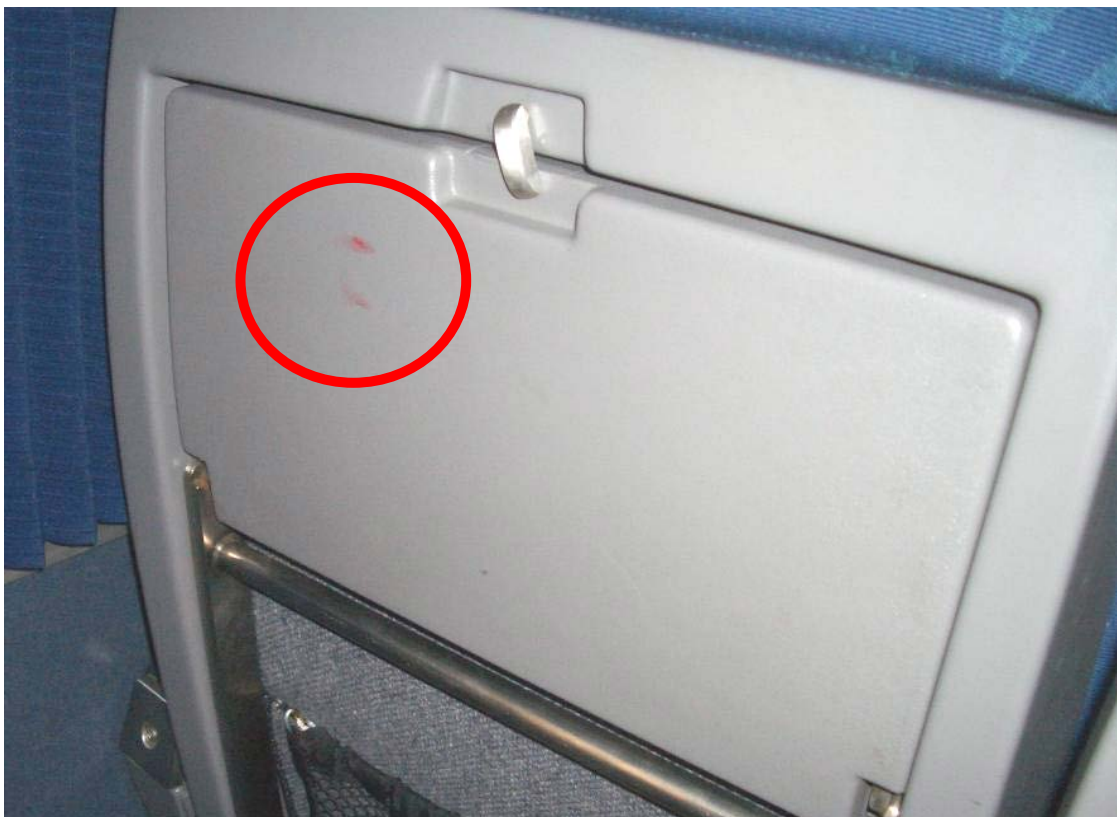
The injuries of the passengers in the coach cars consisted mostly of bloody noses, small cuts, and bruises. Figure A-25 shows evidence of passenger facial impacts with seat backs (circled in red) in the third coach car, and Figure A-23 shows evidence of a bloody nose injury, also in the third coach car;

**Figure A-25. Evidence of passenger injuries from impact with seat backs.**
