RTDF2008-74020

A DYNAMIC TEST OF A COLLISION POST OF A STATE-OF-THE-ART END FRAME DESIGN

US Department of Transportation
Volpe Center
Cambridge, MA

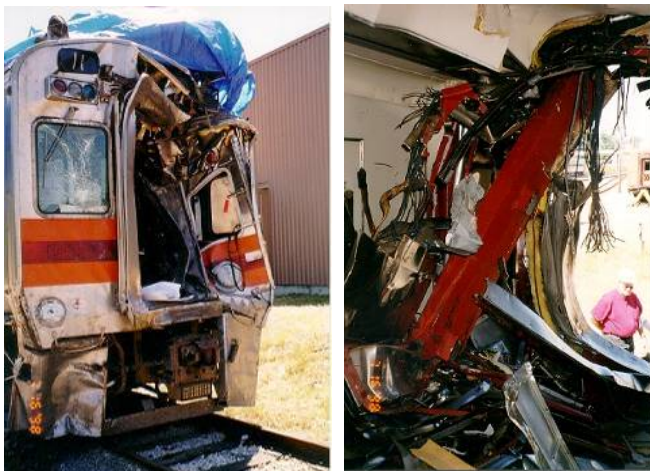
Figure 1. Cab car involved in the grade crossing collision in Portage, Indiana

Figure 1 shows the exterior and the interior of the cab car after the collision. The picture on the right shows the interior of the car. The collision post had been severed and pushed back into the car. Figure 2 shows the 6-foot diameter, 19-ton steel coil. This grade crossing collision is significant because the coil loaded the superstructure of the car, not the underframe.

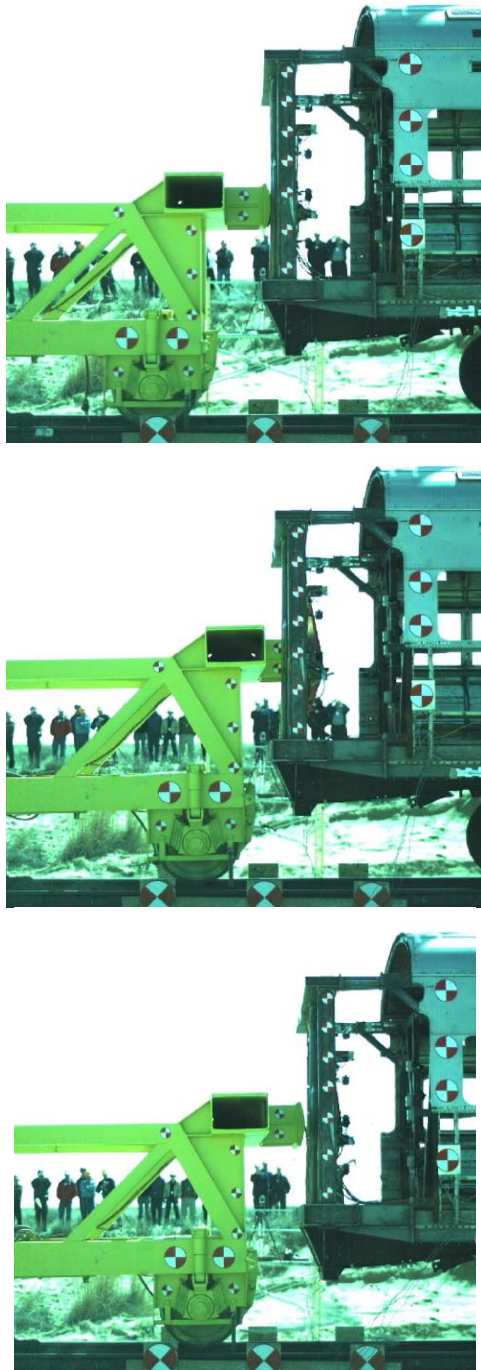
Figure 11. Still photographs from high-speed video

The actual test speed was 18.7 mph. The collision post indented approximately 7.375 inches, meeting the requirement that there be less than 10 inches of crush. The end frame exceeded the energy absorption requirement by absorbing 138,000 ft-lb of energy. Figure 11 shows still frames of the test taken from the high speed video. The top photo shows the cart at the first impact. The second photo shows the cart and

collision post at the maximum amount of collision post deflection. The third photo shows the cart and end frame at the end of the test, after some elastic energy has been recovered from the collision post. The cab car moved back approximately 6 feet after the test and stopped. The cart lifted vertically and moved laterally on recoil. When the cart came down after impact, the wheels missed the track and the cart derailed. Since the cart came down off the tracks, it stopped and did not move backwards.

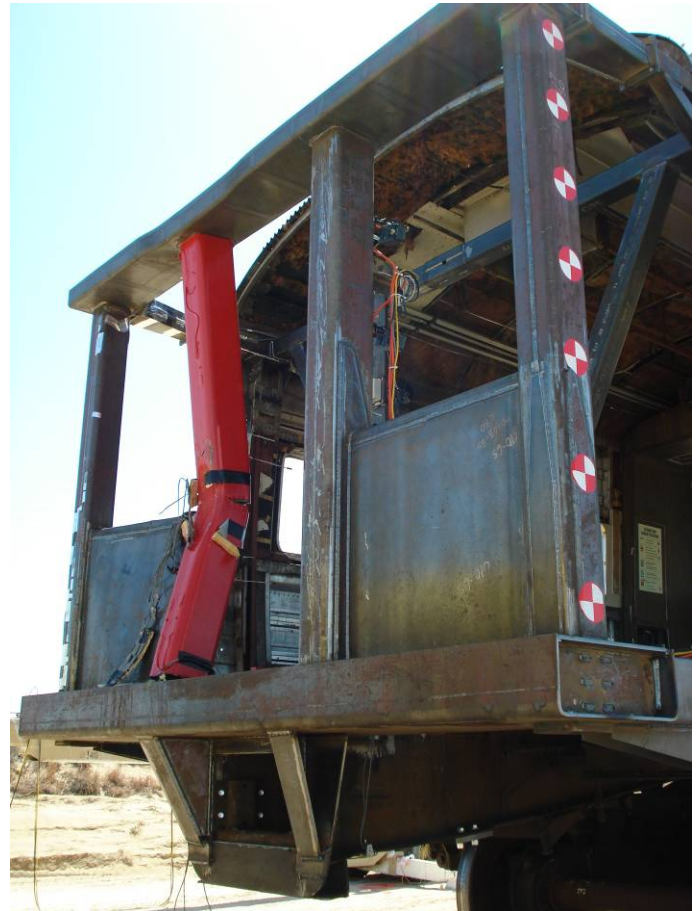
Figure 12. A photograph of the end frame after the test

End Frame Performance Figure 12 shows the end frame after the test. The impacting object pushed in the collision post, lateral shelf and bulkhead sheet. The collision post partly separated from the buffer beam, as did the bulkhead sheet. The shelf separated from the collision post and the corner post. The AT beam, which runs laterally at the top of the end frame, bent down at the connection to the collision post. The welds between the collision post and the AT beam did not crack or fail.

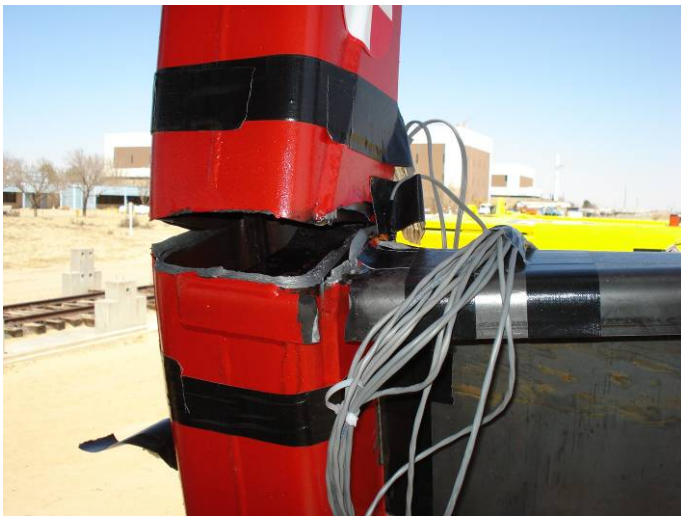
Figure 14. The back of the collision post, at the connection to the shelf, post-test (bottom)

Figure 14 shows the back of the collision post and the connection to the shaft, after the test. The post fractured along the backside and almost entirely along the sides of the post. The front of the post did not fracture. The shelf fractured at the location of the gap between the collision post and the shelf. There are external gusset plates along both the sides of the posts. The plates fractured also.

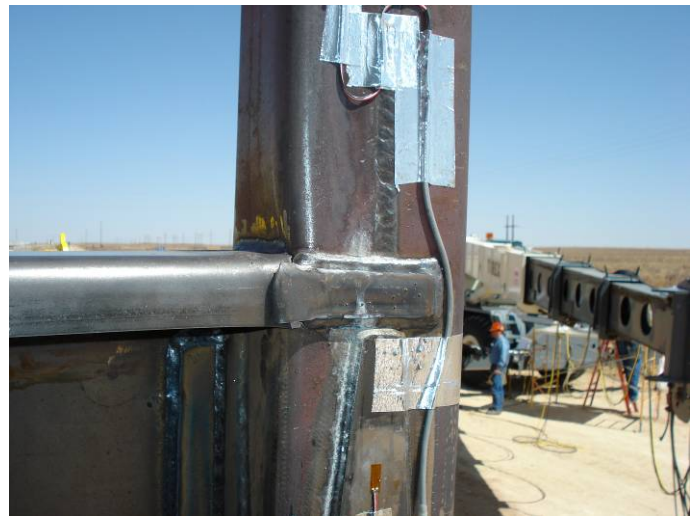
Figure 16. The connection of the shelf to the corner post, post-test

Figure 16 shows the connection between the corner post and the shelf, after the test. During the test, the shelf was pushed in longitudinally toward the center of the train and outward laterally toward the corner post. The corner post has been pushed in and deformed plastically at the shelf. Also, the tab of the shelf fractured off.

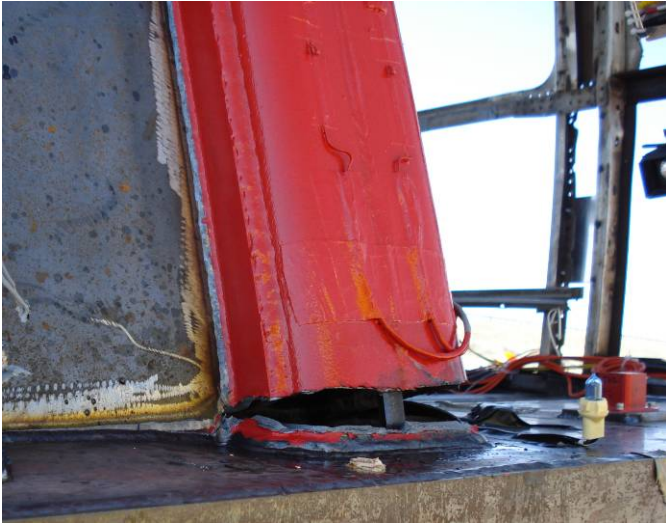
Figure 17. Fracture at the connection between the collision post and the buffer beam

The collision post fractured at the connection to the buffer beam. Figure 17 shows the fracture. The bulkhead sheet tore from the buffer beam at the corner. The crack on the left side of the post (as seen in the picture) extends behind the bulkhead sheet. On the right side of the post, the crack extends almost down the entire side. The buffer beam was distorted and the top plate of the buffer beam pushed down at the location of the collision post and the bulkhead sheet.

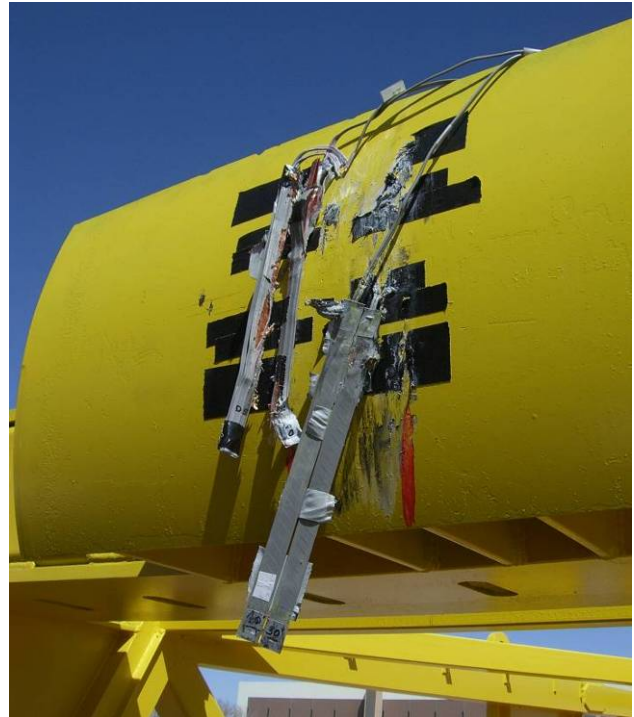
Figure 19. Cart impactor, post-test

frame would absorb the required collision energy. Figure 19 shows the impactor after the test. The cart performed as expected during the test and did not deform. After the test, the cart derailed as expected, due to the off-center load. The cart remained upright. The derailment did not damage the cart.
