**Wheelchair Lifts on Transit Buses  
Summary of U.S. Experience**

**(U.S.) Transportation Systems Center  
Cambridge, MA**

**Urban Mass Transportation Administration  
Washington, DC**

**Jan 83**

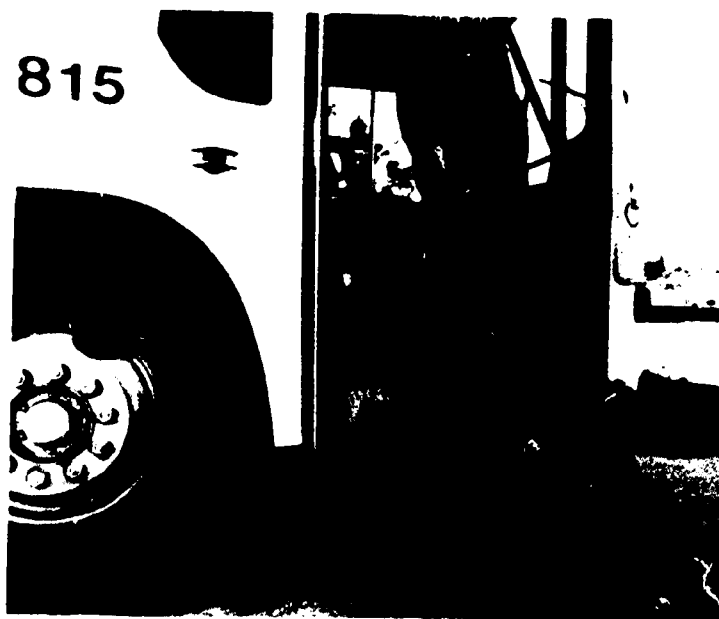
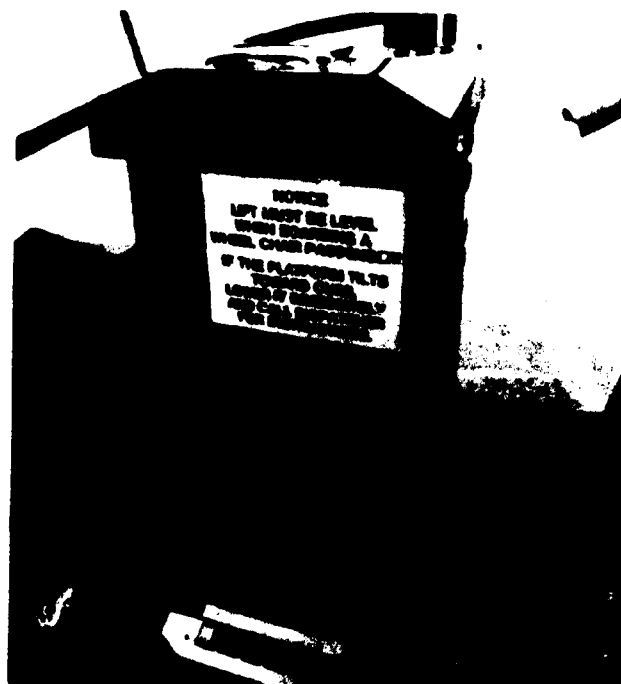
3.2.4.2 Series 140 Lift - Experience with this lift is more limited than with the earlier models. Major problems reported included early failures of the bonding in a batch of rotary actuators which caused the vane to separate from the shaft and immobilize the lift, wiring failures due to harnesses being installed too tight in order to present a neat tidy appearance (at the customers request), and problems with leveling the erected platform. This is not a continuous function on the 140 series as it is on the 120 series. Consequently, the driver must maintain the platform switch in the on position until the platform has leveled. Early release of the control will leave the platform in a plane position, but at a negative angle resulting in a potentially hazardous condition.

**FIGURE 4.3-2: NEGATIVE PLATFORM SLOPE CONDITION AND WARNING POSTED BY RTD**

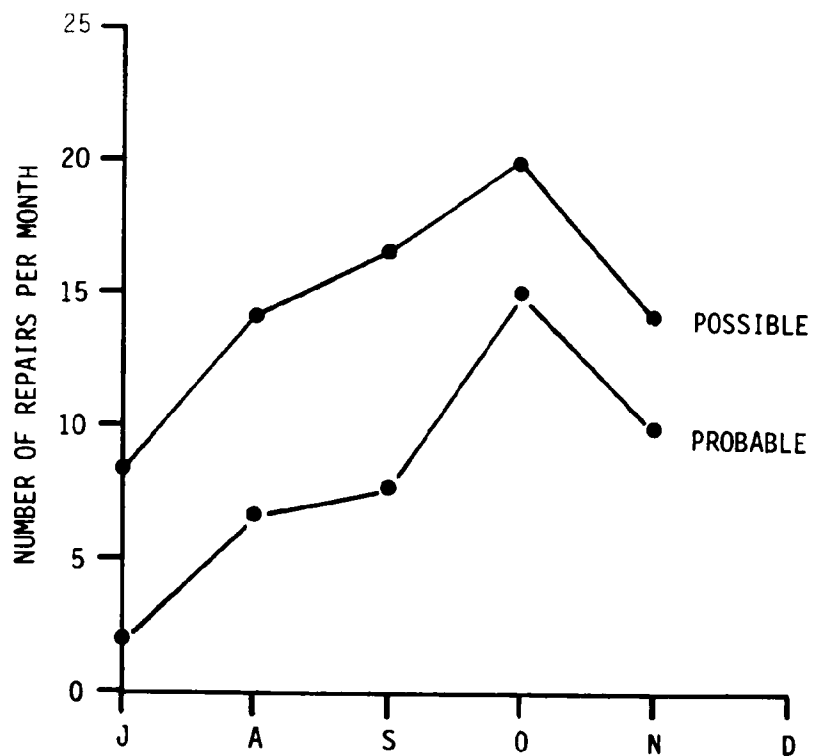
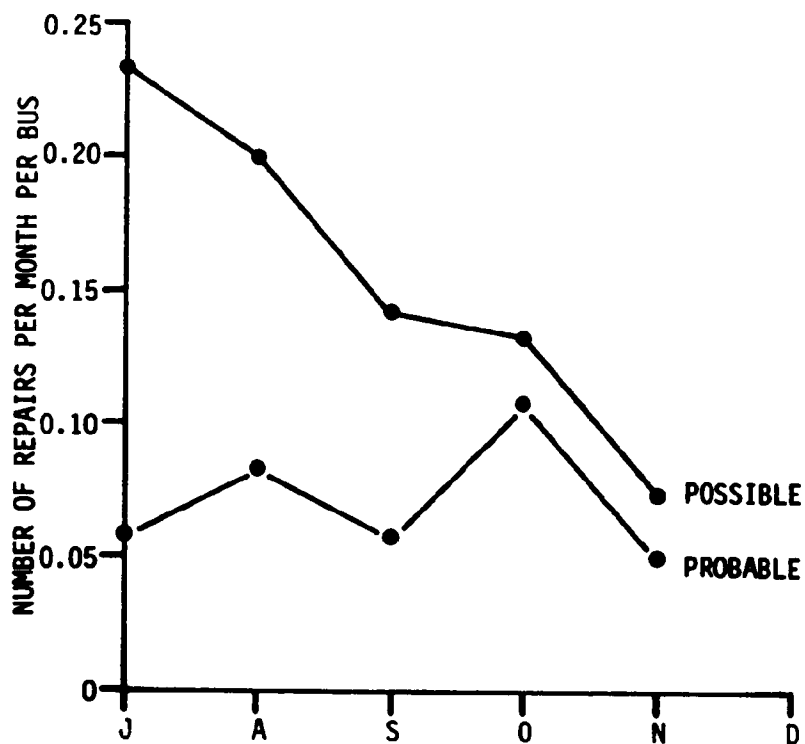
The experience at SCCTA also indicates that any sensitivity to curbing can be eliminated by placing a local bumper ahead of the lift at the outboard edge. This was done on the Gillig buses (#600-681) that were retrofitted with the TDT-50 lift early in 1981. The bumper, which in this case consists of a solid steel ball, was retrofitted to these buses over the summer of 1981 and dramatically reduced the number of sensitive edge repairs in the subsequent months as follows:

FIGURE 4.15-1: TRENDS OF CURBING REPAIRS ON GFC 870 BUSES FOR JULY THROUGH NOVEMBER 1981 AT SCCTA
