**JRC2012-74154**

## **COMPARISON OF INTERIOR CRASHWORTHINESS OBSERVED IN PASSENGER TRAIN ACCIDENTS AND 8G DYNAMIC SEAT SLED TESTS**

**Kristine Severson**

**Volpe National Transportation Systems Center  
Cambridge, MA, USA**

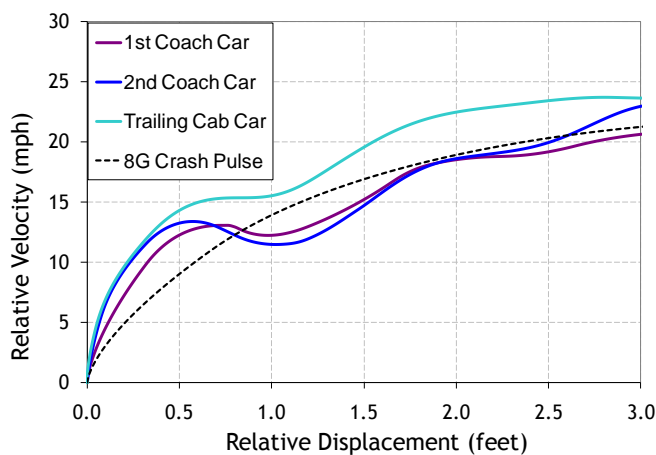
**FIGURE 5. PLOTS OF ESTIMATED SECONDARY IMPACT VELOCITY (SIV) FOR CHATSWORTH**

The SIV plots for the first two passenger cars are very close to that of the 8G pulse. The SIV plot for the trailing cab car is more severe than the 8G pulse. The trailing car in a consist can experience a higher deceleration than the preceding car because there is no trailing car to push it forward. The increased level of interior damage in the trailing cab car compared to the second coach car and the uncrushed portion of the first coach car supports this theory.

increased damage in the cab car could have been the result of higher occupancy in that car, but more likely it was the result of the increased deceleration of the cab car, resulting in secondary impact velocities which are 20-25% higher in the cab car than in the first two coach cars, as shown in the SIV curve in Figure 5.

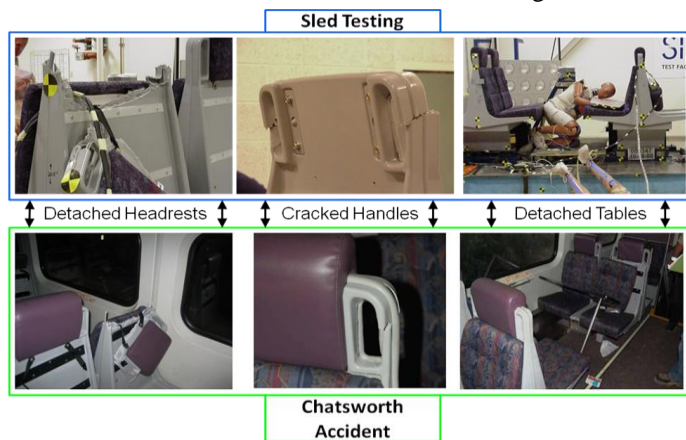
**FIGURE 7. PHOTOS OF SEAT/TABLE DAMAGE**

The sled tests demonstrated that the seats did not meet the injury criteria or compartmentalization requirements specified in the Seat Standard. In two of the three tests without a table, the aisle-side head rest completely separated from the seat back. In the test with the 5<sup>th</sup>- and 95<sup>th</sup> percentile ATDs, the window-side head rest of the facing seat failed completely due to the impact from the larger ATD. In some tests, the grab handles on the head rest cracked, but the head rest did not detach from the seat back. These types of seat damage were also prevalent in the Chatsworth accident.

In the single test with a table between the facing seats, the two 50<sup>th</sup> percentile ATDs impacted the table, causing it to shear off at the wall attachment, which led to a failure at the floor attachment as well.

The cushions were attached to the seat frames with Velcro. They remained attached in all but one test, which was the test with the higher crash pulse. Several seat cushions detached during the accident as well, indicating that the cars may have experienced more severe decelerations than the 8G pulse.

Photographs comparing the similarities in interior damage between the accident and the test are shown in Figure 7.

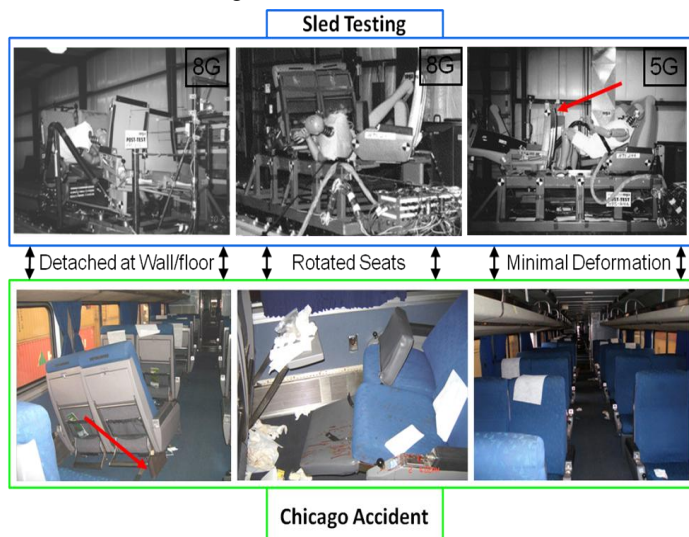
**FIGURE 11. PHOTOGRAPHS OF SEAT DAMAGE**

track had deformed slightly under the forward seat pedestal. The seat separated from the test sled at the wall mounting, which occurred in a number of tests. The wall attachment design that was tested had a very shallow locating pin, which was able to separate from the wall track and dislodge the seat bracket with very minimal deformation. The locking mechanism for the seat rotation failed on the rear seat pair, which only had to endure the inertia of its own mass. The failure was apparently due to a cold weld.

The first 8 G test was conducted with only one ATD in the aisle seat position to increase the load on the locking mechanism that failed in the previous test. In this test the recline mechanism of the forward aisle-side seat back failed, apparently due to a poor weld of the attachment post for the recline mechanism. The seat locking mechanism remained intact. There was virtually no permanent deformation of the forward seat frame.

The four subsequent tests were all conducted with two ATDs and an 8 G crash pulse. The leg rest and seat recline positions were varied in these tests, though it is not obvious that the initial positions affected the outcomes. The most significant seat performance issue was the failure of the wall mounting bracket to remain fastened to the track on the side wall. The wall mounting failed on five of the seven tests, allowing the seat to rotate about the floor pedestal mounting. In two of seven tests the rotation was sufficient to separate the floor pedestal from the seat track, breaking the track in one test. The floor attachment is prone to failure only when the wall mount attachment fails, and the floor attachment is subjected to the entire load. Another common failure involved the recline mechanism. The rod fractured in two tests, and welds that fastened the rod failed in two tests.

Photographs of the detached and unintentionally rotated seats are shown in Figure 11.

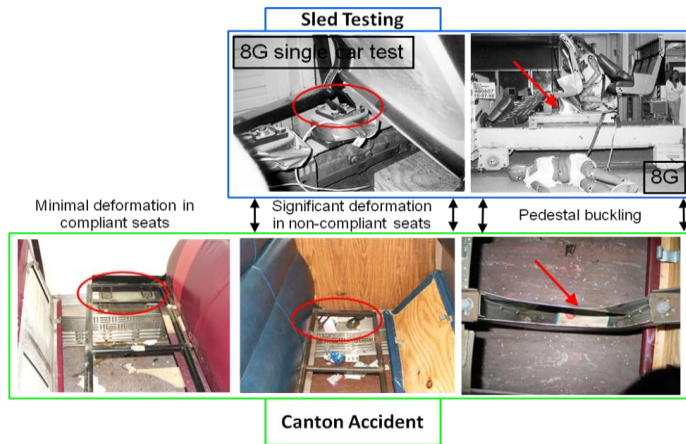
**FIGURE 14. PHOTOGRAPHS OF SEAT DAMAGE IN CANTON ACCIDENT**

The seats in the first coach car #214 sustained minimal damage compared to the other passenger cars. In the second coach car #610, 40-50% of the seats had deformed seat brackets that fasten the seat frames to the side wall. One seat back was cracked in this car. In the third and fourth coach cars #603 and #651 respectively, almost 100% of the seats had deformed brackets. Two seat backs were cracked in Car #651. In the fifth coach car #622, 40-50% of the seats had deformed brackets. The trailing cab car #1523 had Walkover seats, with seat backs failing on four seat pairs. These failures resulted in steel tubes protruding through the fabric, representing a very hostile impact surface.

In both sled tests of the M-Style seat, the seats stayed intact; however, all the cushions from both seats completely detached and became hazardous flying objects during the collision. The pedestal under the forward seat back deformed in each test, but did not detach from the wall or floor mounts. The damage to the seats in the tests was somewhat more severe than the damage to the seats in the accident. This observation is

In both tests of the Walkover seats, the seats stayed intact and the cushions remained attached. The Walkover seat back rotated forward before locking in place, thereby increasing the distance through which the occupants could travel. The same tendency for seat backs to rotate before locking was observed in the accident.

Photographs comparing the seat damage in the sled tests and the Canton accident are shown in Figure 14, for seats that were compliant with the Seat Standard and those that were not.
