Repair of Distortion-Induced Fatigue Damage in Bridge No. 135-87 (043SB and 044NB) Using Newly-Developed Strengthening Schemes

1 Report No. KS-16-06	2 Government Accession No.	3 Recipient Catalog No.	
4 Title and Subtitle Repair of Distortion-Induced Fatigue Damage in Bridge No. 135-87 (043SB and 044NB) Using Newly-Developed Strengthening Schemes		5 Report Date August 2016	
		6 Performing Organization Code	
7 Author(s) Kathleen S. McElrath, Adolfo Matamoros, Ph.D., P.E., Caroline Bennett, Ph.D., P.E., Jian Li, Ph.D., Stan Rolfe, Ph.D., P.E.		7 Performing Organization Report No.	
9 Performing Organization Name and Address The University of Kansas Department of Civil, Environmental and Architectural Engineering 1530 West 15th St Lawrence, Kansas 66045-7609		10 Work Unit No. (TRAIS)	
		11 Contract or Grant No. C1916	
12 Sponsoring Agency Name and Address Kansas Department of Transportation Bureau of Research 2300 SW Van Buren Topeka, Kansas 66611-1195		13 Type of Report and Period Covered Final Report November 2011–August 2015

Final Report

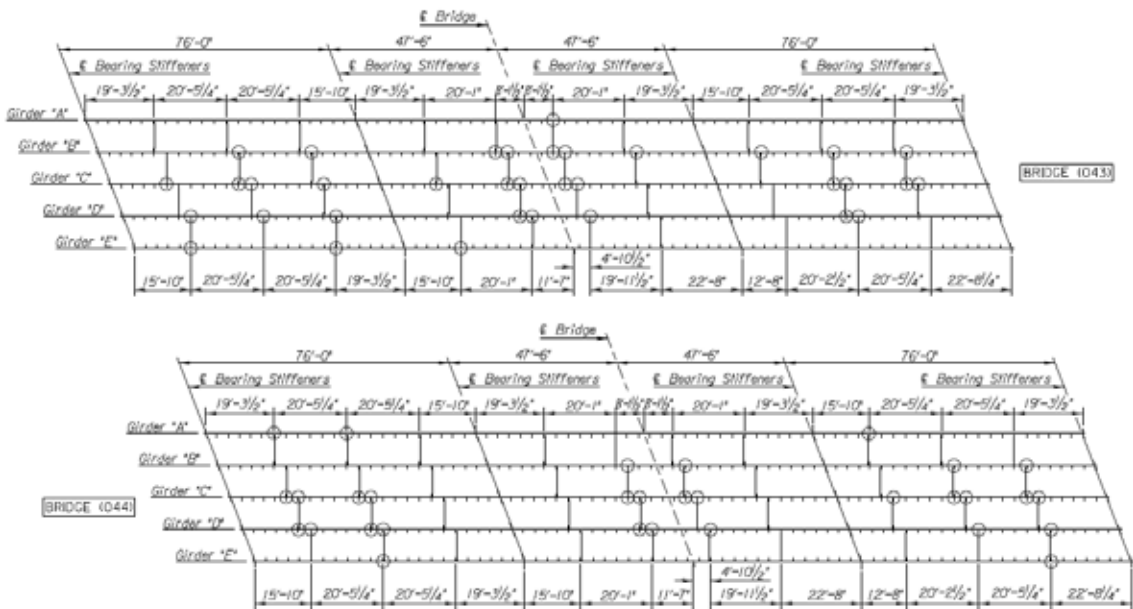
Figure 2.4: Plan of Kansas Bridge 135-87(043/044)

As previously mentioned, skewed bridges with staggered cross frames are likely to have more extensive distortion-induced fatigue cracks in the bottom web gaps due to high differential deflections and reverse curvature deformations of the bottom girder flange (Hartman et al., 2010). This is the case with Kansas Bridge 135-87(043/044), which has a 21° skew and staggered cross frames. According to a 2010 routine snooper inspection, the majority of fatigue cracks are located in the bottom web gaps. Figure 2.4 shows a plan of the bridge with locations of cracking indicated.

Note: Circled areas indicate locations where cracks have been reported.

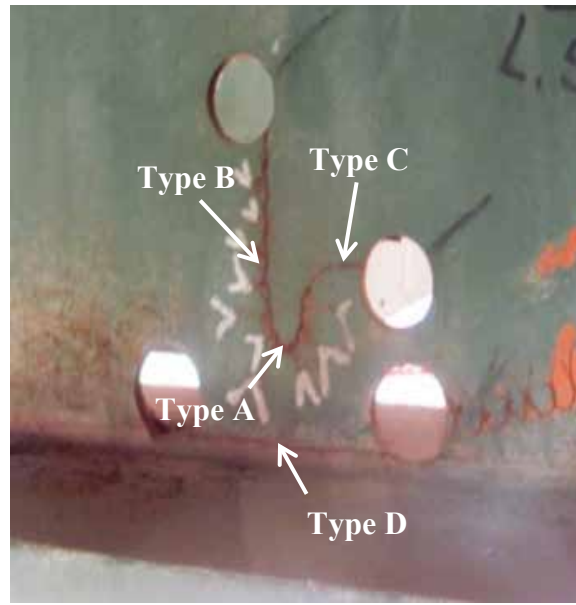
Figure 2.5: Types of Cracks Occurring in Kansas Bridge 135-87(043/044)

Crack types A, B, C, and D (Figure 2.5) have all been reported on Kansas Bridge 135-87(043/044). Type A cracks occur horizontally at the connection plate-to-web weld. Type B cracks occur vertically along the connection plate-to-web weld. Type C cracks propagate away from the connection plate-to-web weld into the base metal of the girder web, and Type D cracks occur along the flange-to-web weld. Drilled crack-arrest holes were implemented in past repairs, but no additional retrofits have previously been applied to the bridge.

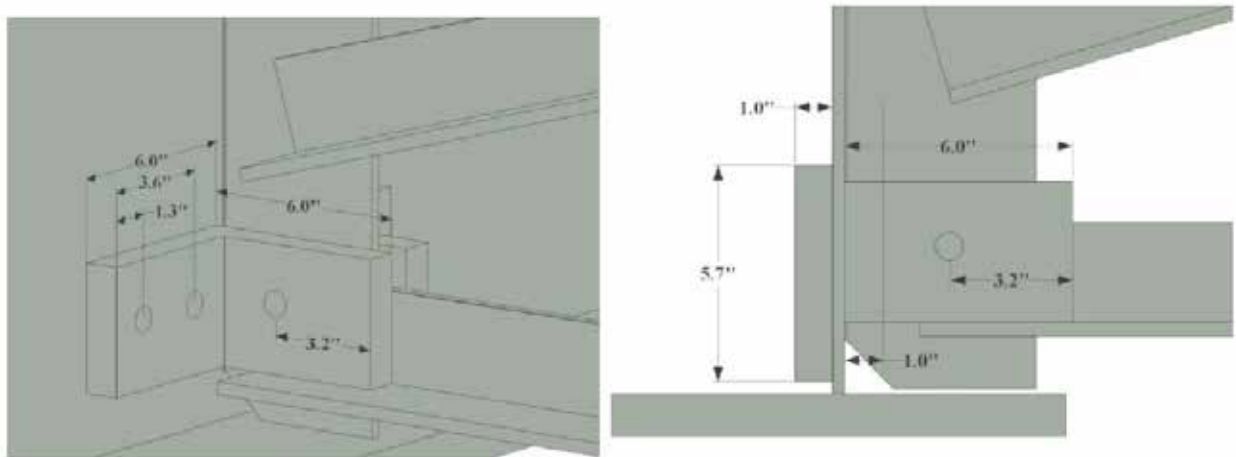
Figure 2.7: Angles-with-Plate Retrofit Recommended to KDOT for Repair of Kansas Bridge 135-87(043/044)

Richardson (2012) concluded that the angles-with-plate retrofit was effective in reducing stresses in the web-gap regions and would be the most cost effective and convenient repair technique. Since this retrofit technique does not require attachment to the girder flange, field

implementation would be simplified in both web-gap regions. In the top web gap, bridge deck removal would not be required. In both web-gap regions, cross frame removal would be unnecessary, because the angles-with-plate retrofit could be bolted through the horizontal cross-frame members while avoiding their outstanding legs. These benefits would reduce labor costs and allow for maintaining daily traffic. Therefore, it was recommended to KDOT that they use the angles-with-plate retrofit on Kansas Bridge 135-87(043/044) to repair distortion-induced fatigue cracking in the susceptible web-gap regions. Based on the parametric results of the angles-with-plate retrofit, recommended dimensions for the angles and backing plate were $L152 \times 152 \times 25$ mm ($L6 \times 6 \times 1$ in.) and $L457 \times 145 \times 25$ mm ($PL18 \times 5^{11/16} \times 1$ in.), as shown in Figure 2.7.

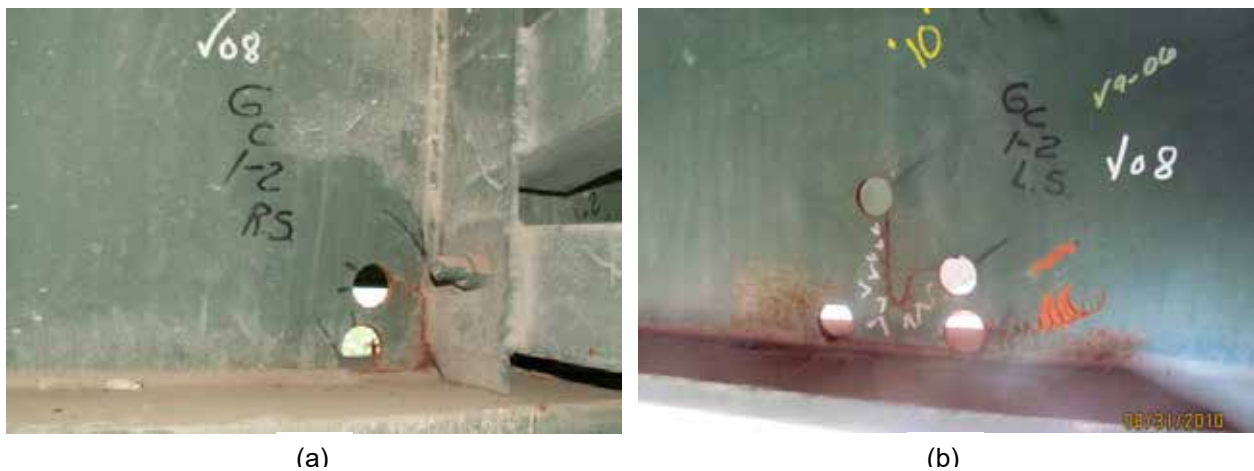
Figure 3.2: Cracking at the Instrumentation Location on the (a) Stiffener Side (b) Non-Stiffener Side

arrest holes had been previously drilled. The top web gap had one 19-mm ($3/4$ -in.) Type A crack that had not been previously repaired. Figure 3.2 shows a photograph of the bottom web gap at the location where the majority of the instrumentation was placed.

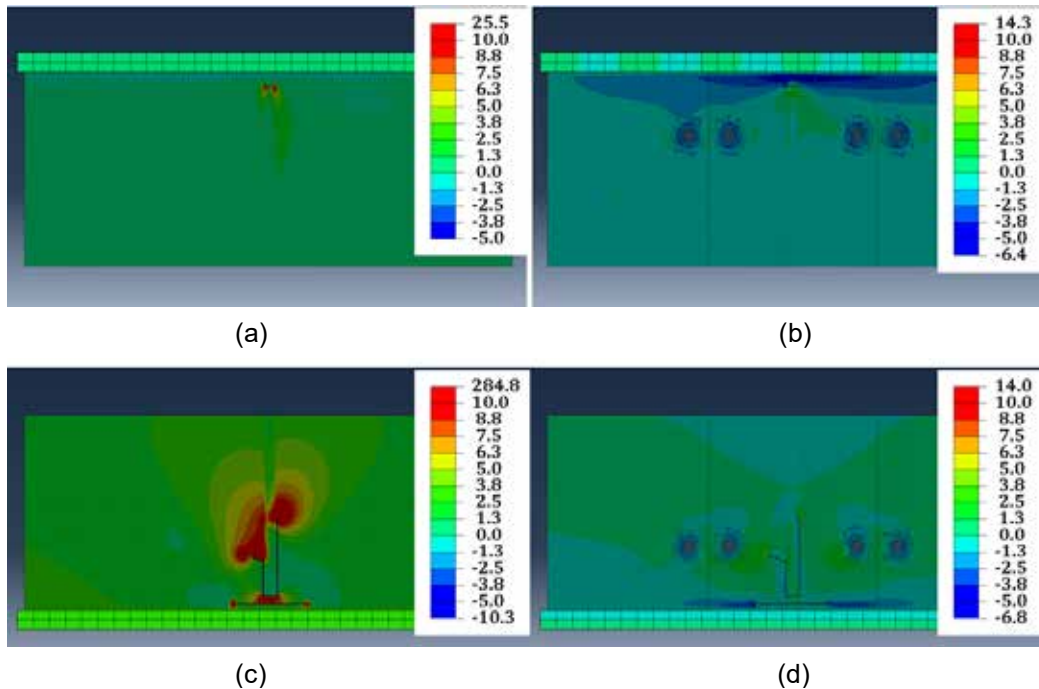
Figure 6.4: Maximum Principal Stresses for Center Load Truck Placement at (a) Top Web Gap, Before Retrofit (b) Top Web Gap, After Retrofit (c) Bottom Web Gap, Before Retrofit (d) Bottom Web Gap, After Retrofit

For all loading scenarios, field test and FE results show that peak stresses in the bottom web gap were significantly reduced after application of the angles-with-plate retrofit. Reduction of stresses in this area is very favorable because, as previously mentioned, the bottom web gap is the region of Kansas Bridge 135-87(043/044) in which the highest web gap out-of-plane stress demands are experienced. Therefore, the reduction of stresses in the bottom web-gap region shows that the angles-with-plate retrofit should be successful in greatly slowing or halting crack propagation for the most problematic areas on the bridge.

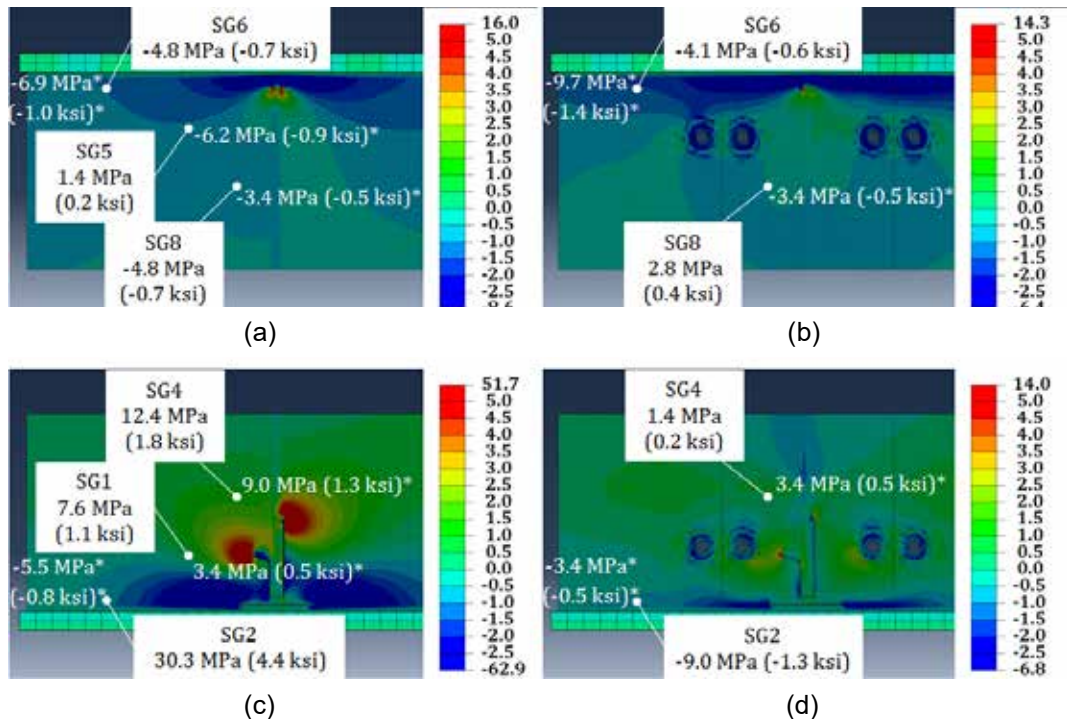
Figure 6.5: Directional Stresses for Center Load Truck Placement at (a) Top Web Gap, Before Retrofit (b) Top Web Gap, After Retrofit (c) Bottom Web Gap, Before Retrofit (d) Bottom Web Gap, After Retrofit

Figures 6.4, 6.5, 6.6, and 6.7 show results and comparisons of strain gage results between the unretrofitted and retrofitted states. Corresponding strain gage measurements and FE results generally show that the stress demand at the bottom web gap was at least 20% higher than that of the top web gap for tests before the retrofit was applied. Since the majority of fatigue cracks found on the bridge have occurred in the bottom web gap, this was expected. It also supports the findings of previous research that has concluded that skewed bridges with staggered cross frames see maximum stress demands and fatigue cracking occurring in the bottom web gaps.

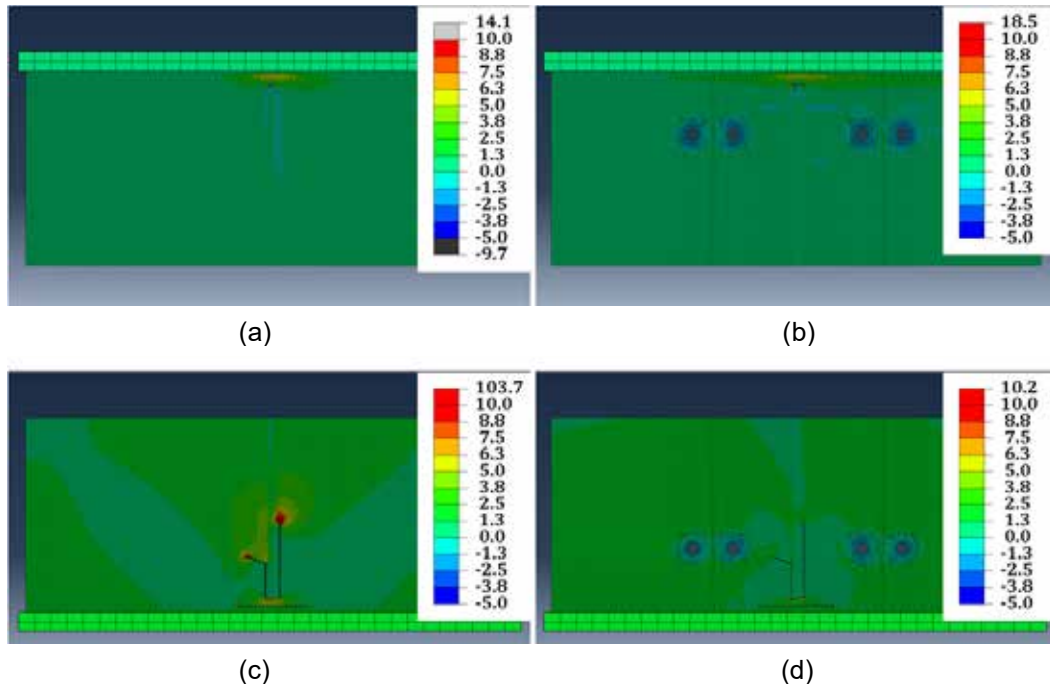
Figure 6.6: Maximum Principal Stresses for West Load Truck Placement at (a) Top Web Gap, Before Retrofit (b) Top Web Gap, After Retrofit (c) Bottom Web Gap, Before Retrofit (d) Bottom Web Gap, After Retrofit

For stresses nearest the top flange, peak stresses showed favorable reduction and behavior after application of the angles-with-plate retrofit for the center truck loading test. However, for the east and west lane truck loadings, low levels of stress decrease, and in a few cases, stress increase, in the top web-gap region were observed. Although the top web-gap region was found to experience lower stress demands before the retrofit than the bottom web gap, this is still a result that warranted further investigation. For this reason, an additional analytical investigation was performed that focused on the top web-gap region of the bridge.

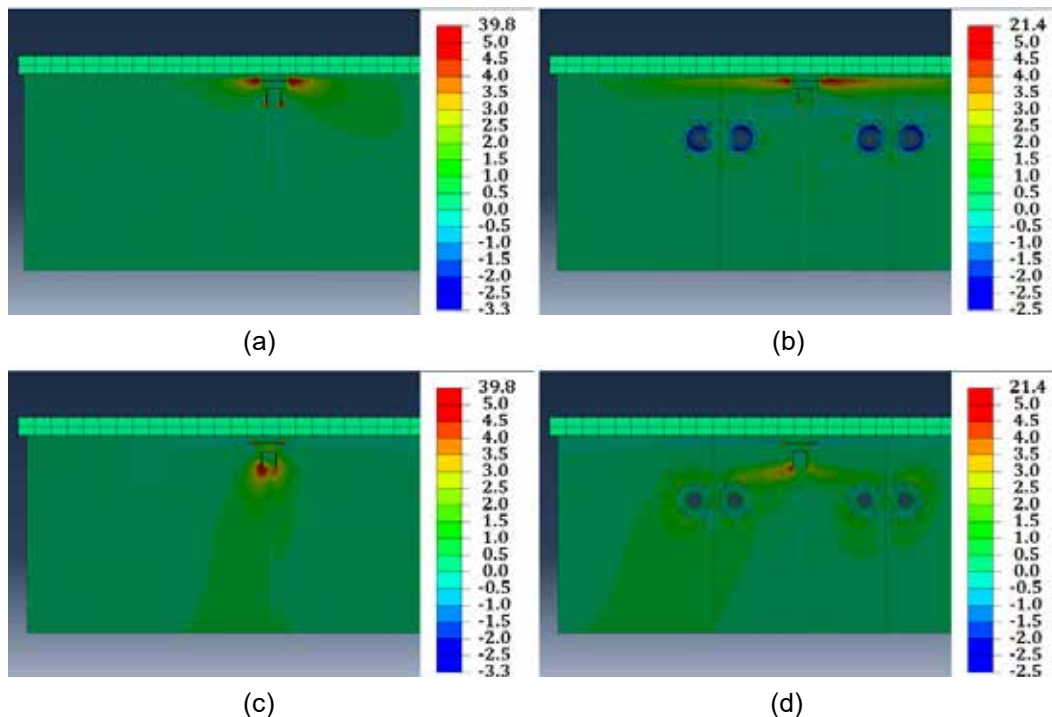
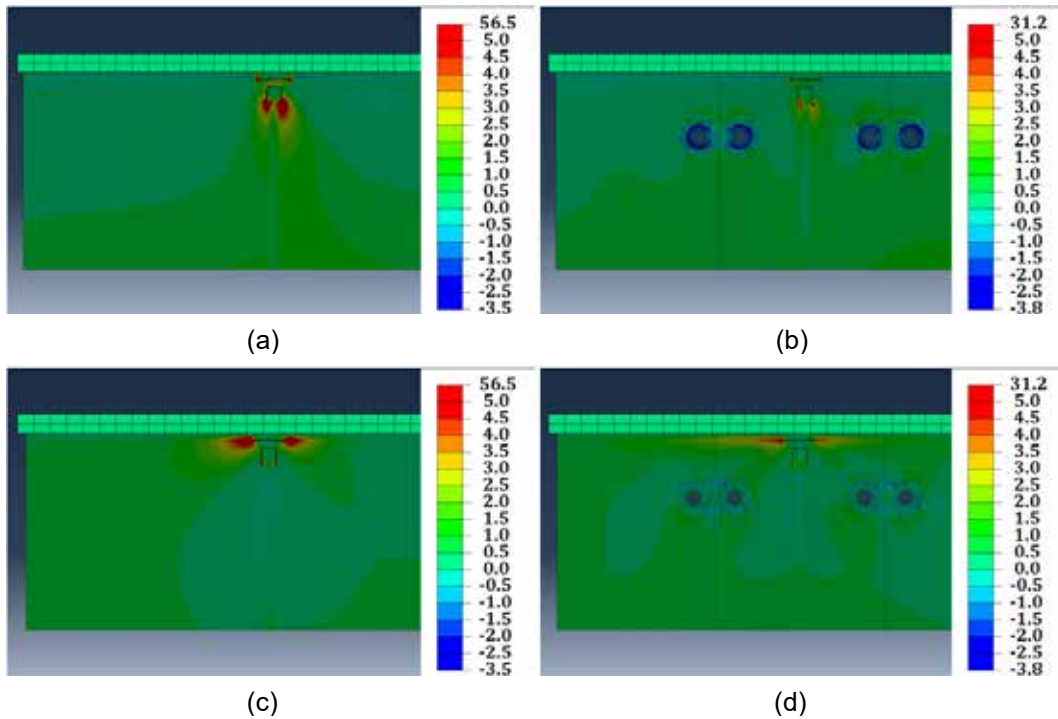
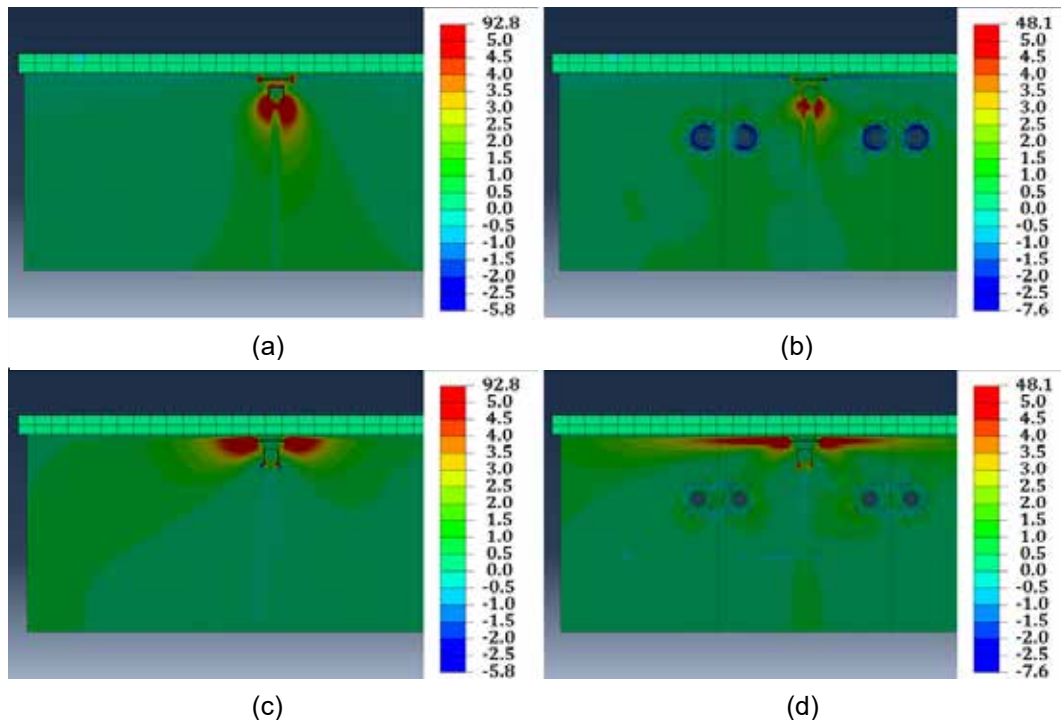
Figures 6.8, 6.9, and 6.10 show maximum principal stresses when both the connection plate-to-web weld and flange-to-web weld cracks were present for all three truck location loadings, both before and after retrofit application. Under bridge center truck loading, the retrofit reduced HSS 1 and HSS 2 stress demands by 66% and 35%, respectively. Under west lane truck loading, HSS 1 stress was reduced by 27% and HSS 2 stress was reduced by 26%. Under east lane truck loading, HSS1 and HSS 2 stresses were reduced by 53% and 23%, respectively.

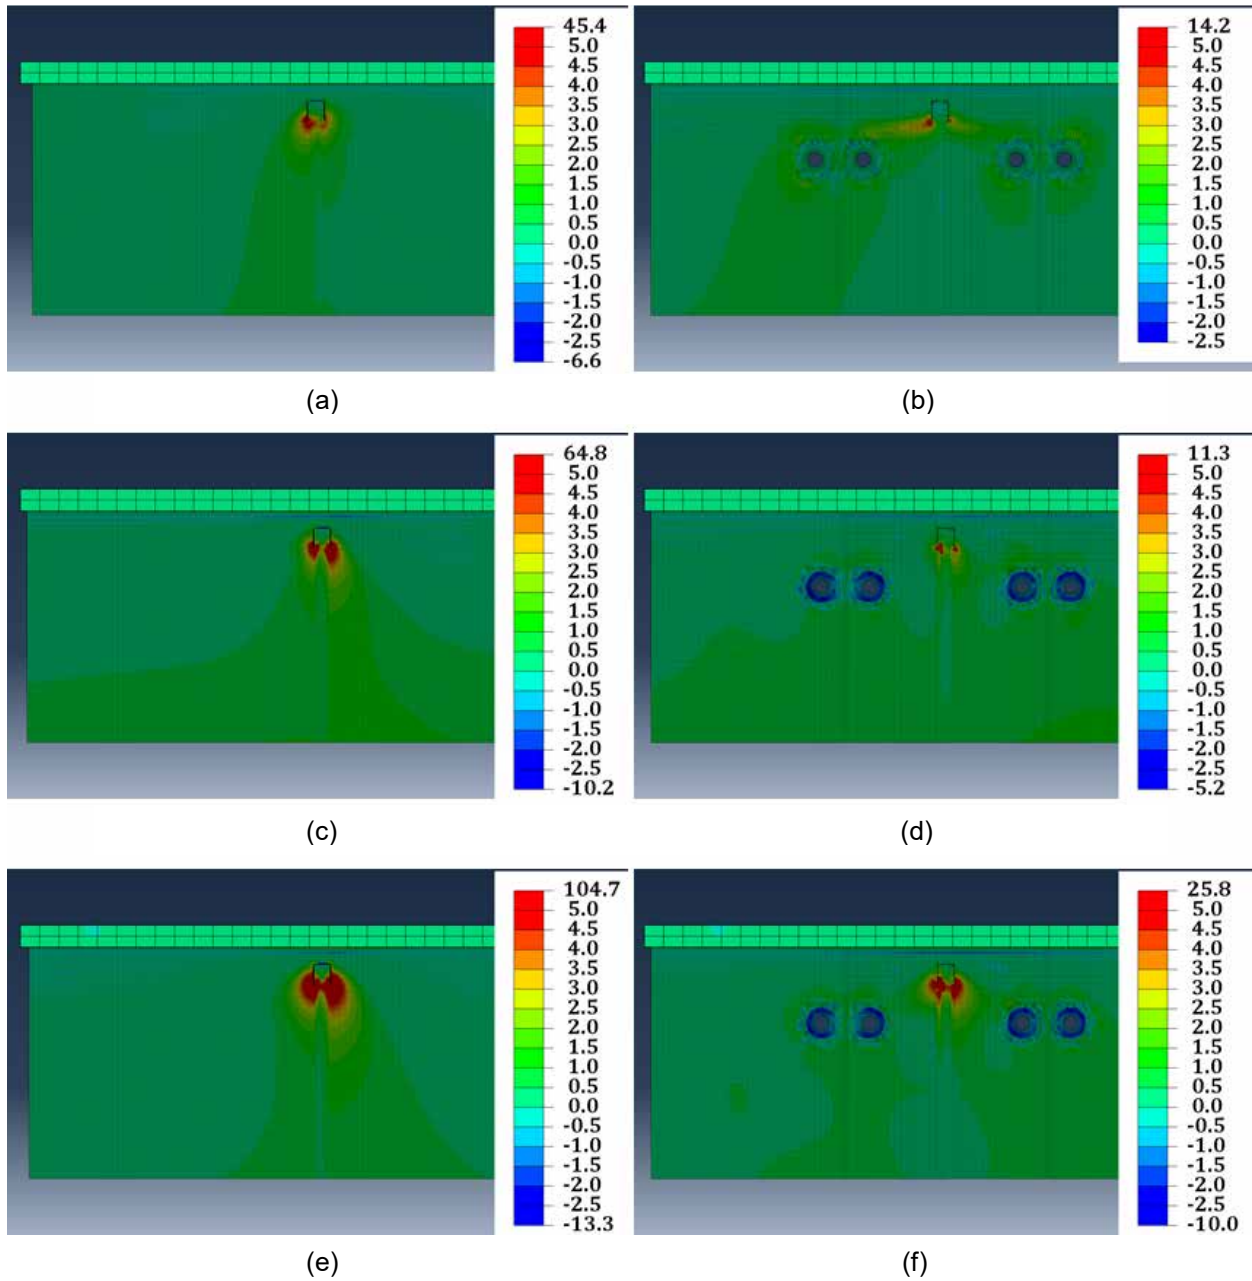
Figure 6.11 shows maximum principal stresses from all three truck location loadings, both before and after retrofit application, for the top web gap when only the connection plate-to-web weld crack was present. After application of the retrofit, HSS 1 stress was reduced under the bridge center, west lane, and east lane truck loadings by 63%, 26%, and 50%, respectively. Figure 6.12 shows maximum principal stresses, both before and after retrofit application, for the top web gap when only the flange-to-web weld crack was present. Application of the retrofit reduced HSS 2 stress demand under the bridge center, west lane, and east lane truck loadings by 23%, 14%, and 2%, respectively.
