This appendix describes the interactions of the equipment, starting from the interaction of the colliding locomotives. The interactions of the coupled passenger equipment are described in detail, and an overview is presented of the interactions of the coupled freight equipment.

## Appendix A.2.1: Additional Detail on Structural Damage to Passenger Locomotive and Cars

## Appendix A.2.2: Additional Detail on Structural Damage to Freight Locomotives and Cars

## Appendix A.3: Fuel Tank Damage

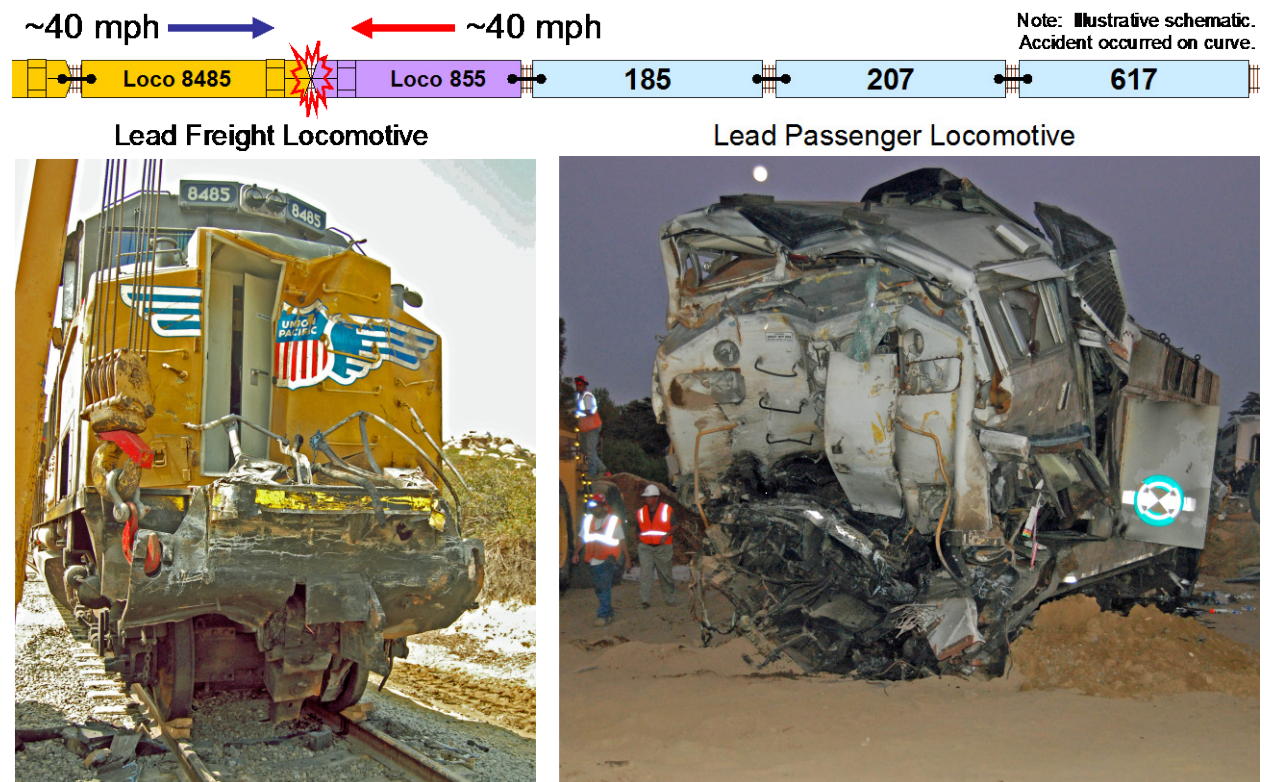
**Figure A.1-1. Lead Freight and Passenger Locomotives, Impact Ends**

Figure A.1-1 shows the impact ends of the lead passenger and freight locomotives. The freight locomotive sustained substantially less damage than the passenger locomotive. Damage to the freight locomotive includes separation of the plow, the breast plate bent up under the underframe, damage to the short-hood door and sheet metal. The draft gear box is largely destroyed, and the draft gear and broken coupler shank can be seen hanging down in the photograph. The collision posts remain essentially intact, and the truck is attached. The passenger locomotive is shown after it has been up-righted. While the shape of the cab appears recognizable, the cab has been pushed back over the rotating equipment, eliminating the operator's survival space. The collision posts have been separated from their attachments to the underframe, and the lead truck is not under this locomotive.

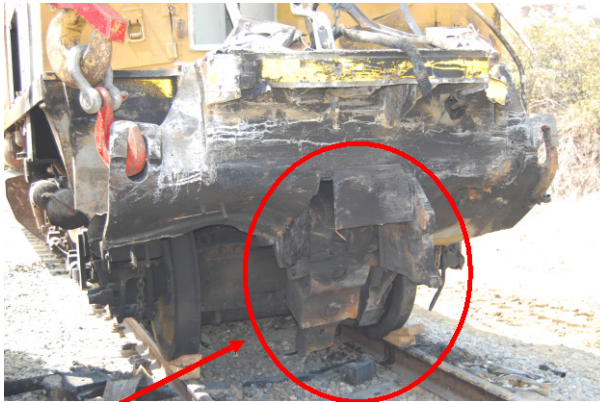
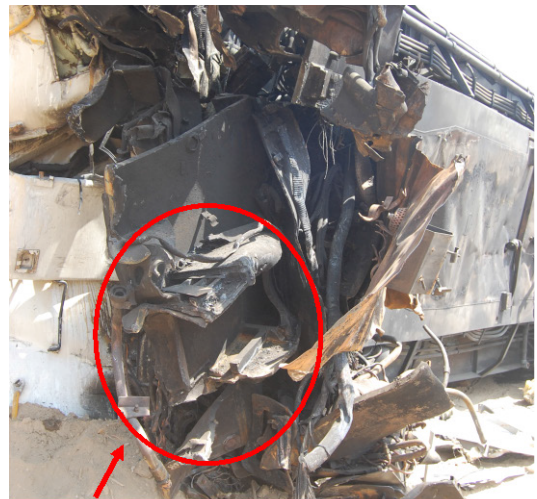
**Figure A.1-2. Coupler and Draft Gear Damage, Lead Freight and Passenger Locomotives**

Broken coupler shank. Coupler draft pocket deformed and oriented downward.

Pilot fractured and tore away. Sides of draft gear pocket fractured.

Coupler and draft gear pocket fractured off of locomotive underframe.

Figure A.1-2 shows the remains of the coupler pockets and draft gear housings of the lead freight and passenger locomotives. Both are substantially damaged. Most of the draft gear housing has been separated from the passenger locomotive and the draft gear, yoke, and coupler are missing from the photograph. The freight draft gear housing also appears to be largely missing, but the draft gear, yoke, and broken coupler shank are hanging, and appear trapped by the bent breast plate.

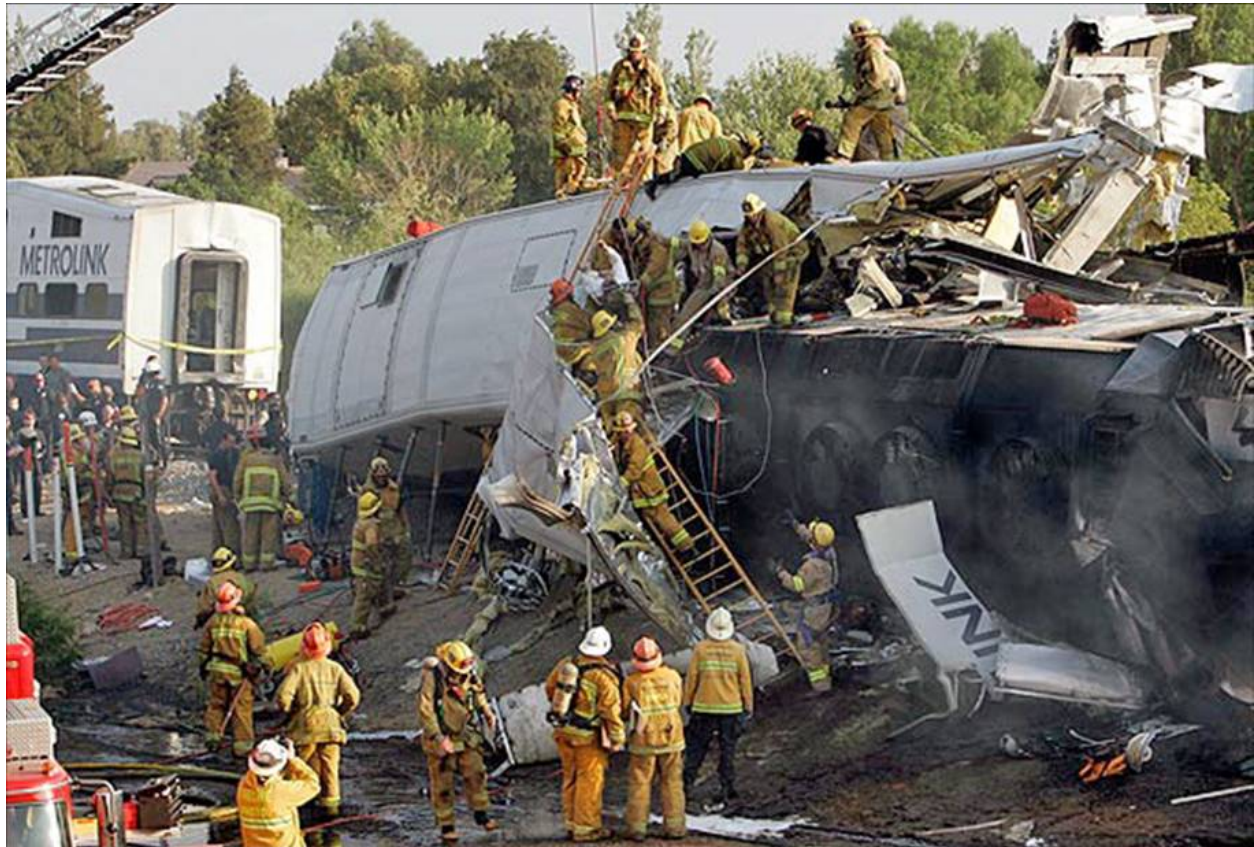
**Figure A.1-4. Interaction of Passenger Locomotive and First Passenger Car**

Figure A.1-4 shows the interaction of the passenger locomotive and the first passenger car. There was extensive structural damage to the passenger car, while there appears to be little damage to the trailing end of the locomotive. The photograph shows the locomotive telescoped into the passenger car. The locomotive is on its side, while the passenger car is not quite fully on its side. (Note: the photograph shows the cars in reverse position from the schematic above that illustrates the relative position of cars in the collision).

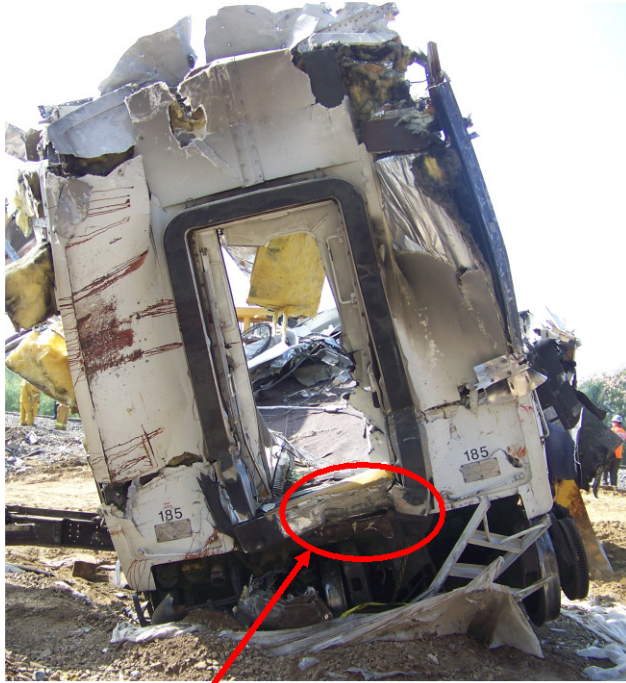
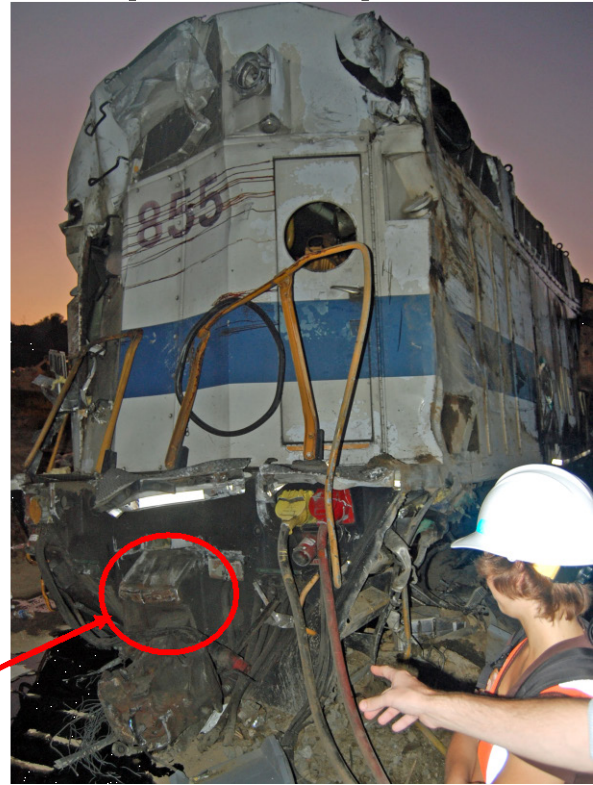
**Figure A.1-5. First Passenger Car Lead End Frame Interaction with Locomotive Trailing End Bellmouth**

Figure A.1-5 shows the lead end structure of the first passenger car, after it has been extracted from the body of the car. The collision and corner posts are essentially intact. There is a large dent in the underside of the end beam, circled in red. The shape of this dent corresponds to the shape of the bellmouth on the trailing end of the locomotive, which is also circled. This dent suggests that the rear of the passenger locomotive applied an upward vertical force to the front of the passenger car, as the front of the passenger car was also pitching downward.

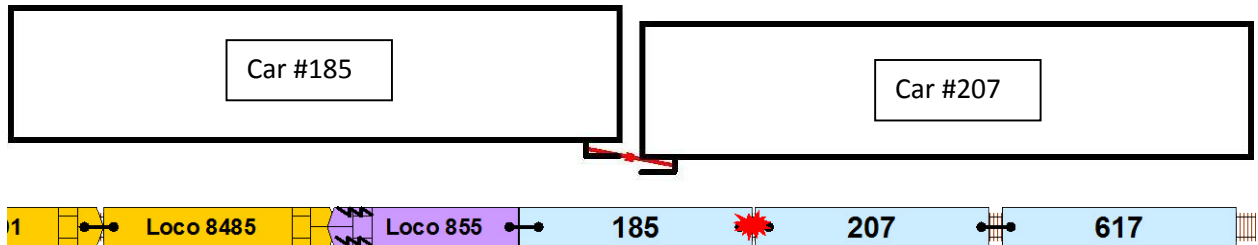
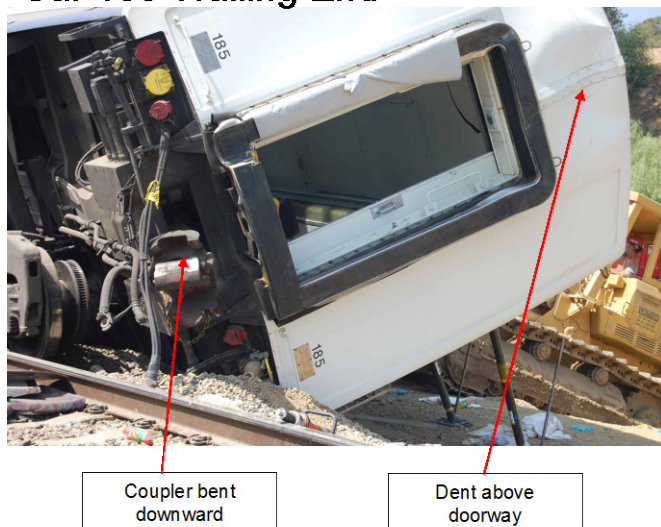
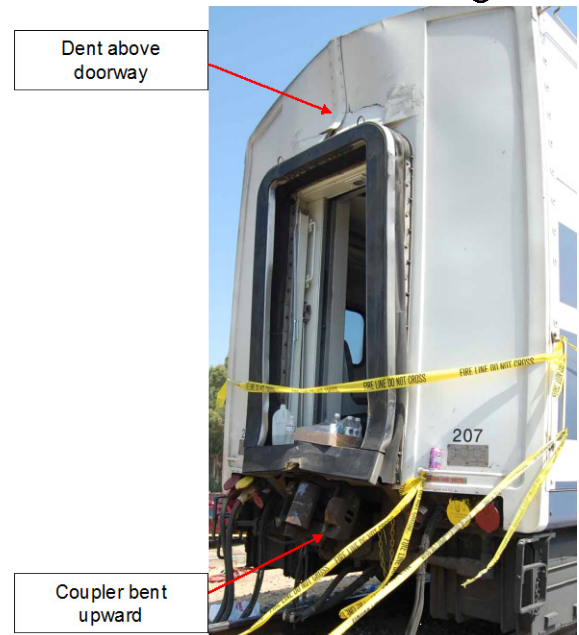
**Figure A.1-6. Trailing End of First Passenger Car and Leading End of Second Passenger Car**

The trailing end of Car #185 lifts upward relative to Car #207. The leading end of Car #207 pitches downward.

Figure A.1-6 shows the interaction between the trailing end of the first passenger car and the leading end of the second passenger car. The first passenger car coupler head is bent downward. There is a dent in the lower corner of the door bellows, on the left side, and there is a dent above the doorway. At the leading end of the second passenger car, the coupler is bent upward. The left side collision post appears bent, near its attachment to the floor-level structure, and the right side post appears bent in a similar location but to a lesser degree. The damage suggests that both cars pitched forward, i.e., the front ends of both cars went down and the back ends went up.

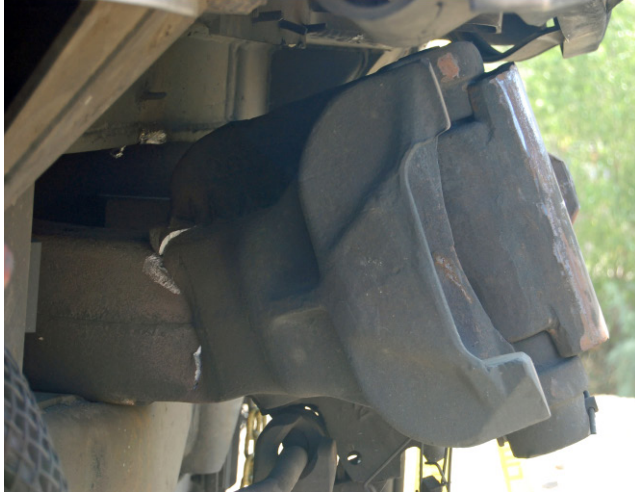
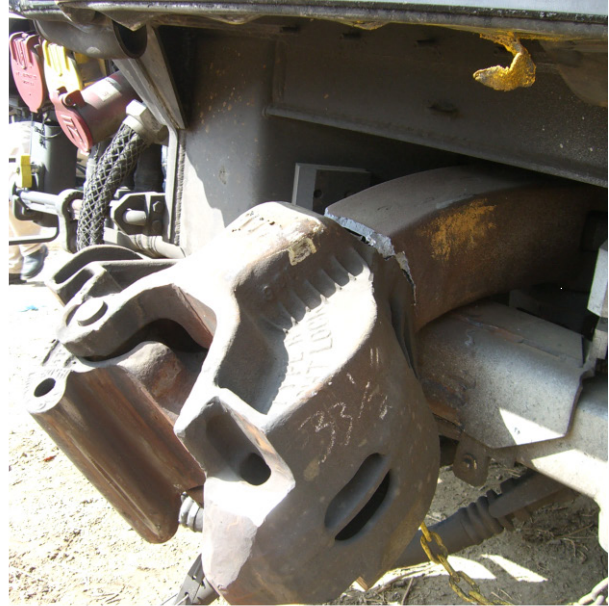
**Figure A.1-7. Trailing Coupler of Lead Passenger Car and Leading Coupler of Second Passenger Car**

Figure A.1-7 shows the trailing coupler of the lead passenger car and the leading coupler of the second passenger car. At some point during the accident, the cars became uncoupled, but the extent of damage suggests that the cars remained coupled for most of the impact, including the pitching forward discussed in relation to Figure A.1-5. There is significant material failure near where the head blends into the shank in both couplers. This damage suggests that the lead car tried to override the second car.

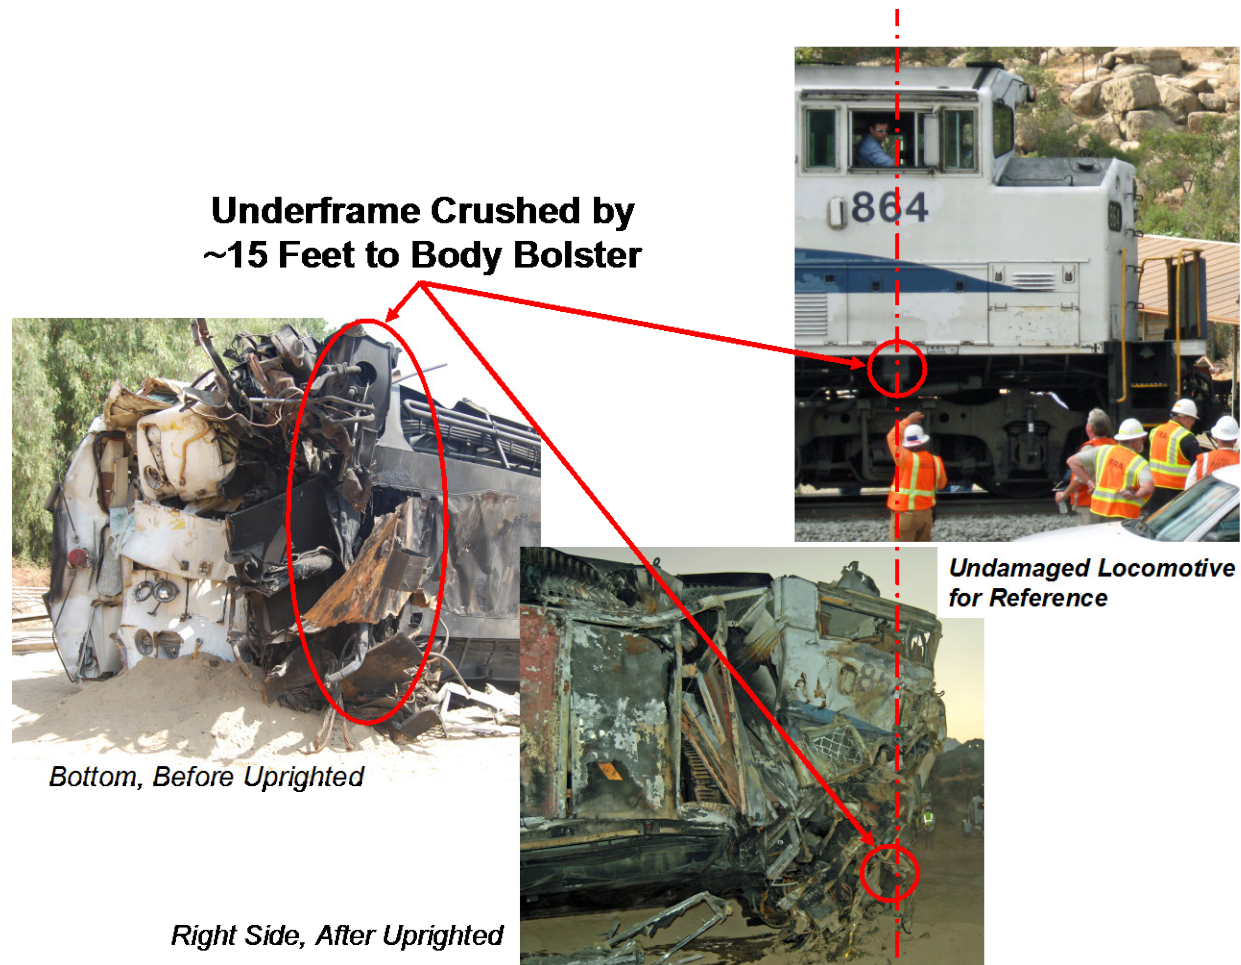
**Figure A.2.1-2. Passenger Locomotive Lead End Crush**

Figure A.2.1-2 shows the structural damage to the lead end of the passenger locomotive. A photograph of an undamaged locomotive is included for reference. While the side window frame is visible in the lower right photo, there is no interior cab space, as the cab has been pushed back over rotating equipment. The locomotive has been crushed approximately 15 feet, from the coupler back to the body bolster. The truck normally mounts to the frame at the body bolster; however, the attachments were destroyed in the collision. The lead truck separated from the equipment it supported, both the locomotive car and the fuel tank.

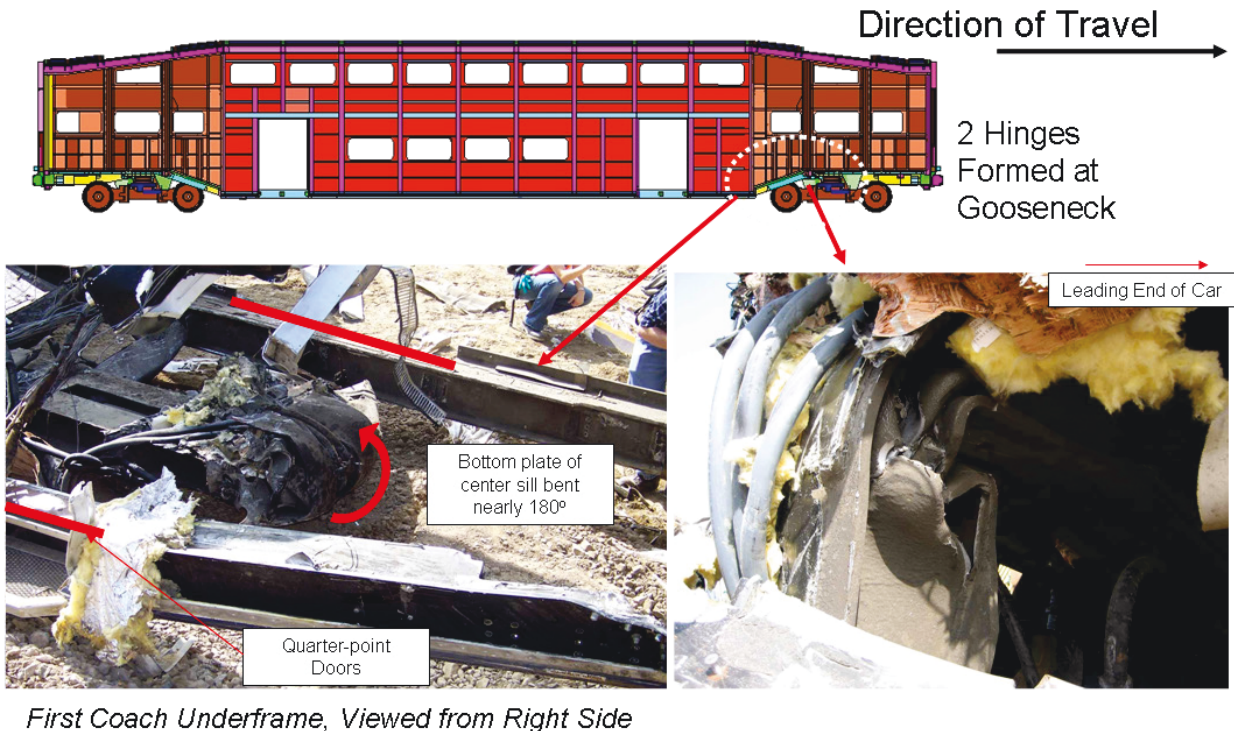
**Figure A.2.1-4. Gooseneck Damage**

Figure A.2.1-4 includes a schematic of the first passenger car, with the primary area of structural collapse circled. The primary area of structural collapse is termed the gooseneck. In this part of the structure, the underframe transitions from being above the truck, approximately 34 inches above top-of-rail (TOR), down to 18.5 inches above TOR. This transition is made to accommodate the two-level center section of the car. The diagonal section of the gooseneck was apparently destroyed in the accident; as no evidence of it was found. The photograph in the lower left of the figure shows the remains of the end of the lower center sill. It can be seen that the end has been pounded and bent nearly 180° into a 'U' shape. The lower side sills extend to essentially their initial length. Holes for the rivet connections to the diagonal portion of the gooseneck can be seen in the right side sill. The photograph on the right shows the remains of the end of the single-level portion of the center sill. This end has been bent down about 90 degrees into a 'L' shape. This end of the center sill does not appear to have been pounded repeatedly, as the lower end of the side sill in the left side photograph appears to have been.

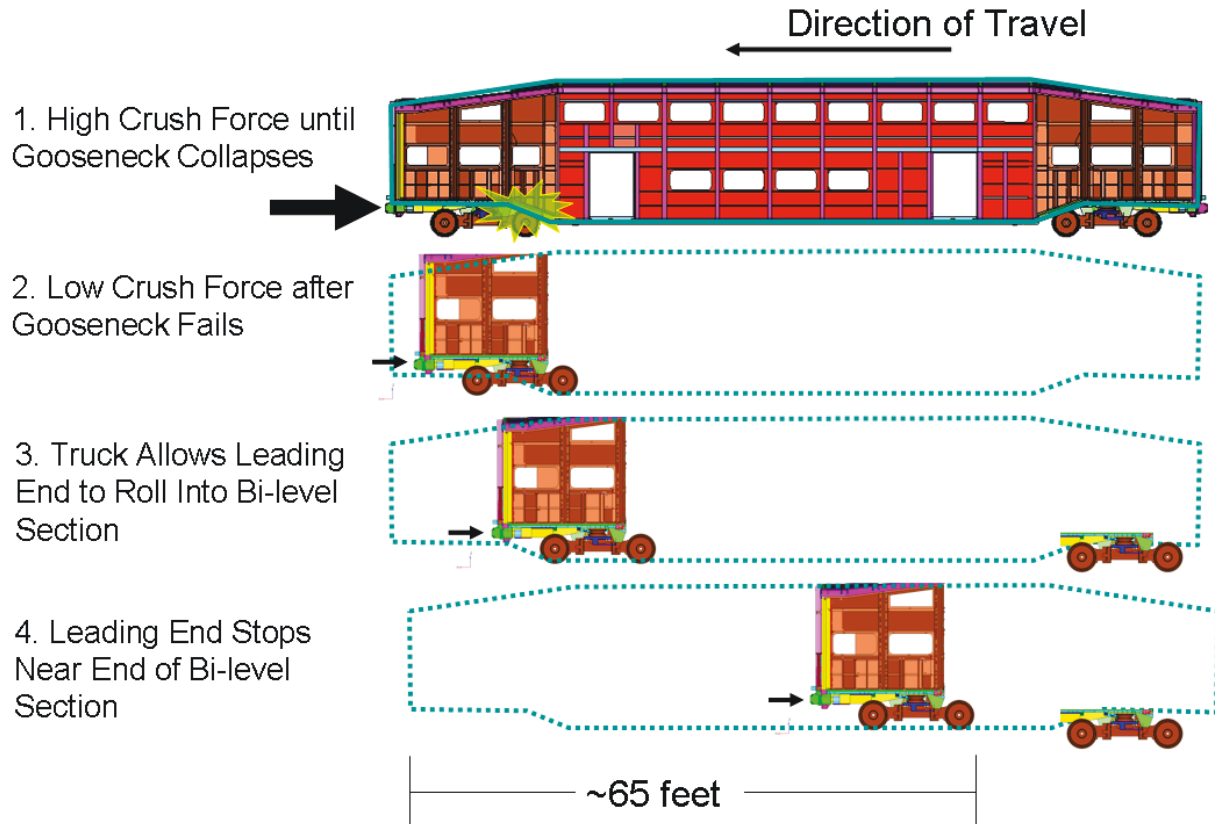
**Figure A.2.1-5. Progression of Gooseneck Collapse and Failure**

Figure A.2.1-5 shows schematics illustrating how the structural damage shown in Figure A.2.1-4 occurred. Shortly after the initial contact between the lead freight and passenger locomotives, a high force was generated between the leading passenger locomotive and leading passenger car. This force was sufficient to cripple and fail the gooseneck area of the passenger car underframe. Simultaneously, due to the geometry of the gooseneck and its mode of collapse, the end underframe and truck were vaulted upward. This upward movement raised the wheels of the lead truck to the height of the lower floor of the bi-level section of the car, and the center sill was no longer carrying a longitudinal force. A relatively low longitudinal load was provided by the remaining sidewall and roof structures. The end section of the car, including the truck that had lifted up, penetrated and moved backward through the bi-level section of the car with relatively little force.

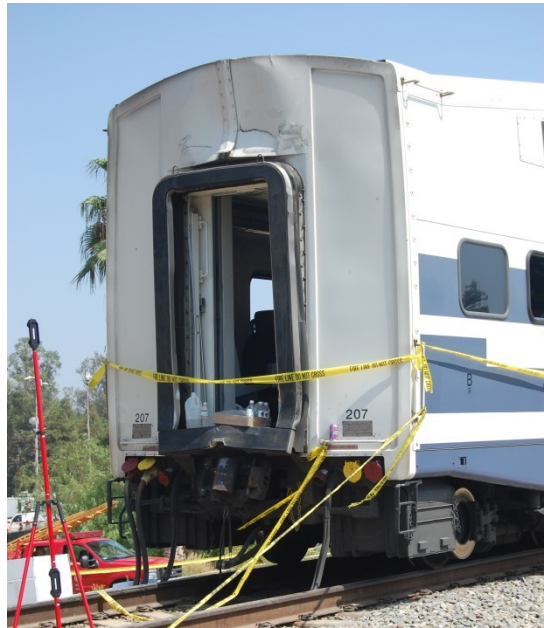
**Figure A.2.1-9. Leading End of Second Passenger Car**

Figure A.2.1-9 shows the leading end of the second passenger car. The bellows shows damage from contact with the car ahead. There are dents on the bellows frame, just above the spring loaded buffer beam. There is also damage to the fiberglass end cap above, just above the bellows. This damage is consistent with the leading car attempting to override this car.

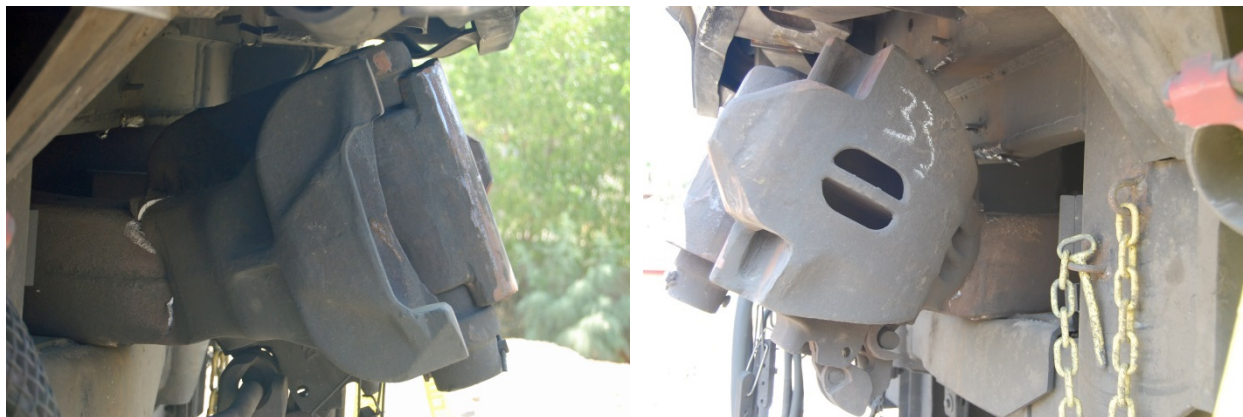
**Figure A.2.1-10. Leading (B) End Coupler of Second Passenger Car**

Figure A.2.1-10 shows left-side and right-side view of the leading end coupler of Car #207. The coupler is bent at the connection area between the head and the shank. The head is bent upward at an angle of roughly 30 degrees. There are indications of material failure near the corners of the shank where it meets the head. The material of the sidewalls of the shank remained together. The damage suggests that separation of the head and the shank is imminent. This damage is also consistent with the lead car attempting to override Car #207.

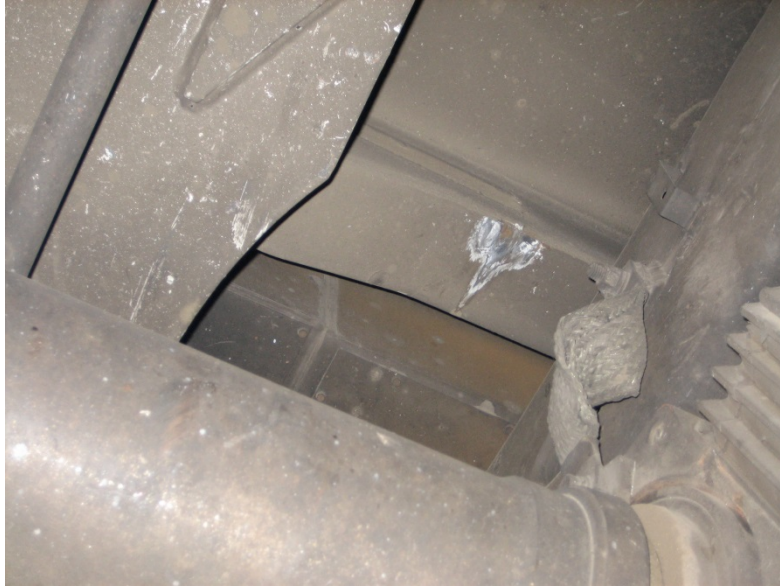
**Figure A.2.1-11. Scar on Carbody Above B End Outboard Axle Bearing Housing**

Figure A.2.1-11 shows a scar on the underframe. This scar appears to be due to the bearing housing of the truck axle contacting the underframe. Such contact could occur if the truck pitched significantly during the impact.

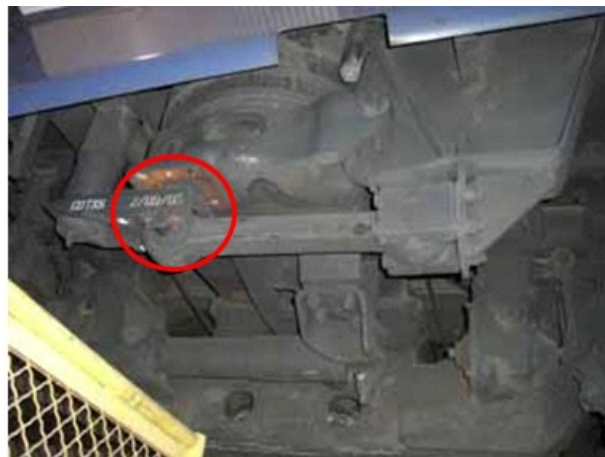
**Figure A.2.1-12. Second Passenger Car Sidewall and Truck Attachment Damage**

Figure A.2.1-12 shows sidewall deformation near the gooseneck region of the underframe. Both ends of the car showed similar damage, on opposite sides. On the leading end, the sidewall damage appeared to be associated with a bubble-shaped deformation in the bottom plate of the draft sill, however, the bubble appeared to be shallow. It was not possible to measure the flatness of this plate with the truck in place to confirm the presence of a bubble. On the left side of the leading end, the bolts to the drag link attachment to the carbody were also broken. The failure of these bolts was similar to the failure seen on the trailing truck of the first car. Similar failures have also been observed in an impact test of similar equipment [1].

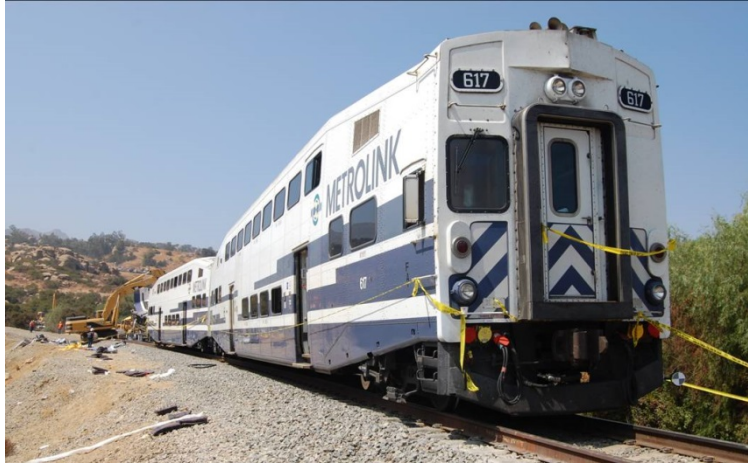
**Figure A.2.1-13. Trailing Cab Car and Failed Truck Retention Mechanism**

Figure A.2.1-13 shows the third passenger car, Metrolink Passenger Car #617. There was virtually no structural damage to this car, however the truck retention mechanism did fail (not visible in the photo). Despite this equipment failure, the running gear remained intact and the truck remained in place beneath the car.

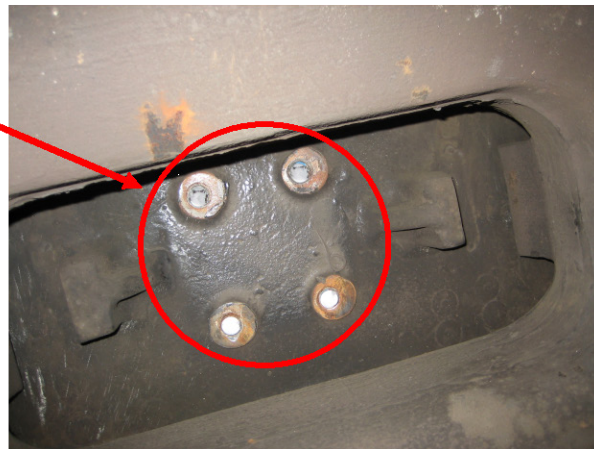
**Figure A.2.1-14. Failed Truck Retention Mechanism on Trailing (F) End of Trailing Passenger Car**

Figure A.2.1-14 shows the mounting boss for the truck retention mechanism, with the broken bolts visible. The truck retention mechanism is a tulip-shaped casting that protrudes through the rectangular hole in the truck frame. The base of the tulip normally mounts to the casting boss with four bolts. There is normally clearance between the rectangular hole and the tulip-shaped casting, which allows the truck to rotate, so the car can negotiate a curve. The failure of these bolts in the trailing cab car was similar to the failure of these bolts seen on the trailing truck of the first car. Similar failures have also been observed in an impact test of similar equipment [1].

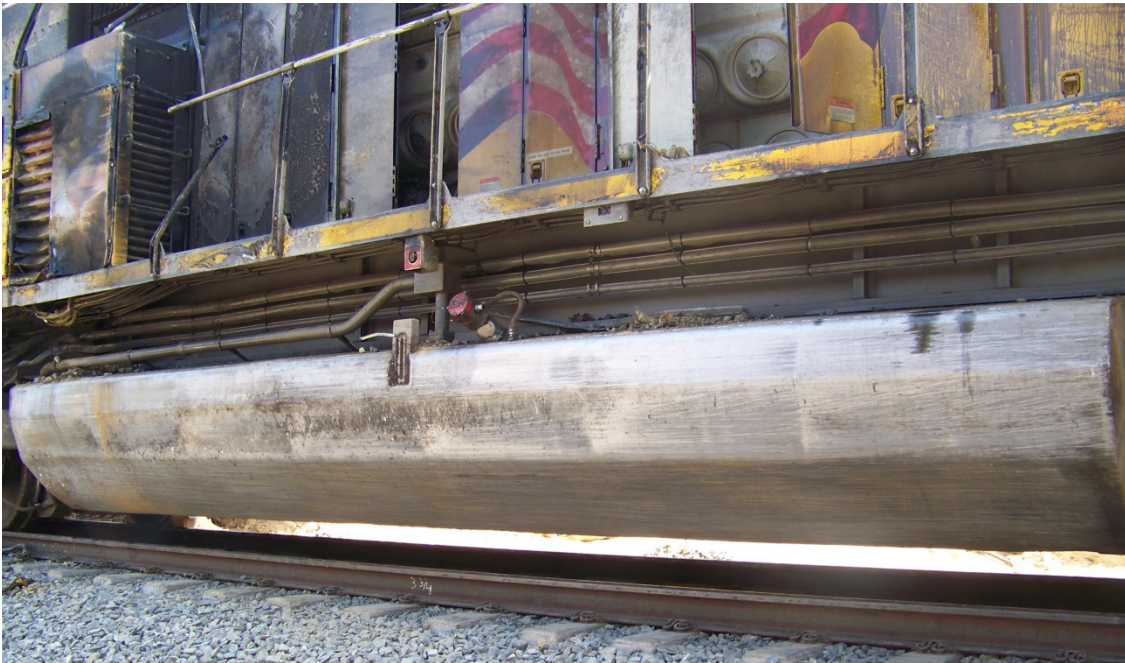
**Figure A.2.2-3. Left Side of Lead Freight Locomotive**

Figure A.2.2-3 shows that the right side of the locomotive has little damage. The underframe is essentially intact, and both trucks and the fuel tank remained attached.

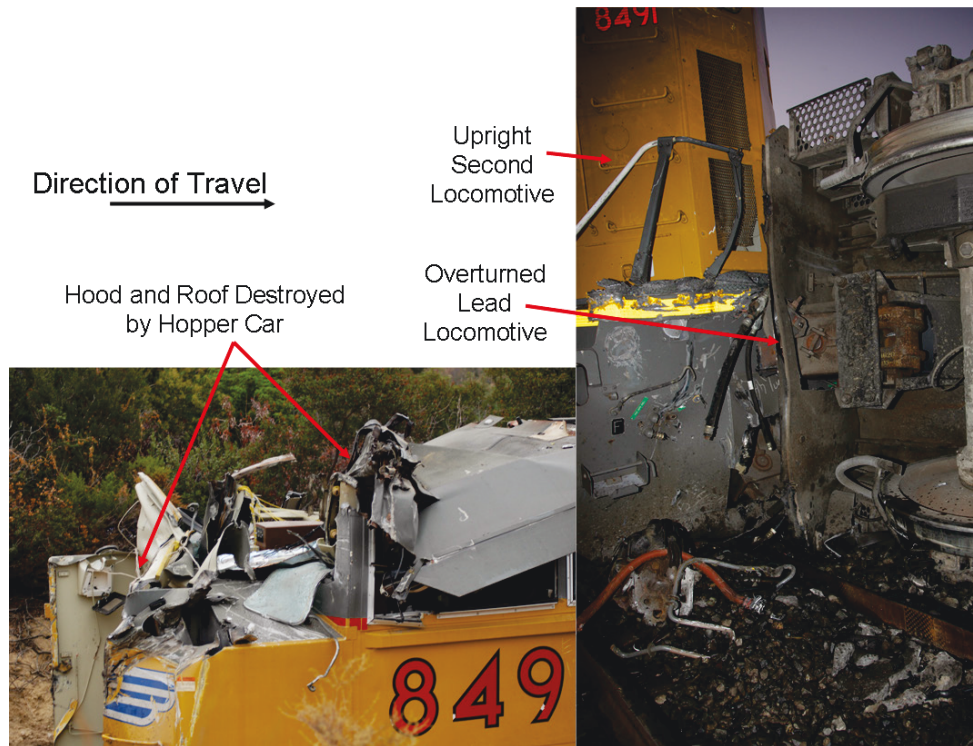
**Figure A.2.2-5. Second Freight Locomotive Structural Damage**

The photos in Figure A.2.2-5 depict the damage to the second freight locomotive inflicted by the hopper car and the damage caused by the interaction between the first and second freight locomotives.

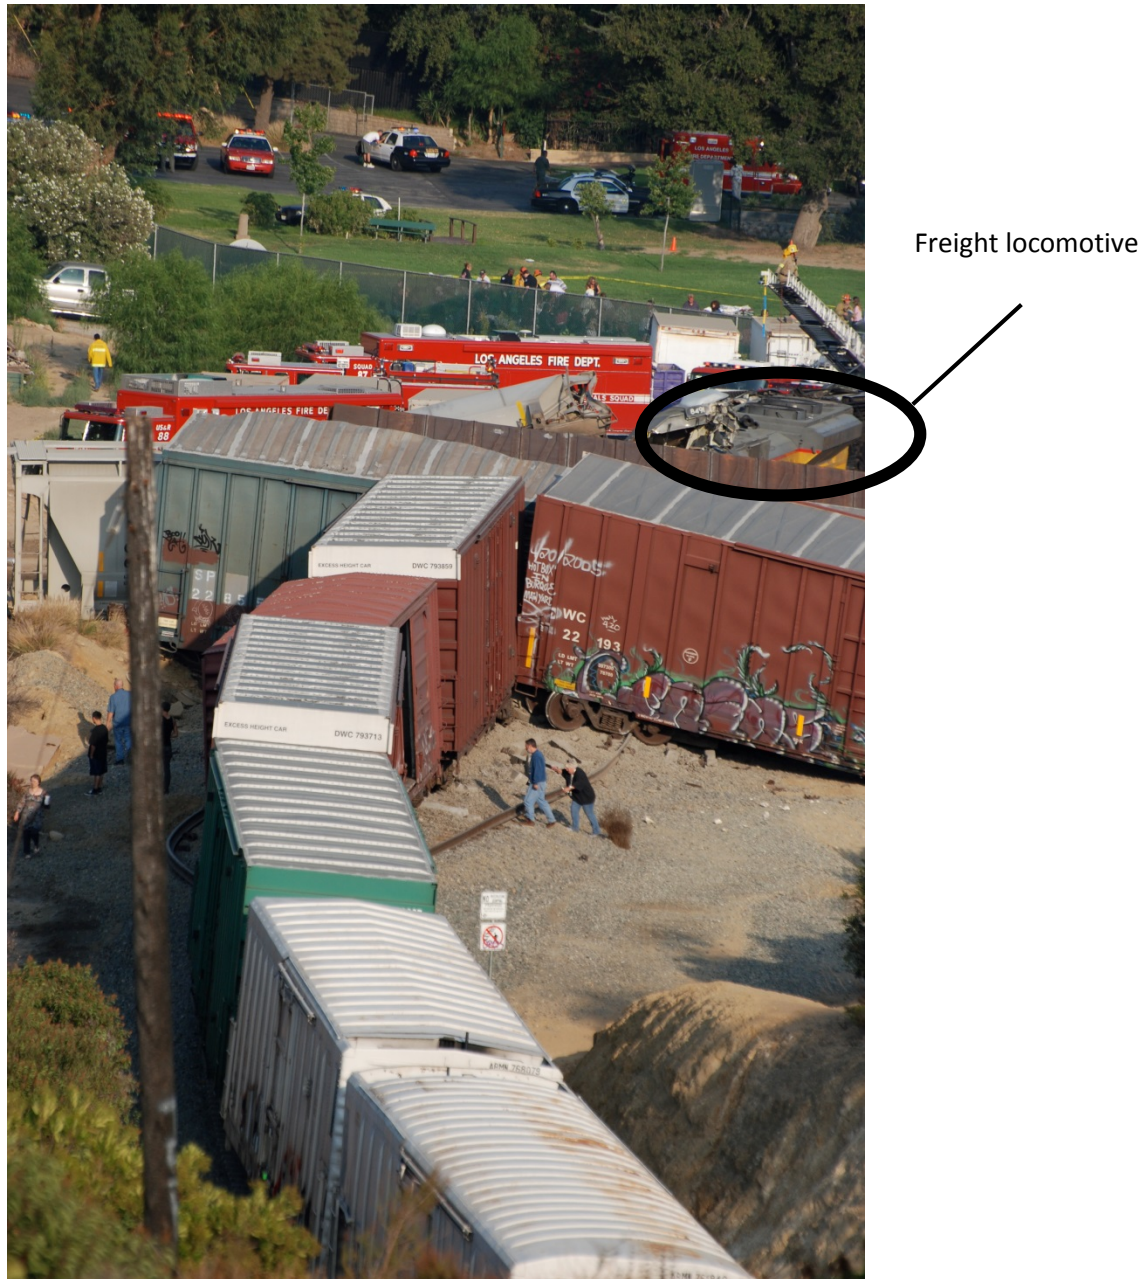
**Figure A.2.2-6. Trailing Freight Equipment**

Figures A.2.2-6 through A.2.2-8 show the trailing freight equipment. The second freight locomotive and its damaged roof can be seen in the upper-right portion of the photograph above. The end of the covered hopper car resting on the short hood can also be seen. The end of a second covered hopper car can be seen on the left side of the photograph. Three box cars are then stacked up perpendicular to the track. The next three box cars are upright and derailed. A rail can be seen near the two-people walking up to the middle upright and derailed freight car. The three freight cars near the bottom of the photograph are upright and on the track, as well as the remaining four trailing freight cars, which are not visible in the photograph.

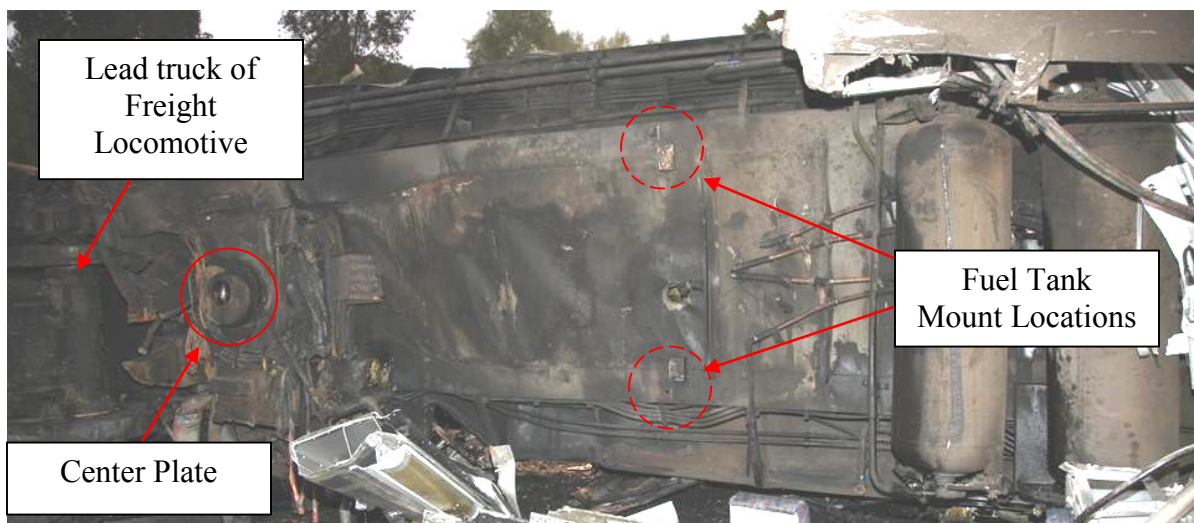
**Figure A.3-5. Passenger Locomotive Underframe, Before Locomotive Moved by Rescue and Recovery Crew**

This photograph shows the passenger locomotive's center plate, the area where the lead truck is normally attached. The underframe of the locomotive has been deformed backward, resulting in the center plate moving toward the trailing end of the locomotive. Visible toward the center of the photograph are the locations of the trailing-end fuel tank mounts. The top location (left hand side of the upright locomotive) still contains a mounting bolt that has been fractured.

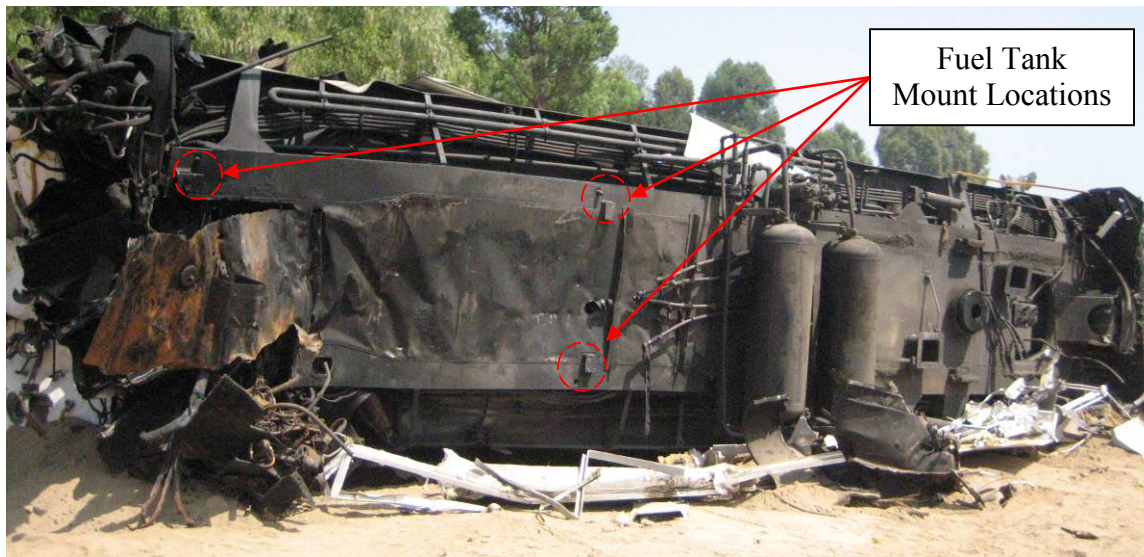
**Figure A.3-6. Passenger Locomotive Underframe, After Locomotive Moved by Rescue and Recovery Crew**

Prior to the crashworthiness team's arrival on scene, the freight locomotive and the passenger locomotive were moved as part of the rescue and recovery operations. As a result of this move, portions of the damaged passenger locomotive underframe were disturbed, including the center plate from the lead truck. Figure A.3-6 is a photograph of the underframe of the locomotive after it was moved from its post-accident location. Three fuel tank attachment locations are highlighted in this photograph. Two of these three locations include fractured mounting bolts still in their holes.

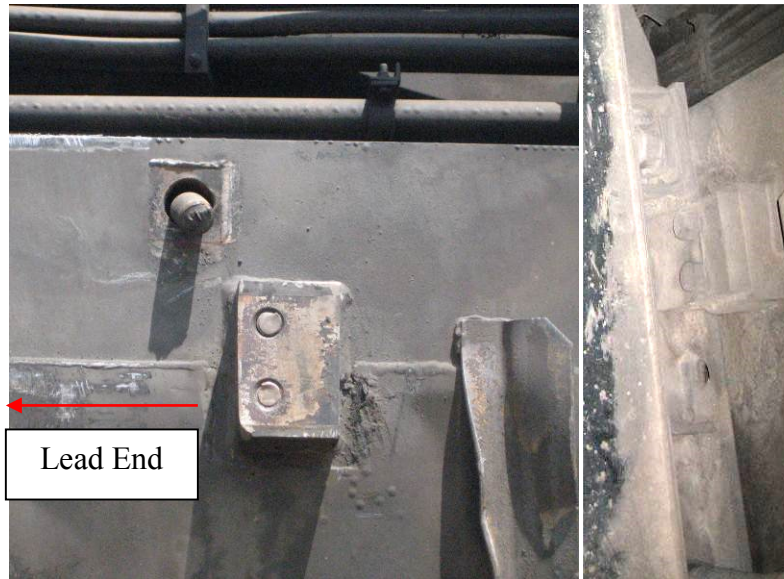
**Figure A.3-7. Fractured Fuel Tank Mounting Arrangement (left), undamaged Exemplar Mounting Arrangement (right)**

The left side of Figure A.3-7 shows one of the fractured bolts and damaged clips used to mount the fuel tank. This particular bolt was located on the left-hand side of the locomotive, at the trailing end of the fuel tank. The bolt is visibly bent toward the rear of the locomotive. It is unknown whether the orientation of the bolt was a result of the accident or a result of movement during rescue and recovery operations. Additionally, the clip has sustained damage, including shearing of the bolt heads and an apparent fracture to the clip itself. For reference, the right side of Figure A.3-7 shows an undamaged fuel tank mounting arrangement on an exemplar locomotive of a similar type to that involved in the accident. Note that the reference photograph has been rotated to provide a similar view to that of the overturned locomotive.

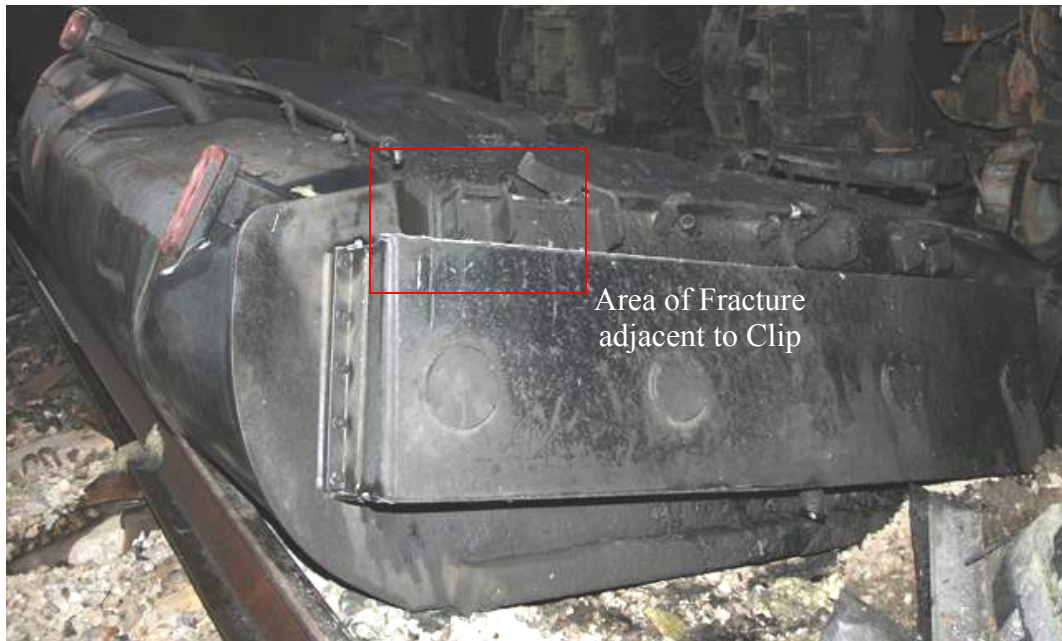
**Figure A.3-8. Trailing End of Fuel Tank**

Figure A.3-8 shows the accident fuel tank in its post-accident position. The end shown was toward the trailing end of the passenger locomotive. At the top of the fuel tank there is fracture in the area where the clip would have contacted the fuel tank, indicated above by the box. There does not appear to be a breach of the fuel tank at this end. This area of fractured fuel tank would have been mounted at the location depicted in Figure A.3-7.

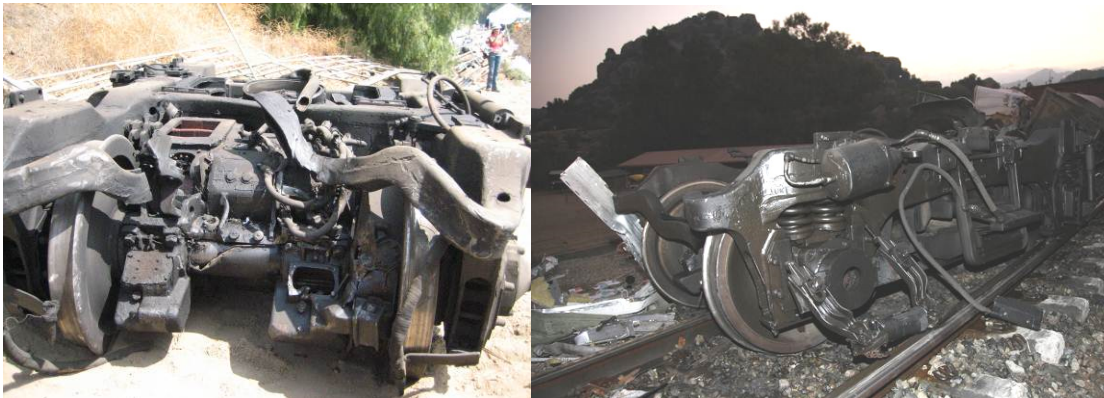
**Figure A.3-9. Passenger Locomotive Lead Truck: Leading End (left) and Trailing End (right)**

Figure A.3-9 shows the lead truck of the passenger locomotive. Note that these photographs were taken at two different times. The left side photograph was taken after the truck had been moved, and the right side photograph was taken when the truck was still in its post-accident position, prior to the arrival of the crashworthiness team. The leading end of the truck, shown on the left, featured extensive structural damage to its frame. The lateral member has been bent backward and has fractured. The trailing end of the truck, shown on the right, also shows some structural damage. The trailing lateral member has been bent toward the lead end of the locomotive. It is

probable that the trailing end of the lead truck was able to contact the leading end of the fuel tank during the collision, contributing to the breach of the tank and its eventual attachment failure.
