EVALUATION REPORT

FIBER-REINFORCED POLYMER (FRP) PULTRUDED DECKING MATERIAL AND HELICAL ANCHORING SYSTEM FOR USE IN SNOW FENCE APPLICATIONS

Location: Livingston, Montana. Interstate 90, MP-332, Park County

Project No.: IM90-7(63)331

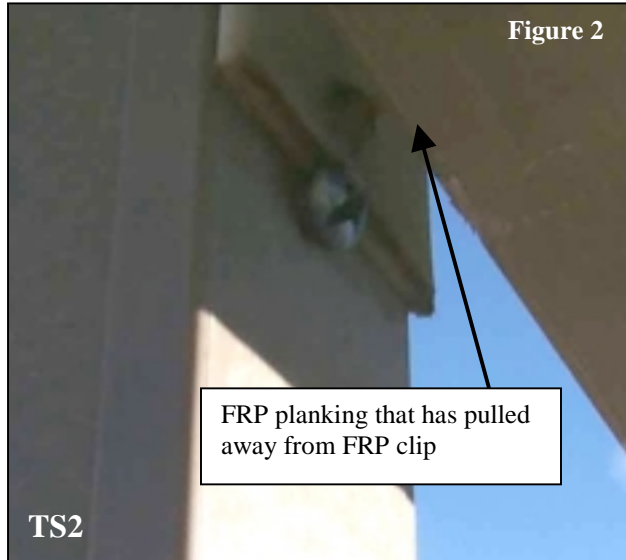
The evaluation consisted of a visual inspection of the FRP material and the structural supports. Special attention was given to the attachments of the FRP (setting screws, FRP clips) and the Helical Anchors used to secure the TS2 section to the ground. The section TS2 front FRP planking had expanded or pulled away from the FRP clip attachment (see Figure 2). This occurrence is just on one clip attachment and was not noticed on any

other areas of the test sections during this inspection. At this time, all other connections used to attach the FRP planking to the frames are intact with no evidence of loose screws or chipping of the FRP rail attachments. All bolts used to secure the frame to the helical anchors were tight with no visual evidence of sawing action. There has been no apparent shifting of the overall frame assembly since the Spring 2000 evaluation. Visual appearance of all the FRP material shows no signs of sun or wind degradation.

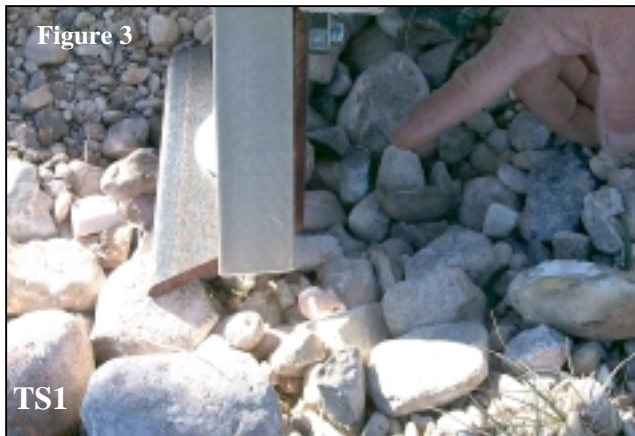
The broken bolt on the right rear sill attachment on TS1, documented in the spring 2000 inspection, shows no sign of additional movement or frame deterioration (Figure 3).

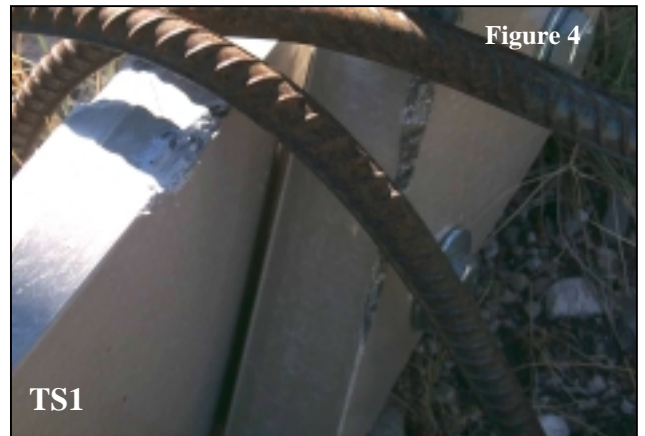
It was noticed on Section TS1 (figure 4), that the rebar used to secure the center sill bracing is abrading the FRP material. This will be watched closely for additional deterioration in later inspections.
