# **NATIONAL TRANSPORTATION SAFETY BOARD**

## **RAILROAD ACCIDENT REPORT**

**DERAILMENT OF AMTRAK TRAIN NO. 6  
ON THE BURLINGTON NORTHERN RAILROAD  
BATAVIA, IOWA  
APRIL 23, 1990**

**Abstract:** This report explains the derailment of Amtrak Train No. 6 on the Burlington Northern Railroad at Batavia, Iowa, on April 23, 1990. The safety issues discussed in this report are the lack of consistency, continuity, and comprehensiveness in Burlington Northern's Maintenance of Way Standard Practice Circulars, the efficacy of the rail expansion and contraction tables in Burlington Northern's Maintenance of Way Rules for in-track electric flash butt-welding operations, the propriety of conducting in-track electric flash butt-welding operations and out of face maintenance operations in cold weather, the effectiveness of Burlington Northern's track buckling prevention seminar for the in-track electric flash butt-welding operation, the adequacy of Burlington Northern's supervision of in-track electric flash butt-welding operations and implementation of maintenance of way standards; the ambiguity of Burlington Northern's rail temperature record form, and the lack of temperature quality contro

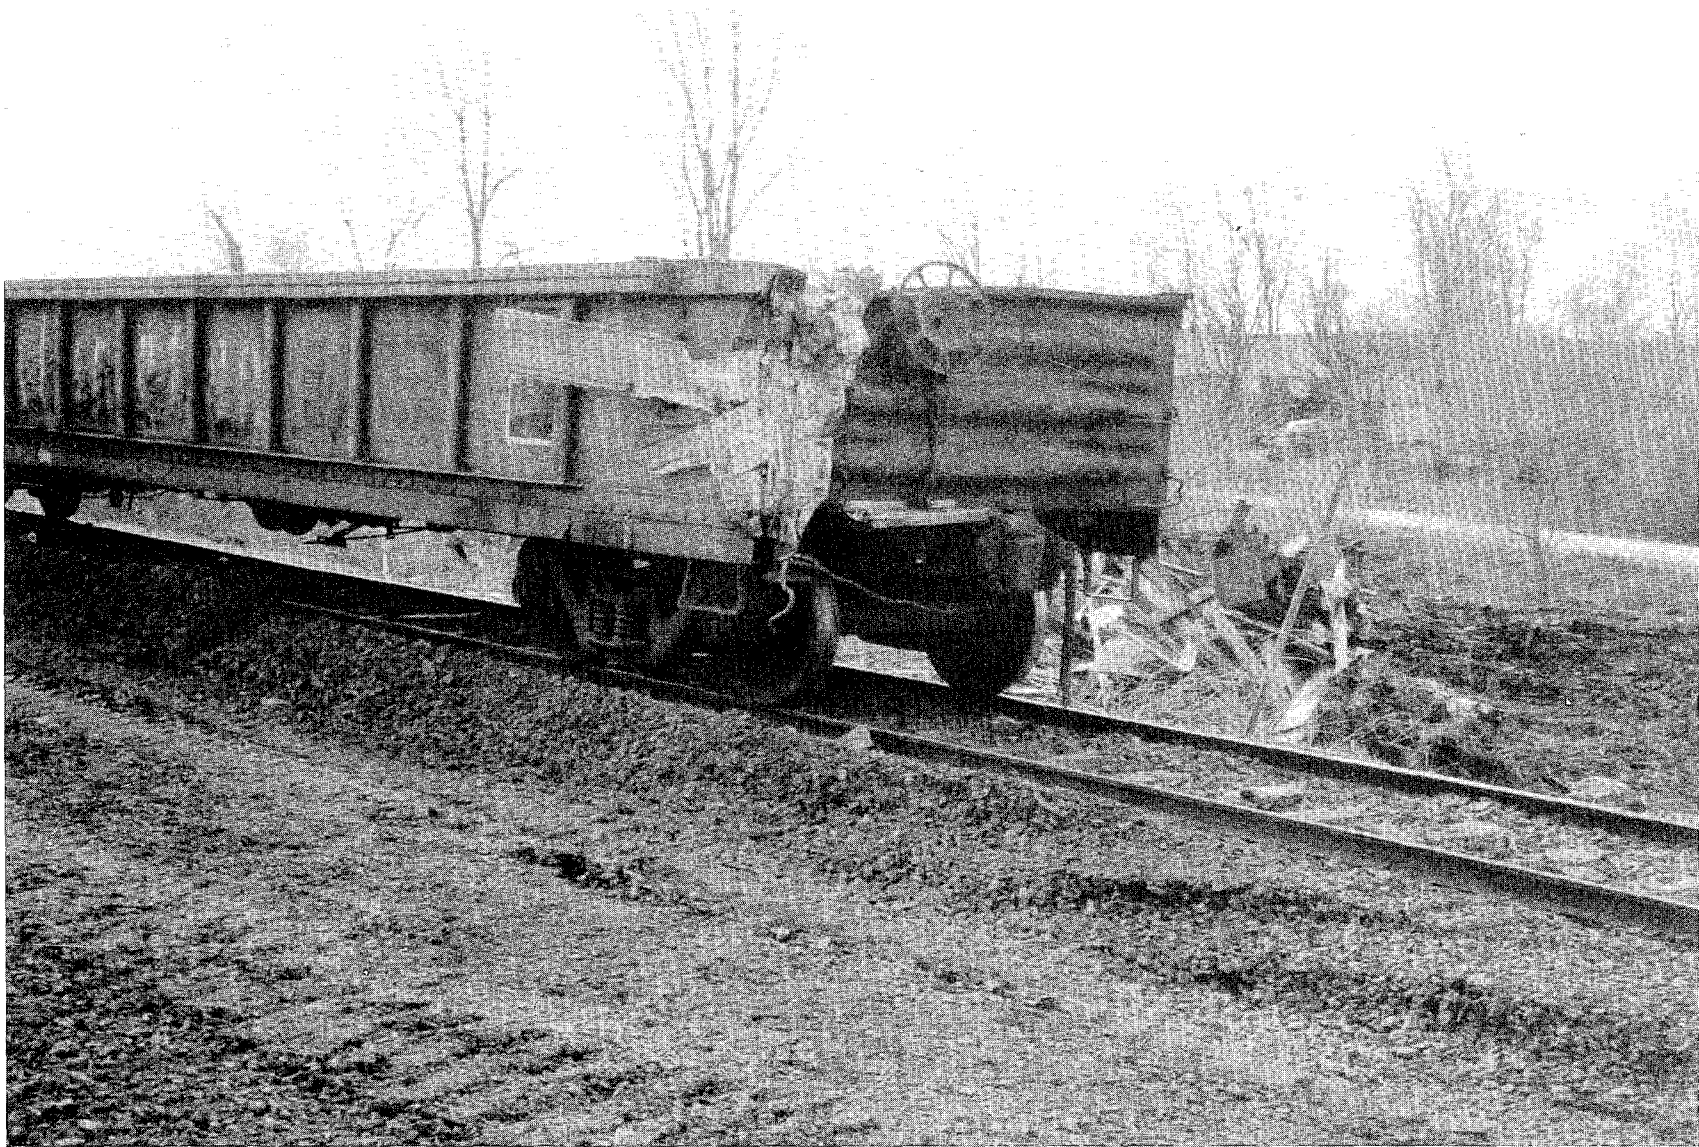
Figure 4.--Damage to gondola.

The last four cars showed evidence of contacting or striking the empty gondola car that had been placed on an adjacent parallel siding. A corner of the gondola contained pieces of stainless steel from the passenger car side sheeting. All contact points on the gondola and the passenger cars matched according to height and other dimensional data. The gondola had been struck on the corner near the hand brake and was moved along the length of the siding until it struck a derail<sup>9</sup> near the switch stand. (See figure 4.)

The fourth car from the end, sleeping car No. 32064, received a slight crease about 18 feet long on the B end<sup>10</sup> and about 60 inches from the top of the track rail, where it contacted the gondola side's top rail lip. The next car, coach No. 31012, contacted the bottom edge of the gondola side sill, which ripped a continuous cut into the side sheet stainless steel sheathing of the passenger car about 3/4 of its length, then caught and bent the corrugation and step at the A end. The corner of

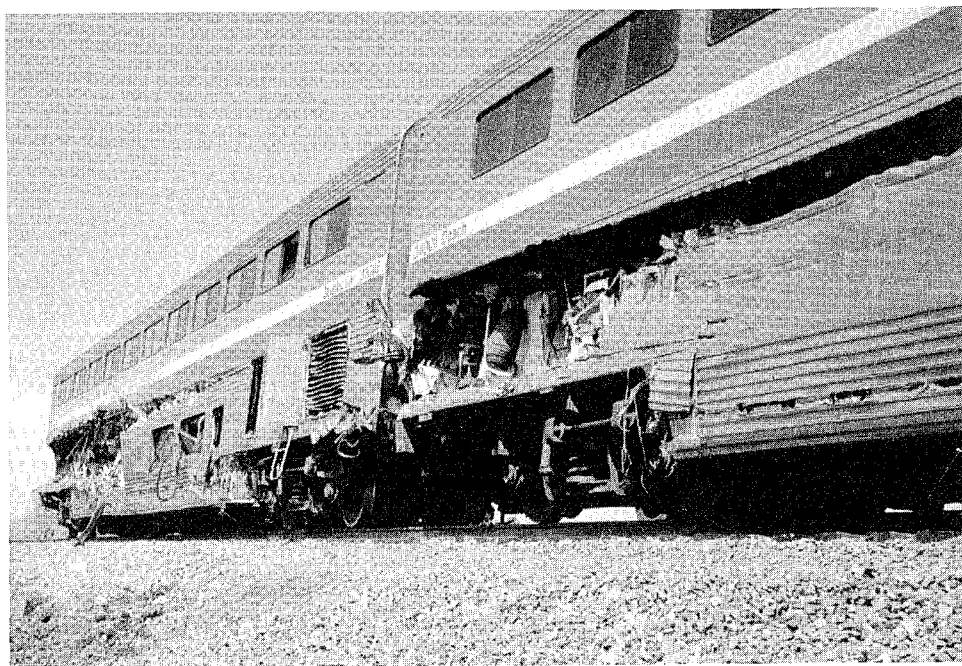
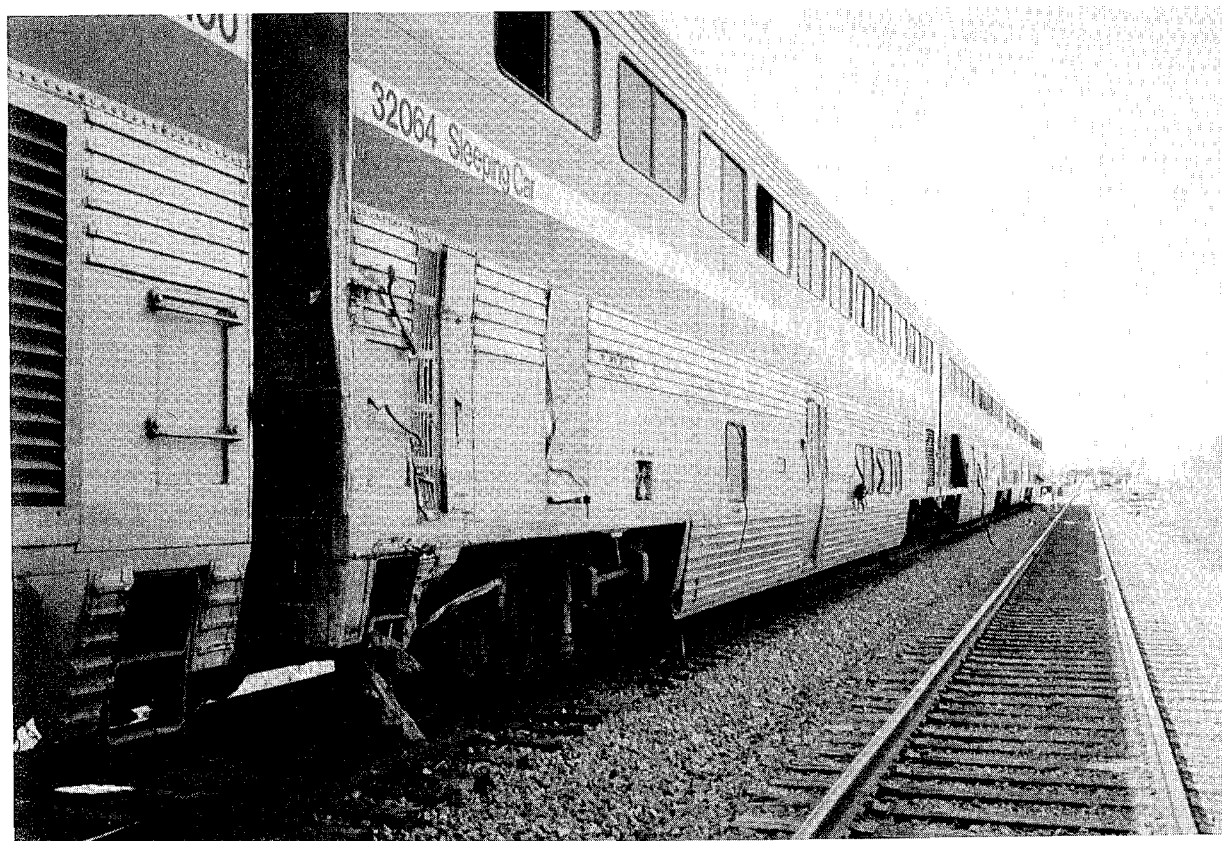
Figure 5.--Damage to coach and sleeping cars.

the gondola ripped large gashes in the trailing half of the last two cars on their south sides just below the top/lower deck separation (See figure 5)

These last two cars, coach No. 34001 and sleeping car No. 32046, had significant interior damage. Coach No. 34001 had interior and exterior wall damage from the upper level floor starting at seats 75-76 on the right (south) side and continuing to seats 83-84 at the end of the car. In sleeping car No. 32046, the interior and exterior walls of rooms 14 and 15 were destroyed, along with the car's stairwell.

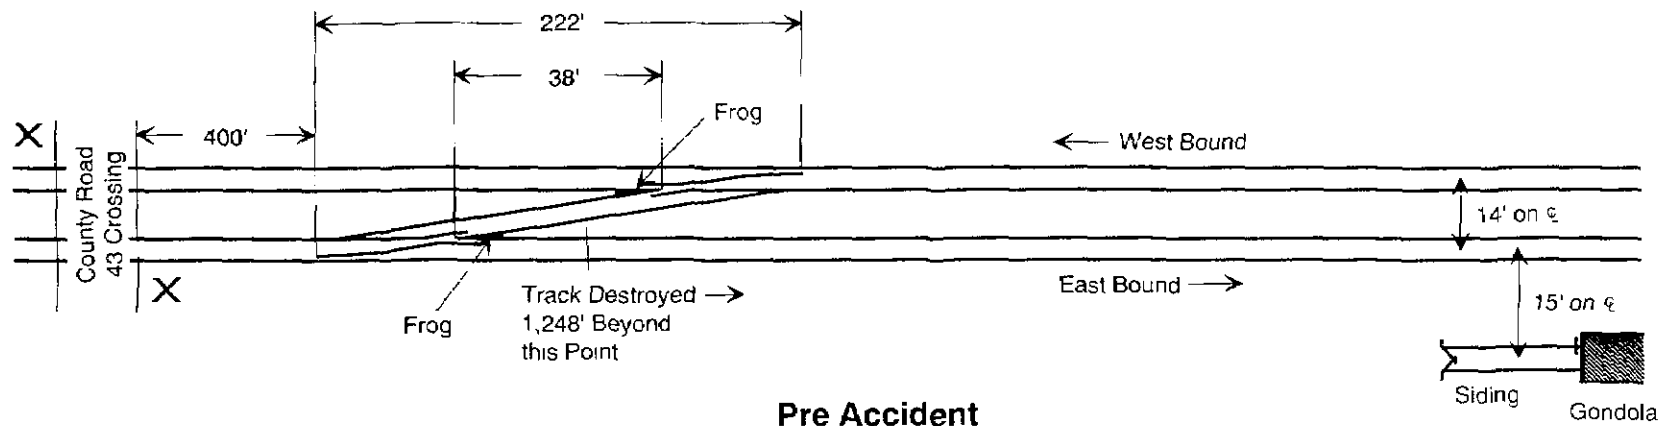
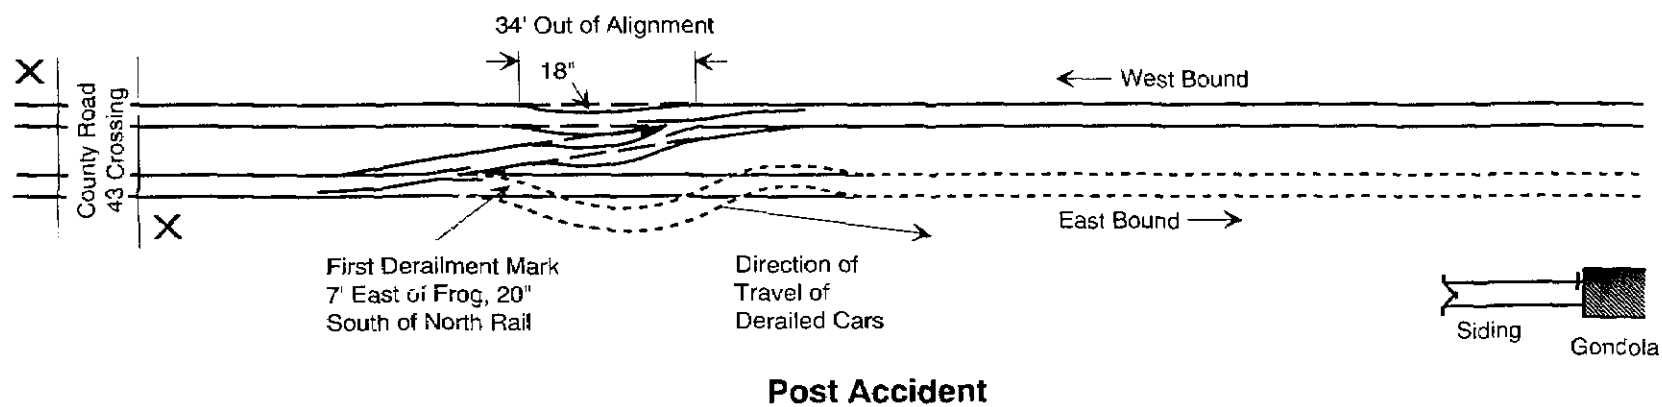
Figure 8.--Accident site track alignment.

**Postaccident Track Inspection** --About 3 hours after the derailment, an IDOT track inspector arrived at the accident site. He had been a State track inspector since 1974 and was familiar with the Batavia area. The IDOT inspector noted that the ties near the frog of the crossover turnout on the eastbound main were out of alignment and had been 12 inches further south before being pulled back toward their original position by the derailing train. This side movement included about 30 feet of track structure on either side of the frog. Based on this evidence, he concluded that the derailment had occurred underneath the train and that the force of the train's forward movement had tended to straighten the track back into alignment. (See figure 8.)

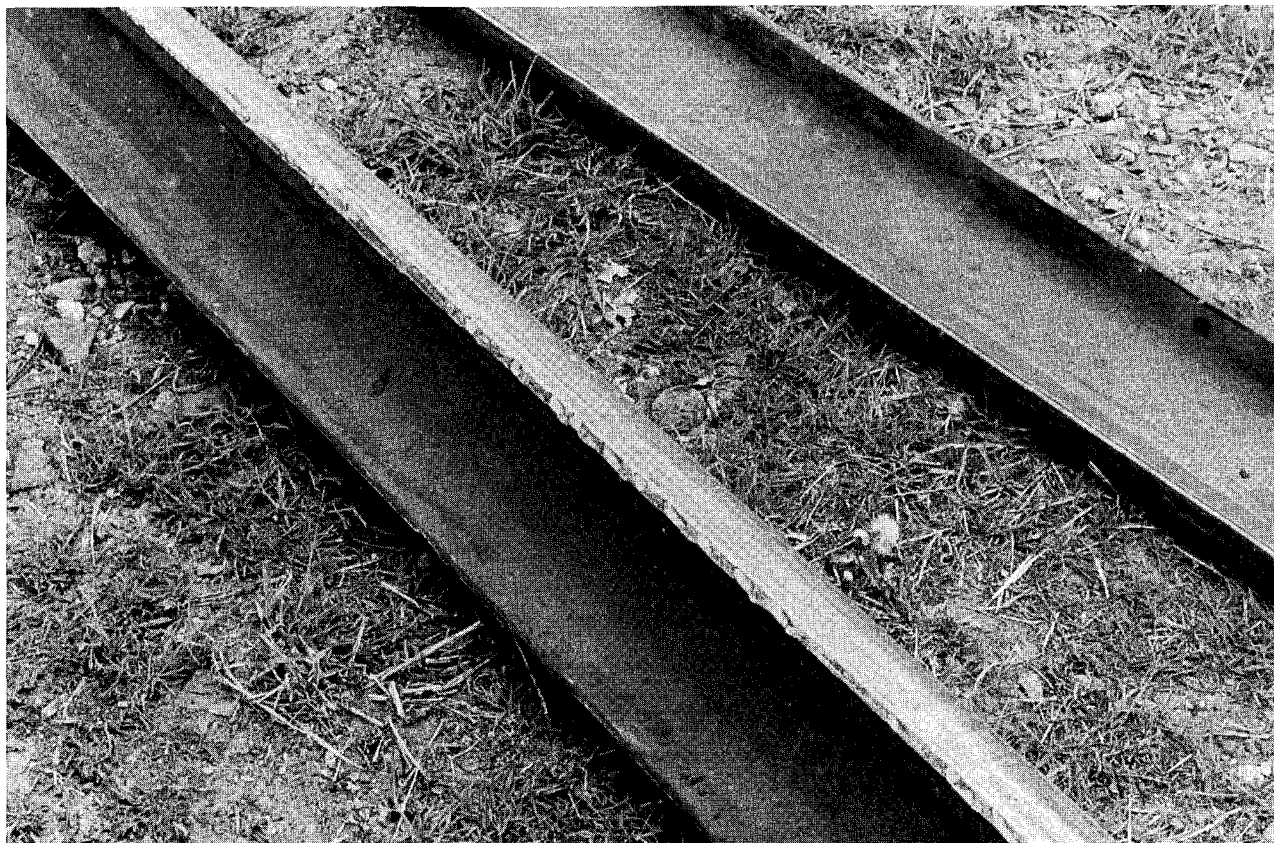
Figure 11.--Heavy gauge face gouging on one rail.

Two pieces of welded rail, each about 600 feet long, were salvaged from the derailment and examined. They were sections from the north and south rails of the eastbound mainline between the crossover and the stub track. The rails showed few flange marks on the web and base except at the west end of the south rail, where some anchor marks were present on the bottom base of the rail for about 100 feet. A wheel running on the side of the sharp corners of the rail base had flattened the field side of the south rail base. This condition became more pronounced near the west end of the rail, which had been behind the crossover frog. The base of the north rail had similar deformations but only on the east half.

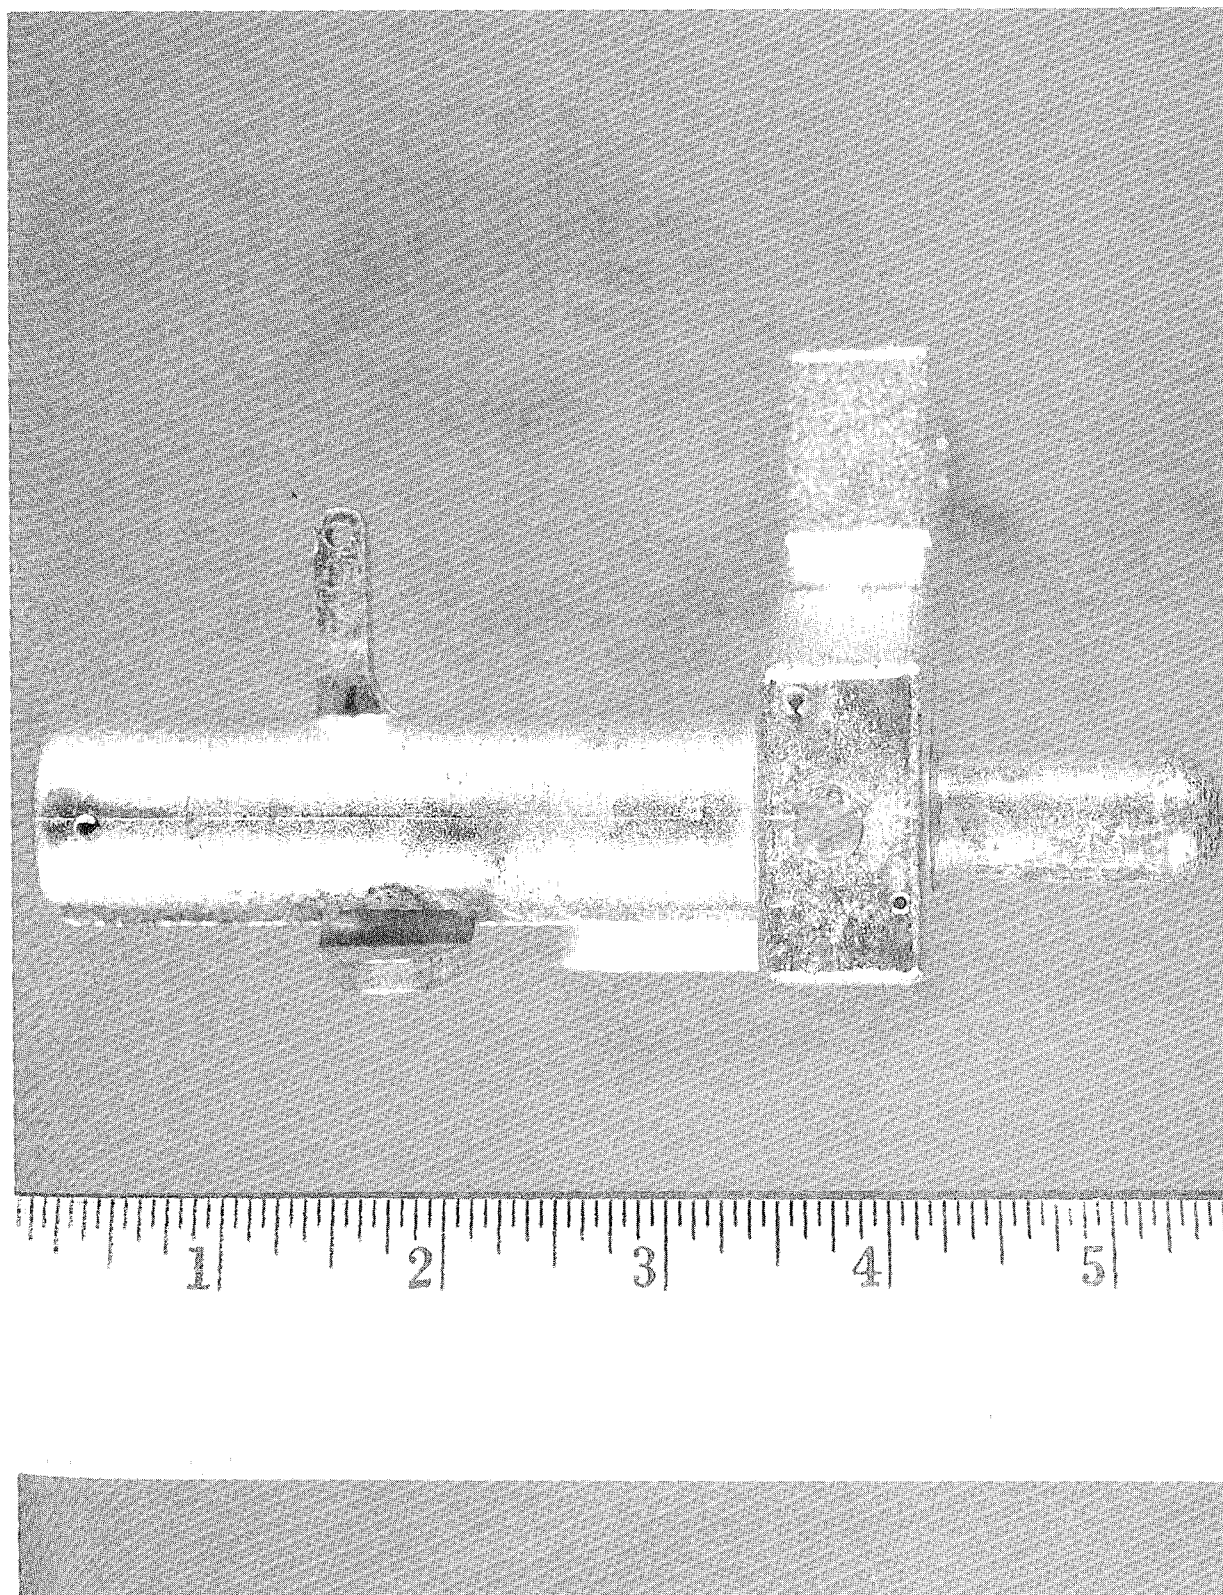
Figure 13.--Trison, Inc., seat lock.

**Seat Rotation and Seat Locks** --After the accident, Safety Board investigators inspected all the passenger car interiors at the accident site for damage and sources of injury. Safety Board investigators noted that several seats in each coach were unlocked and in some cases rotated. Inadvertent seat rotation during a derailment can lead to injury. Some seats with serviceable locks were found unlocked. One Trison lock from car 34001 appeared to be defective and was removed for further tests. The Safety Board mailed 116 questionnaires to passengers involved in the accident. Of 72 responses received, 12 (16 percent) said their seats had swiveled or shifted in the accident. Passengers responding to the questionnaire attributed their injuries to striking the seat in front of them, the floor, or luggage.

On September 12, 1990, Safety Board investigators examined an Amtrak train at Omaha, Nebraska, without prior notice. Several seats in each coach were found to be unlocked, although the locks were mechanically sound. The car seats had both Trison and AMI seat locks. From conversations with passengers and on-board service personnel, investigators determined that passengers frequently depress the locking pedal under the seat in the mistaken impression that the pedal is for some other purpose, such as reclining the seat, rather than unlocking and rotating the seat. Consequently, seats are inadvertently unlocked. On-board service personnel, such as the car attendants, have no specific instructions to check and ensure that seats are locked after the train leaves its point of origin.
