ACCIDENT ON THE  
CLEVELAND, CINCINNATI, CHICAGO &  
ST. LOUIS RAILWAY

AUGUSTA, IND.

MARCH 15, 1937.

INVESTIGATION NO. 2159

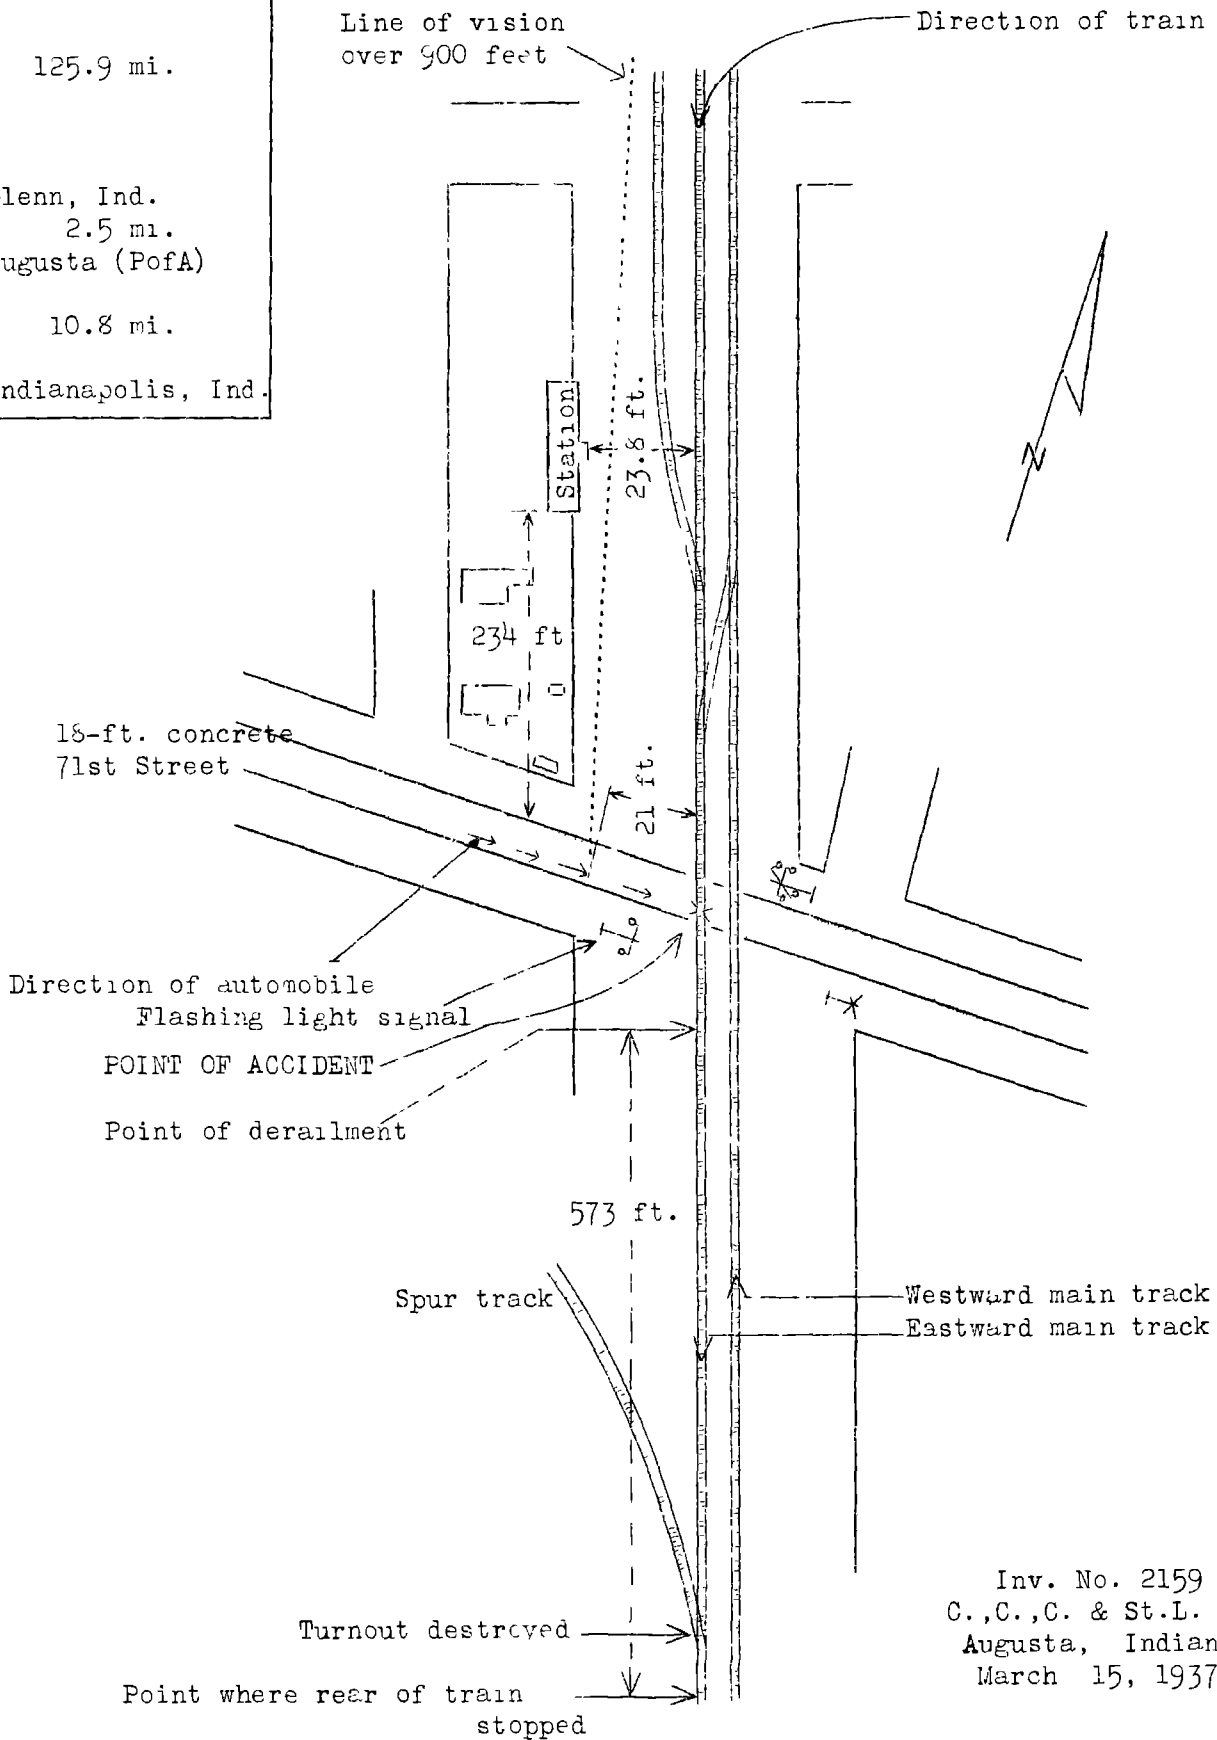
Inv. No. 2159  
 C.,C.,C. & St.L. Ry.  
 Augusta, Indiana  
 March 15, 1937

The highway involved crosses the tracks at an angle of about  $71^{\circ}$ ; it is 18 feet in width and is constructed of concrete, with the exception that on the crossing the surface is composed of a mixture of asphalt and crushed stone. It is straight for 1,000 feet when approaching from the south, and is practically level. Protection for highway traffic is provided by means of flashing-light signals located on each side of the tracks. The signal governing north-bound highway traffic is mounted on a mast which is located 6 feet 6 inches from the right edge of the pavement and approximately the same distance from the nearest rail. The centers of the lenses are 7 feet 6 inches above the ground level, and hoods are provided

over the lenses which extend outward a distance of about 9 inches. The operation of these signals is controlled by means of track circuits, the circuit in the eastward track extending to a point 3,178 feet west of the crossing. In addition to the flashing-light signals, there is a cross-bar sign in the northeast angle of the intersection bearing the words, "RAILROAD CROSSING", while under the crossed bars there is another sign horizontally mounted, on which the word "DANGER" is painted.

For north-bound highway traffic there is an unobstructed view of the flashing-light signals for a distance of about 600 feet. The view to be had of an approaching east-bound train is obstructed by various small buildings, including the station, located in the southwest angle of the intersection, but when 21 feet from the nearest rail a clear view can be had when the train is more than 900 feet distant.

The first mark of the derailment of the train was at a point 41 feet east of the center line of the crossing, and the engine stopped on its left side, squarely across both main tracks, at a point 1,164 feet east of the first mark. The train was entirely derailed with the exception of two wheels under the last car, but none of the cars was overturned.

The automobile stopped approximately 25 feet north of the point of accident and 10 feet east of the right edge of the pavement, destroying the relay case which housed the mechanism controlling the operation of the flashing-light signals; the body of the automobile was practically destroyed. The railway employees killed were the engineman and the fireman.
