**RAILROAD ACCIDENT INVESTIGATION**

**Report No 3822**

THE COLORADO AND SOUTHERN RAILWAY COMPANY

SEPTEMBER 22, 1958

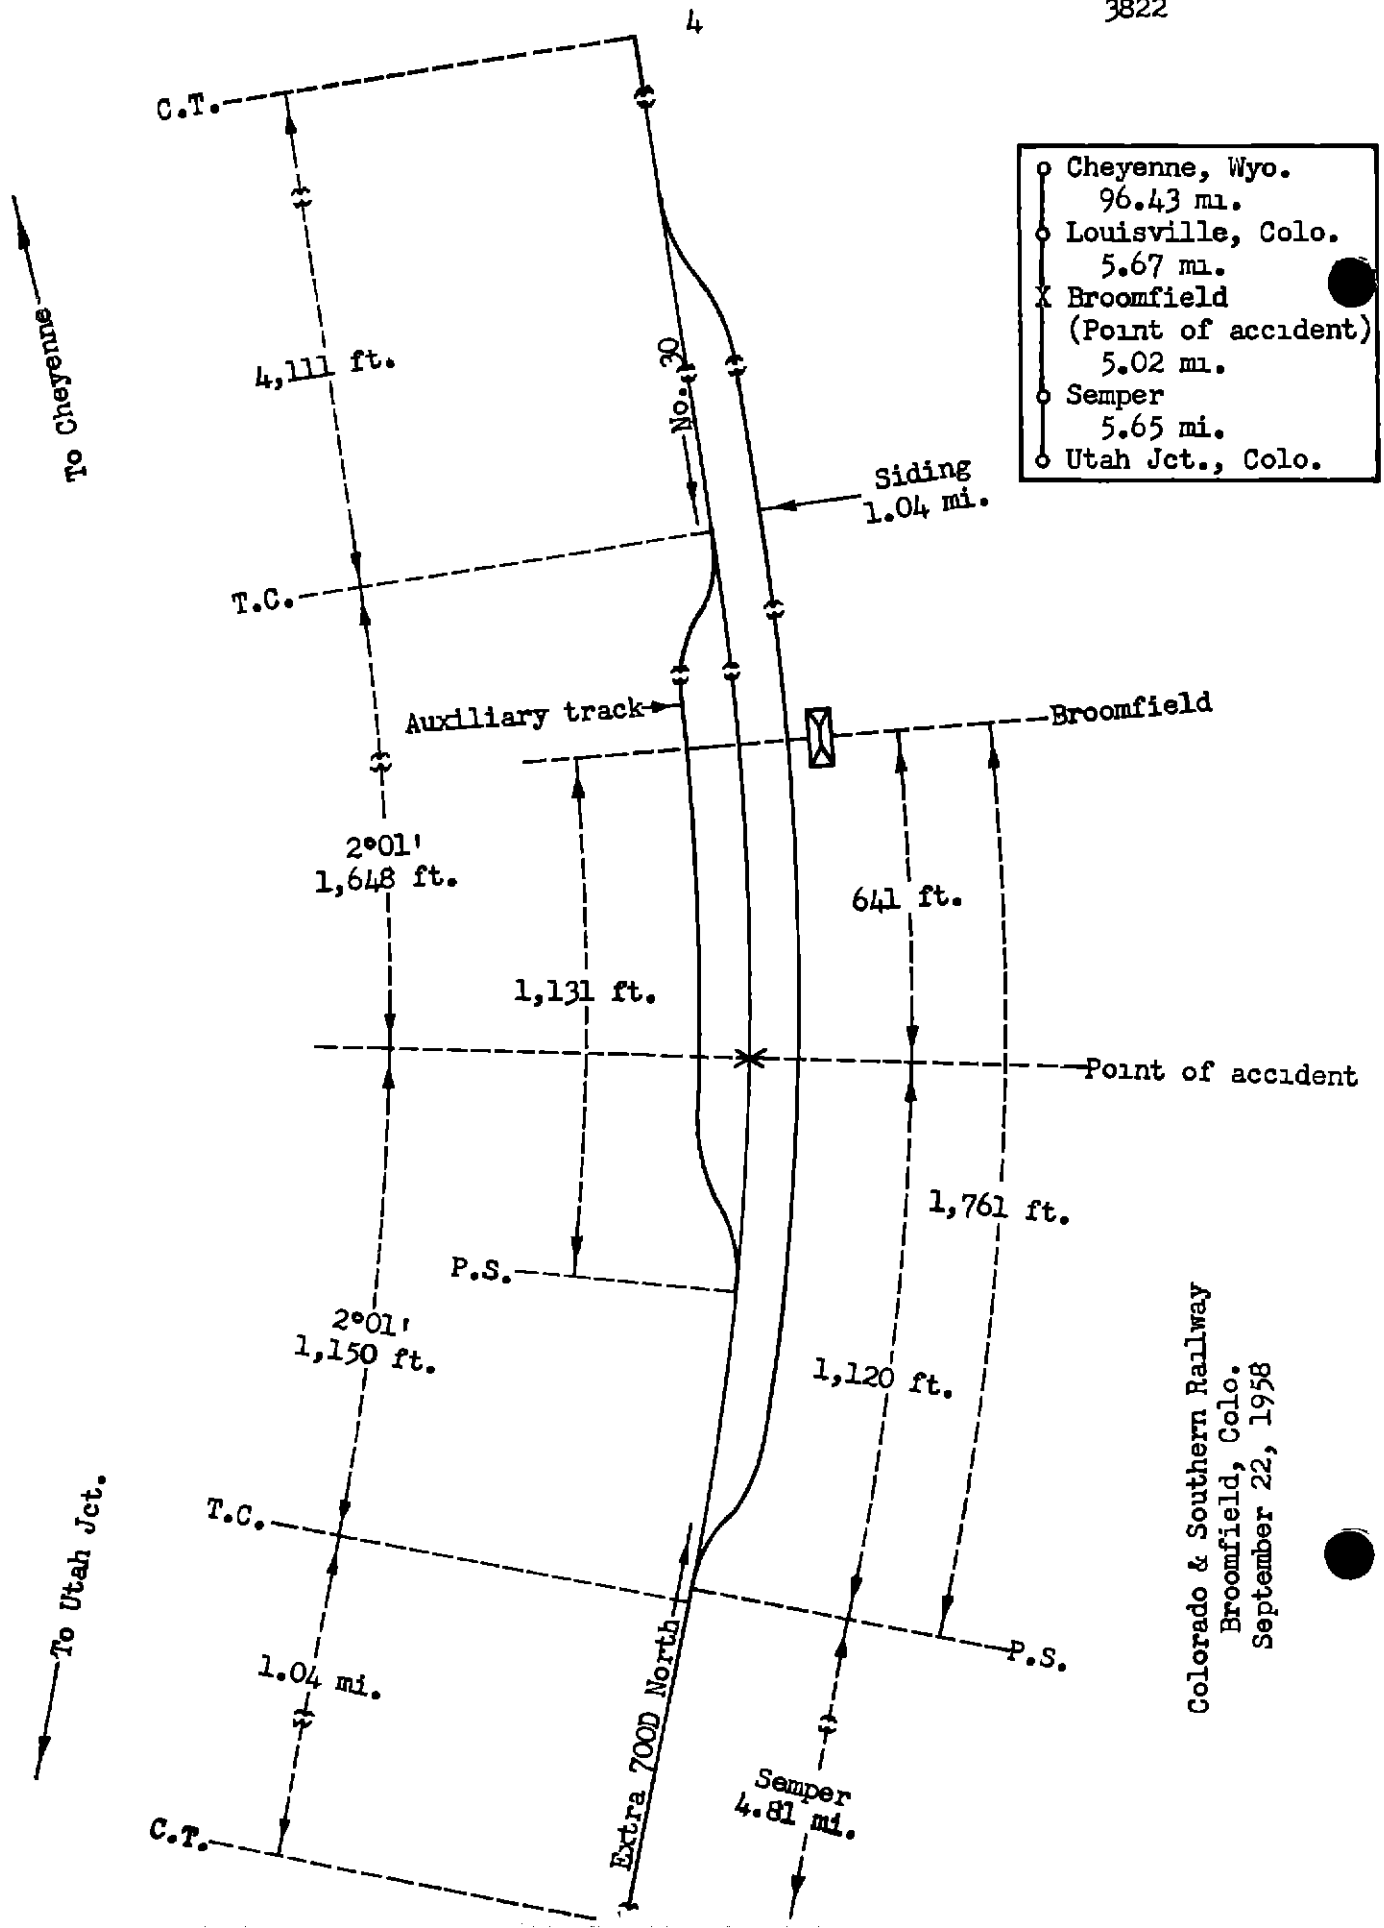
Colorado & Southern Railway  
 Broomfield, Colo.  
 September 22, 1958

This accident occurred on that part of the Northern Division extending between Utah Jct , Colo , and Cheyenne, Wyo , 112.8 miles, a single-track line over which trains are operated by timetable and train orders. There is no block system in use. At Semper, 5.65 miles north of Utah Jct , a siding about 4,100 feet in length parallels the main track. At Broomfield, Colo , 10.7 miles north of Utah Jct , a siding 1.04 miles in length parallels the main track on the east. The south switch of the siding is 1,761 feet south of the station at Broomfield. An auxiliary track parallels the main track on the west in the vicinity of the point of accident. Each end of this track connects with the main track. The south switch is located 1,131 feet south of the station. The accident occurred on the main track at a point 1,120 feet north of the south switch of the siding at Broomfield and 641 feet south of the station. From the south there are, in succession, a tangent 1.04 miles in length, a 2°01' curve to the left 1,150 feet to the point of accident and 1,648 feet northward. From the north there are, in succession, a tangent 4,111 feet in length and the curve on which the accident occurred. The grade is 0.77 percent descending southward at the point of the accident.

In the vicinity of the point of accident the view of the track ahead from a locomotive moving in either direction is considerably restricted by curvature of the track and structures erected near the right-of-way.
