REPORT OF THE DIRECTOR

ILLINOIS CENTRAL RAILROAD

COVINGTON, TENN.

INVESTIGATION NO. 2079

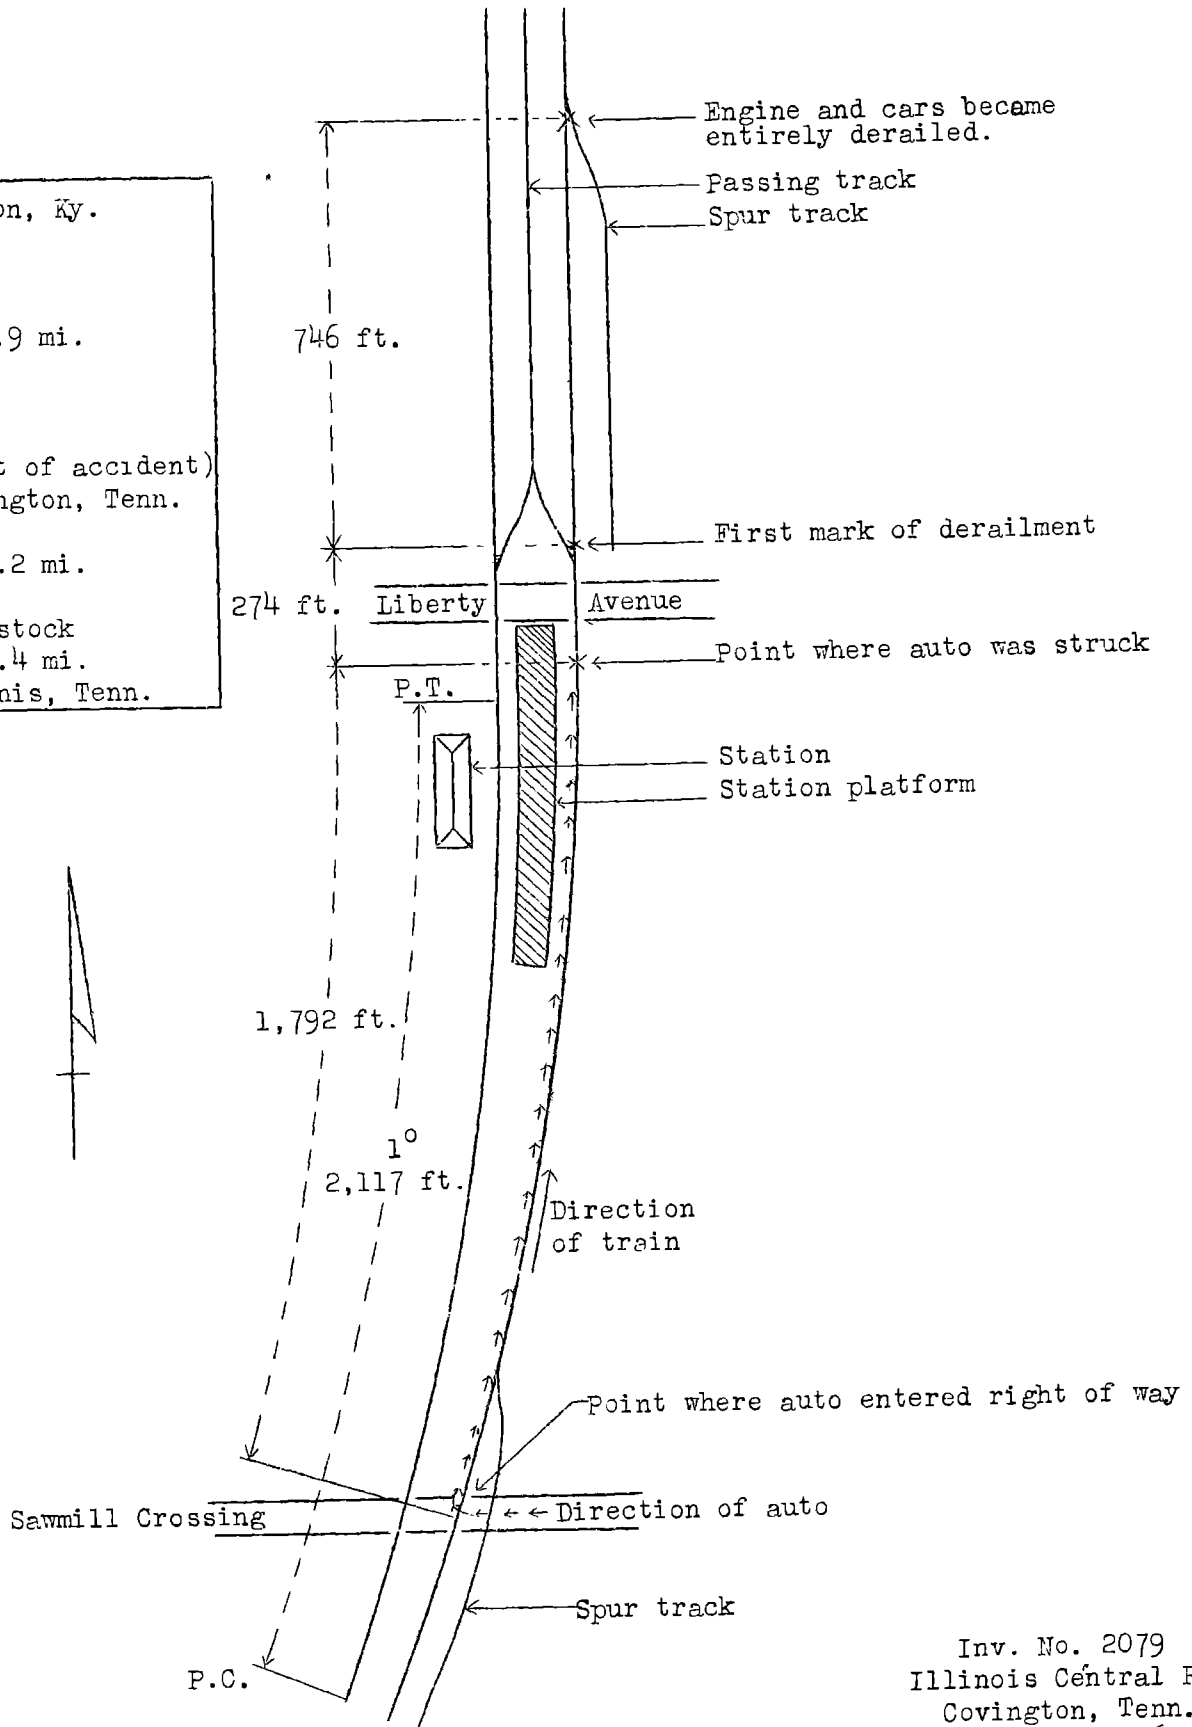
Inv. No. 2079  
 Illinois Central RR,  
 Covington, Tenn.  
 July 10, 1936

The station at Covington is on the west side of the main tracks and a street known as Liberty Avenue crosses the tracks at a right angle at the northern end of the station platform, the center line of the highway being 109 feet north of the point of accident and about 300 feet north of the center of the station. North of Liberty Avenue there is a facing-point switch leading from the north-bound main track to the left to an auxiliary passing track, this switch being located 212 feet from the point of accident. At a point 1,072 feet north of the point of accident, there is a trailing point switch leading to industries on the east side of the main tracks. The first highway south of the station is Sanford Avenue, known as "Sawmill Crossing," 1,901 feet from Liberty Avenue; this highway crosses the tracks at a slight angle and serves a lumber yard located on the east side of the tracks.

After striking the automobile, the engine apparently continued on the rails until it encountered the facing-point switch leading to the auxiliary passing track, where one pair of engine-truck wheels became derailed. It then continued until it reached the trailing-point switch several hundred feet farther north where the final derailment occurred. The engine stopped on its left side diagonally across the tracks, with its head end 1,361 feet north of the point where the automobile was struck; the first two cars stopped on their right sides to the right of the north-bound track, while the coach, club car and front truck of the first sleeping car also were derailed, these cars remaining upright. The automobile was carried on the pilot of the engine until it stopped, being finally deposited on the north-bound track 41 feet beyond the front of the engine. The employees killed were the engineman and fireman.
