REPORT NO. 3447

LOUISVILLE AND NASHVILLE RAILROAD COMPANY

IN RE ACCIDENT

NEAR JACKSON, KY., ON

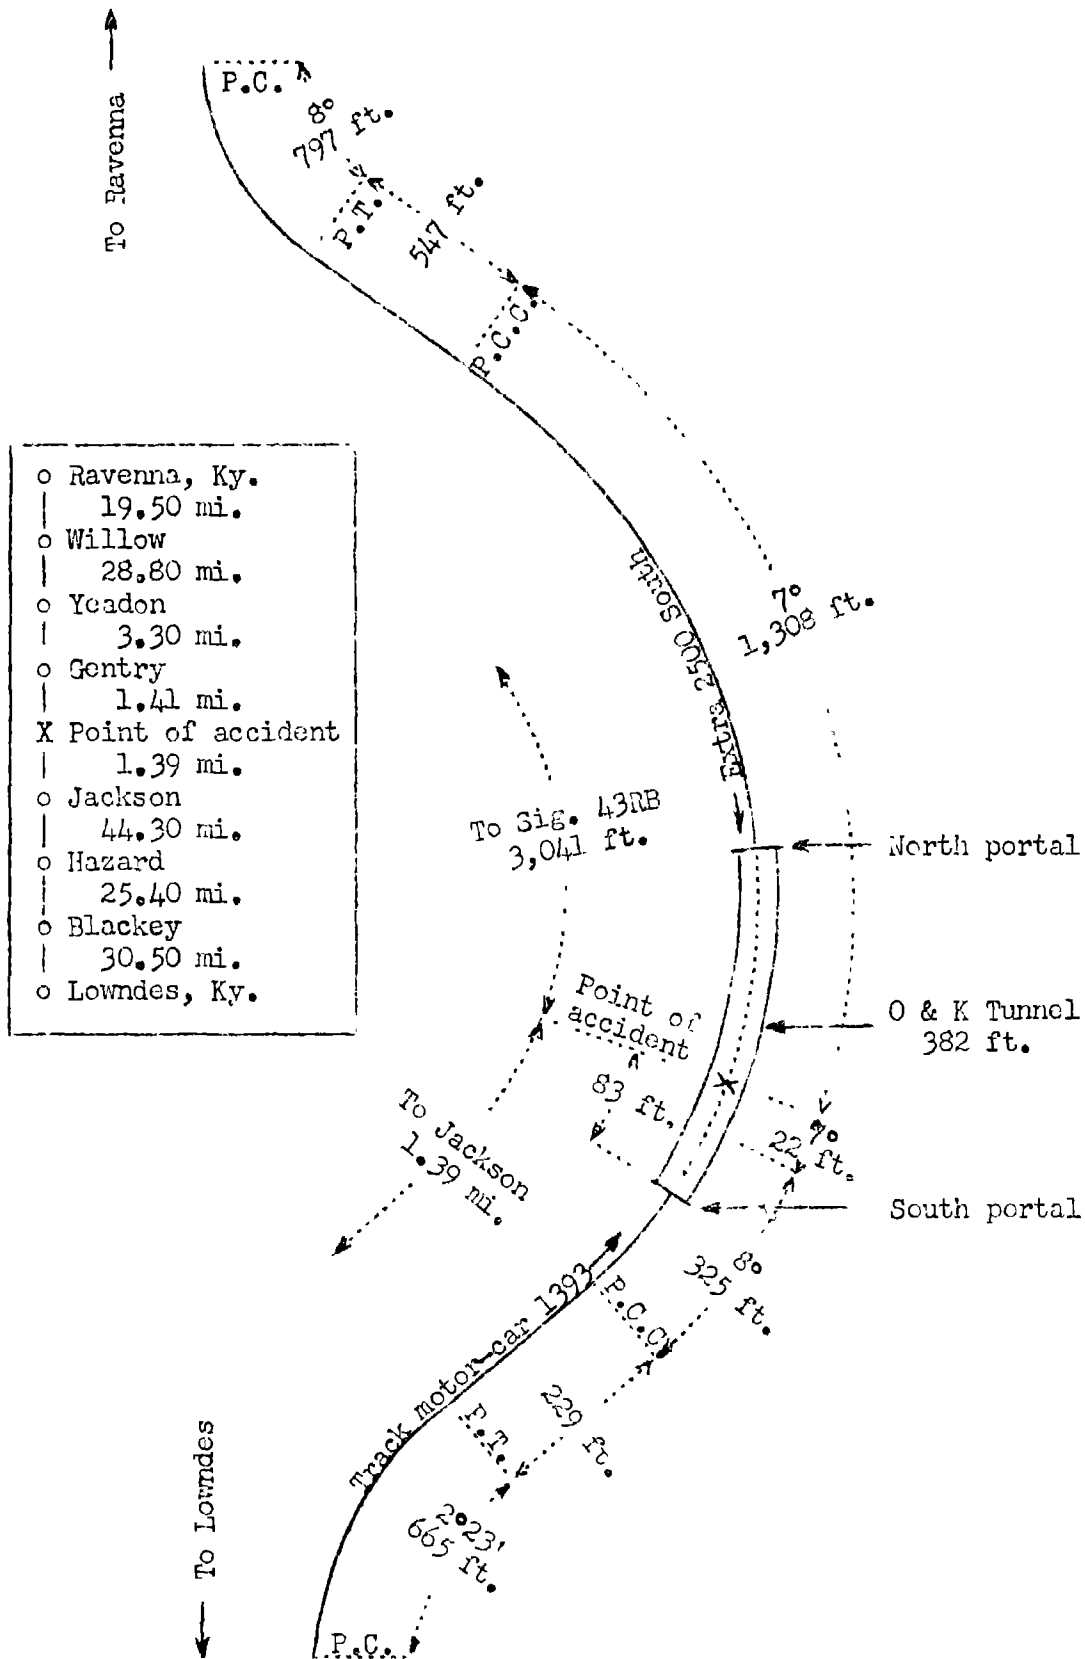
Report No. 3447  
 Louisville and Nashville Railroad  
 Jackson, Ky.  
 December 4, 1951

O & K Tunnel is located 1.39 miles north of the station at Jackson. The accident occurred on the main track at a point 83 feet north of the south portal of this tunnel. The tunnel is 382 feet in length, 17 feet 6 inches in width at subgrade, 13 feet 3 inches in height from the tops of the rails to the springing line of the arch, and 22 feet in height from the tops of the rails to the top of the tunnel.

Track motor-car 1393, occupied by a maintenance-of-way bridge foreman and five employees, departed north-bound from Jackson at 3 p. m. About 6 minutes later, while moving through O & K Tunnel at a speed of about 8 miles per hour, it collided with Extra 2500 South at a point 83 feet north of the south portal of the tunnel.
