ACCIDENT ON THE  
MICHIGAN CENTRAL RAILROAD

WAYNE JCT., MICH.

JULY 5, 1936

INVESTIGATION NO. 2076

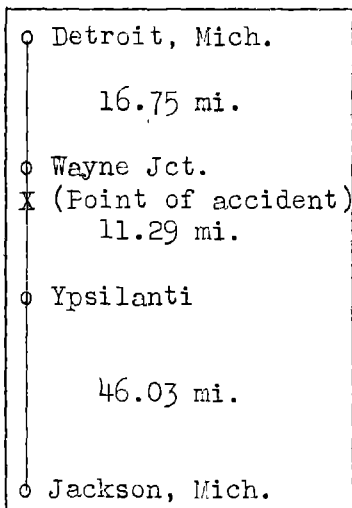
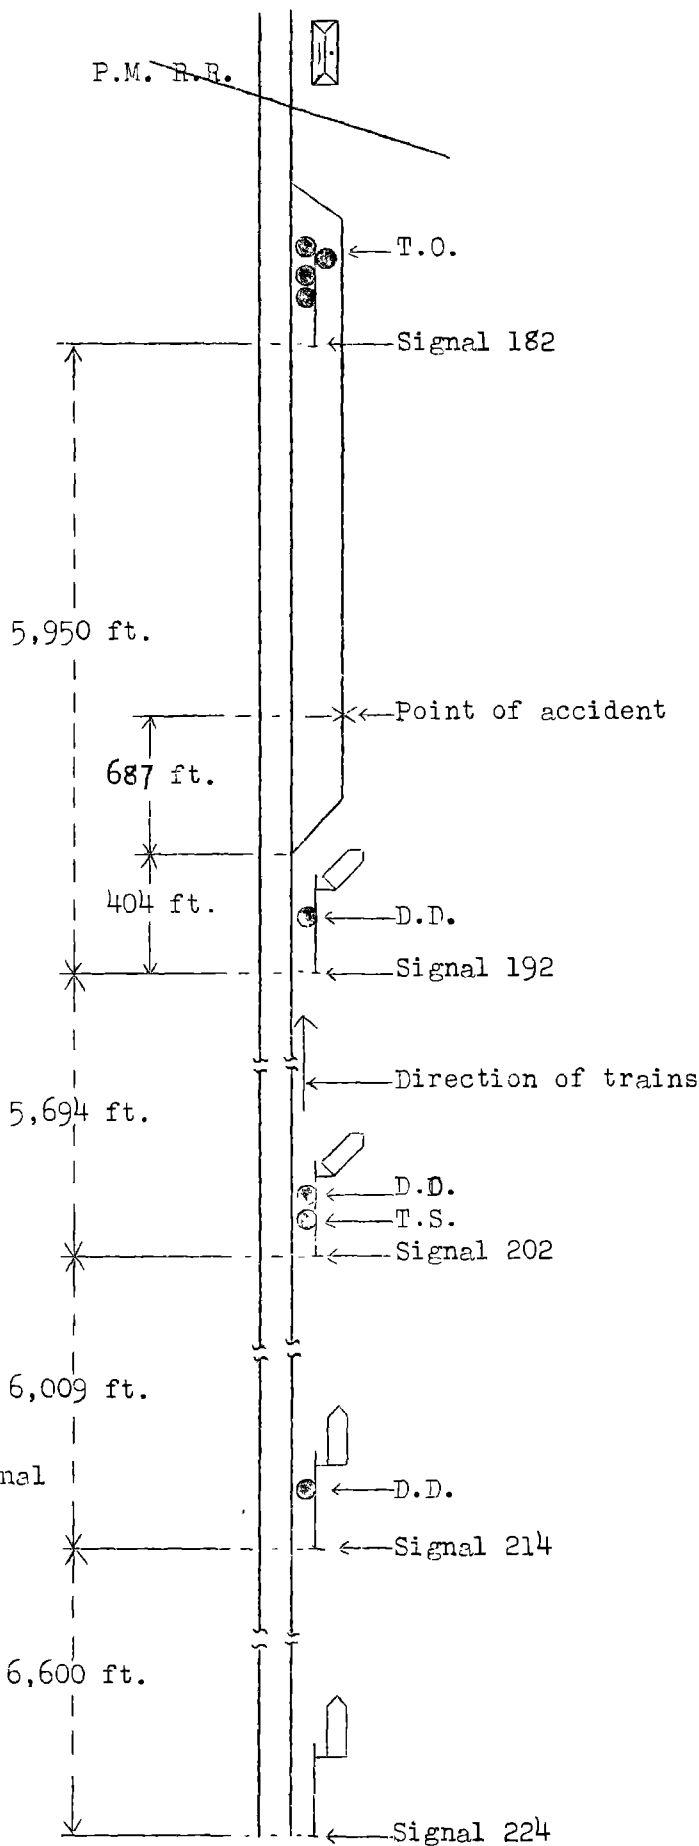
Inv. No. 2076  
Michigan Central R.R.  
Wayne Jct., Mich.  
July 5, 1936

The signals directly involved in this accident are automatic signals 192, 202 and 214, located 404, 6,098, and 12,107 feet, respectively, west of the passing-track switch. These signals are of the upper-quadrant, 3-position, semaphore type, approach lighted; in addition, these three signals are equipped to display three-block indications by the addition of a yellow light to the left of the signal mast, below the semaphore arm. The indications displayed by these signals are as follows: Red, stop then proceed at restricted speed; single yellow, prepare to stop at next signal, train exceeding medium speed (a speed not exceeding 30 miles per hour) must at once reduce to that speed; double yellow, prepare to stop at second signal; green proceed. The additional yellow light to the left of the signal mast is referred to as a "Double-distant signal"; at signal 202, under this double-distant signal, there is a take-siding signal, controlled from the interlocking tower at Wayne Jct., and arranged to display a flashing red light. Turnout switches are equipped with switch circuit controllers adjusted so as to open the contacts when the switch point controlling both sides of the signal control circuits is open 1/4 inch. Automatic train-stop inductors are located approximately 70 feet in the rear of the
