ACCIDENT ON THE  
NEW YORK, NEW HAVEN AND HARTFORD RAILROAD

SOUTH NORWALK, CONN.

OCTOBER 18, 1937.

INVESTIGATION NO. 2209

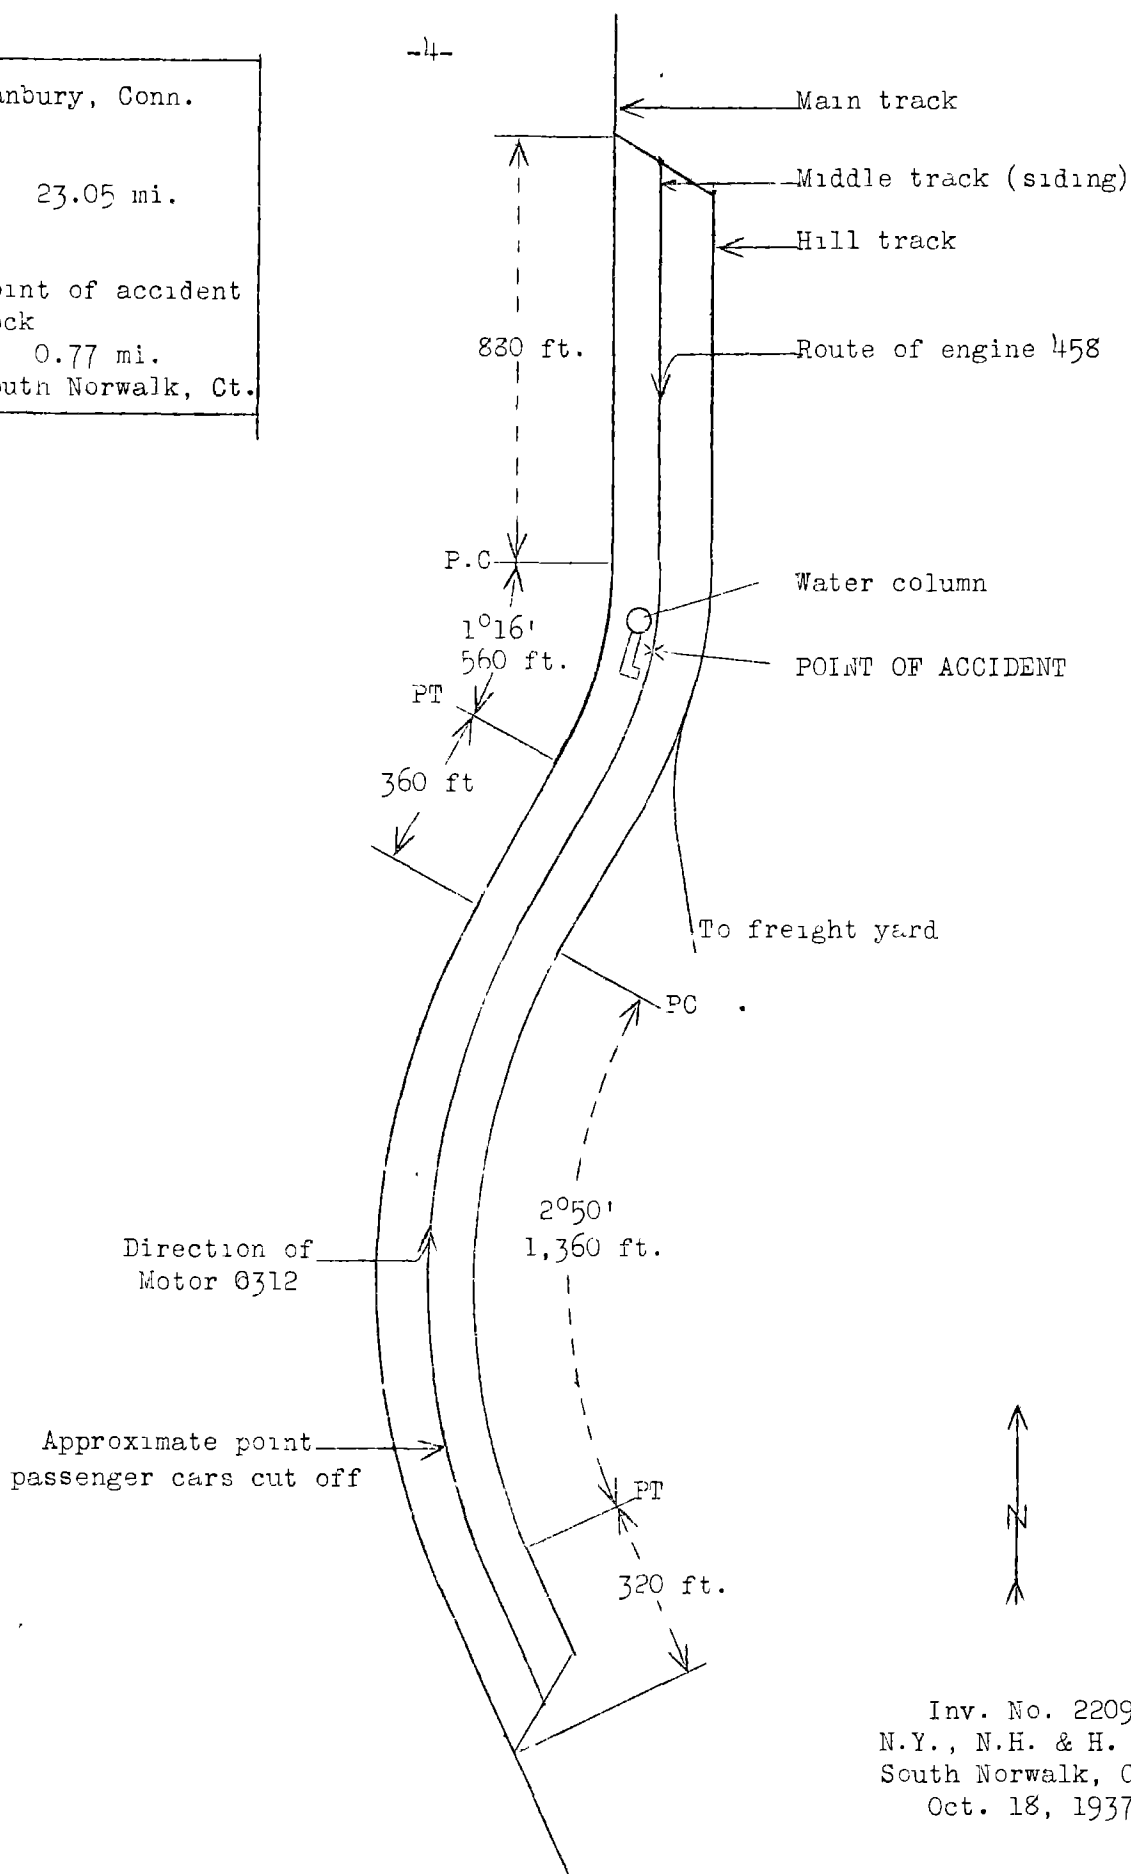
Inv. No. 2209  
 N.Y., N.H. & H. R.R.  
 South Norwalk, Conn.  
 Oct. 18, 1937

This accident occurred on that part of the New Haven Division which extends between South Norwalk and Danbury, Conn., a distance of 23.82 miles. Beginning at the south end of "Dock" yard at South Norwalk, two tracks, known as the "middle" and "hill" tracks, branch off from the main track and parallel it on the east for a distance of approximately 3,700 feet; the accident occurred on the middle track, which is used as a siding, at a water column located between the main and middle tracks about 2,400 feet north of the south end of this yard. Approaching from the south there is a 1°16' curve to the left, the point of accident being about 300 feet north of the south end of this curve; the grade is 0.85 percent descending.
