## INTERSTATE COMMERCE COMMISSION

REPORT OF THE DIRECTOR OF THE BUREAU OF SAFETY CONCERNING AN  
ACCIDENT ON THE LINE OF THE SOUTHERN PACIFIC COMPANY  
NEAR MONTEREY, CALIF., ON OCTOBER 26, 1933.

February 8, 1934.

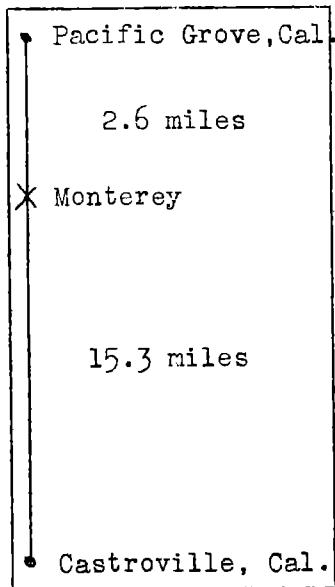
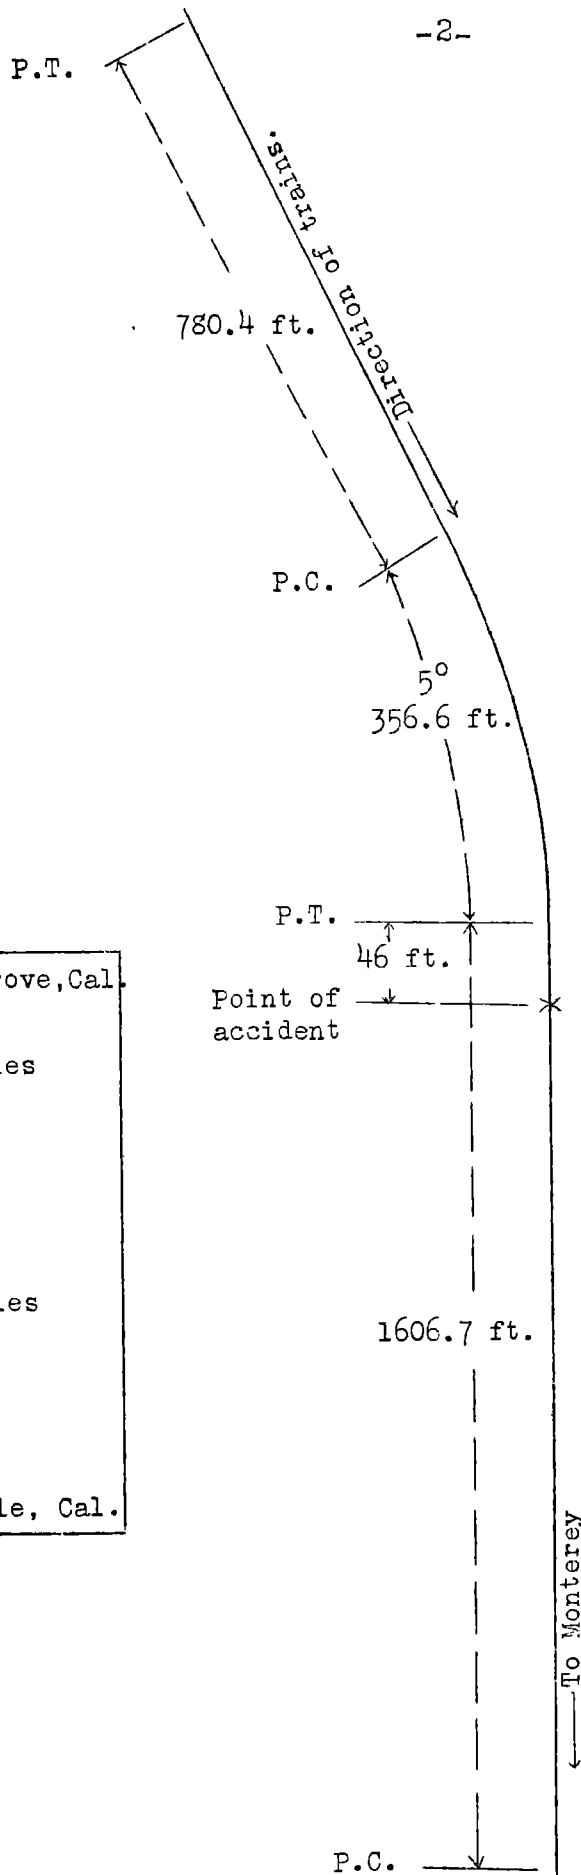
Inv. No. 1863  
Southern Pacific Co.  
Monterey, Calif.  
Oct. 26, 1933

This accident occurred on the Monterey Branch on the Salinas Subdivision of the Coast Division, which extends between Castroville and Pacific Grove, Calif., a distance of 17.9 miles, and is a single-track line over which trains are operated by time table and train orders, no block-signal system being in use. The accident occurred at a point more than 1 mile east of Monterey; approaching this point from the east, the track is tangent for a distance of 780.4 feet, followed by a 5° curve to the right 356.6 feet in length, and then tangent track for a distance of 1,606.7 feet, the accident occurring on this latter tangent 46 feet from its eastern end. The grade at the point of accident is 0.81 per cent ascending for west-bound trains. Owing to the curve, an embankment and buildings, a full view of a caboose standing at the point of accident, from the engineman's side of a west-bound train, was limited to a distance of about 300 feet.
