INTERSTATE COMMERCE COMMISSION  
WASHINGTON

REPORT OF THE DIRECTOR  
BUREAU OF SAFETY

ACCIDENT ON THE  
UNION PACIFIC RAILROAD

INVESTIGATION NO. 2162

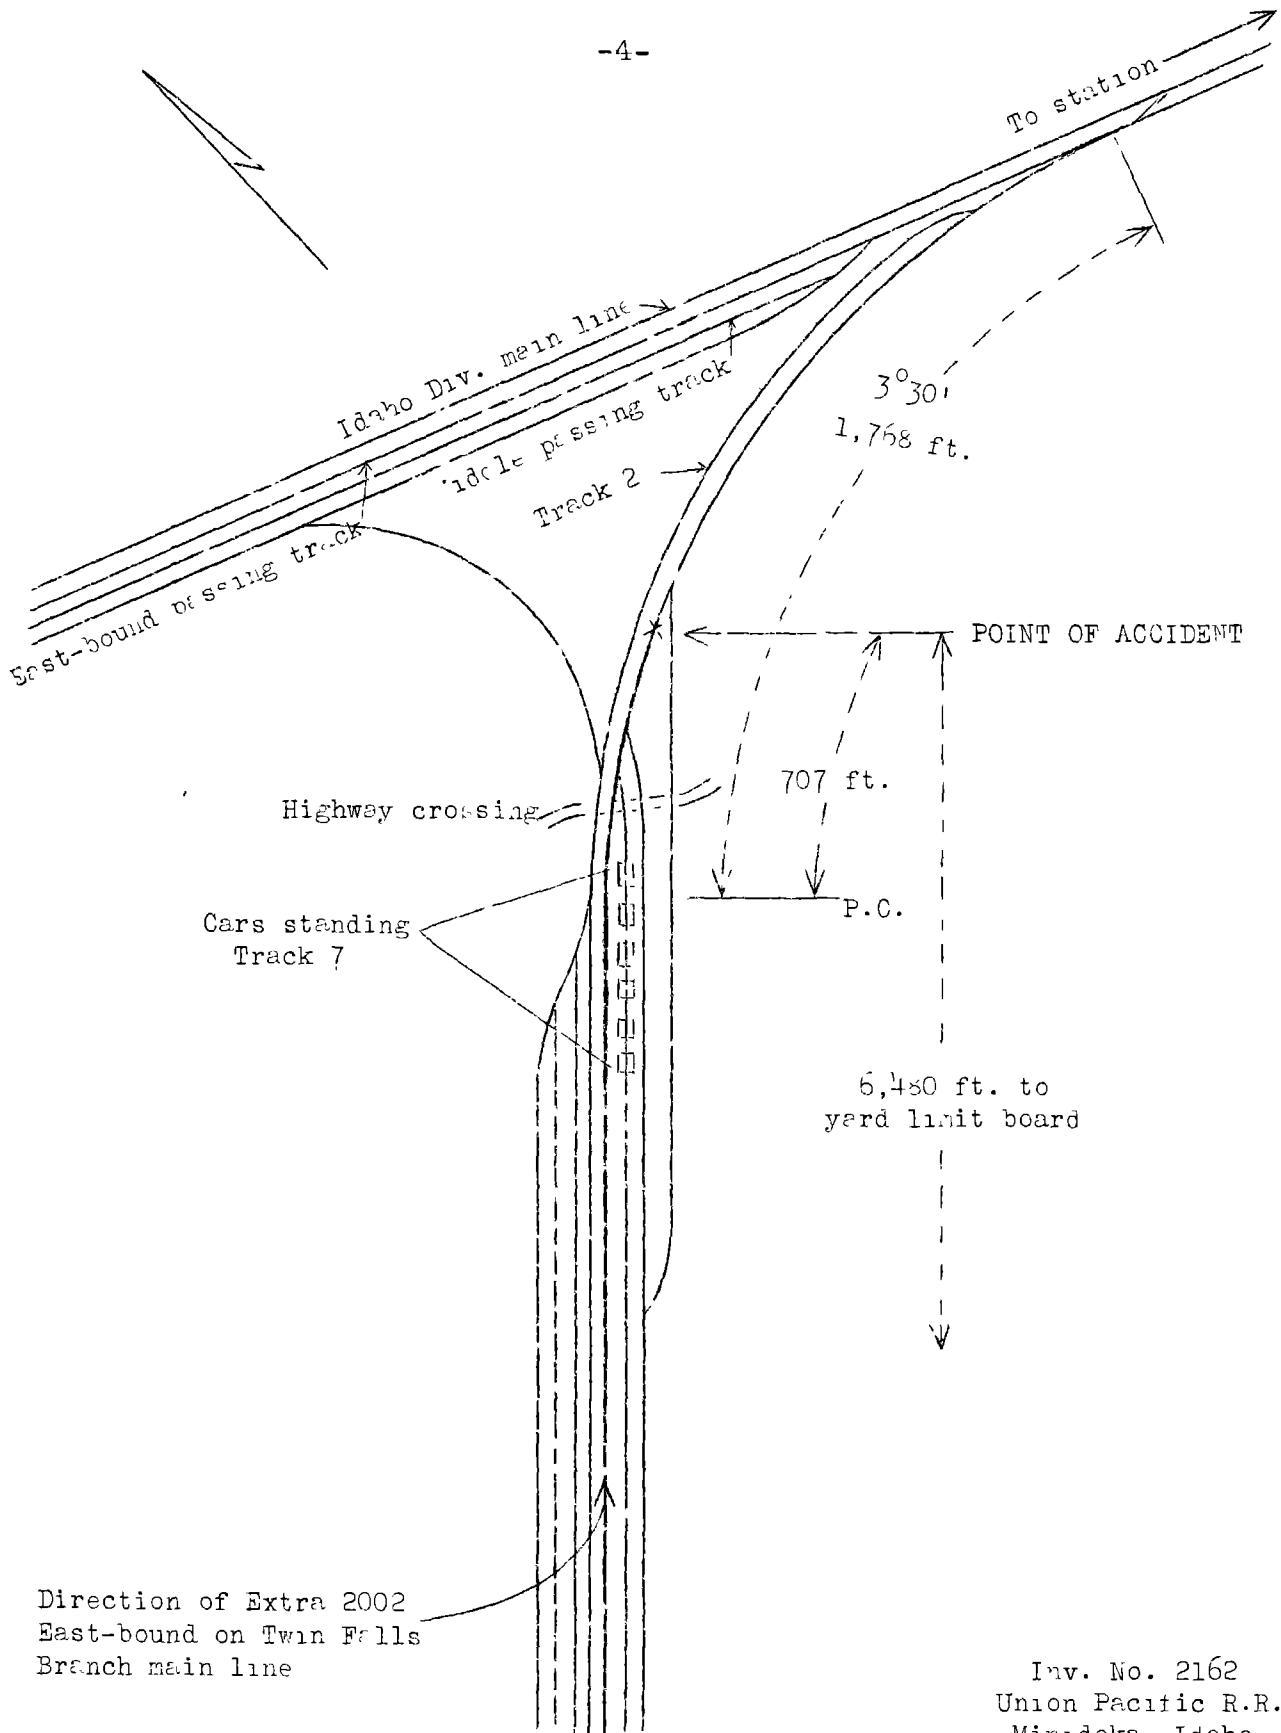
Inv. No. 2162  
Union Pacific R.R.  
Minidoka, Idaho  
March 19, 1937

The Twin Falls Branch connects with the main line of the Idaho Division at Minidoka and a Y is located at the junction; the main line of the Twin Falls Branch forms the south leg of the Y, upon which the accident occurred. An auxiliary track, known as track 2, parallels this leg of the Y on the north and joins it near the junction switch. Yard tracks parallel both sides of the main track on the Twin Falls Branch west of the Y, and at the time of the accident several cars were standing at the east end of track 7, which lies immediately south of the main track, and the range of vision of the engineman of an east-bound train across the curve to the point of accident was restricted to about 617 feet.
