HIGHWAY-RAILROAD ACCIDENT REPORT

WATERLOO, NEBRASKA, PUBLIC SCHOOL  
SCHOOL BUS  
UNION PACIFIC RAILROAD COMPANY FREIGHT TRAIN  
ACCIDENT  
WATERLOO, NEBRASKA  
OCTOBER 2, 1967

NATIONAL TRANSPORTATION SAFETY BOARD  
DEPARTMENT OF TRANSPORTATION  
WASHINGTON, D. C.  
20591

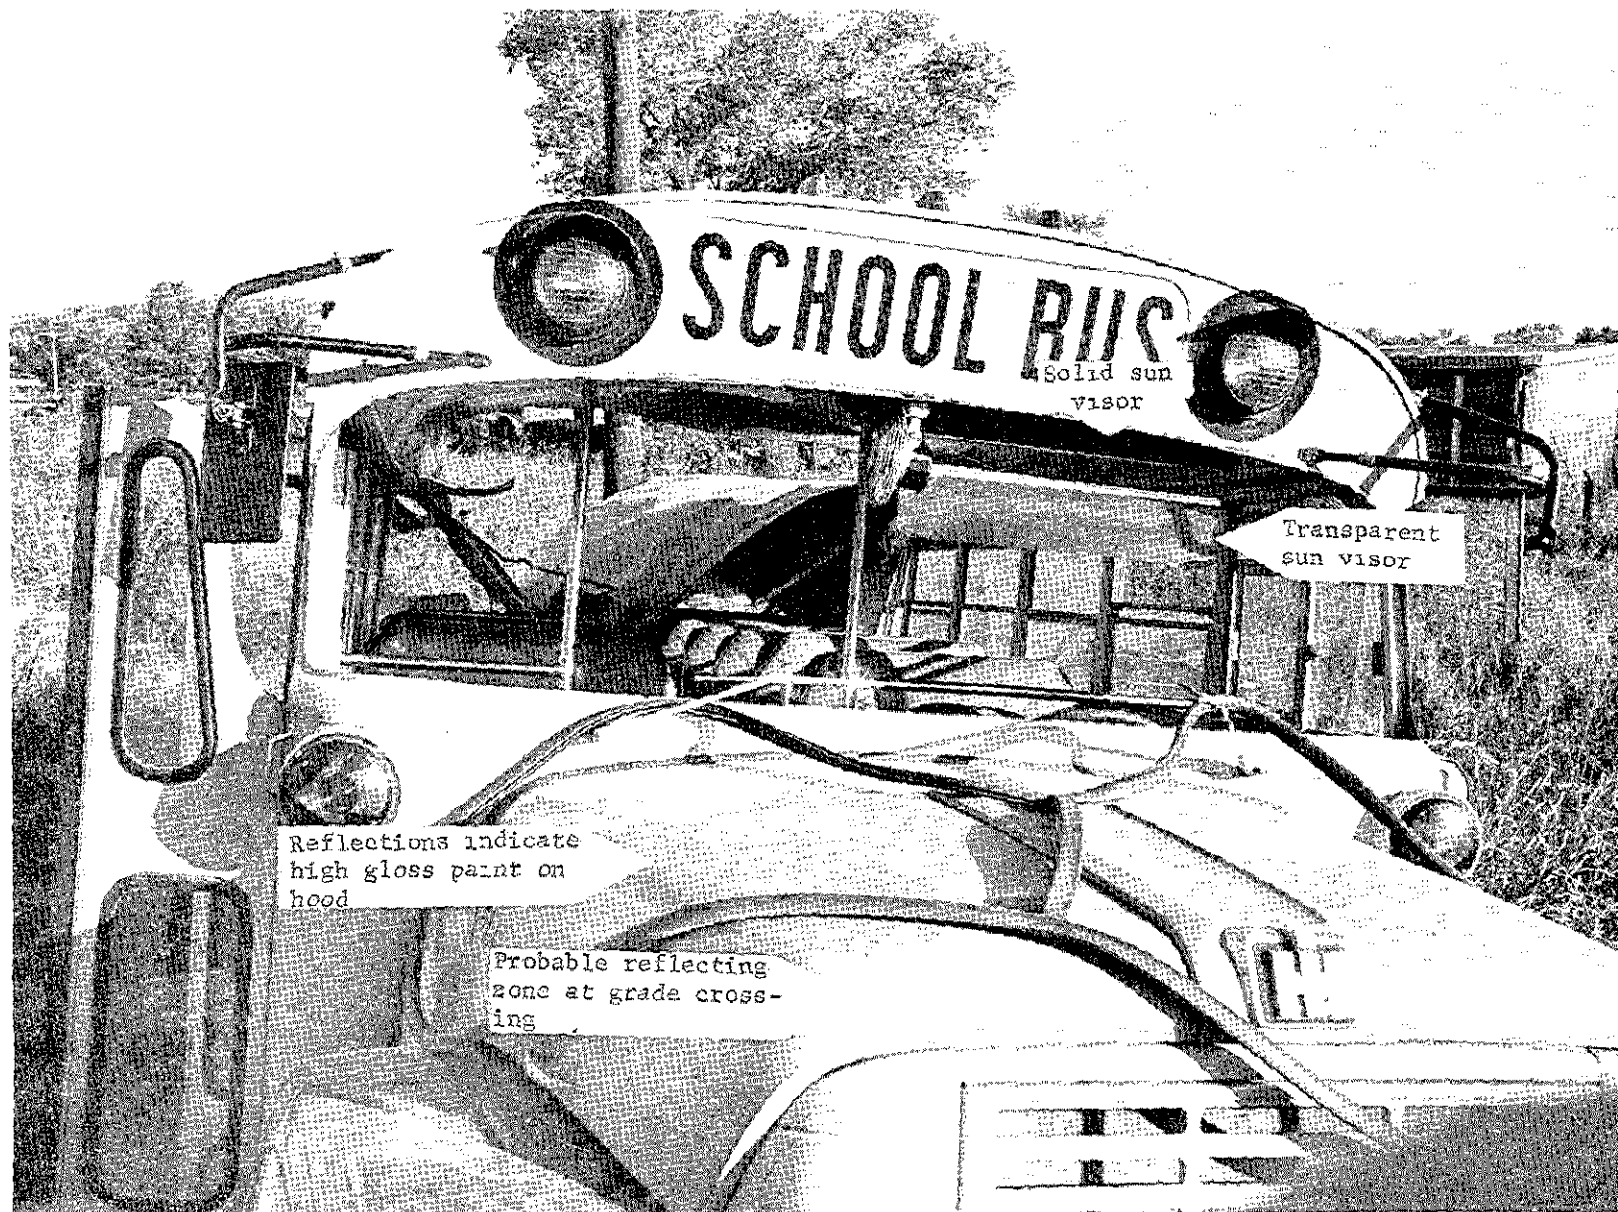
As he approached the crossing, the bus driver stated that he could not see ahead very well due to the glare of the sun and that he had the windshield sun visor down. He was not wearing sun glasses.

1. FRONT OF SCHOOL BUS AFTER THE ACCIDENT PHOTOGRAPH ILLUSTRATES THE GLOSSY HOOD OF THE BUS, THE POSITION OF THE TWO SUN VISORS, AND THE OPEN WINDOWS ON THE LEFT SIDE OF THE BUS.

6. The Safety Board recommends that the Federal Highway Administration establish a vehicle safety standard to protect driver vision against external sun glare.

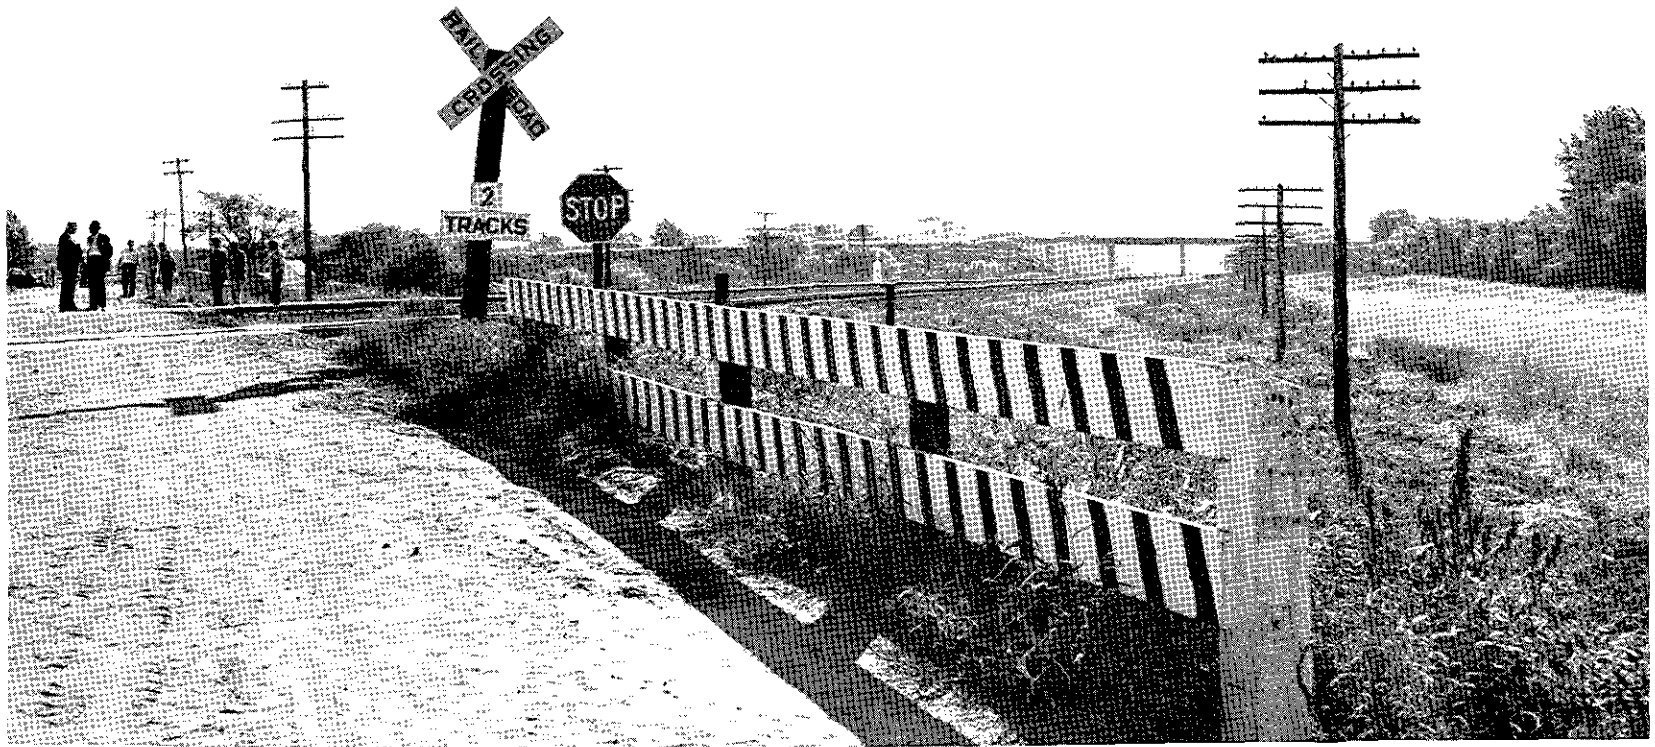
2. VIEW OF THE RAILROAD CROSSING, THE WARNING SIGNS, THE TRACKS, AND THE COMMUNICATION POLES, SEEN WHEN LOOKING IN THE DIRECTION OF THE VIADUCT.

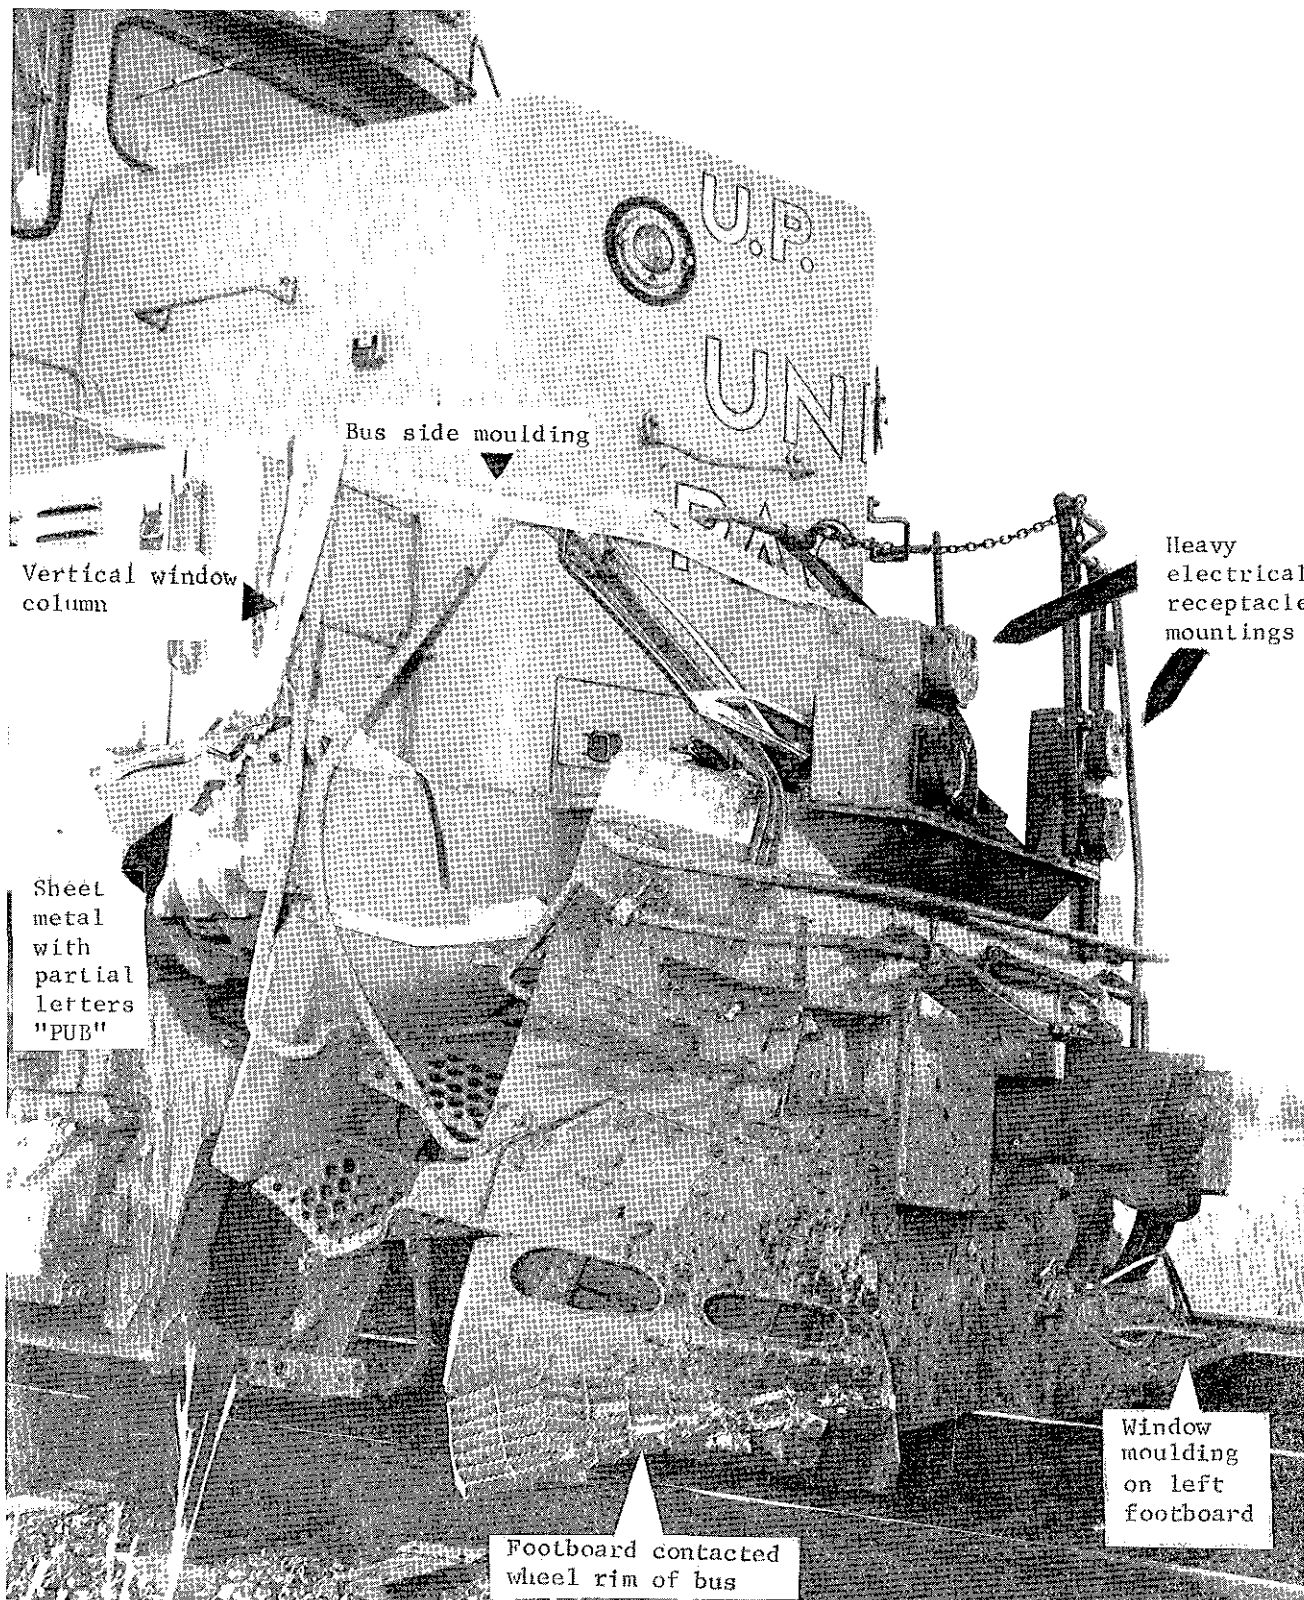
Part of the bus structure, including one windowpane, at least one window post, and longitudinal structure was struck and held by the front of the locomotive and remained there after the impact. (See Illustration No. 4.) Detailed areas of the train caused specific forms of damage. The first point of contact between train and bus was at the outermost vertical edge of the fourth post from the front door of the bus. The next contact was the front surface of the right footboard of the locomotive which struck the right rear dual wheel of the bus, catching and indenting the rim. This rim contact created the forceful pull on the bus frame to the rear, rotating the main chassis of the bus.

4. FRONT END OF LOCOMOTIVE, U.P. #708, TAKEN SHORTLY AFTER ACCIDENT

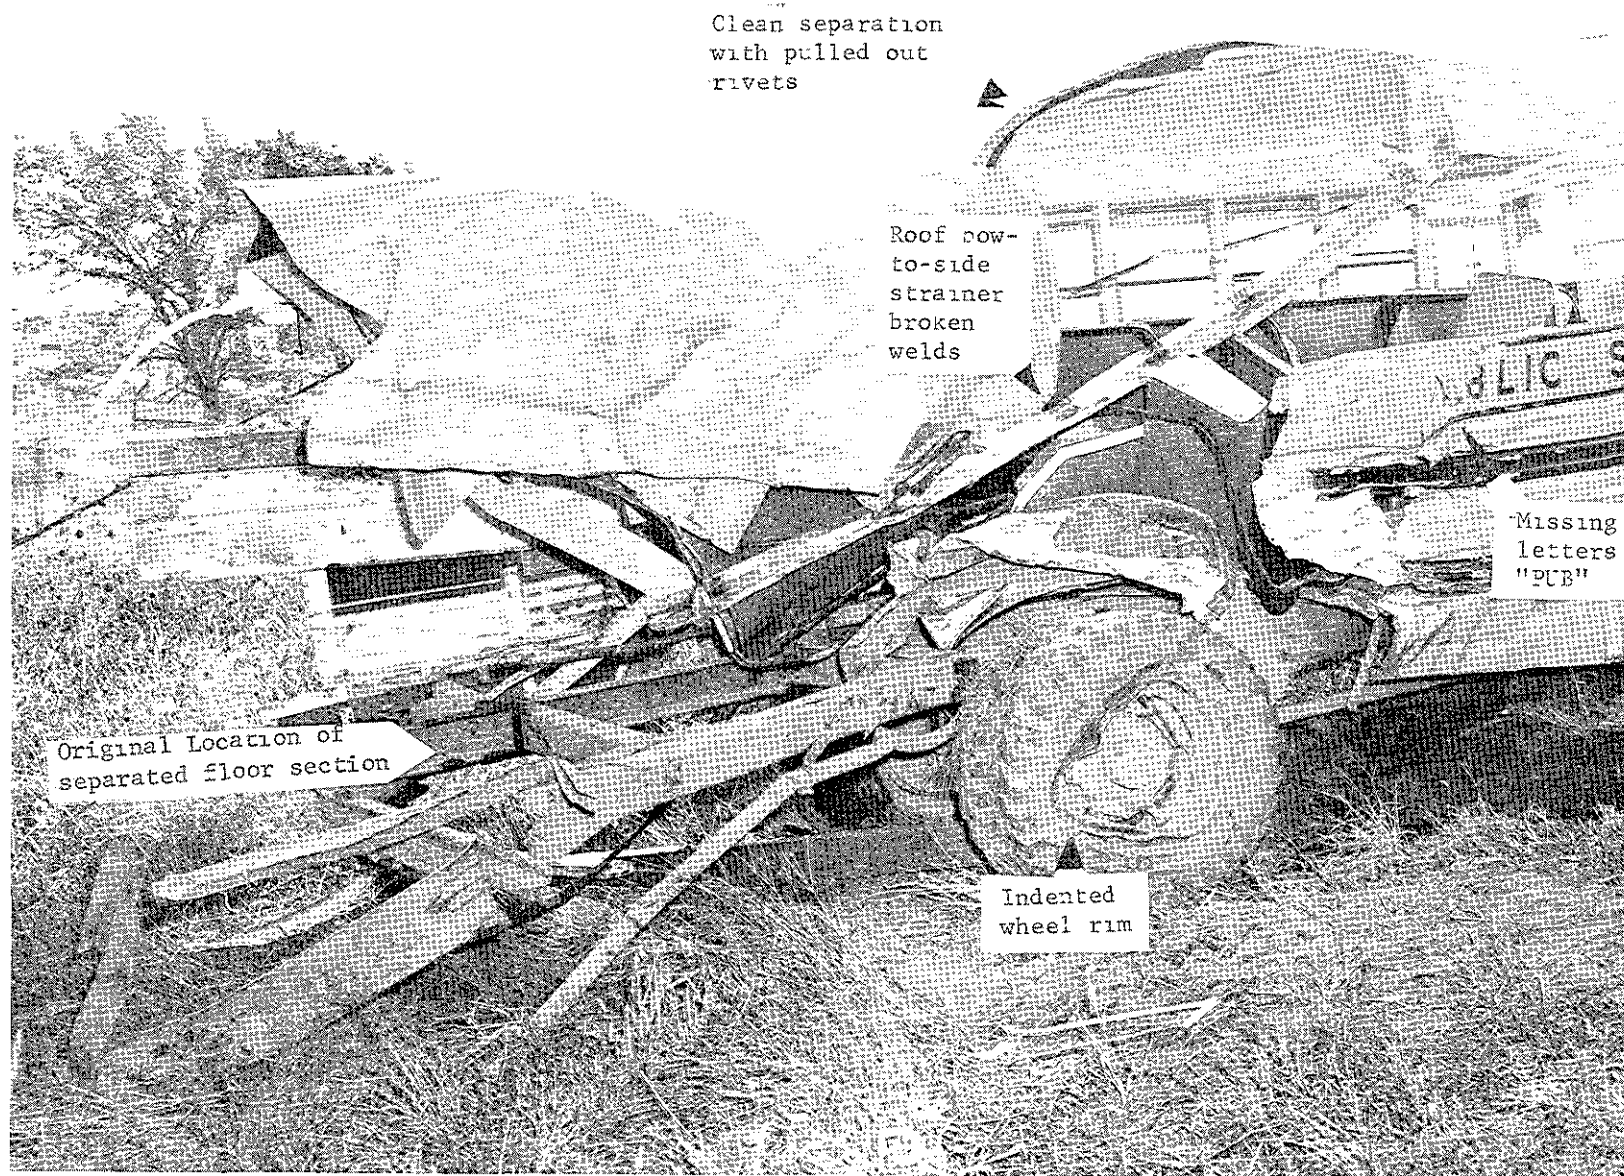
Spacing between rivets varied from two inches to as much as nine inches between rivets, as measured on another bus of the same model, so that the full strength of joining was not obtained. Welds in body structure which failed included some which had been welded over only a portion of the available length of contact. The majority of failures at welds were through welds, not in parent metal, again accompanied by little or no distortion of nearby structures. The wreckage includes numbers of highly significant examples of failures in which the general shape of sheet metal remained, but the parts have separated. (See Illustrations No. 5 and No. 7.)

5. RIGHT REAR OF THE SCHOOL BUS AFTER THE ACCIDENT AND AFTER THE BUS WAS MOVED FROM CONTACT WITH THE COMMUNICATION POLE.

3. The Safety Board recommends that the Federal Highway Administration consider the need for requirements for structural strength of school bus bodies in connection with its study of desirable standards for protection of school bus occupants. In particular, the Board recommends that program A.1.1.4 of the National Highway Safety Bureau, titled "Design, Fabrication, and Test of a Safe School Bus Interior," be expanded in scope to include consideration of structural integrity and intrusion into the school bus interior.

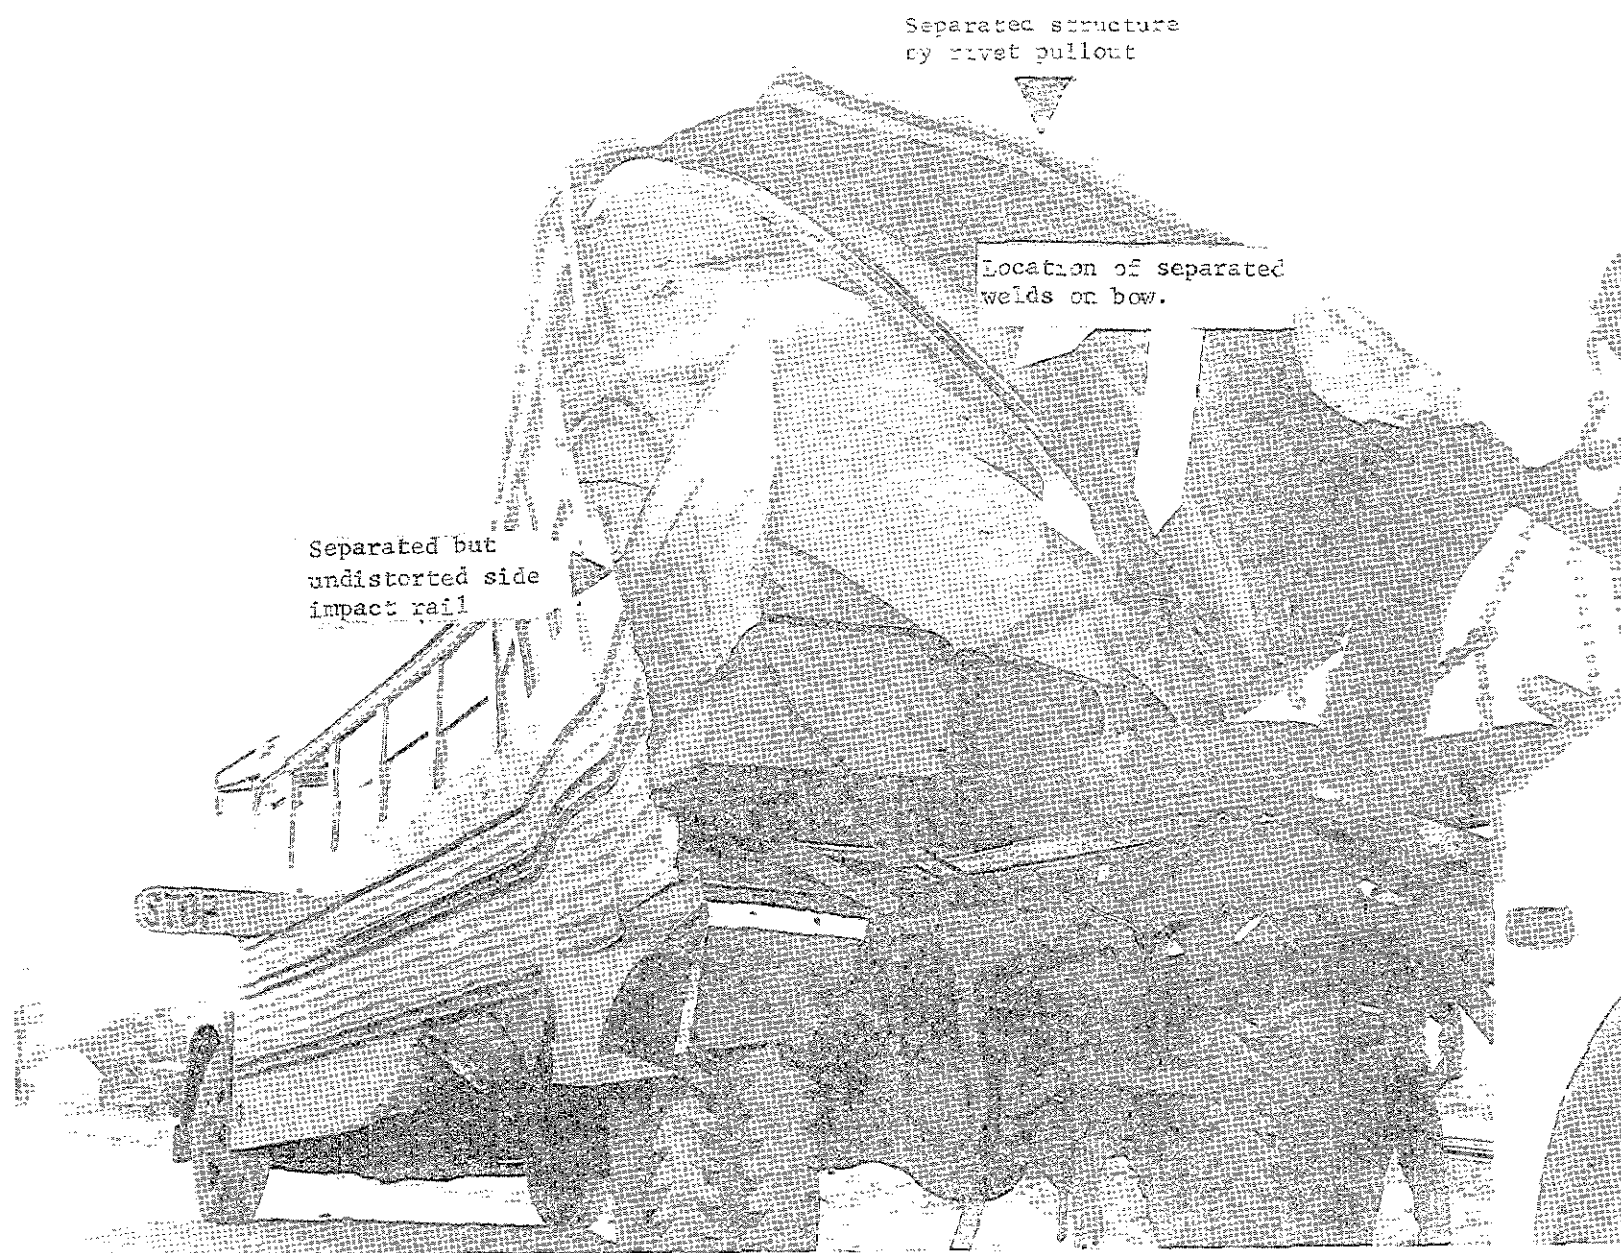
When the impact with the pole occurred, a large portion of the rear of the bus, including the side, window posts, floor, rear seats, and emergency door, continued backward away from the direction of the train. This portion had been loosened and partially detached by the initial impact and appeared to have rotated around the relatively rigid pole. At least four seats and other components of the bus were projected approximately 50 feet to the rear of the bus, or were dropped there by the train.

With few exceptions, the sheet metal sections of the body did not fail internally, but separated along their lines of connection. The most frequent form of failure was the pulling out of rivets.

6. REAR END OF THE SCHOOL BUS AFTER THE ACCIDENT AND AFTER THE BUS HAD BEEN MOVED FROM CONTACT WITH THE COMMUNICATIONS POLE. PHOTOGRAPH SHOWS THE DISINTEGRATION OF THE REAR OF THE BUS.

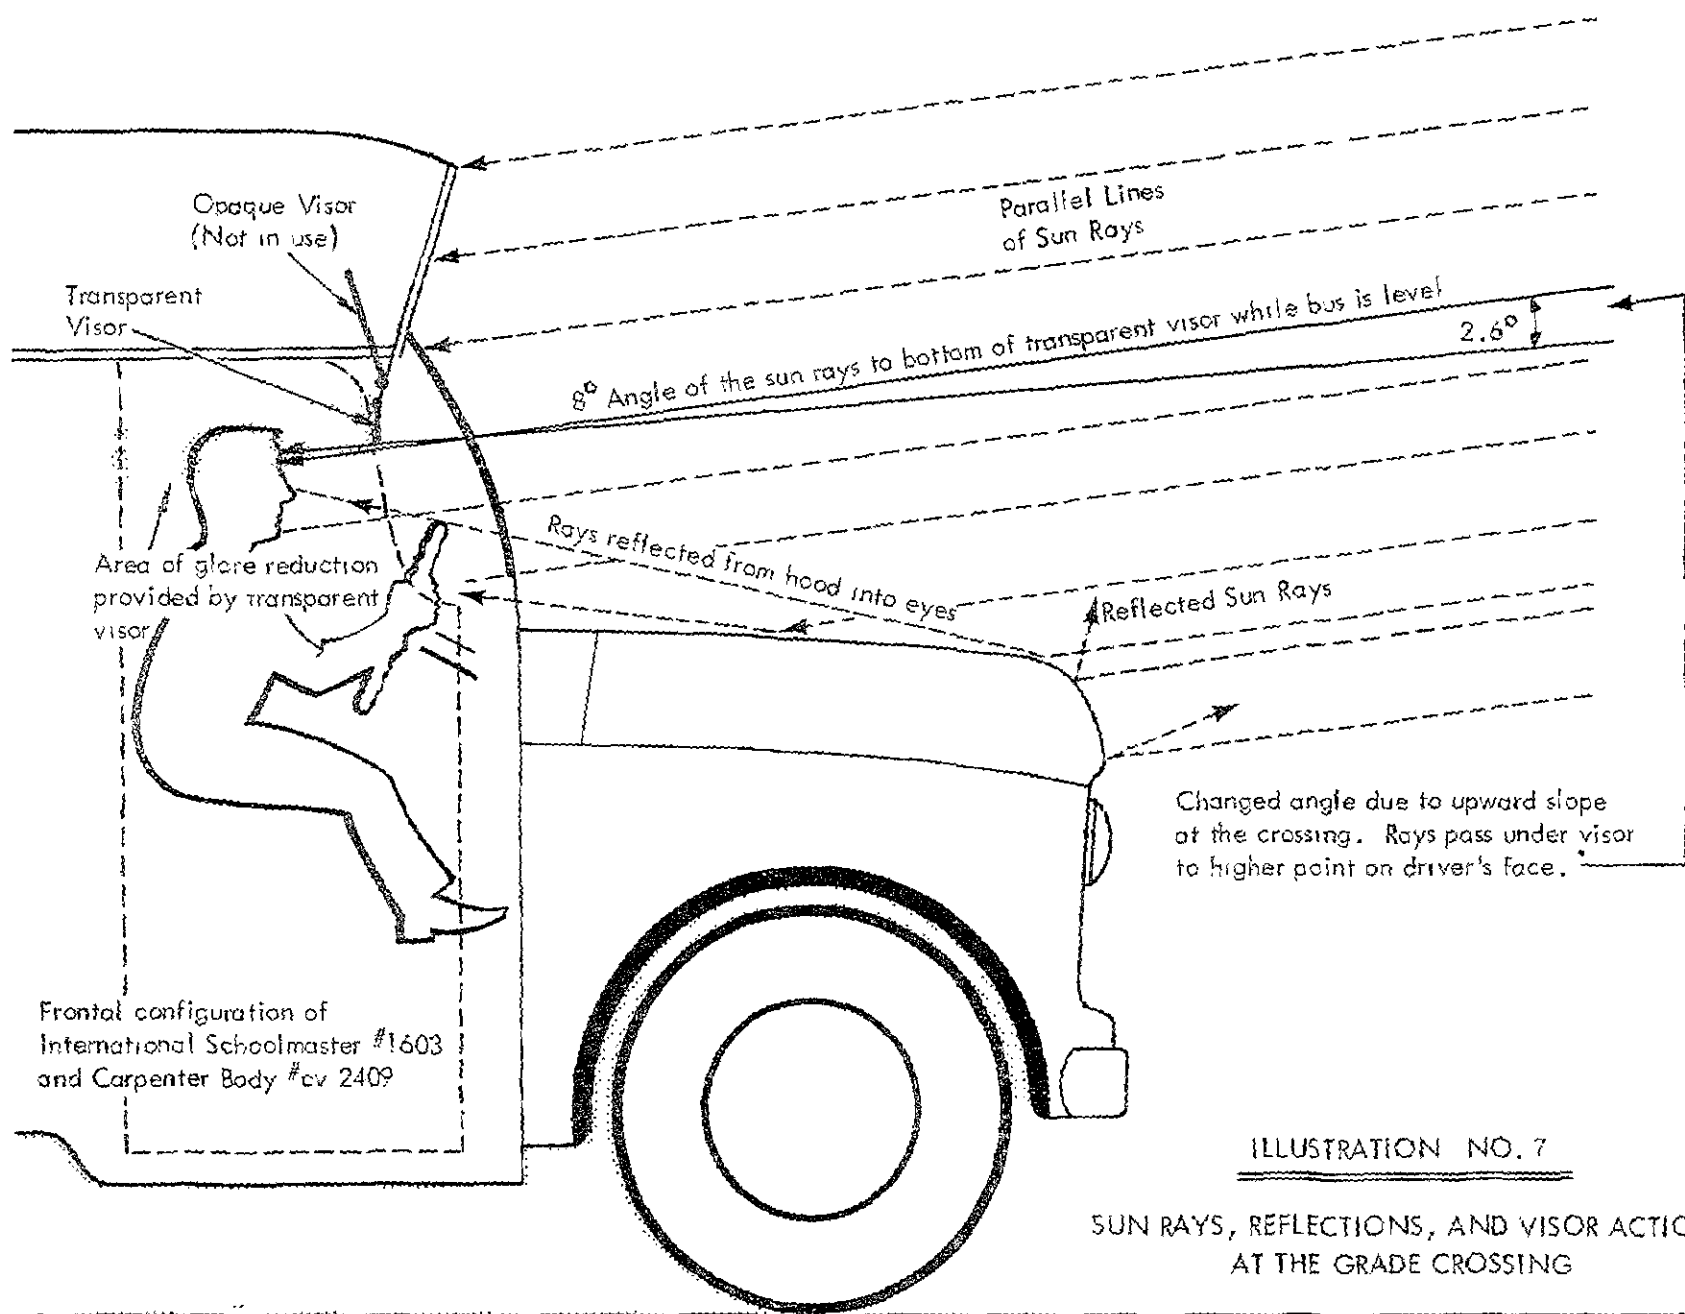
ILLUSTRATION NO. 7

The second problem was the upward inclination of the road, tending to move the shadow of the visor and to allow the sunlight to strike directly into the driver's eyes. This has been noted in analysis as a possible surprise factor tending to blind the driver, but there is no way to determine whether this condition actually occurred. The change in angle and other glare problems are diagrammed in Illustration 7. The visor arrangement on the school bus was actually superior to that generally found in most passenger cars and most trucks, and the visor design alone is not considered a cause of the accident.

SUN RAYS, REFLECTIONS, AND VISOR ACTION  
AT THE GRADE CROSSING
