Montana Department of Transportation Research Program November 1999

CONSTRUCTION REPORT

FIBER-REINFORCED POLYMER (FRP) COMPOSITE PULTRUDED DECKING MATERIAL AND HELICAL ANCHORING SYSTEM FOR USE IN SNOW FENCE APPLICATIONS

- Location: Livingston, Montana. Interstate 90, MP-332, Park County
- Project No.: IM90-7(63)331
- Description: Installation of two test sections of snow fencing using two proprietary materials; Pultronex EZ-Deck and A. B. Chance Helical Anchoring System.

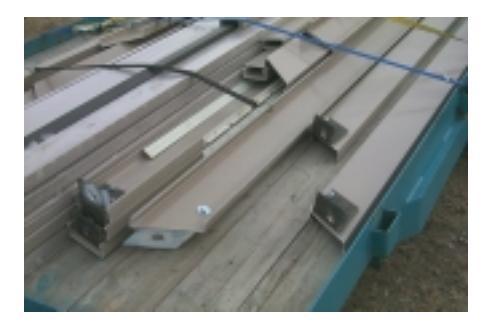
Figure 1.

Construction of TS1 began approximately 8:45 am. Knopfle Construction had drilled and set concreted anchor bars prior to the construction of TS1. The FRP bracing supports were pre-cut and brackets attached in-shop as seen in figure 1. The clip bracket attachment, which secures the slat to the brace frame, was also installed in-shop.

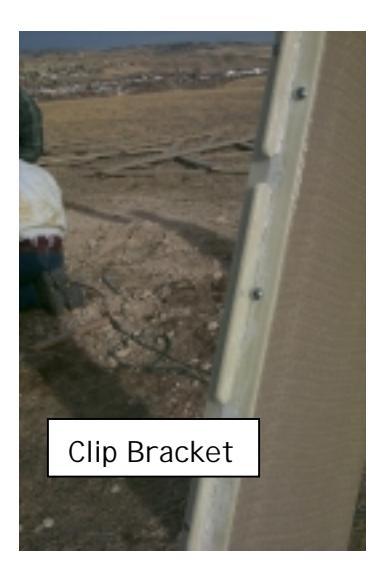
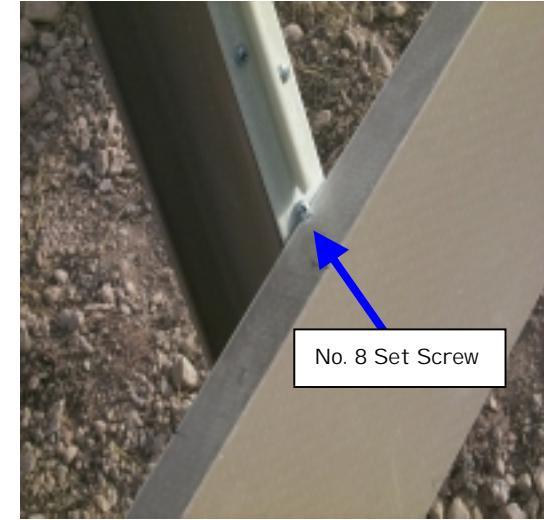
Figure 2.

The FRP decking planks were attached by snapping the c-shaped material to the clip bracket. In normal application of this product, the 'boards' are side by side in close proximity to each other (within a ¹/₄ inch). This insures a stable, tight fit. In this situation, there is a missing board due to the required design of snow fence (alternating plank, then space and plank). To compensate for the lack

of support, a no. 8 setting screw was used to secure the plank to the clip attachment (see figure 2). This will substitute support, which the missing plank would have done. Installation of the MDT design (TS1) was completed in approximately 2.5 hours. The TS1 Front brace consisted of two FRP planks, overlapped by one foot against each other (figure 5). MDT design had specified a single length brace. Anchor system #3 (MDT Standard Spec. 607) specified #19 rebar for sill isolation (restricting lateral movement and sawing action).

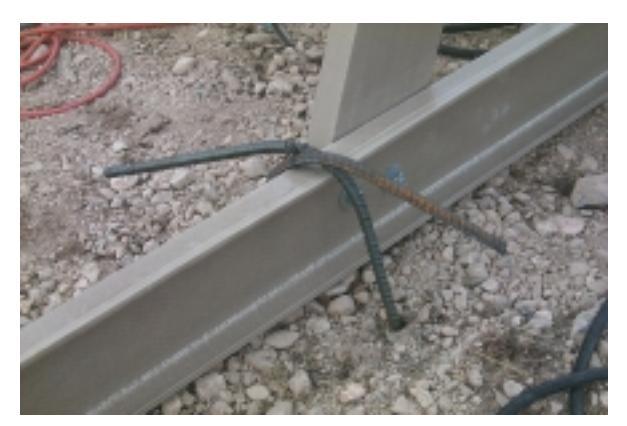
Figure3, Anchor Sill.

The Contractor did not have the correct size of rebar, they used a smaller diameter rod and bent the rods over the sill and tied them with baling wire (figure 3).

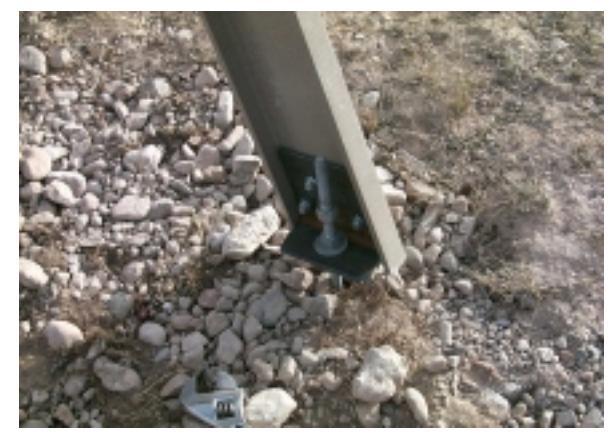
Figure 4.

The fence sill was connected to the anchor bar (TS1) by two nuts with washers. The height of the anchor attachment apparently was set to high within the concrete pile to set the sill placement firmly to the ground. This has the TS1 Snow fence section setting approximately two inches above the ground, the section is sitting on the bolted anchor and not on the ground. This was a concern of Scott Keller that

the structure may have too much lateral movement during high winds that may result in premature failure of the anchor bolts or other attachment hardware in the fence due to turbulence and vibration, (see figure 4).

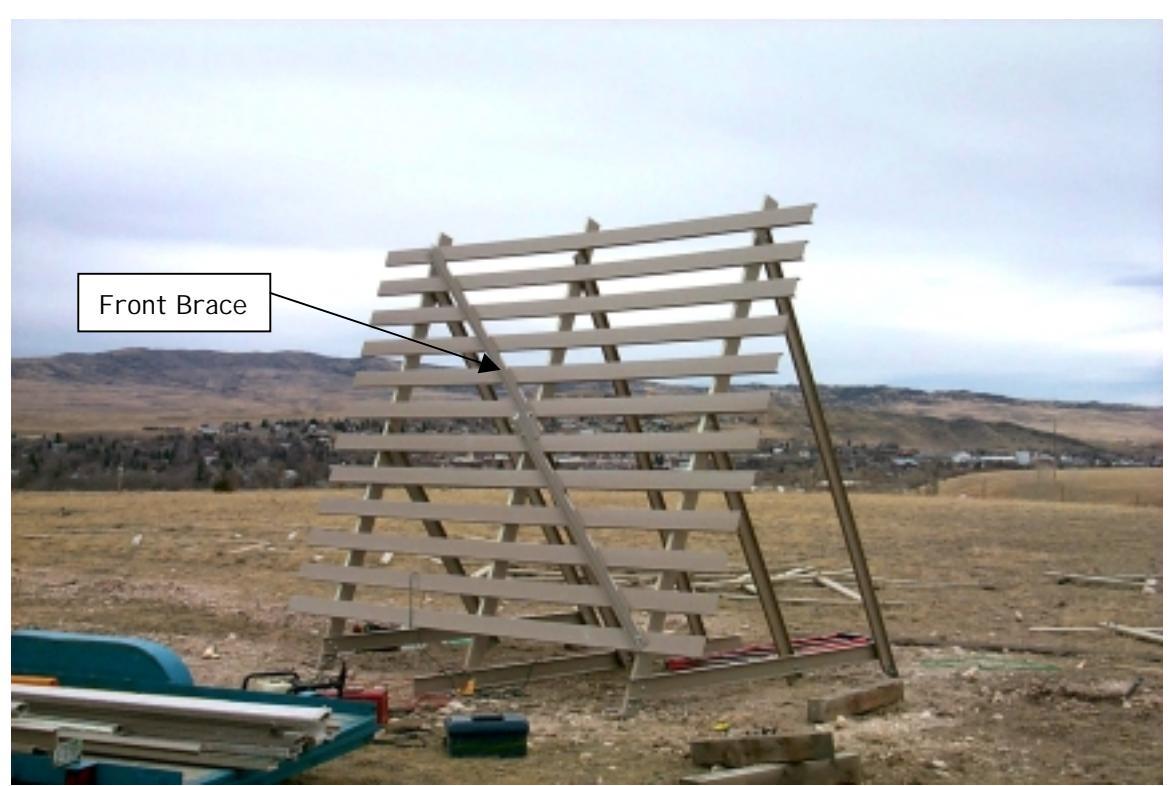
Figure 5.

Figure 5, Completed TS1 snow fence section.

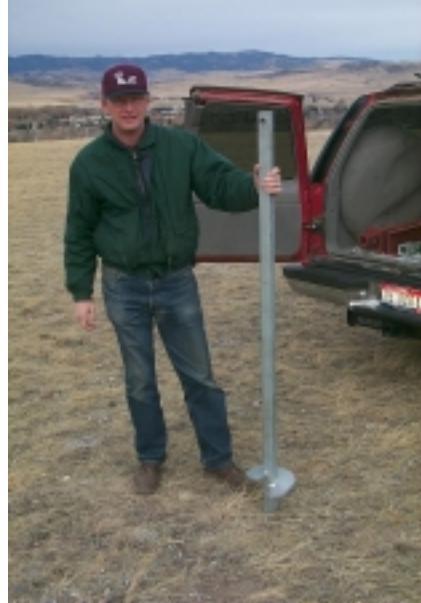
Figure 6.

Test Section 2 (TS2), was constructed using the design submitted by Dave Morris. Prior to installation, the Helical Anchors were drilled into the ground using a hydraulic rotary device attached to a backhoe (figures 6 & 7).

The Helical Anchor used was a high-strength, 1.75 inch by five-foot single coil as seen above.

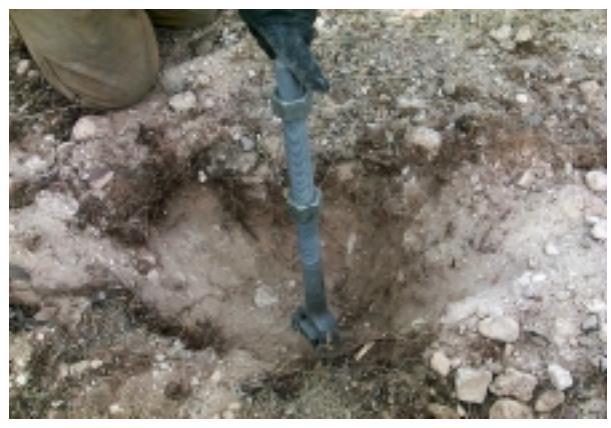
All four anchors were in place within 45 minutes upon the arrival of the backhoe. The ground appeared to be rubble/cobble type material. The anchor was inserted about a foot below the surface. A second threaded shaft was connected to the anchor with a u-shaped bracket (figure 8). The sill was then attached to the threaded bracket.

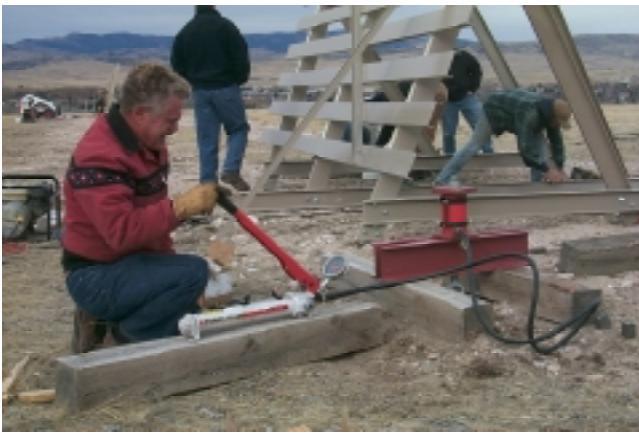
Prior to sill attachment, an extraction and compression test was performed on the first Helical Anchor installed. The extraction psi went at 35,000. The compression test resulted in a 40,000 psi. 10,000 is the MDT spec. No other tests were performed on the remaining anchors (see figure 9). Test section 2 was constructed in one hour once all anchors had been installed. No problems were reported during construction of TS2.

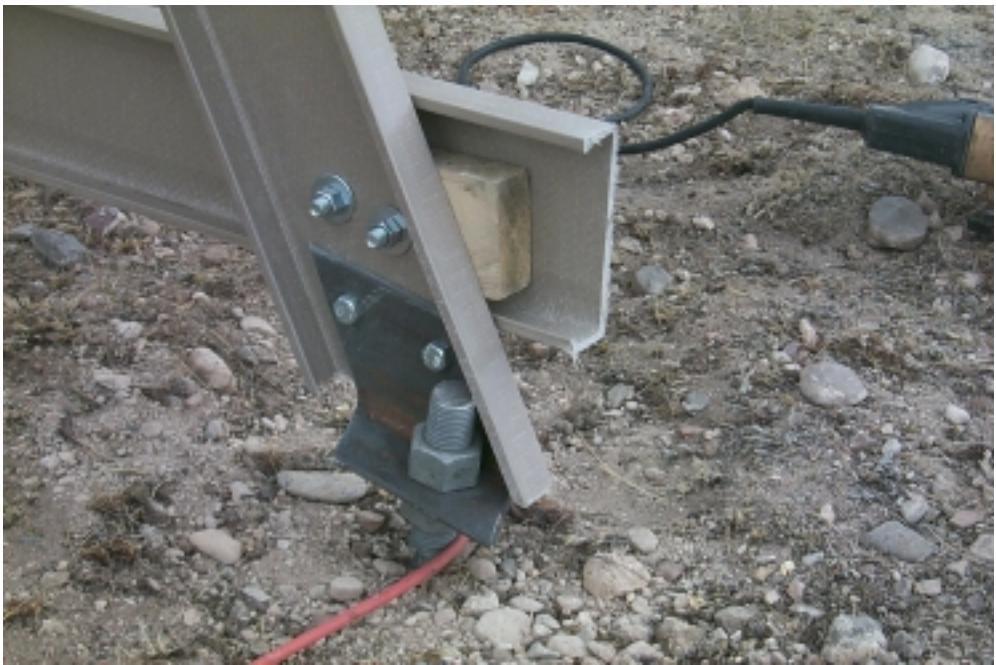
FRP frame attachment to Helical Anchor.

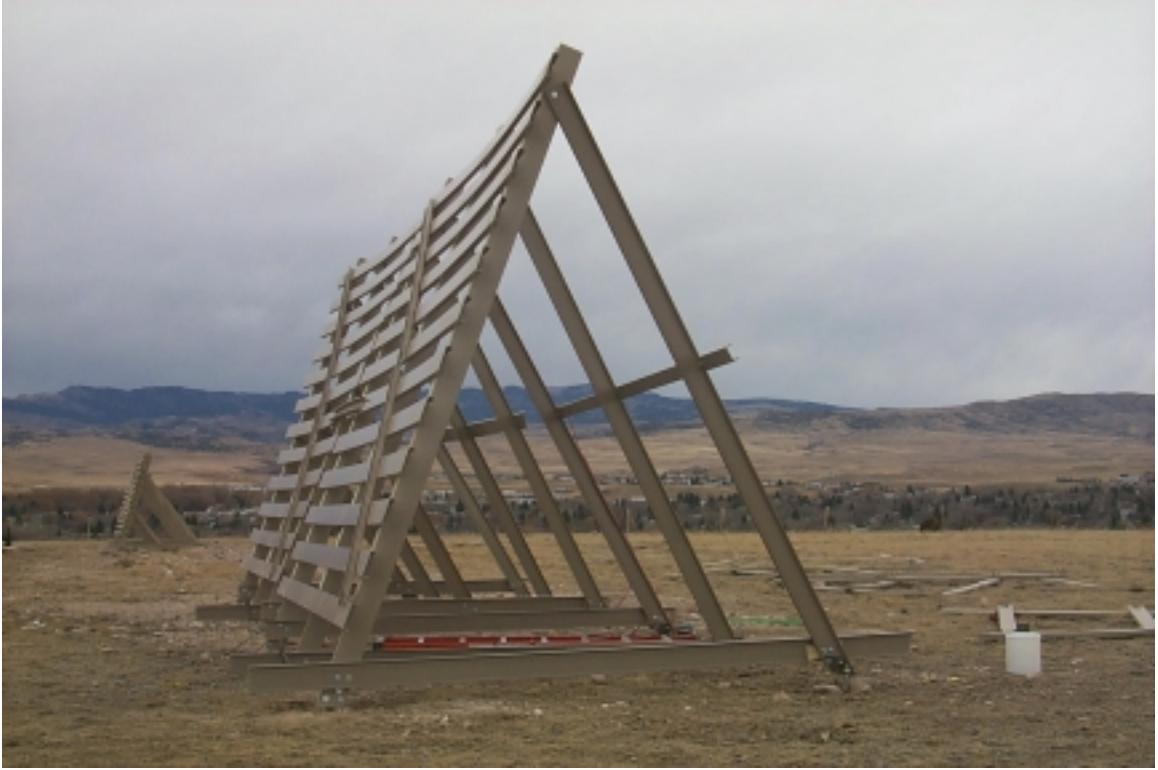
Side view of completed test sections 1 & 2.
