Office of Research, Development and Technology Washington, DC 20590 Ground Penetrating Radar (GPR) Technology Evaluation and Implementation: Appendices A Through F

DOT/FRA/ORD-20/18

Final Report May 2020

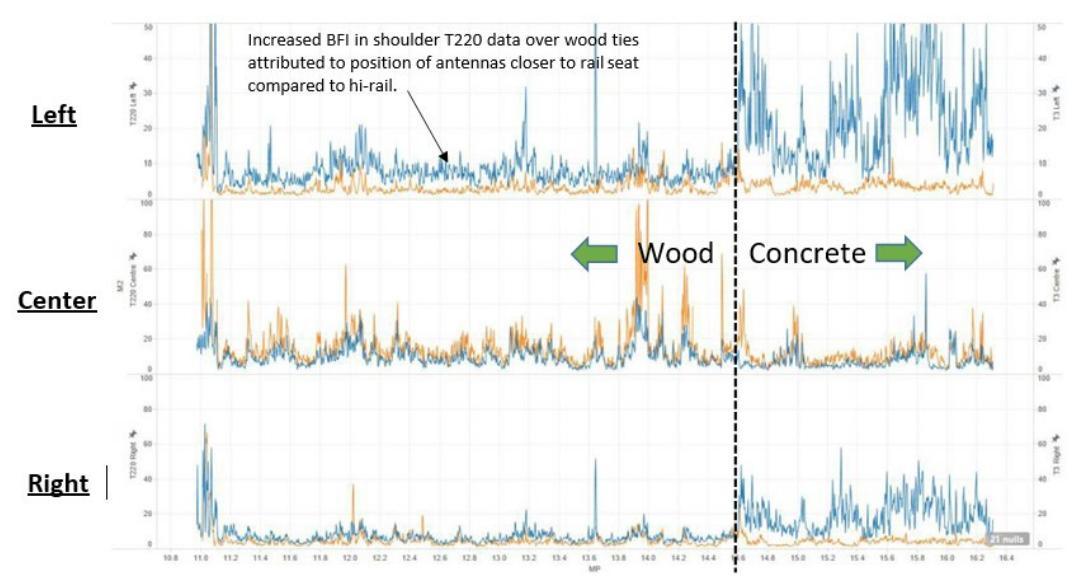
Figure E 25. Increased BFI in shoulder T220 data over wood ties

(orange) and DOTX220 (blue) for a section of both wood and concrete ties on Main 2 between \sim MP 11.0 and MP 16.3. The transition from wood to concrete occurs at \sim MP 14.6

- The near-surface interference observed at the concrete tie sample locations on Main 1 and at other locations on Main 1 and Main 2 is much less apparent on the newly constructed December 2016 section of concrete tie track between Milford and Pleasant Dale.
- This suggests the interference may be associated with specific properties of the concrete ties as well as the position/orientation of the shoulder antennas relative to the ties.

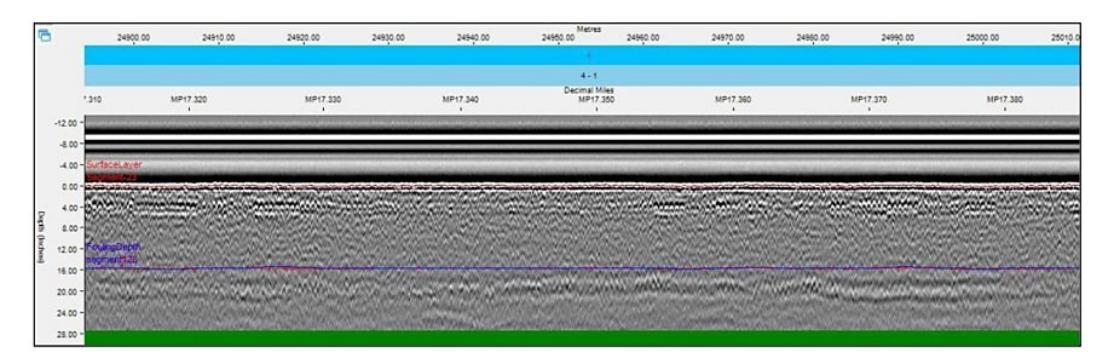
Figure E 26. Well-defined deep ballast/sub-grade interface at ~18–20 inches depth

The right shoulder 2 GHz radargram from recently constructed track on Main 1 at \sim MP 17.350 illustrates well-defined deep ballast/sub-grade interface at \sim 18–20 inches depth, a deep FDL depth (+16 inches) and BFI of less than 5.

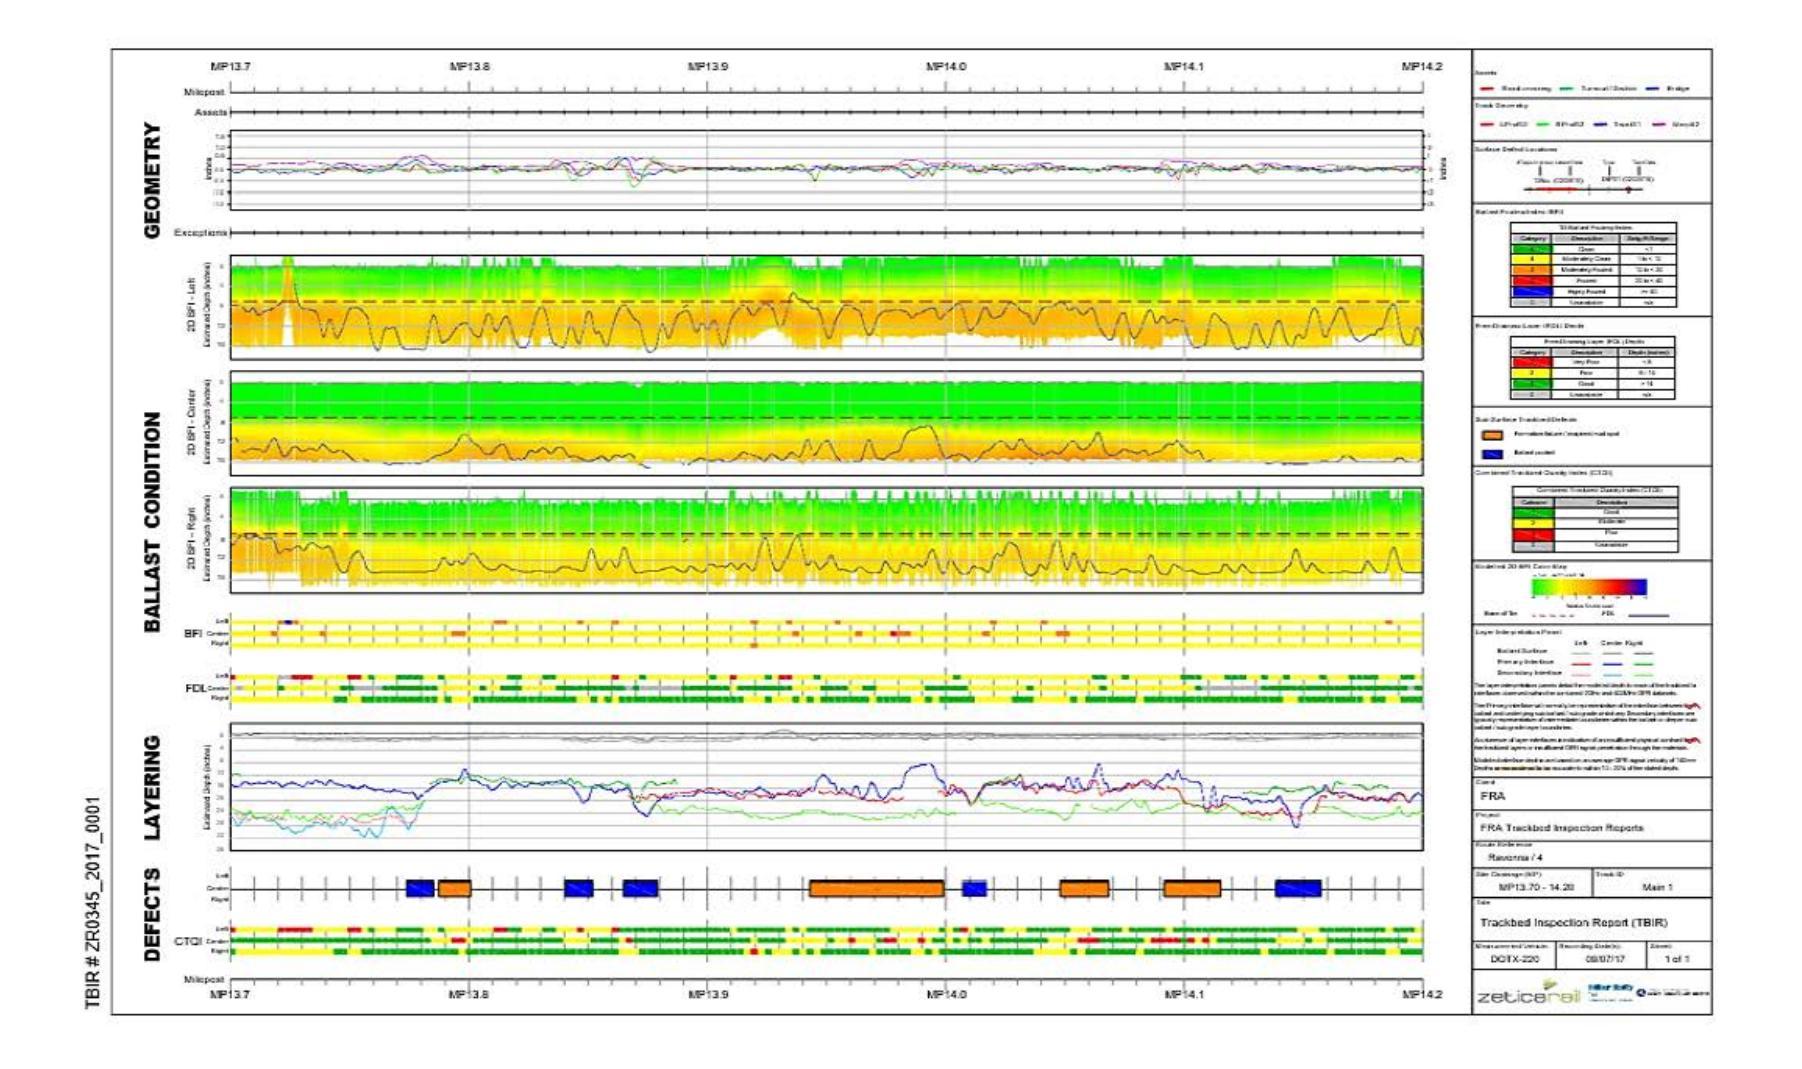
Trackbed Condition Summary	The general condition of the trackbed within this 1/2 mile is classified by the Combined Trackbed Quality Index (CTQI) as Good, with relatively low levels of ballast fouling (predominantly CAT 4 - Moderately Clean) on all three data channels (left & right shoulders and track center) and a Good to Poor free-draining layer depth of between 8 to +16 inches. Short sections of Moderate to Poor quality trackbed are associated with localized defects (see below). Increases in track geometry Profile and Twist have been identified at a number of locations within this section but all lie within exception limits for the posted track speed / class.
Trackbed Layer Summary	A well-defined Primary layer interface interpreted as the base of clean ballast, has been identified in the track center for the majority of the 1/2 mile and less continuously on the ballast shoulders. With the axception of a number of identified ballast defects, the modeled depth to the interface is generally at or close to design depth, lying at between 16 - 20 inches from surface. Through much of this section, local increases in reflection strength on the primary interface and attenuation of the GPR signal in the underlying materials suggest that the sub-grade is likely to comprise relatively moist, cohesive materials. On the right shoulder, the Primary interface is generally absent and is instead replaced by a more uniform Secondary interface lying at modeled depths of between 24 - 28 inches. This interface is interpreted as the base of sub-grade. Between ~MP13.700 and MP13.780 it is additionally evident within the track center and on the right shoulder.

Trackbed Defects Summary	MP13.774 - MP13.785, MP13.840 - MP13.852, MP13.855 - MP13.879, MP14.060 - MP14.018, MP14.149 - MP14.158 - Ballast pockets: These are characterized by localized increases in the depth to the Primary layer interface of between 4 - 8 inches indicative of possible locally soft subgrade / soil conditions. They are predominantly observed within the track center. The three anomalies between MP13.774 and MP13.879, are associated with an apparent cross-cutting drainage feature and may be associated with an unidentified cross-track culvert or pipe. A similar pocket has been identified at the same location in the GPR data acquired on Main 2 (see TBIR# ZR0345_2017_0002). MP13.080 - MP13.801 - MP13.801 - MP14.019, MP14.091 - MP14.115 - Subgrade pumping / failure, mud spot development: These defects are characterized by localized reductions in the modeled depth to the Primary layer interface, indicates that a slight deterioration in track geometry Wall.399. MP13.999. MP14.080 - MP14.069 - MP14.115 - Subgrade pumping / failure, mud spot development: These defects are characterized by localized by localized with an apparent cross-cutting drainage for the site and may be associated with an and the GPR data acquired on Main 2 (see TBIR# ZR0345_2017_0002). MP13.091. MP13.001. MP13.001

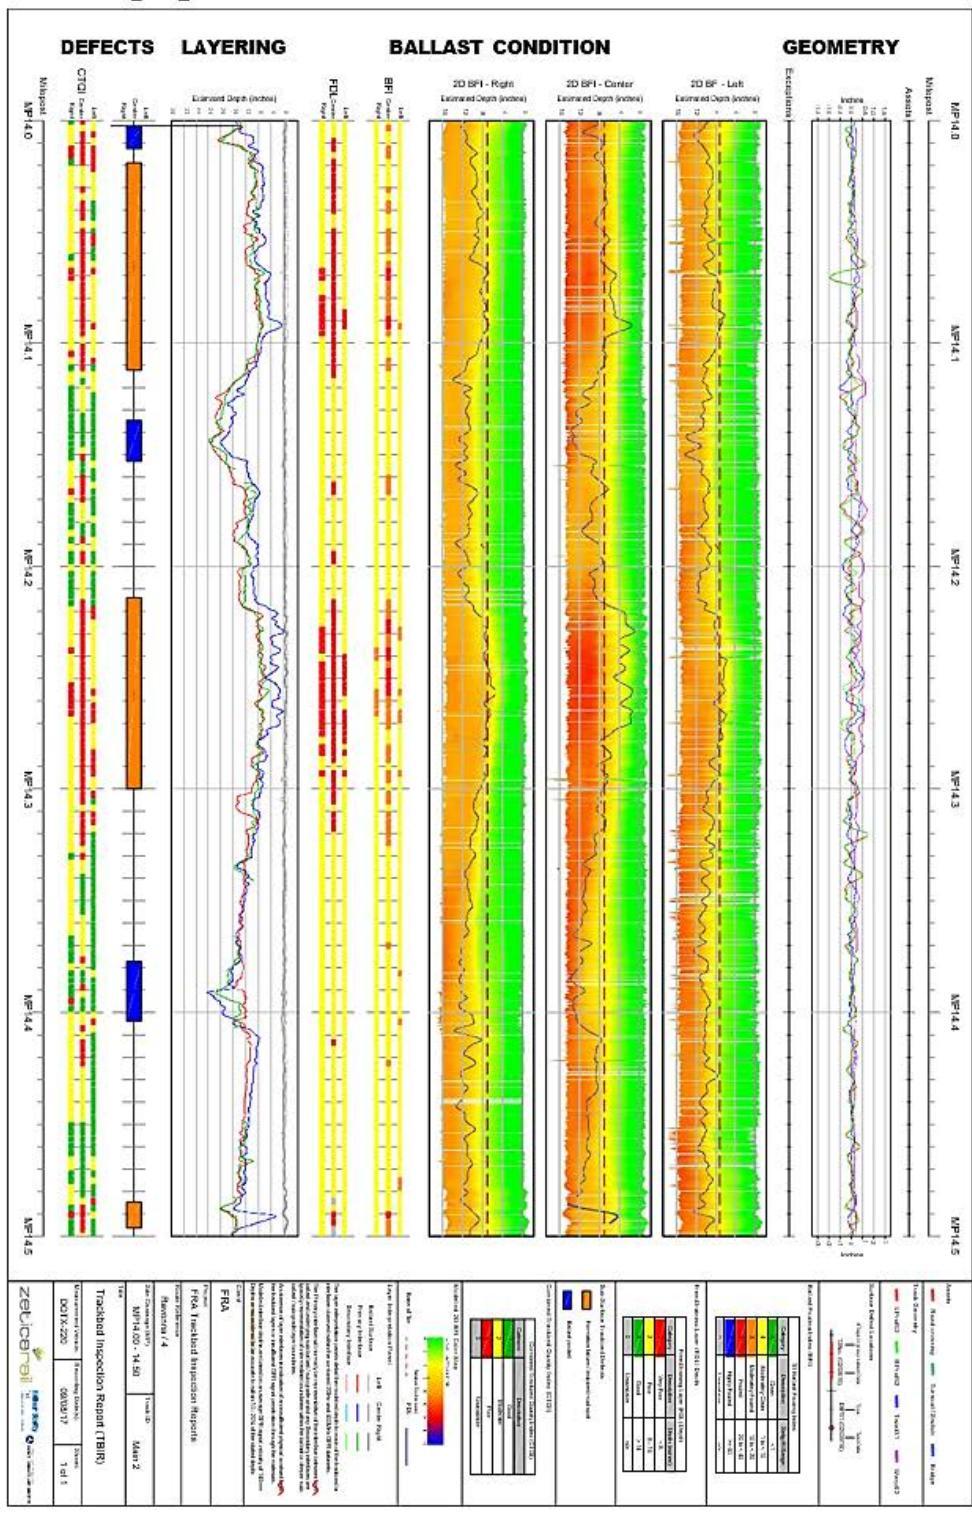
TBIR # ZR0345_2017_0002

Trackbed Condition Summary	The condition of the trackbed within this 1/2 mile is classified as generally. Moderate to Good within areas outside of the identified trackbed defects. The condition on the ballast shoulders is typically slightly better than that of the track center, primarily as a result of improved ballast quality. Areas of Poor quality trackbed are characterized by modeled ballast fouling ranging from Moderately Fouled to Fouled, a shallow [<8 inches] modeled free-draining layer (FDL) depth, particularly in the track center, and an irregular ballast profile.
Trackbed Layer Summary	A well-defined continuous Primary layer interface has been identified over the majority of the 1/2 mile on all three data channels (left & right shoulders and track center) at modeled depths of between <4 inches and 24 inches. The interface is variably interpreted as representing the boundary between clean ballast and fouled material, and clean ballast and sub-grade. There is no evidence of a deeper, secondary, interface within the 2GHz datasets indicating that the base of the trackbed lies below ~3 feet through this section. No 400MHz data was available from the DOTX- 220 survey.

Trackbed Defects	MP14.000 - MP14.012 - Ballast pocket: Characterized by a localized increase in the modeled depth to the Primary layer interface from ~10 - 16 inches to over 20 inches on both the left and right shoulders attributed to soft sub-grade conditions. Attenuation of the GPR signal below the interface is proteinally indicative of increased % moisture within the underlying materials. MP14.019 - MP14.012 - Insufficient Clean ballast thickness, mud spot development and surface mud: This section of track is characterized by a shallow Primary layer interface (< 8 inches in center] and correspondingly shallow FDL together with evidence of both active (surface) and developing (sub-surface) mud spots in the center and on the right shoulder. Coincident with this defect is a well- defined negative (Dip) left and right profile deviation of ~1 inch in the track geometry data, potentially indicating locally soft trackbed conditions. The deviation does not constitute a track geometry exception for the posted track speed/dass.

Summary	MP14.135 - MP14.153 - Ballast pocket: This feature comprises a relatively broad low in the ballast profile that extends to a modeled depth of ~28 inches. It is coincident with a cross-track drainage feature viable in aerial imagery of the site and may be associated with an unidentified culvert/pipe. A similar anomaly is identified here in the GPR data acquired on Main 1. MP14.214 - MP14.300 - Developing and active mud spots, insufficient clean ballast thickness, elevated % moisture: This defect is characterized by an irregular and very shallow (<4 inches) Primary layer interface and correspondingly shallow FDL. The elevated reflection amplitude of the Primary interface and attenuation of the signal in the underlying materials is potentially indicative of elevated moisture levels within the near-surface materials. Various TG surface parameters are slightly elevated within this section but lie within exception limits. MP14.236 - MP14.404 - Ballast pocket (center only), MP14.485 - MP14.495 - Active mud spot (center only): Weil-defined "30-ft wide anomaly. No significant track geometry response.
