Seattle Wide-area Information For Travelers

# Communications Study

Contract Number: WSDOT Y-5908

October 19, 1998

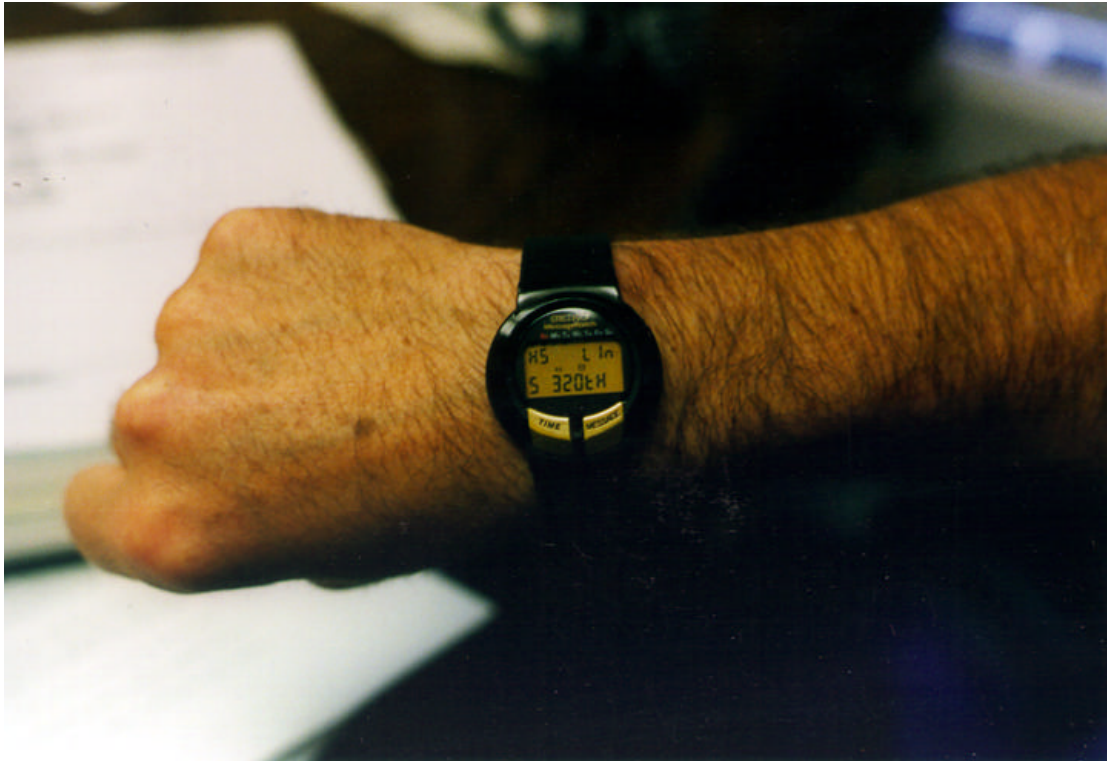
Figure 1-2. Seiko MessageWatch.

These devices are commercially available and widely used in the Seattle area to deliver personal-paging services and “information service” messages. Current information-service messages include weather forecasts, financial market summaries, local sports scores and winning lotto numbers. SWIFT traffic messages were featured as an added information service.

SWIFT test participants who used the Seiko MessageWatch supplied information to the Evaluator about the usual routes, directions, days and times of the day they traveled. Traffic messages indicating the location and severity of traffic problems that the user might encounter were sent based on the resulting travel profile. Because the Seiko MessageWatch stored eight messages, only traffic problems that resulted in substantial delays were sent.

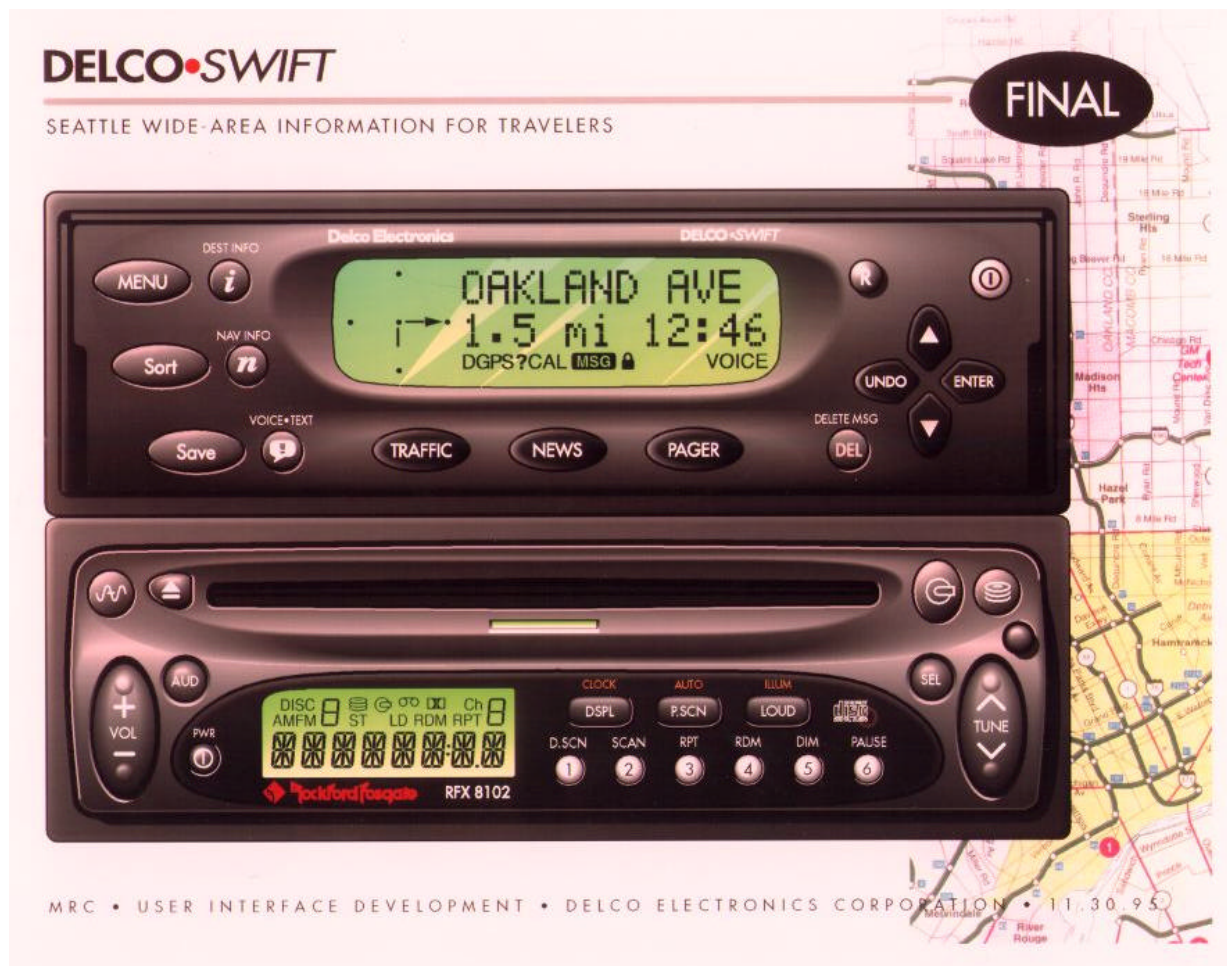
Figure 1-3. Delco In-vehicle Navigation Device.

Real-time traffic-incident information was transmitted over the Seiko HSDS. The HSDS receiver was built into the Delco in-vehicle navigation unit filtered out any messages that were outside a pre-defined distance (e.g., 20 miles) from the current location of the vehicle. The navigation unit also decoded upon demand the SWIFT traffic messages from text into a “voice” that provided incident details to the driver. Although messages were retransmitted every minute, only new or modified messages were announced to the driver.

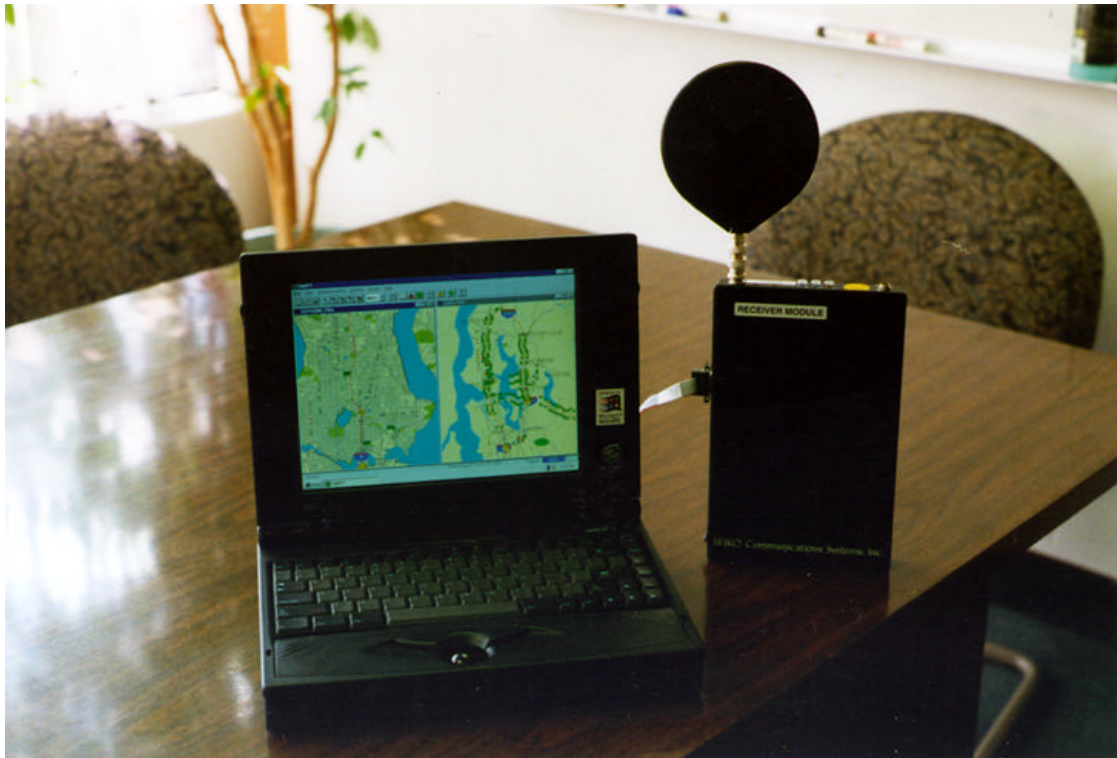
Figure 1-4. SWIFT Portable Computer and RRM.

All of the traveler information for SWIFT portable computers was displayed using Etak Geographical Information System (GIS) software to show the location of each piece of data. The software allowed the user to select the type(s) of information (i.e., traffic incident, speed/congestion or transit-vehicle location) to be displayed on a map of Seattle. A "Yellow

Pages" directory was also installed and linked to the GIS software to show the location of a selected business or point of interest. SWIFT portable computers also offered transit schedule information from static database tables inside the computer.

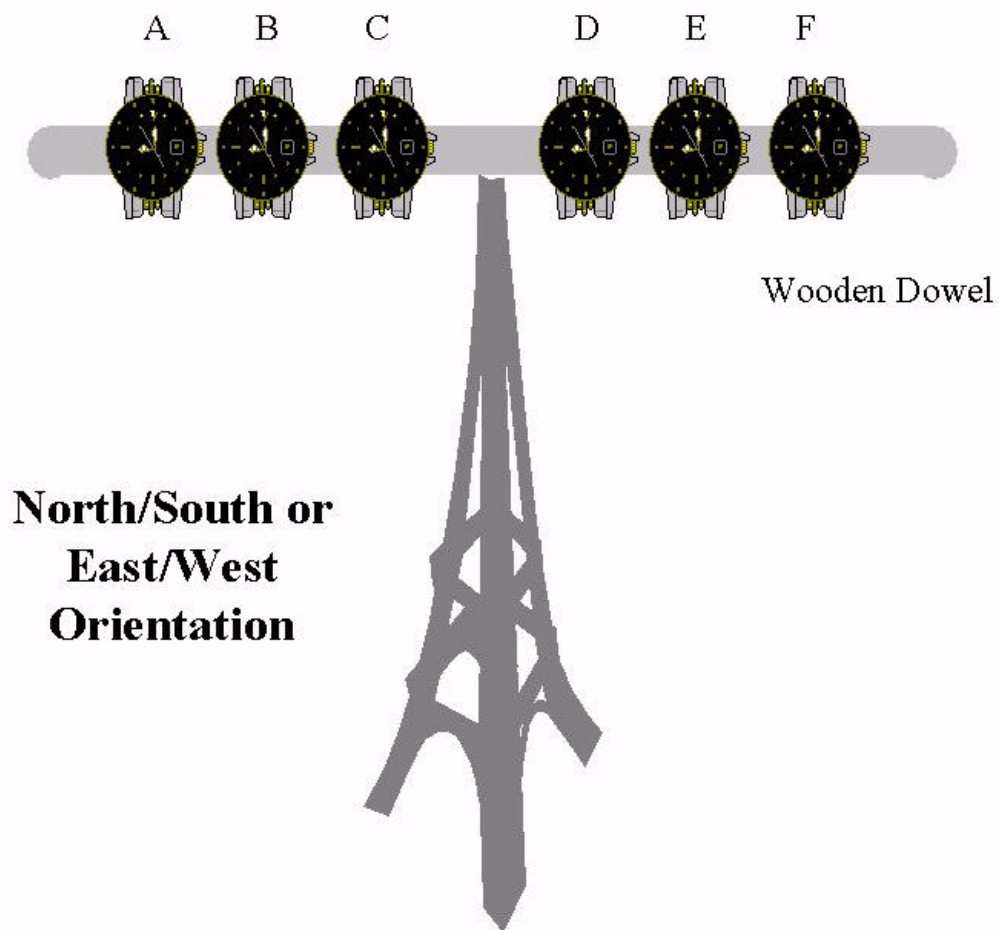
**Figure 2-2. Drawing of Seiko MessageWatch Horizontal Test Configuration.**

period in order to collect a statistically relevant number of sample points. To reduce the duration of the watch test, six watches were included in the test configuration. By allowing the test to run for an hour or more, about ten measurement points per watch, or sixty total, were collected.

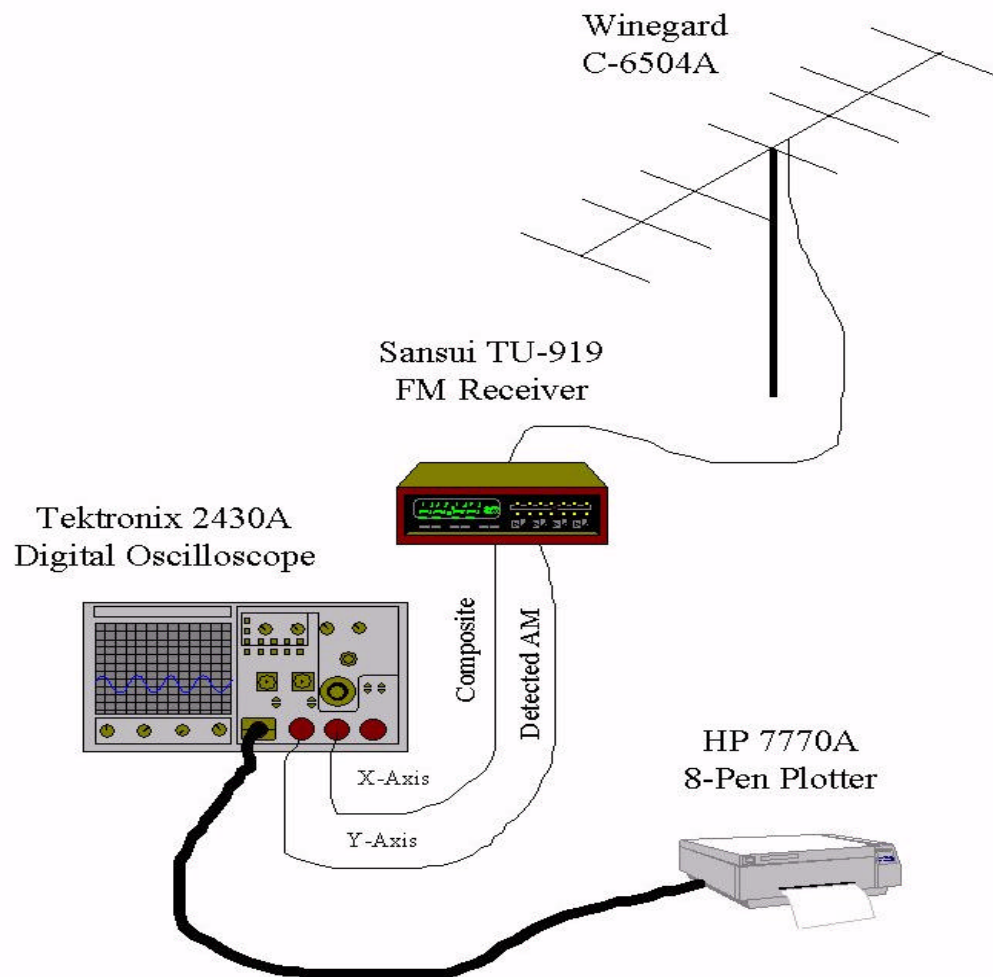
**Figure 2-7. Multi-path Test Configuration Diagram.**

For the purposes of the *SWIFT Communications Study* testing, a simple technique was employed to detect the presence of multi-path interference using the TREQ monitor system. This system was capable of being locked to a specific HSDS station. At test locations where poor reception was found, but where there was adequate RSL, a multi-path situation may exist. Since the azimuth (bearing angle) from the test location to the specific transmitter was known in advance, it was possible to replace the omni-directional test antenna with a directional antenna pointed directly at the transmitter. By using this method, one can compare the two sets of measurements and observe changes in the BER and PCR from the particular station. In cases where significant multi-path was indeed present, the directional antenna technique greatly improved receiver performance. In addition, experimental measurements were also made at varying off-azimuth bearings up to  $\pm 25^\circ$ . This method can help identify if there is more than one multi-path signal and generally from what direction(s) they are being received. However, due to the fairly wide pattern of this directional antenna, exact measurements were not able to be taken.

A Winegard Directional FM antenna, Model # CA-6065, was used during the testing to isolate observed signal degradation possibly caused by multi-path environments. This antenna, designed with 10 dB of gain, was mounted on a 5 foot 1 $\frac{1}{4}$ " steel mast which was supported with a 3' roof-mount tripod. The beam-width of this antenna across the FM band was 60 degrees or less, with a fast drop-off in received signal level beyond this point. Consequently, when this antenna is aimed at a station, the level of multi-path will be significantly reduced if the received signal is originating from angles greater than  $\pm 30$  degrees. An improvement in BER/PCR over that measured with the OMNI antenna configuration strongly suggests that the cause of poor performance may be

- Step 5B: By pointing the directional antenna “off-axis” in incremental steps, determining if there was another direction at which the RSL, BER and PCR was also significantly improved

- Step 5C: Use the directional antenna with a Sansui FM receiver and a Tektronix 3036A oscilloscope to measure the amount of detected audio present in the suspect signal
- Step 6: A manual log of all test-equipment settings, locations and physical environments was maintained for all sites tested.

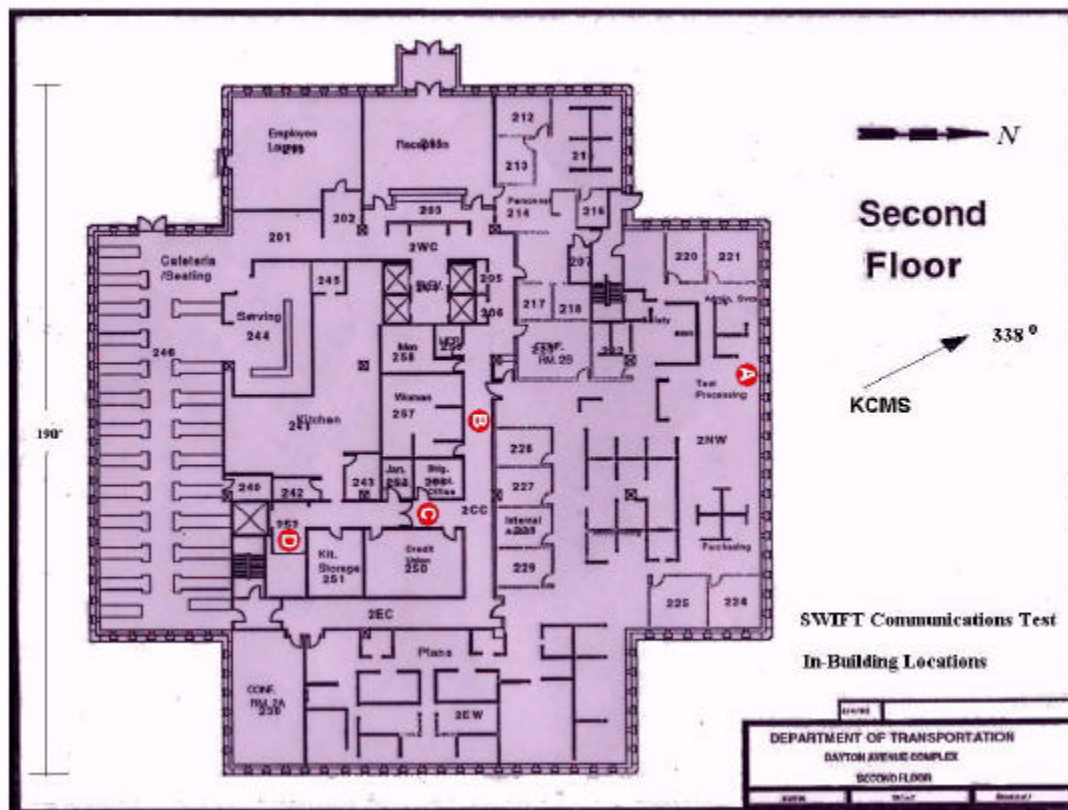
Figure 2-9. TSMC Floorplan Showing Inside Building Measurement Locations.

As indicated on the floorplan of the WSDOT Traffic Systems Management Center (TSMC) shown in Figure 2-9, there were four in-building measurement locations. These were designated 6A, 6B, 6C and 6D. Location 6 as noted on was used as a reference and was measured outside the TSMC facility.

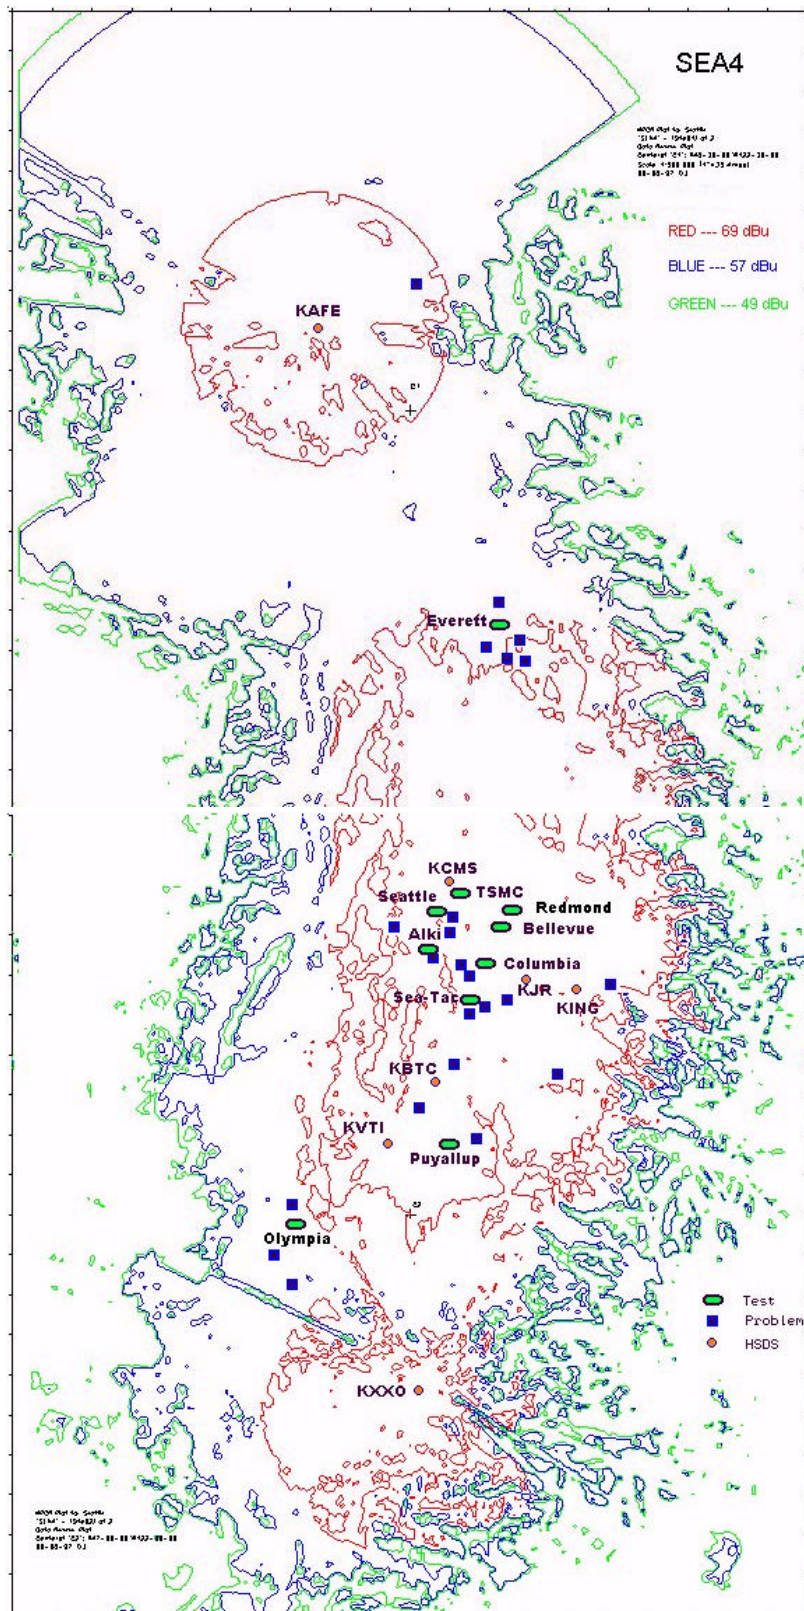
**Figure 3-2. Composite Predicted Signal Levels for Remote Receiver Module.**

The RSL measurements made as part of these tests track reasonable well with the simulation contours produced by Seiko. While the simulated signal levels were sometimes higher than those measured, the correlation was strong enough to support using Seiko's simulation as a tool for system coverage planning and transmitter site selection. Plots of BER and PCR as a function of signal level produced from the test results indicated that the error rates and minimum signal levels quoted in Seiko's HSDS specifications are valid. In particular, it should be noted that all SWIFT field-test sites except Everett (Site #4) had at least one station with a reception rate of 99%, indicating probable reception of messages. Copies of these curves are presented in the following sections.

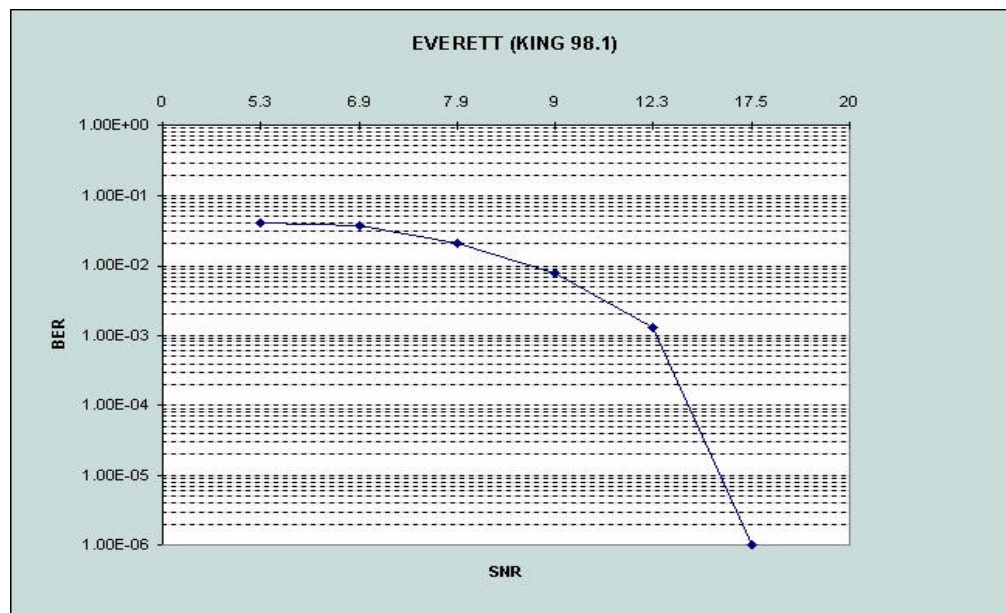
**Figure 3-10. BER versus SNR Performance at Location #4 Using A Directional Antenna.**

At this test location, the initial data-collection effort was flawed by an apparent loss of Seiko test messages. A review of the seven terrain profiles revealed signal occlusions from every station except KING. Interesting enough, KING with a significant signal level of -63 dBm, still performed very poorly at approximately 30%. The BER and PCR performance curves are shown in the Figures 3-10 and 3-11, respectively. Also, please refer to the performance analysis spreadsheet for test location #4, shown in Figure 3-12. This outcome appeared to be the best indication so far of severe multi-path interference. Similarly, the two RRM devices were locked onto KING at 98.1 MHz, but their message performance was poorer than normal in the 70% range. The analysis and discussion of the multi-path experiment at this location is discussed elsewhere in this section.

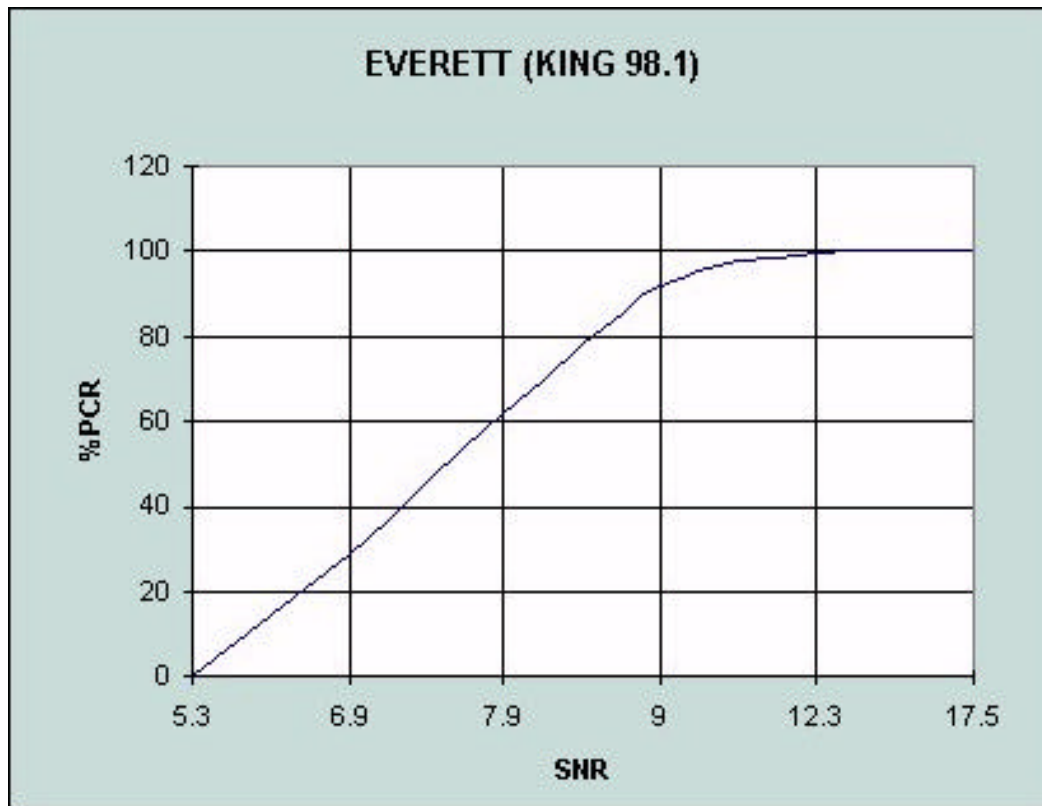
**Figure 3-11. PCR versus SNR Performance at Location #4 Using A Directional Antenna.**

The message performance data collected from the two RRM's was not surprisingly identical, regardless for their antenna orientation. The six watches similarly performed without errors at 100%. The BER curve for location #5 is shown below in Figure 3-13. It was developed using error rate data from an attenuated signal from station KCMS. Similarly, the PCR performance curves for locations is shown in Figure 3-14, with the performance analysis spreadsheet shown in Figure 3-15. These measurements were performed using a reasonable strong signal from KCMS of -62 dBm and introducing attenuation in steps until both quantities were affected. By adding attenuation in increments, such 10 dB, until performance started to fall of and then adding smaller, 3 dB, increments, the data points for these two curves were developed.

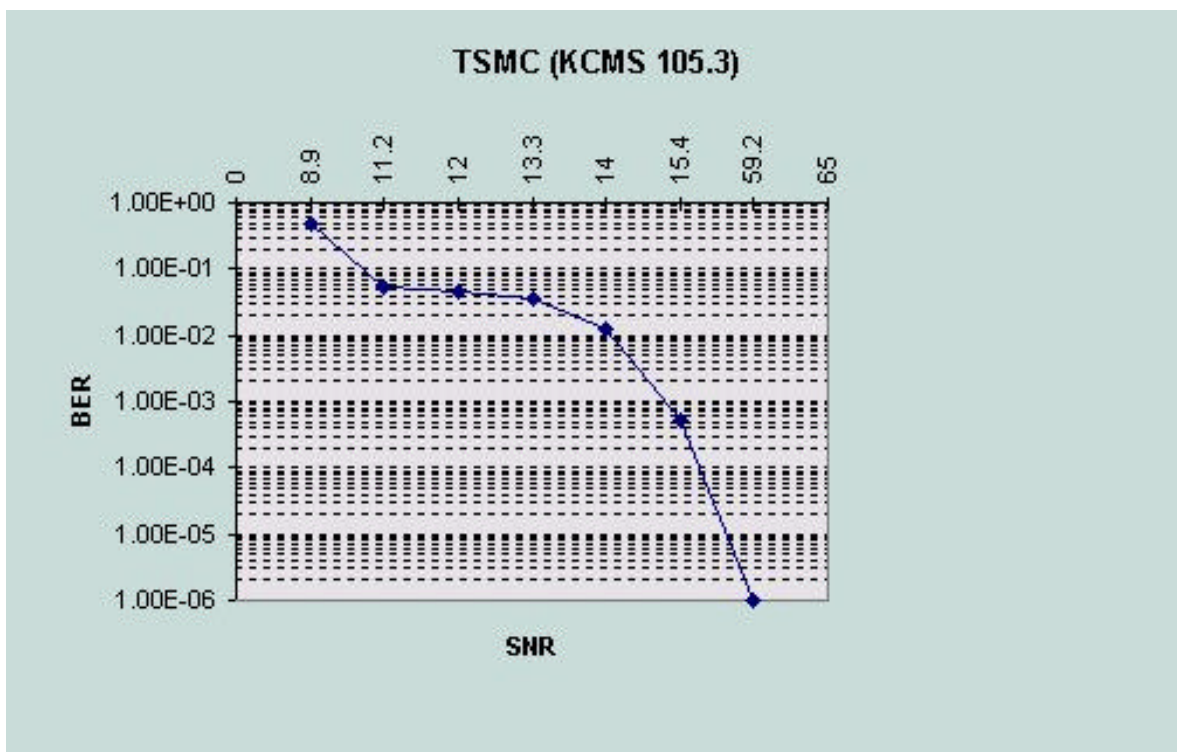
**Figure 3-16. BER versus SNR Performance Characteristics for Location #6.**

Conditions at this test location initially indicated that a multi-path environment might be the cause of the inability to take data from six out seven FM stations. After reviewing the transmission path terrain profiles, the results suggested that all but two had significant terrain blockages and six of seven were at a distance of about 20 miles or more. KCMS, unlike any other test was very close, 1.8 miles, with a -20 dBm signal which overwhelmed the RRM's and watches, causing them to lock on hard to the 105.3 MHz frequency. Manually forcing the watches to scan did not change the results. The only other station for which data was able to be collected on the TREQ was KAFE, with an RSL of -70 dBm. Figures 3-16 and 3-17 illustrate the BER and PCR curves for test location #6, respectively, while Figure 3-18 shows the performance analysis spreadsheet for location #6.

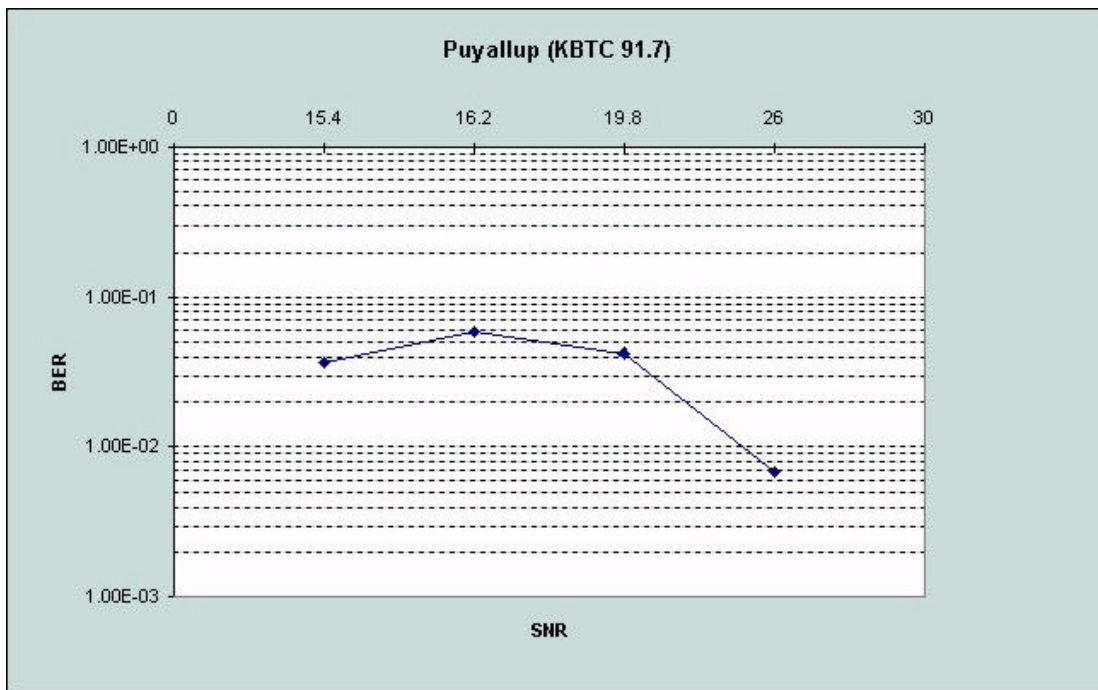
**Figure 3-22. BER versus SNR Performance for KBTC at Site #8.**

Figures 3-22 and 3-23 illustrate the BER and PCR versus SNR performance exhibited by signals received from KBTC. In addition, Figure 3-24 shows the summary performance analysis spreadsheet for data collection efforts made at test site #8.

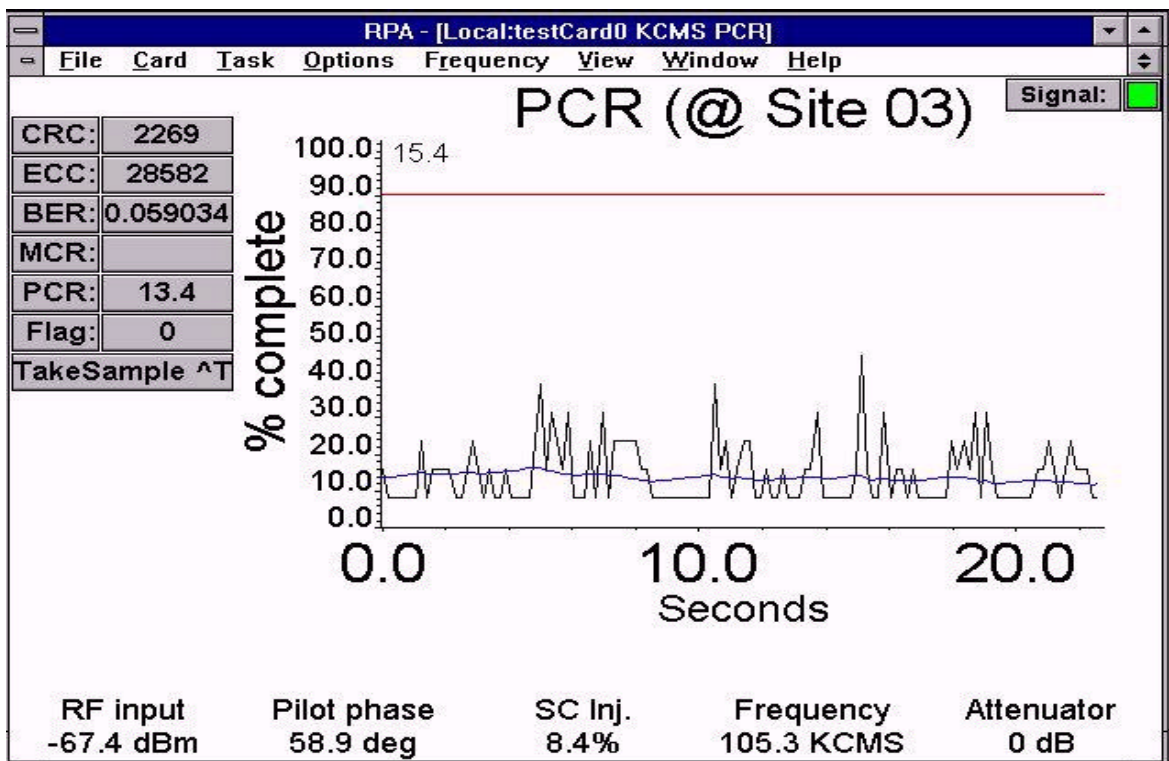
Figure 3-25. Suspected KCMS Multi-path Signal Measured at Site #3 with Omni Antenna.

There was an indication of multi-path problems from KCMS at this test location. The method used to determine if this interference could be mitigated was change receiver antennas on the TREQ system from the calibrated omni-directional dipole to the more directional FM antenna. By adjusting the signal attenuation to equalize the difference in gain between the two antennas, approximately 10 dB the effective directional pattern might reduce the sidelobe signals enough to improve the measured performance. Figure 3-25 shows the PCR performance for station KCMS, as measured by using the omni-directional antenna.

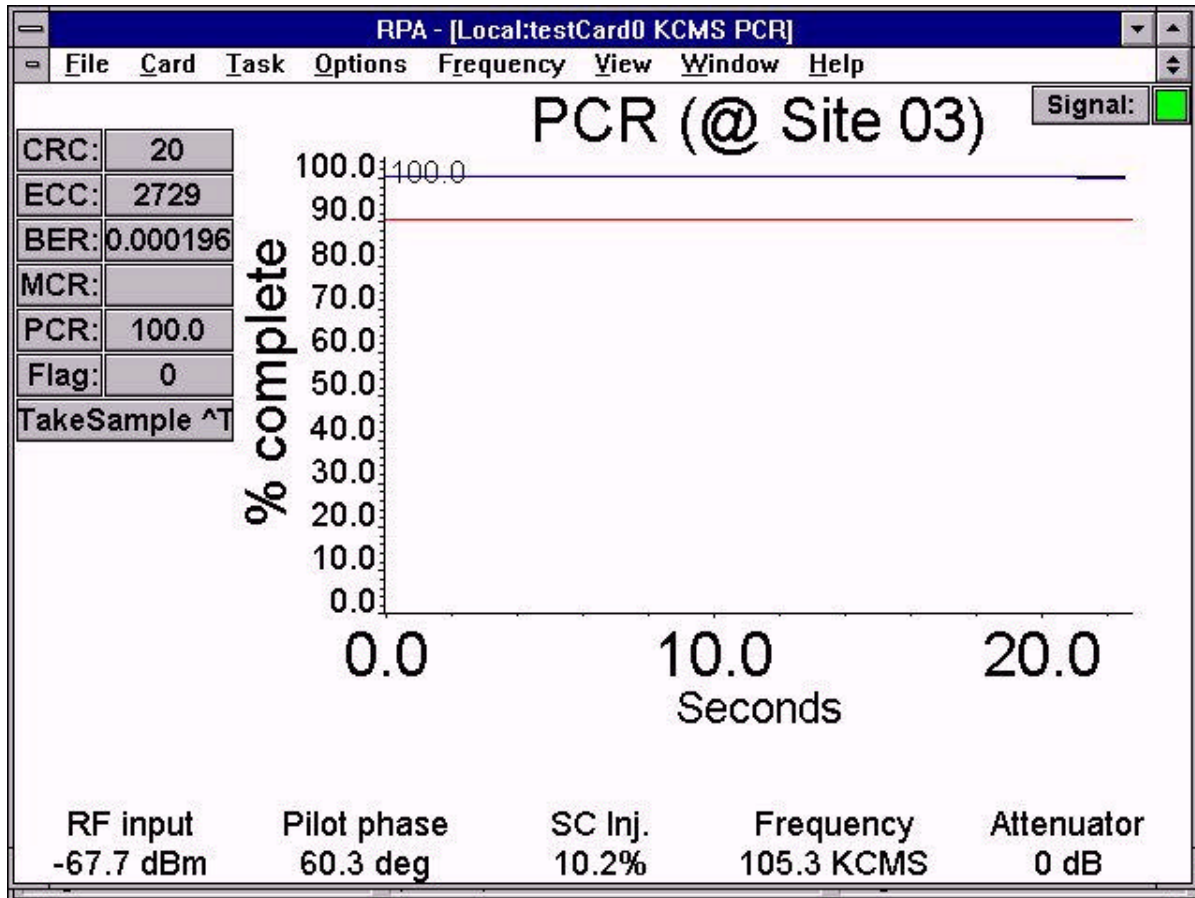
**Figure 3-26. Same KCMS Multi-path Signal Measured at Site #3 with Directional FM Antenna.**

The data recorded here is PCR and is shown to be about 10%, the effective BER is  $5.9\text{E-}2$ . When the directional antenna is connected to the TREQ signal input, the resulting improvement in PCR and BER reasonably suggests that the signal shown in Figure 3-25 was subjected to significant multi-path interference. This result is shown in Figure 3-26, below.

This result indicates the KCMS signal shows a greatly improved PCR, approaching 90% with the directional antenna. In addition, the resulting BER has now been reduced to an exceptionally low value of  $1.9\text{E-}4$ .

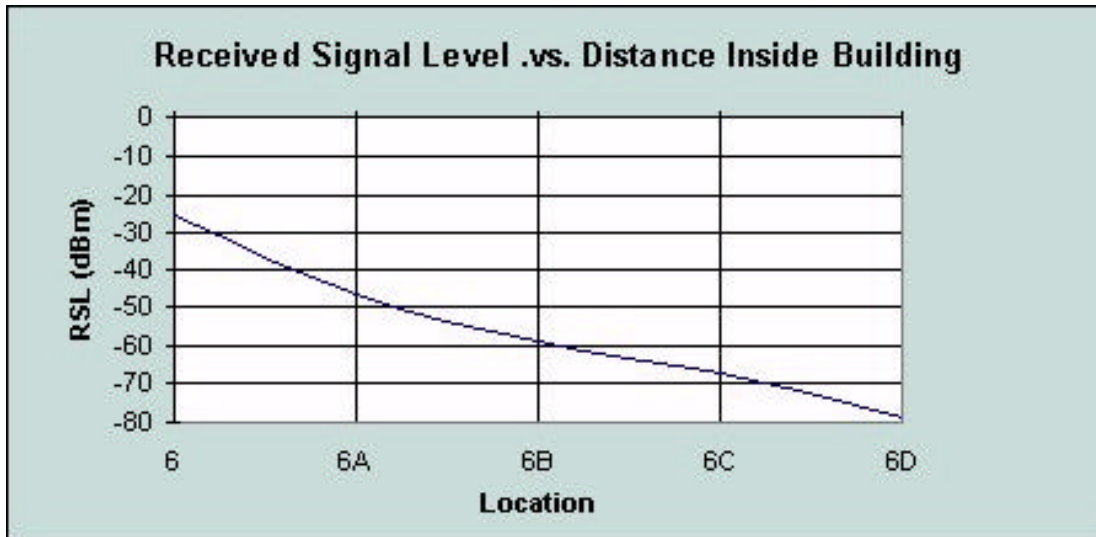
Figure 3-29. TSMC Inside Building Measurement of RSL at Four Locations.

Figures 3-29, 3-30 and 3-31 show the measurements taken at increasing distances inside WSDOT's TSMC building for RSL, BER and PCR, respectively. These curves confirm that the RSL, BER and PCR is degraded as distance inside the building increases.

These test measurements are useful in a general sense for predicting the effects of reductions in signal strength as the receiver is moved deeper into the building, away from the exterior walls. There are, however, many other variables which might influence this signal attenuation phenomenon. They are: building construction techniques and materials, frequency of signals being received, number, size and placement of windows, to name a few.

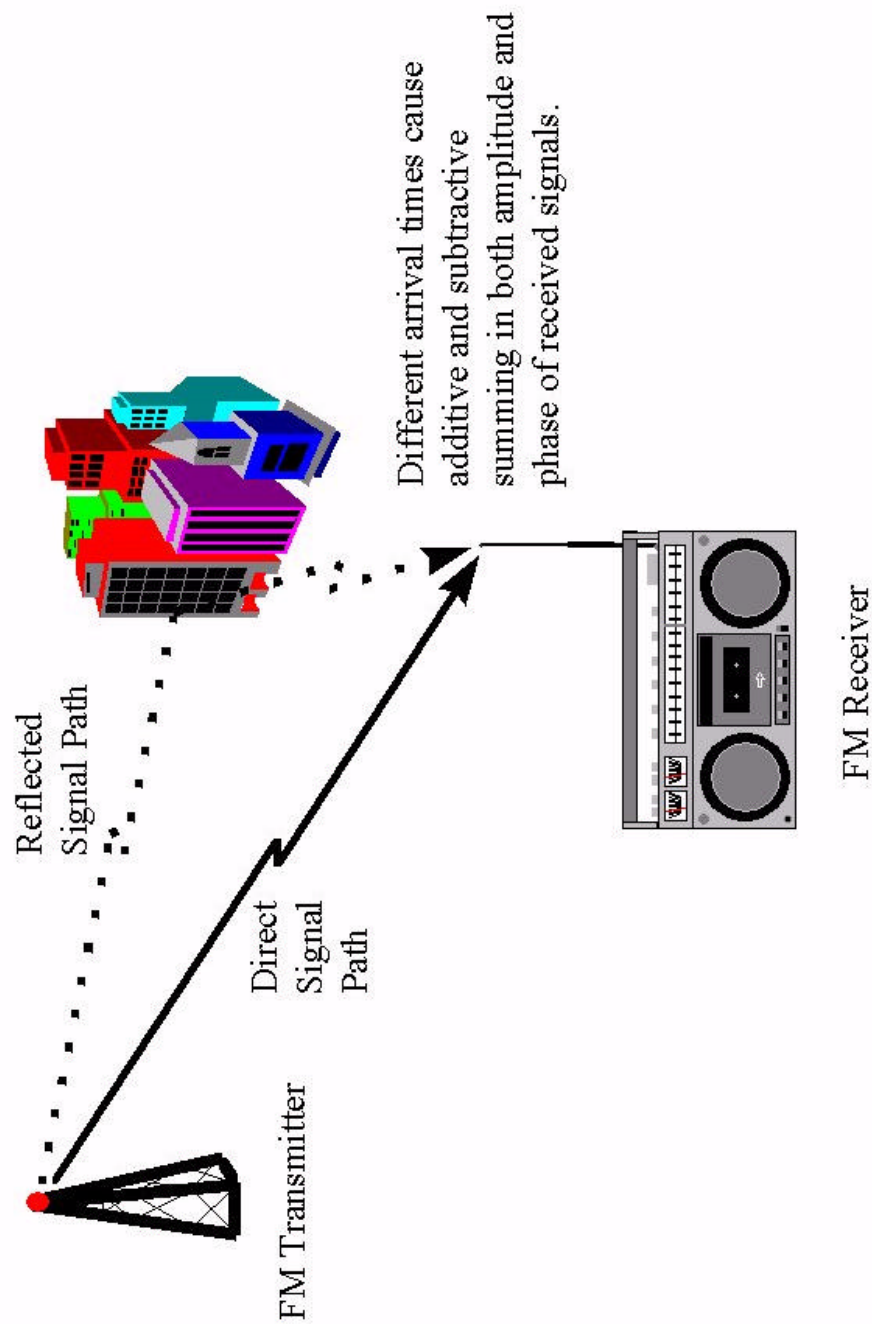
**Figure 4-1. Example of Multi-path Propagation Mechanisms.**

Even though the Seiko HSDS system performs reasonably well in the Seattle area, there are some regions where significant variations in terrain severely affect coverage. When this situation is found to be the case, it is recommended that more rigorous multi-path analyses and testing be performed in advance of system deployment. For example, where multi-path interference was observed in the tests, it was always associated with two/three high power stations. It is suggested that this multi-path problem might be mitigated by using a larger number of local, lower-power stations instead of higher-powered ones. A recommendation is made that further analysis into this issue be conducted and although it is uncertain how this may effect system costs, it is believed that coverage problems in these specific areas can likely be improved. Figure 4-1 illustrates one of several possible multi-path mechanisms.
