DOT HS 808 080  
Final Report

January 1994

**A Study of Commercial Motor Vehicle Electronics-  
Based Rear and Side Object Detection Systems  
Prepared in Response to:  
Section 6057: P.L. 102-240  
December 18, 1991  
Intermodal Surface Transportation Efficiency Act  
of 1991**

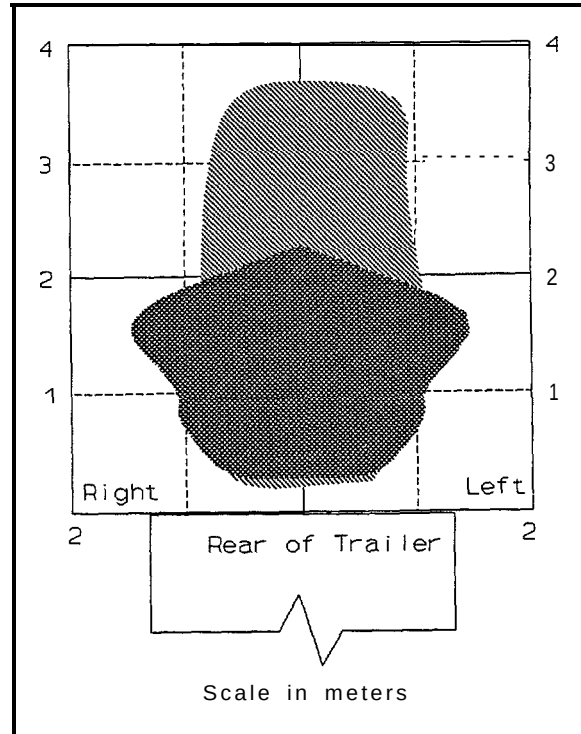
The shortest and longest detection zones measured for the cardboard target are shown in Figure 1. These zones cover most, but not all of the area immediately behind the trailer. The detection zone, however, did not extend beyond the sides of the trailer. The maximum rearward distance ranged from about 2.2 meters to 3.6 meters.

**Figure 1 Shortest and Longest Detection Zones to Cardboard Target Covered by Rear Object Detection Systems**

The results of the detection range measurements illustrate several aspects of device performance. The devices have a limited range of about 2 to 4 meters for detecting objects. The limited range helps prevent the devices from sounding an alarm at non critical objects far away from the backing vehicle. Because the range does not extend beyond the sides of the trailer, the devices will be less helpful to drivers in preventing backup crashes to objects that are moving into the path of the backing vehicle. The detection range varies from device to device and depends on the reflective characteristics of the object. Also, some devices were observed to exhibit day to day variability in detection performance. Because of this variability in object detection capability, drivers can not solely rely on device warnings to determine where objects are located. Thus, these devices supplement but do not substitute for the driver's need to be attentive when backing.

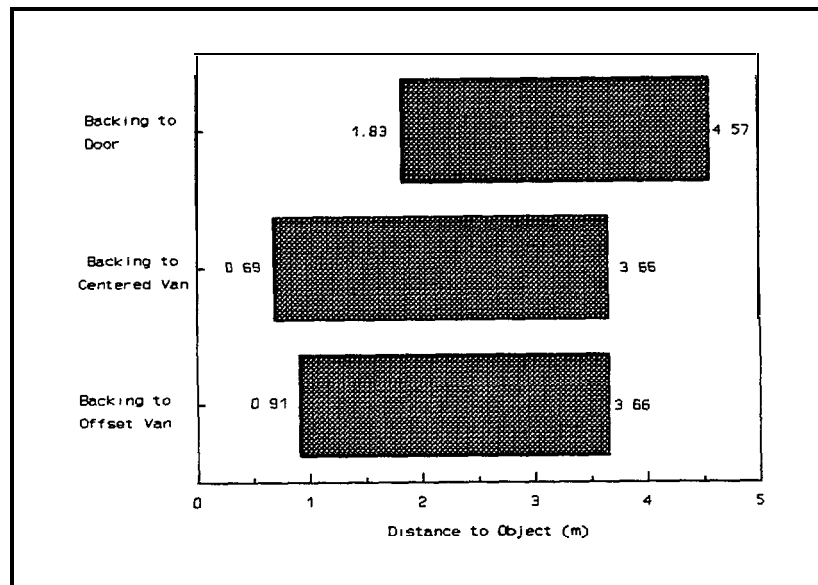
The range of distances at which the five different devices first detected the overhead garage door and van are shown in **Figure 2**. These distances are generally less than the cardboard detection distances.

**Figure 2 The Range of Maximum Detection Distances to Three Different Objects Provided by Five Rear Object Detection Systems**

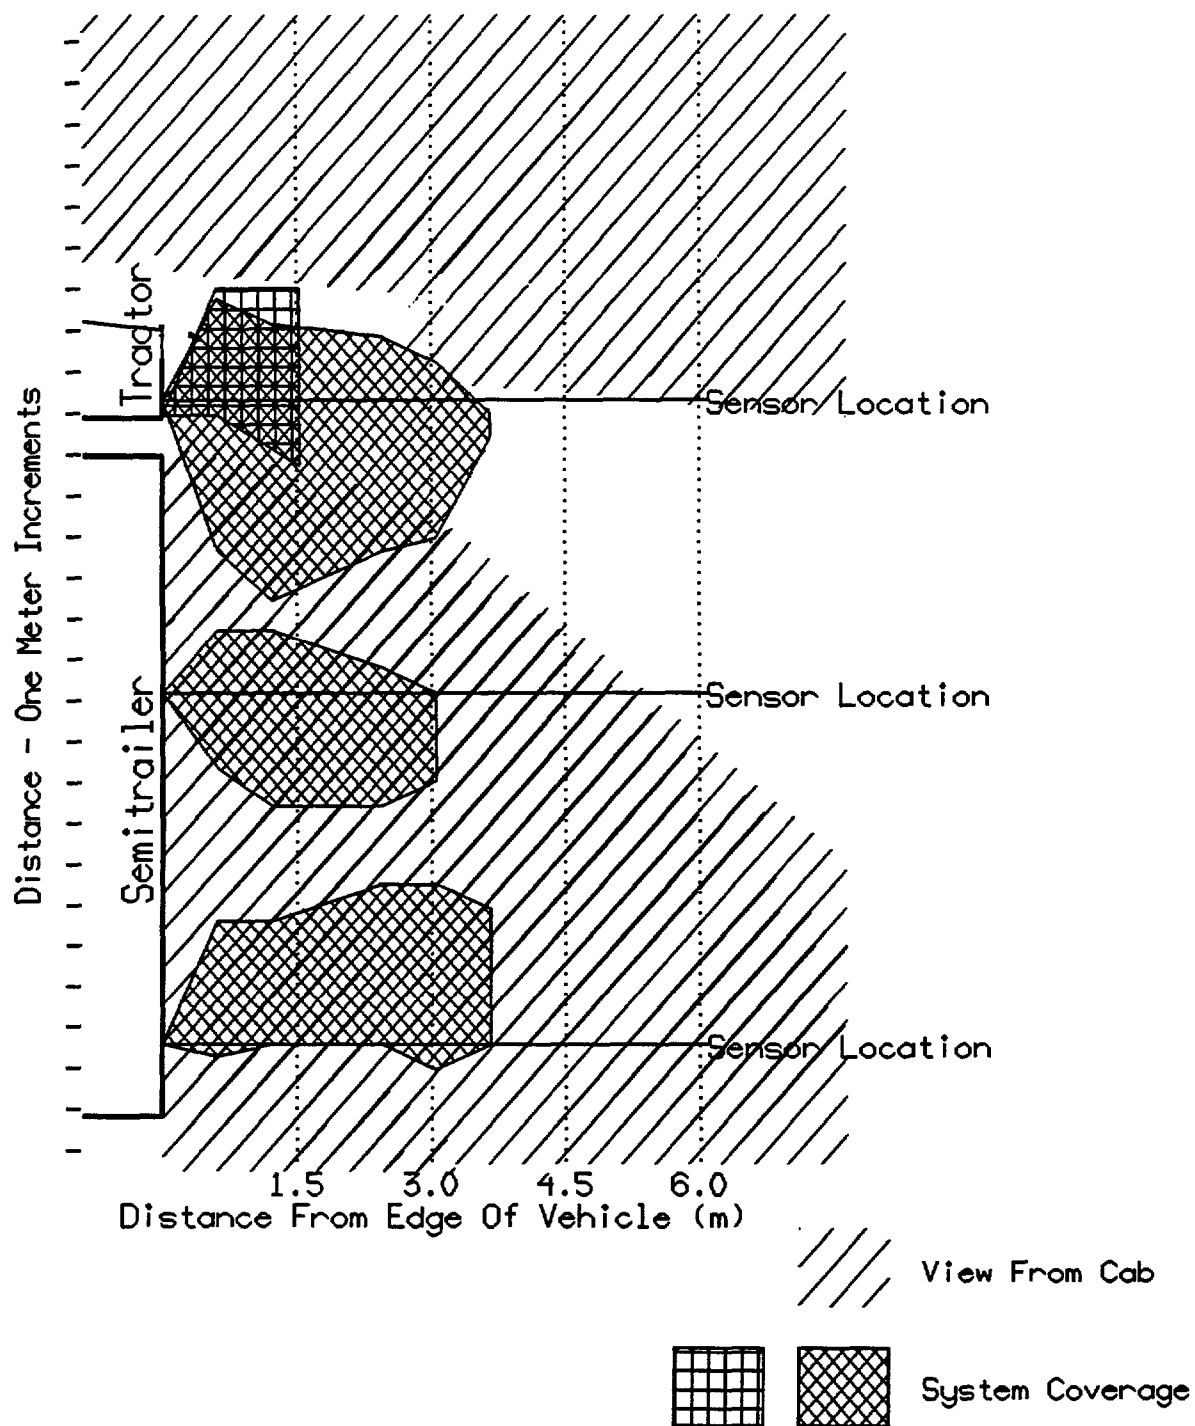
The passenger car detection zones for two right side object detection systems are shown in **Figure 3**. The figure is a schematic depiction of the right half of a tractor-semitrailer. The sparse, diagonal hatching in this figure shows the area over which a driver can detect an object with a height of 1.180 meters using either the right-side mirror system (consisting of a plane mirror and a 373-millimeter radius of curvature shallow convex mirror) or direct observation through the windows of the tractor cab. (The height of 1.180 meters corresponds to the height of the roof of a small car.) The area that is not covered by this sparse hatching is the area that is not visible either directly or indirectly, i.e., the so-called "blind spot."

The dense hatching shows the detection fields of each of the sensors of two, right-side object detection systems. The square hatching is an ultrasonic system; the diagonal hatching is a radar system. The fields were determined by locating the midpoint of a very slowly moving car when the vehicle was first detected by each sensor and when the sensor stopped detecting the vehicle. Note that the ultrasonic system uses only one sensor to detect adjacent vehicles while the radar system has three.

**Figure 3 Detection Zones of Two, Right-Side Object Detection Systems and Driver View From the Tractor Cab**

This figure shows that the coverage can overlap the existing area visible to drivers as well as the “blind spot” to the immediate right of the tractor.
