**KTC-90-16**  
**LOUISA BYPASS EXPERIMENTAL PROJECT**

Final Report

Kentucky Transportation Center  
College of Engineering  
University of Kentucky

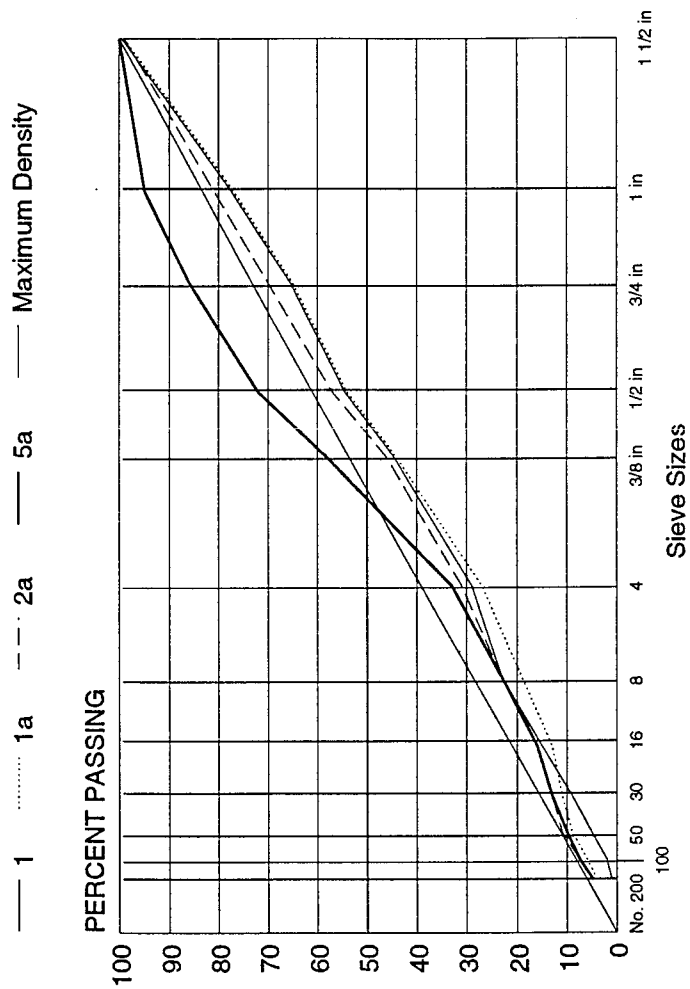
FIGURE 3. TRIAL LARGE-STONE GRADATION BLENDS

# GRADATION OF LAB TEST MIXTURES

SIEVE SIZES RAISED TO 0.45 POWER

Initially, 11 gradations were considered for laboratory testing. Each gradation was made by blending two or three coarse aggregates and one sand fraction. The blended gradations were within the Kentucky Class K Base specification limits. Figure 2 illustrates the Kentucky specification limits (1) for Class K Base large-stone mix.
