RDT 01-002C

# **Destructive and Non-Destructive Testing of Bridge J857 Phelps County, Missouri**

Volume III  
Strengthening and Testing to Failure  
of Bridge Piers

April, 2001

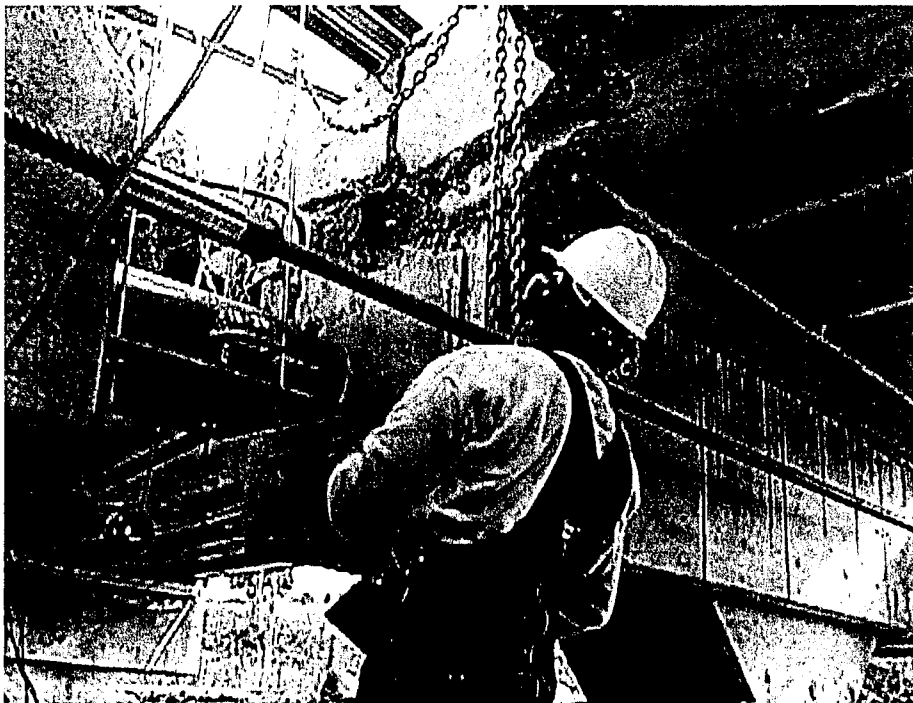
**Figure 3.9.** Placing the middle jack.
