**CORROSION RESISTANCE AND SERVICE  
LIFE OF DRAINAGE CULVERTS**

**State Job 99700-3335-119, WPI 0510756  
Contract No. B-9898  
Final Report to Florida Department of Transportation**

**Alberto. A. Sagüés  
Principal Investigator  
Department of Civil and Environmental Engineering  
August 20, 2001**

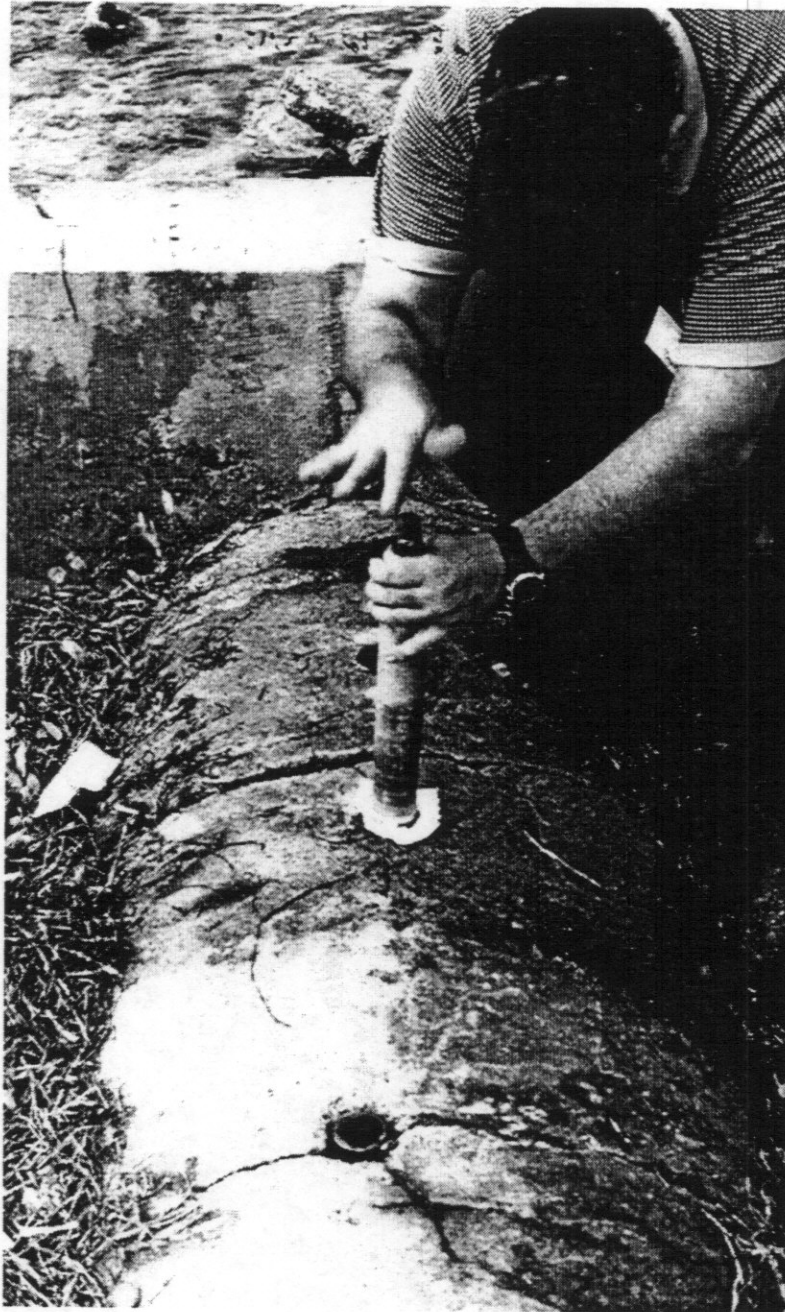
Figure 30. Site No. 7. End of San Jose Street. Low Tide. Core extraction. Evidence of pipe distress.

As shown by the chemical analysis information in Table 4, the water in locations 04 to 07 had a composition typical of seawater (with perhaps some minor dilution), and the soil next to the culvert showed significant seawater contamination in three of those locations. These extremely aggressive conditions are consistent with the evidence of pronounced corrosion seen at 3 of those sites. As expected, the sites where the Crown was below high tide (thus less likely to experience evaporative chloride concentration) have the best overall appearance and less evidence of rust in the rebar inside cores. The two sites with Crown above high tide had the most evidence of damage. Although all culverts examined appeared to be still fully functional, the condition at location 07 (estimated age 43 years) appears to be indicative of a structure approaching the end stages of its service life (See Figures 30 and 31).

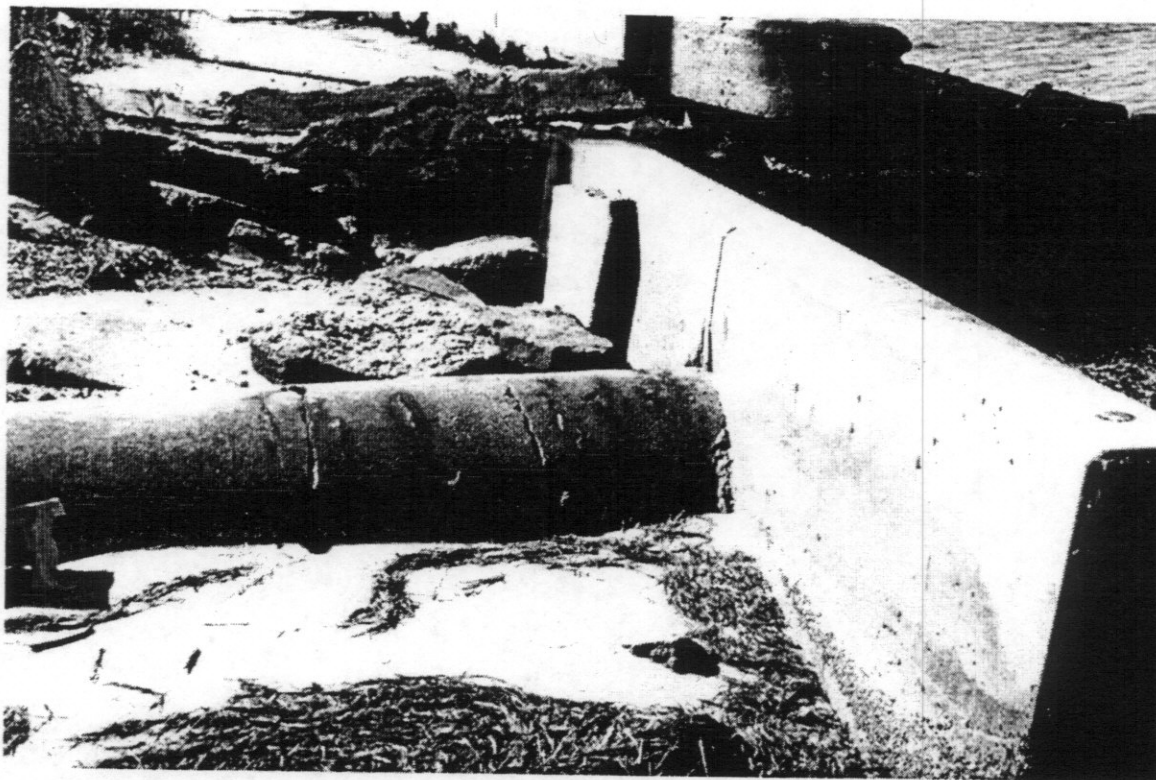
Figure 31. Site No. 7. End of San Jose Street. Low Tide. Side View.
