# 1999 Statewide Micro Surfacing Project

1. Report No. MN/RC - 2001-11		2.		3. Recipients Accession No.	
4. Title and Subtitle  1999 STATEWIDE MICRO SURFACING PROJECT			5. Report Date June 2001		6.

## Final Report

Thomas J. Wood and Gerard Geib  
Minnesota Department of Transportation  
Office of Minnesota Materials and Road Research  
Physical Research  
1400 Gervais Avenue  
Maplewood, MN 55109

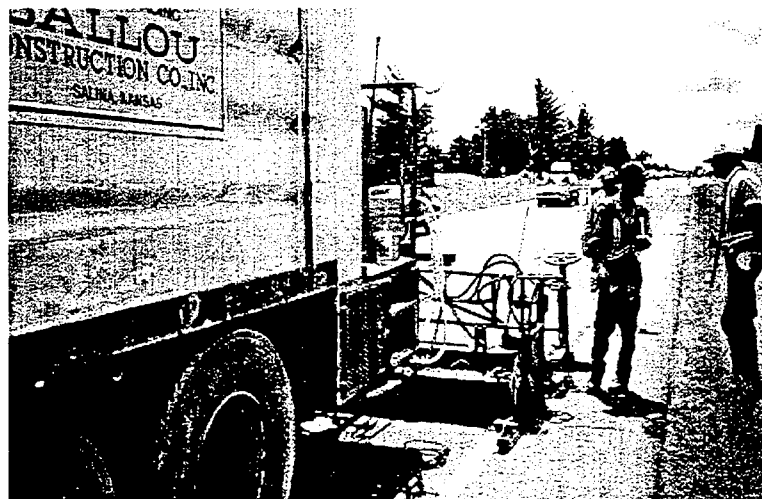
Photo 2

Front View of continuous Micro Surfacing Machine.

Micro Surfacing is made using a mobile mixing/paving machine hereafter referred to as a Micro Surfacing machine (Photos 1 & 2). MN/DOT's specification only allows use of a continuous Micro Surfacing machine; truck mounted Micro Surfacing machines are not allowed. This requirement is in place to limit the number of joints made in the surfacing project. The Micro Surfacing machine is supported by a fleet of supply trucks that carry aggregate, water, and emulsion to the Micro Surfacing machine (Photo 3). The Micro Surfacing machine is able to carry approximately 12 tons of aggregate, as well as all the other components. The supply trucks are located in front of the Micro Surfacing machine,

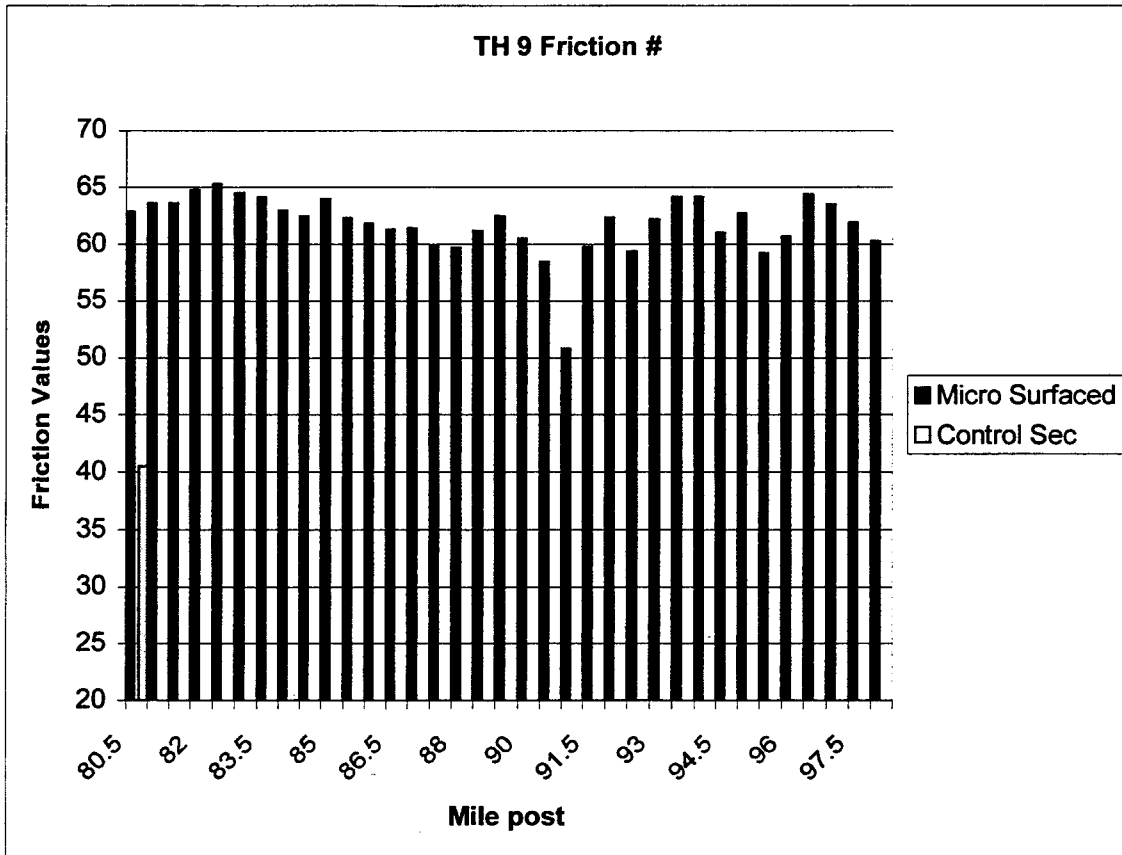
Graph 3

Early review in the late fall of 1999 has shown very fine cracks appearing on both edges of the routed crack sealant. The Micro Surfacing appears to have a strong bond to the crack sealant. Friction test were run on this

segment in the Fall of 1999 and shown that use of Micro Surfacing yielded a significant increase in the friction numbers (Graph 3).

Friction numbers for TH 9

approaches were Micro Surfaced to increase friction and eliminate accidents caused by icing. ISSA Type III (Table 1) was chosen for this project because of its larger size. The early friction numbers on I-94 are in the low 40's. It appears that the macro texture furnished by this size aggregate is too rough to generate accurate friction numbers with Mn/DOT's testing equipment. Friction testing was only completed on TH 9 and I-94 in the fall of 1999. All of the sections will be tested on an annual basis to determine how wear from traffic affects the friction values (Graph 3).
