# PREVENTING CRACKING AT DIAPHRAGM/PLATE GIRDER CONNECTIONS IN STEEL BRIDGES

Sponsored by the  
Iowa Department of Transportation  
and the Iowa Highway Research Board  
Iowa DOT Project HR-393

JUNE 1998

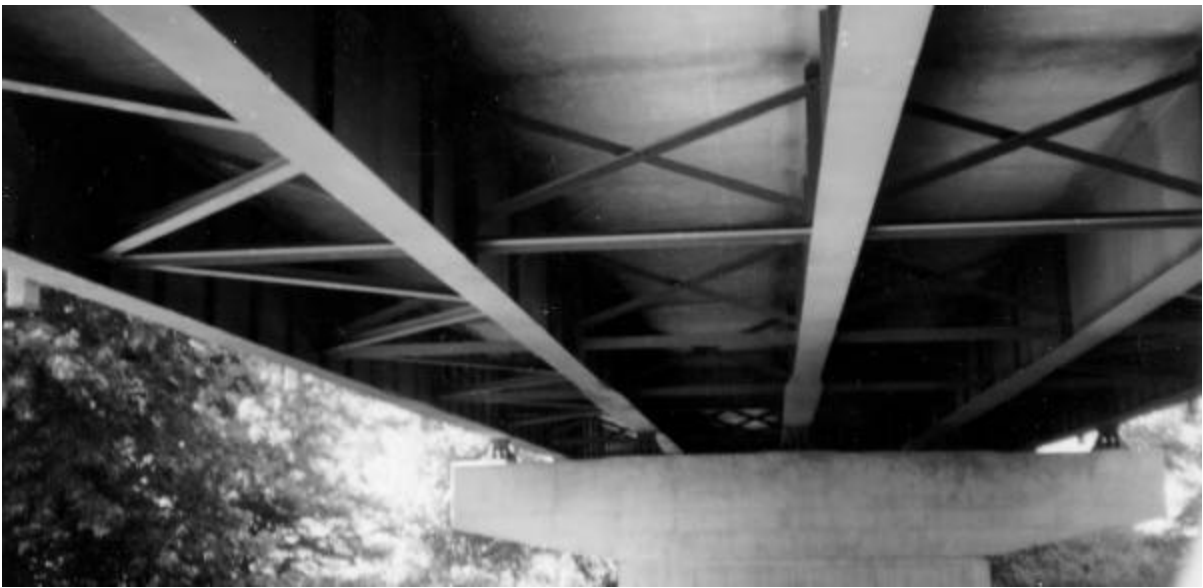
(a) Overview and roadway

(b) Diaphragm system

Figure 2. Boone River Bridge on IA-17 (Bridge X1)

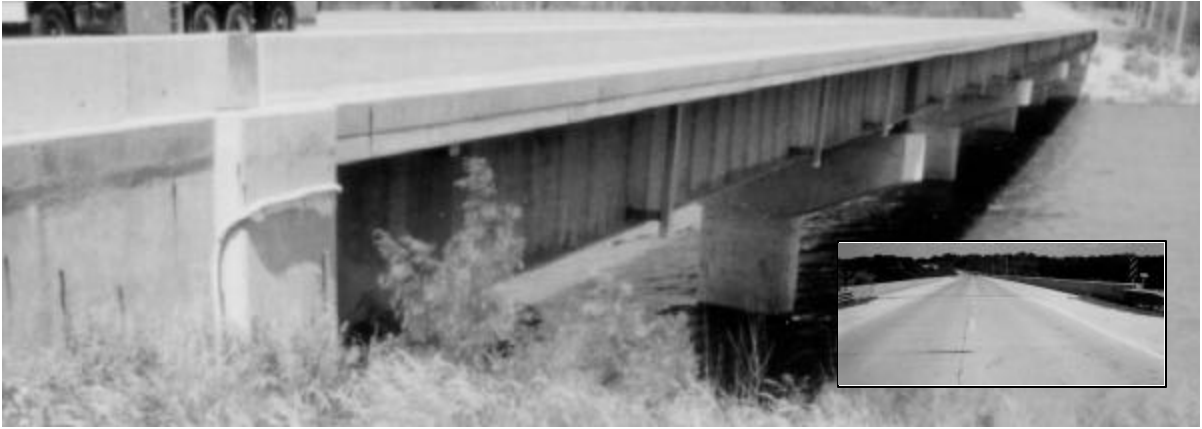
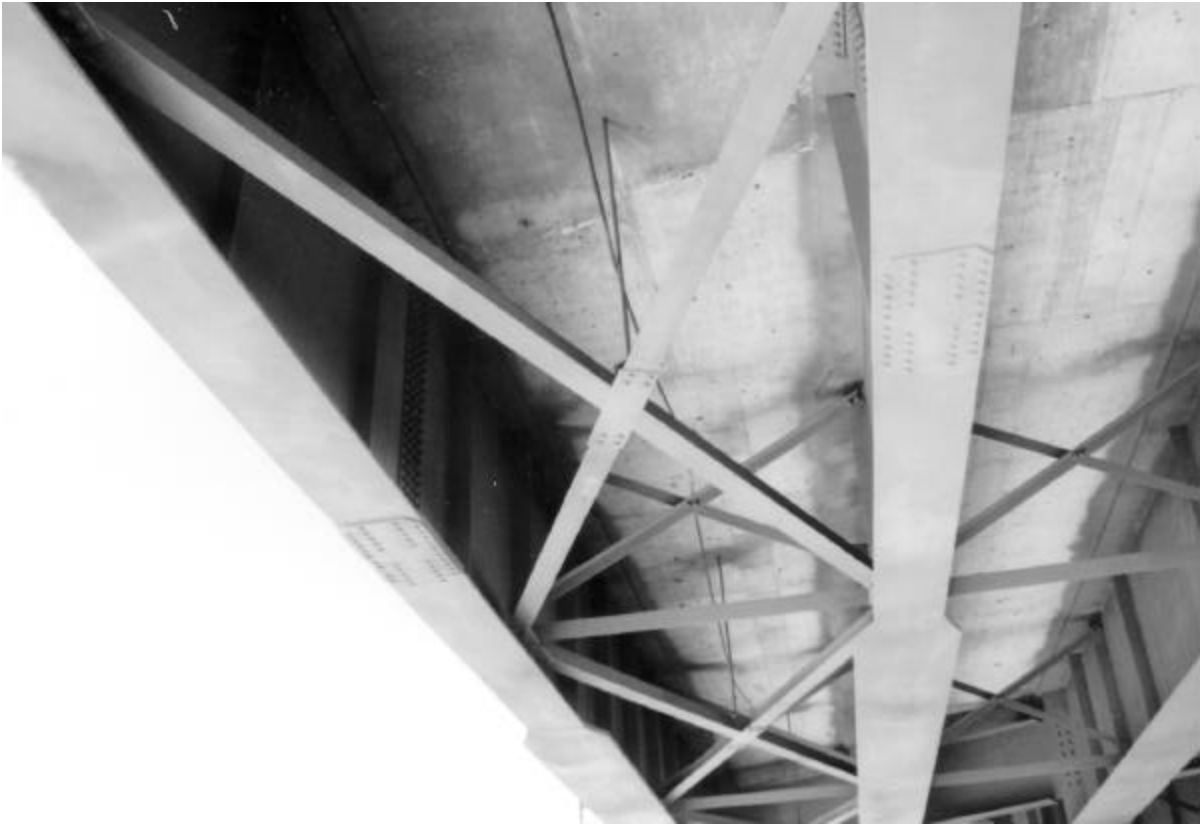
(a) Overview and diaphragm system

(b) Roadway

Figure 3. Des Moines River Bridge on IA-210 (Bridge X2)

The Des Moines River Bridge (Br. No. 0804.9S210) carries Iowa Highway 210 (IA-210) over the Des Moines River west of Madrid in Boone County (Figure 3). The roadway

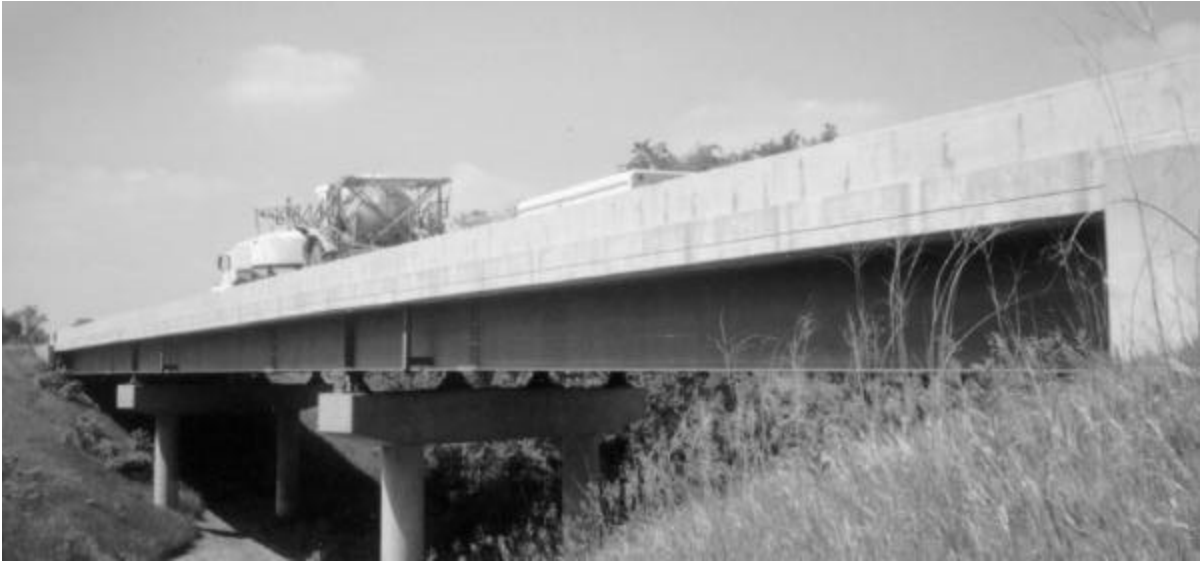
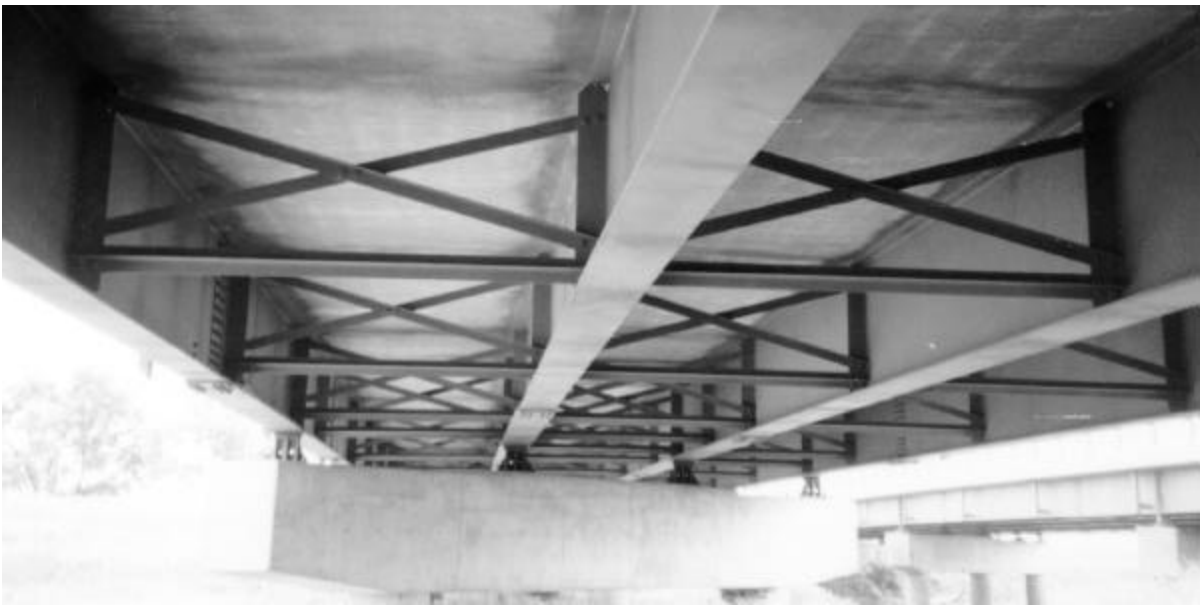
(a) Overview

(b) Diaphragm system

Figure 4. The I-80 Bridge no. 7804.8L080 (Bridge X3)

This bridge (Br. No. 7804.8L080) is located in Pottawattamie County, 3.7 miles (5.9 km) west of the junction of Interstate 80 (I-80) with U.S. 6 Highway. It carries the westbound traffic of I-80 over an abandoned railroad (Figure 4). The bridge was constructed in 1965. The superstructure consists of four continuous steel plate girders topped by a reinforced concrete deck slab. The girders have three spans of 91.5, 117, and 91.5 ft (27.9, 35.7, and 27.9 m), respectively, with a lateral spacing of 9 ft-8 in. (2.9 m) and a total bridge width of 32 ft (9.8 m). The bridge has X-type diaphragms spaced at approximately 22 ft (6.7 m) intervals. The bridge superstructure is skewed  $30^\circ$ , and its supporting two piers and two stub reinforced concrete abutments are supported on piles. Vertical stiffeners are provided at intervals that do not exceed 3 ft-7 in. (1.1 m). Stiffeners are closely fitted to the tension flange with an average web gap height of 1.75 in. (44 mm). Fatigue cracks have been detected in the web gap region at nine locations. As a retrofit, holes were drilled at the crack tips. However, the cracks extended beyond the drilled holes in some locations. Crack extensions were treated by drilling holes at the new crack tip locations. The last fatigue-type inspection of the bridge was in September 1995. The bridge was tested on July 29, 1997. This bridge is referred to as Bridge X3.

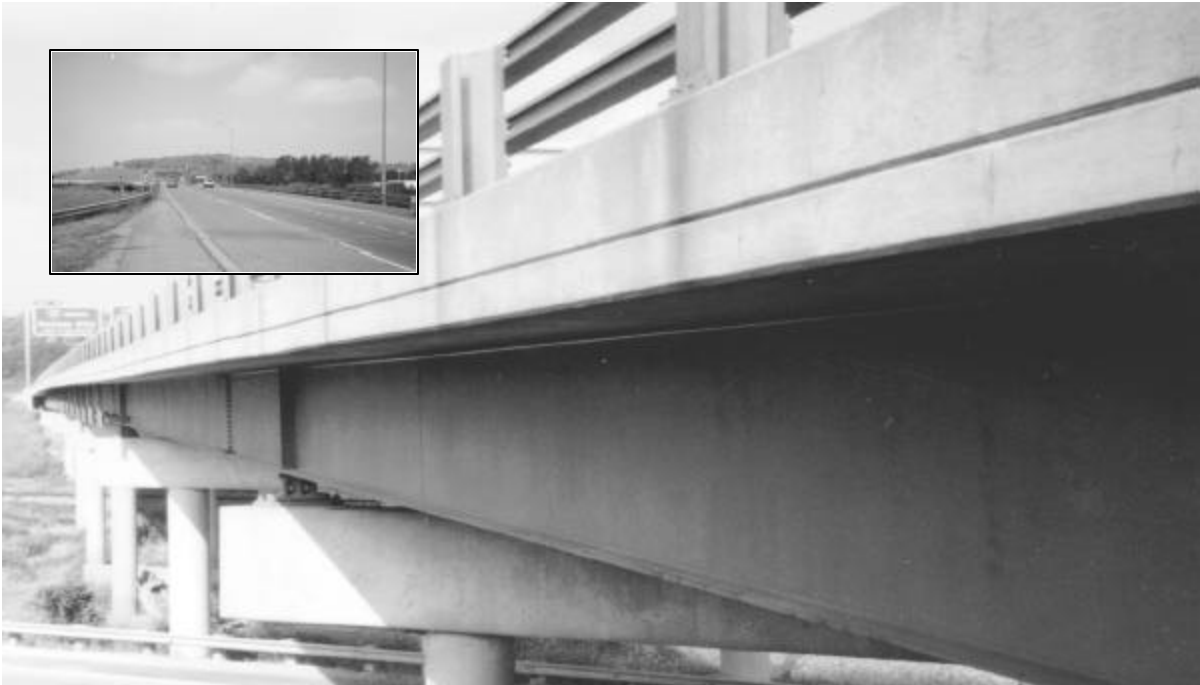
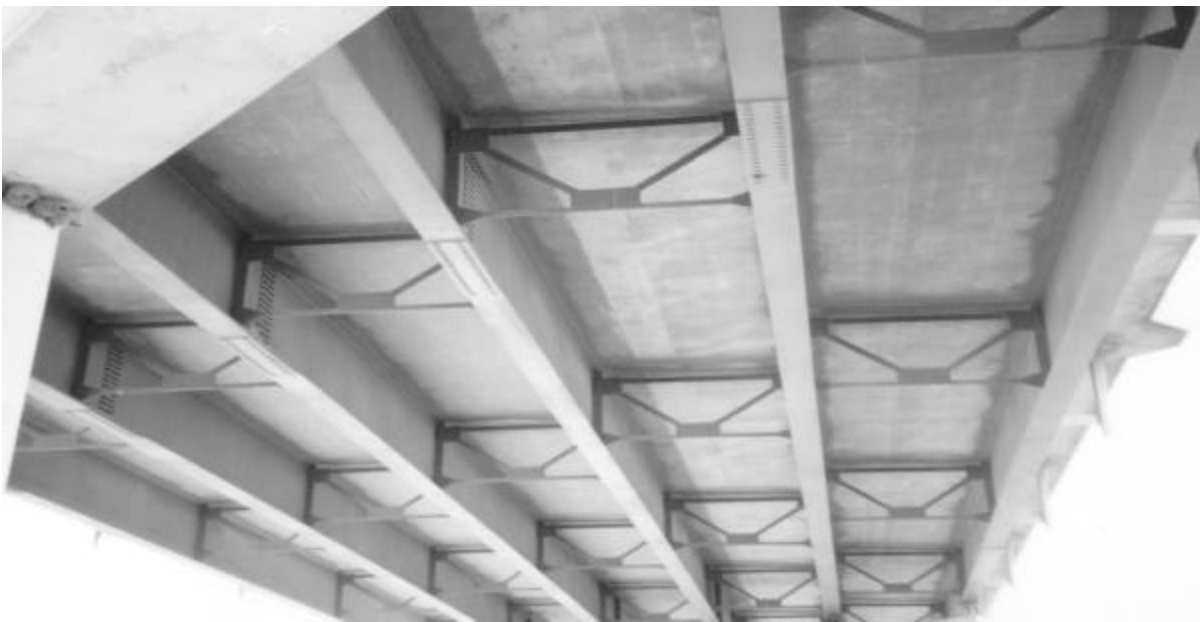
(a) Overview and roadway

(b) Diaphragm system

Figure 5. The I-80 Bridge over the Mosquito Creek (Bridge K1)

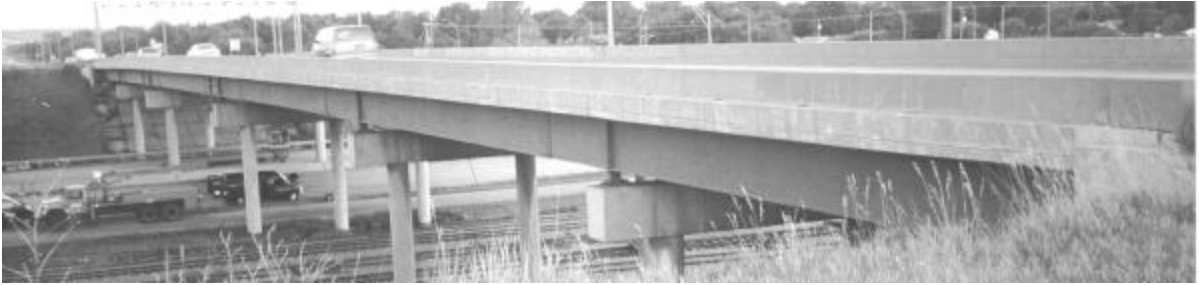
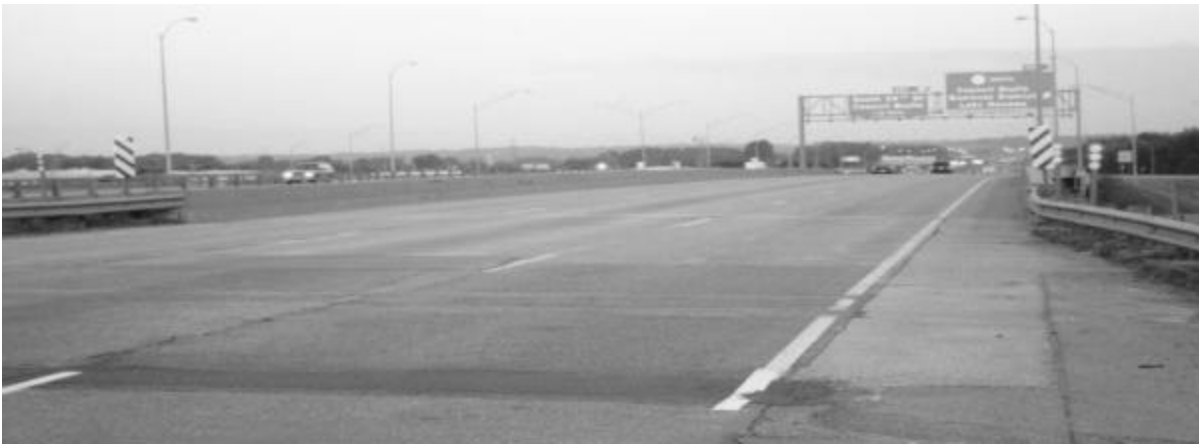
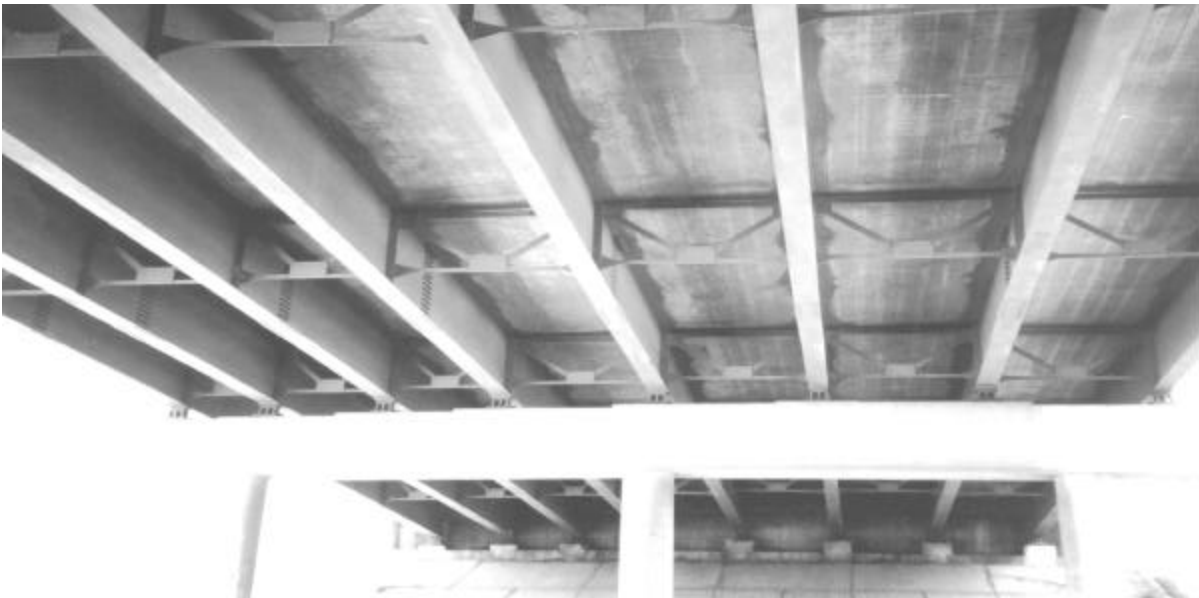
(a) Overview

(b) Roadway

(c) Diaphragm system

Figure 6. The I-80 Bridge over IA-192 (Bridge K2)

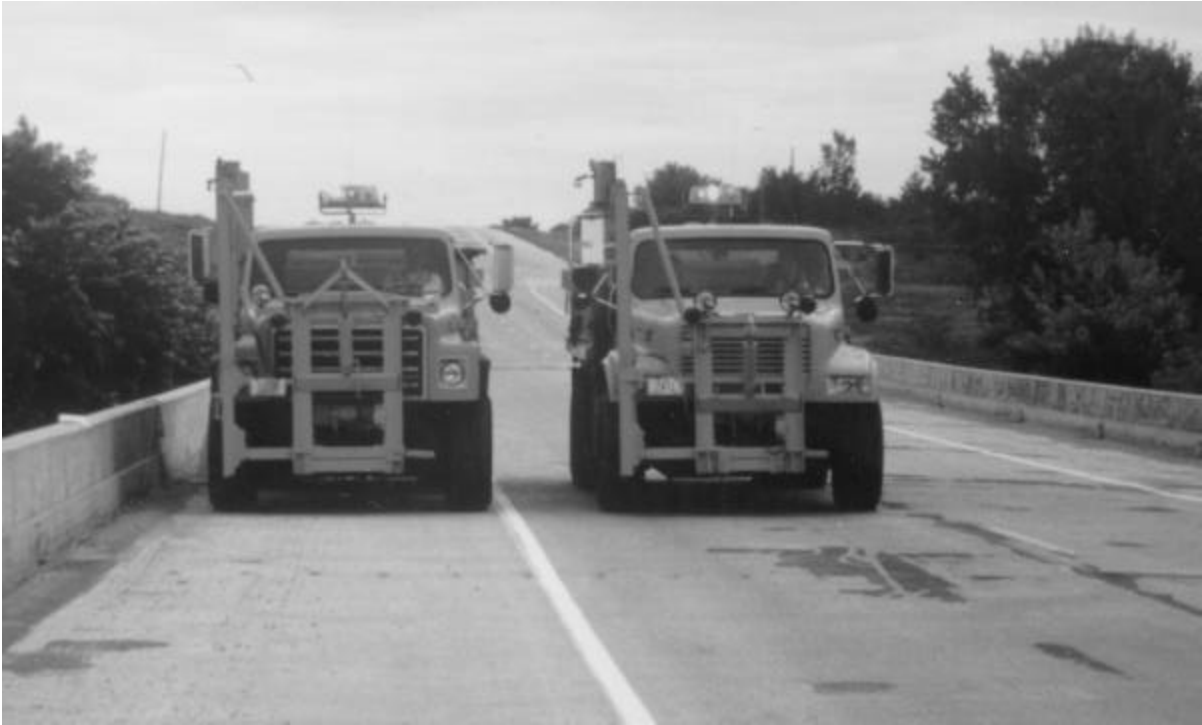
Figure 7. Trucks used for testing Bridge X1

The Iowa DOT provided two loaded rear tandem axle trucks for each bridge (see Figure 7 for trucks used for testing Bridge X1). The majority of the tests (described later) utilized only one truck traveling on the bridge in different lanes and shoulders at speeds varying from 5 mph (8 km/h, crawl speed) to more than 60 mph (96 km/h). For two bridges, however, the two trucks were run side by side in a few tests at the crawl speed. Different trucks were used during tests on different bridges; however, the dimensions and weights were consistently similar. Before testing, each truck was measured and weighed. The gross truck weight ranged from 49 kips (220 kN) to 53 kips (238 kN). Table 1 lists the front axle, rear axle, and gross weights of the test trucks. Although not reported here, additional data were collected during ambient heavy truck traffic.

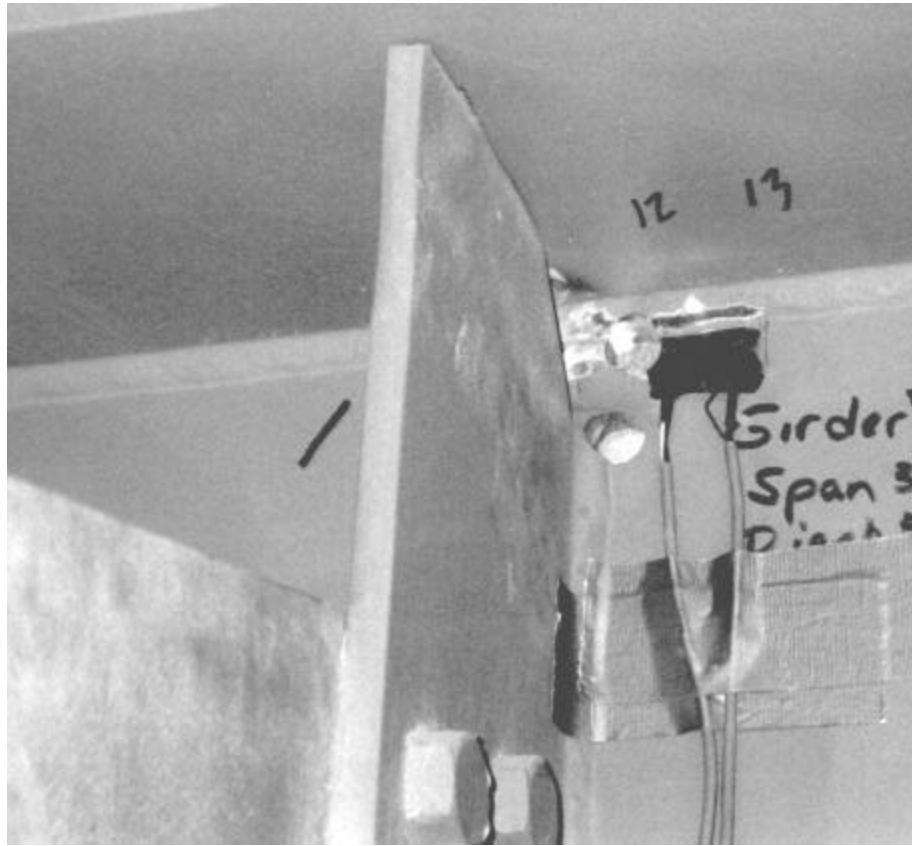
(a) Overview

(b) Drilled holes and cracks

Figure 16. Crack and drilled holes at Location HX3
