# **REPORT TO CONGRESS**

## **School Bus Safety: Crashworthiness Research**

**April 2002**

**Research and Development  
National Highway Traffic Safety Administration**

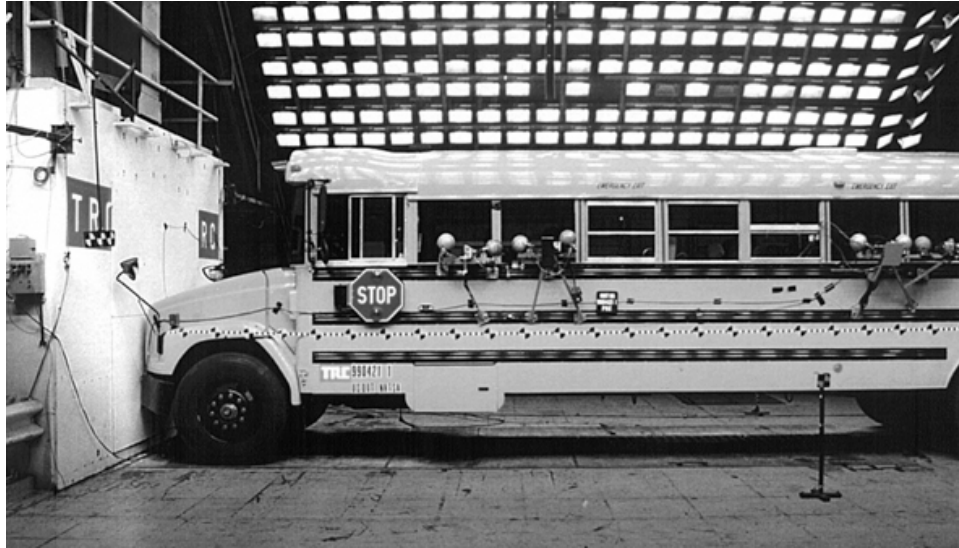
**Figure 1. Pre-Crash Photograph of Frontal School Bus Test.**

Figure 1 shows the pre-impact conditions for the test. Figure 2 presents the final resting position of the bus after the impact with the rigid wall.

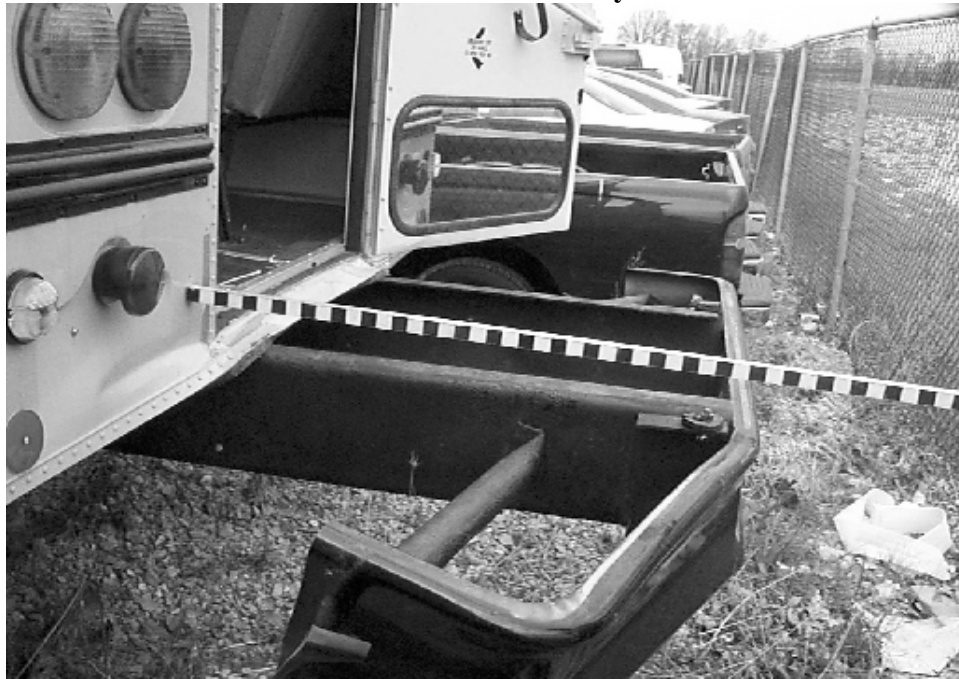
**Figure 3. Post-Test Photograph of Frontal Test Showing Body to Frame Movement**

As typical of large school bus manufacture, the body of the bus is mounted to the frame rails of the chassis by a series of clips or clamps. As shown in Figure 3, this non-rigid mounting feature allowed the bus body to slide forward approximately 36 inches (92 cm) during impact. This dissipation of impact energy over a longer time duration acted to reduce the interior contact speeds and resulting acceleration levels on the vehicle's occupants.

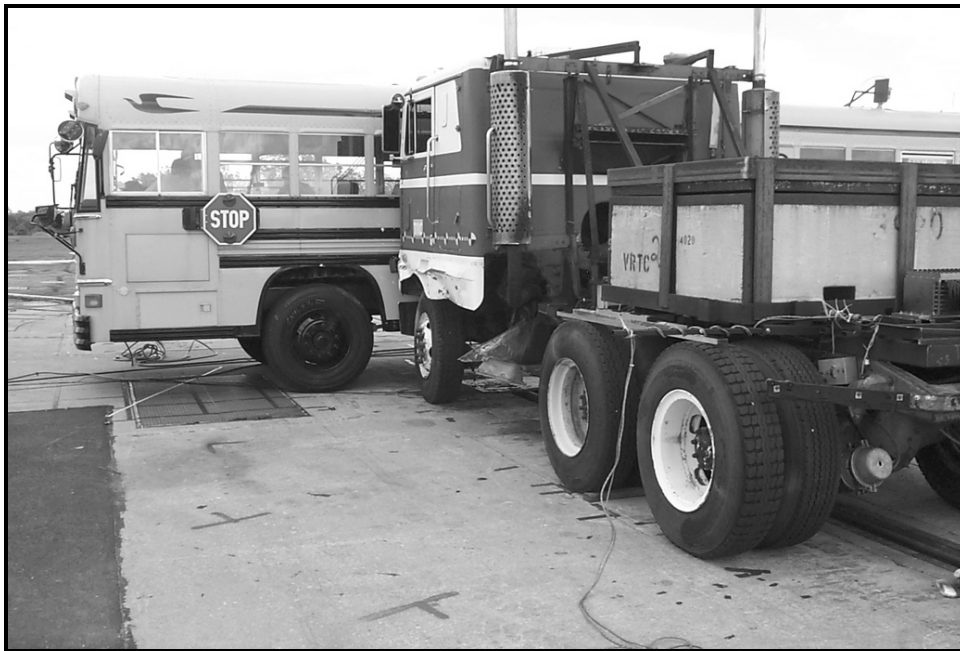
**Figure 7. Pre-Test Photograph of Side Impact School Bus Crash Showing Bullet Truck**

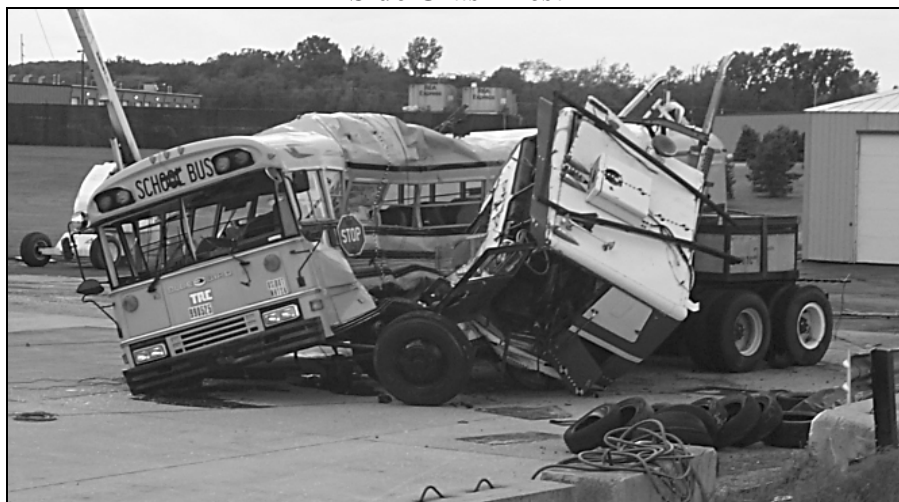
**Figure 8. Post-Test Photograph Showing Final Resting Positions**

A post-impact photograph showing the post-crash positions of the school bus and truck is contained in Figure 8. During impact, the truck penetrated the bus side approximately half way into the compartment, and remained engaged while rotating 180 degrees before coming to a stop. The front axles were severed from both vehicles as seen in Figure 8.

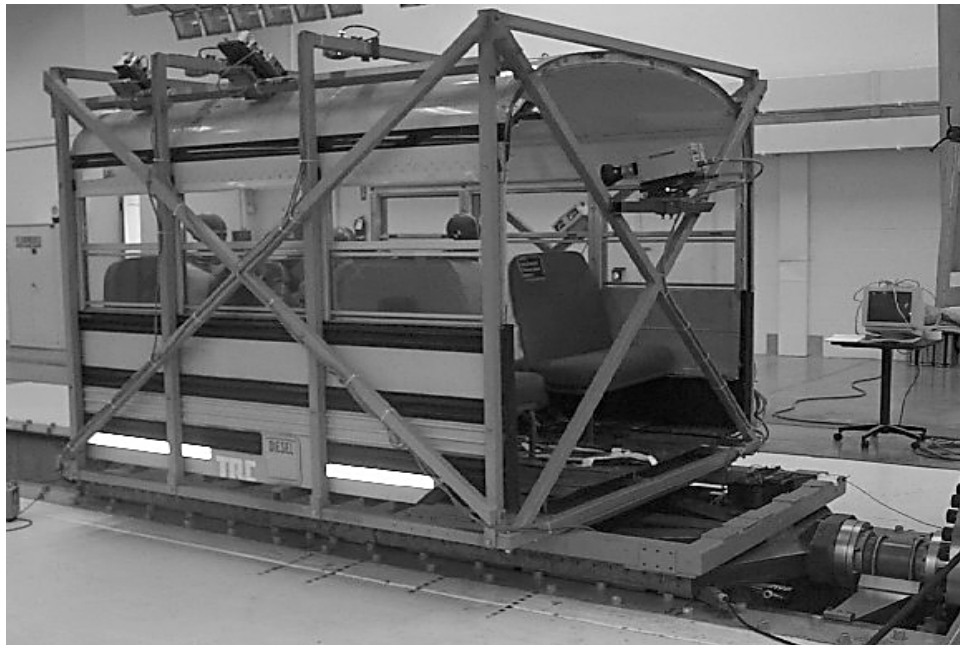
**Figure 11. First Sled Buck used in Simulating Frontal Crashes**

Sled tests were conducted using two different test bucks to evaluate bus safety restraint systems. The first test buck was fabricated by mounting a section from the body of the school bus on the sled. This was done to assess the degree of deformation/energy absorption by the bus floor and its interaction with the seats, and to assess any potential for occupant interaction with portions of the interior other than the seats themselves. The finished test buck is shown in Figure 11. The bus body section contained three rows of seats on both the right and left side of the center aisle. This allowed for testing a maximum of 2 rows of dummies per test.

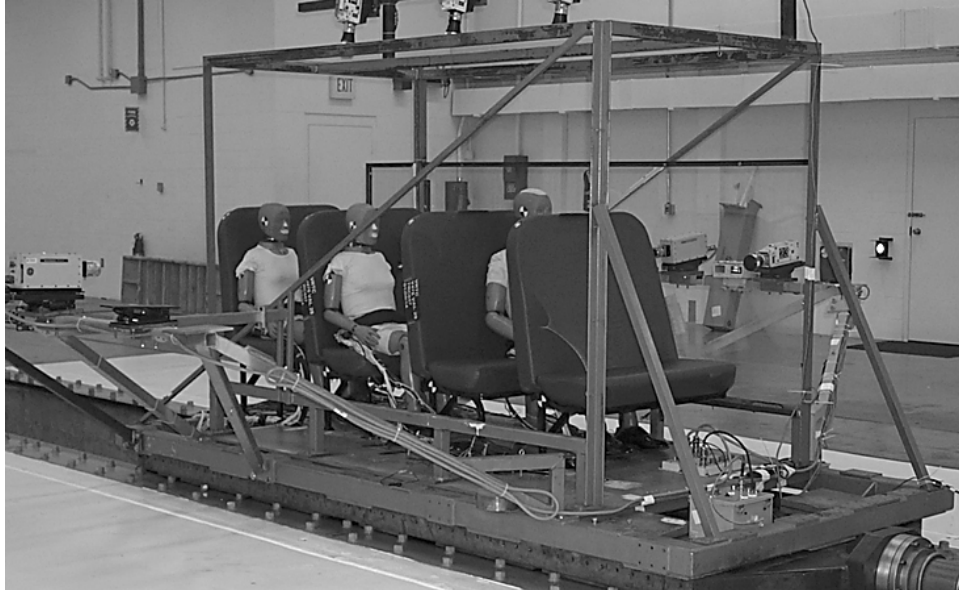
**Figure 12. Second Sled Buck used in Frontal Crashes**

floor of the bus shell from loading by the mounted bus seats<sup>14</sup>. Thus an open frame, rigid floor, sled buck was used to provide a more consistent test platform. It allowed for better high speed imaging of the test event, which resulted in better analyses of the dummies and their interaction with the bus seats and restraint systems. Figure 12 is a photograph of the modified sled buck used in the second test series.

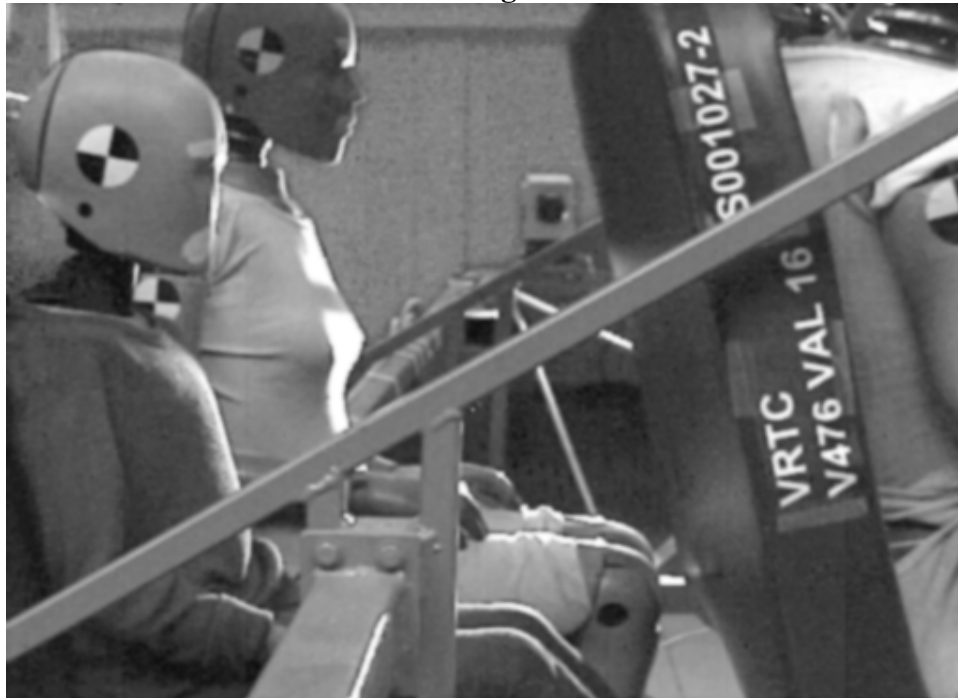
**Figure 16. Initial Position of the 6-year-old and 5th Percentile Female Dummies**

With the onset of the test, the dummy slides forward on the bench seat. The dummy remains in an upright-seated position until the knees of the dummy strike the seat back in front of it. At this point the upper torso begins to rotate forward and downward. The dummy's head strikes the seat back, pushing the head backward which bends the neck. Figure 17 is an image taken at 100 milliseconds into the crash event at the point of knee contact.

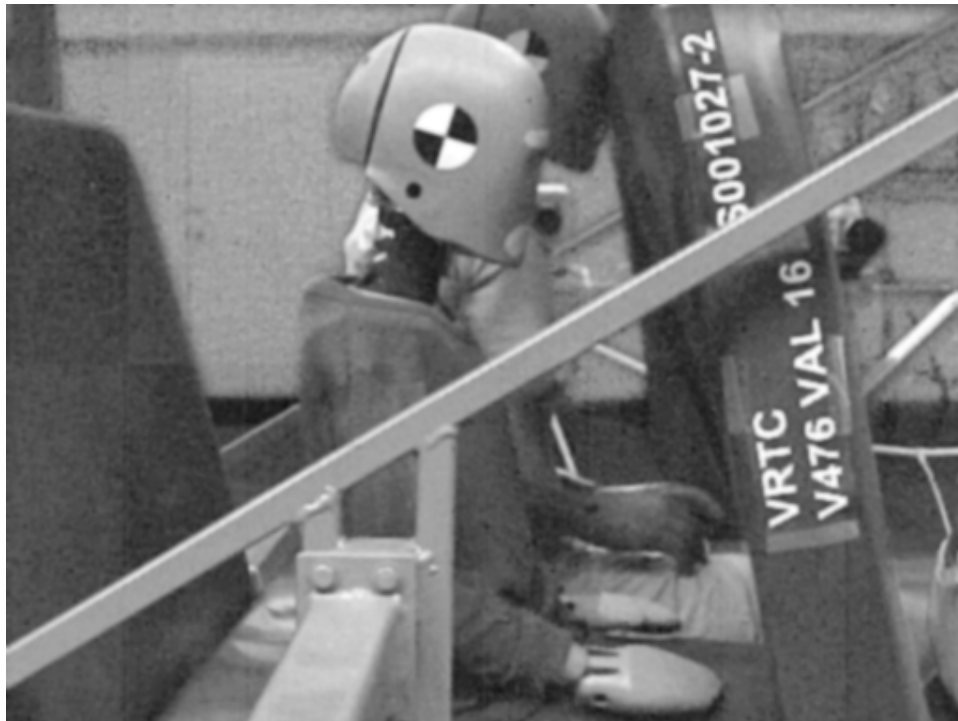
Figure 17. Compartmentalization Test, Knees make Contact with Seat Back at 100 msec

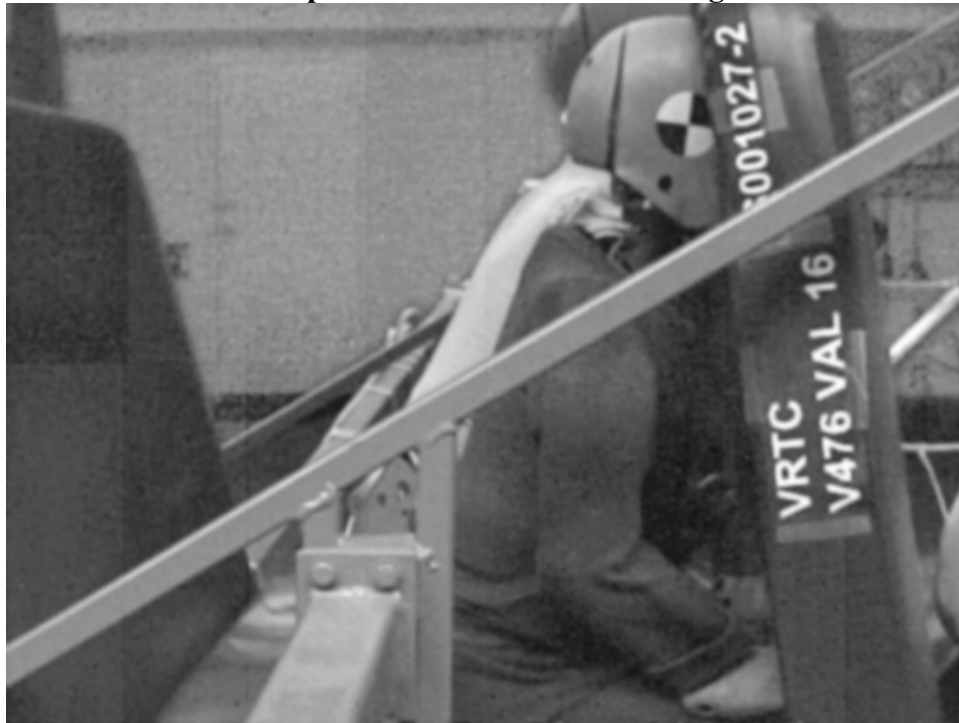
Figure 18. Compartmentalization Test, Upper Body Pivots and Head Contacts at 150 msec

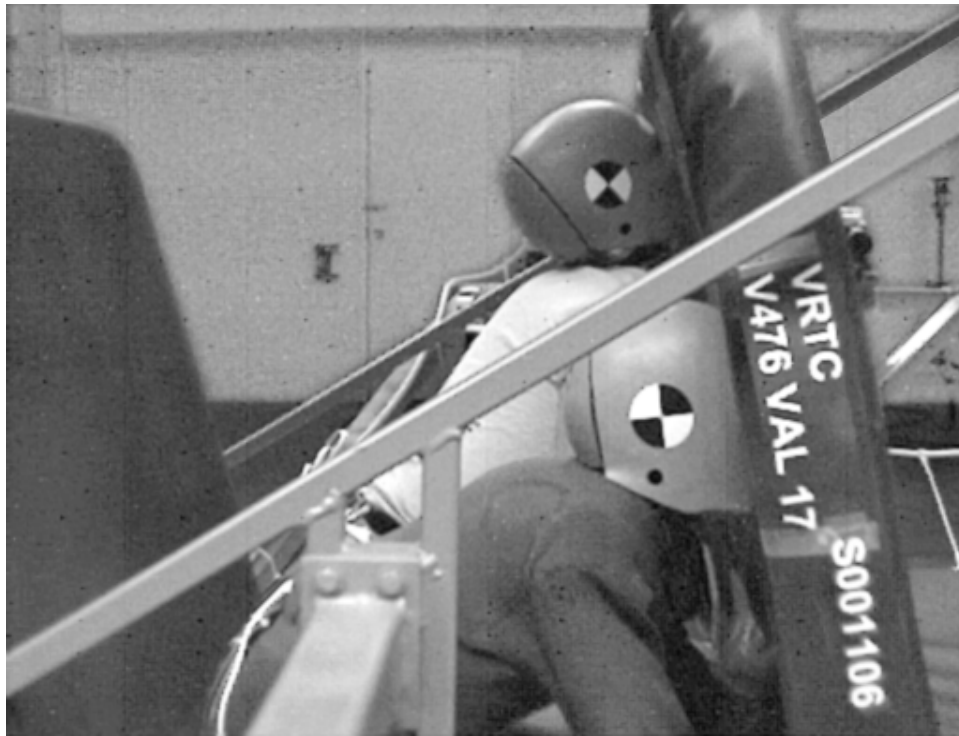
Figure 20. Lap Belt Test at Maximum Neck Extension, 150 msec

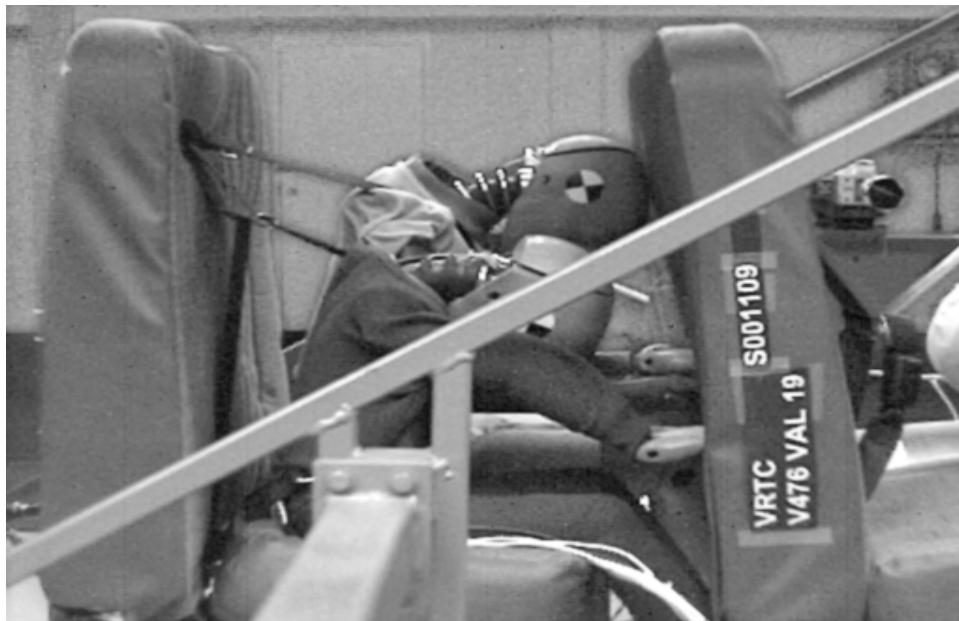
Figure 21. Lap/Shoulder Belt Test at Maximum Neck Flexion

The lap/shoulder belt restraint systems typically prevented head impact into the seat back. The few exceptions with the 50<sup>th</sup> percentile male dummy resulted in very minor impacts with low resulting injury criteria values. As seen in Figure 21, a 5<sup>th</sup> percentile female and 6-year-old dummy were restrained properly with the lap/shoulder belt systems. The injury criteria values observed were the results of inertial loading on the head and neck as they snapped forward when the torso was restrained by the restraint system.
